WPR24FA227

## INVESTIGATION PHOTOGRAPHS

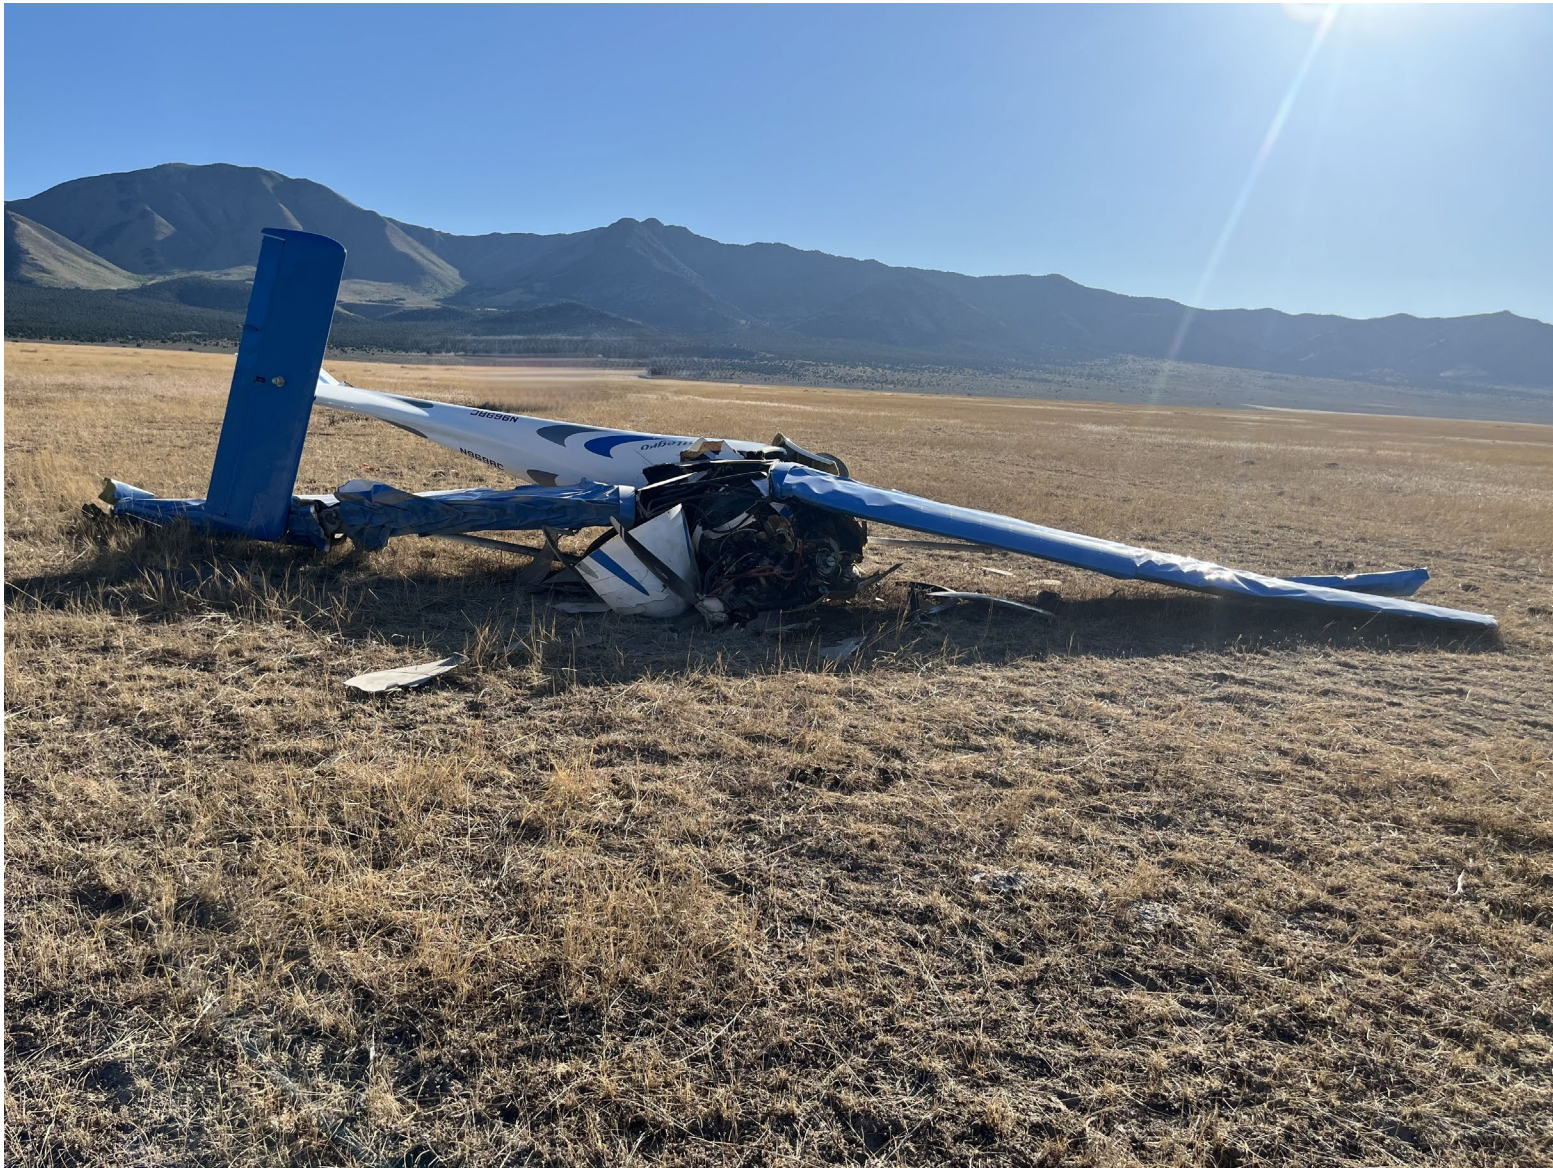
**Photograph 1 - View of accident site (Courtesy of Utah Co Sheriff)**

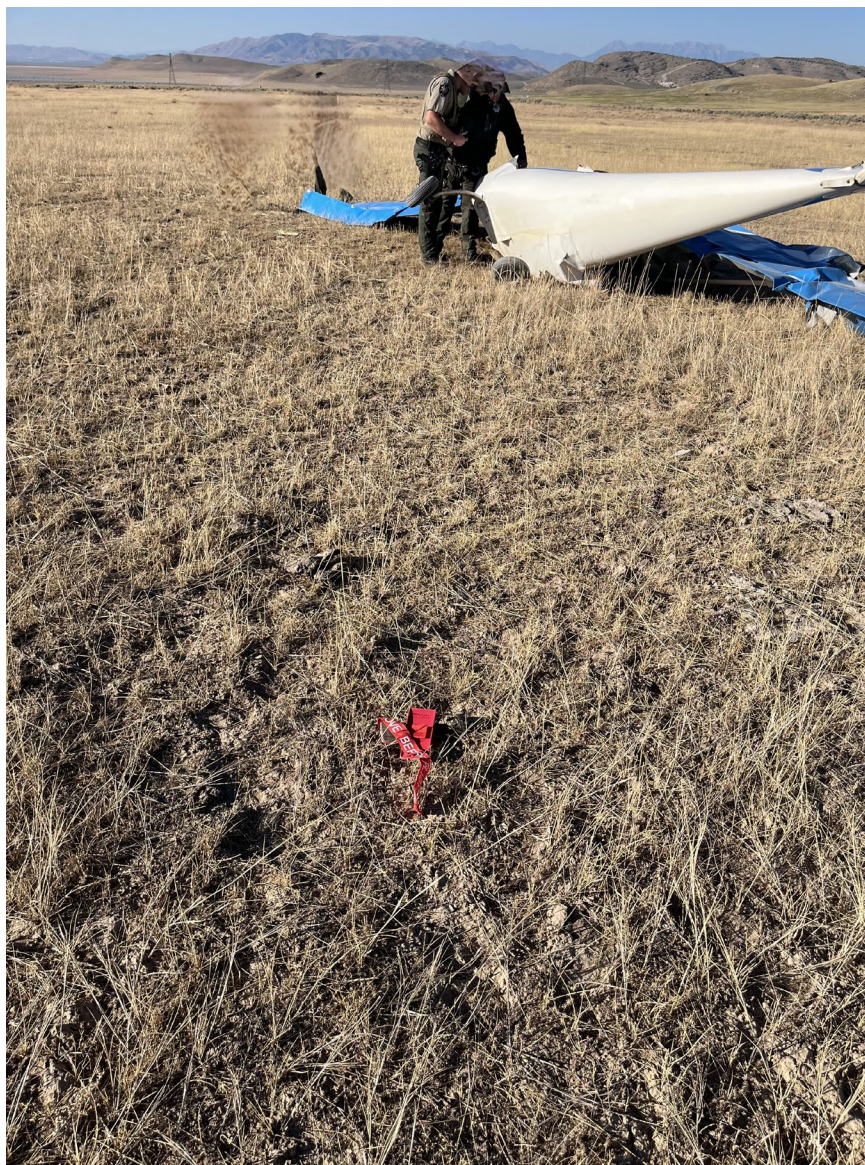
**Photograph 2 - View of control locking devise (Courtesy of Utah Co Sheriff)**

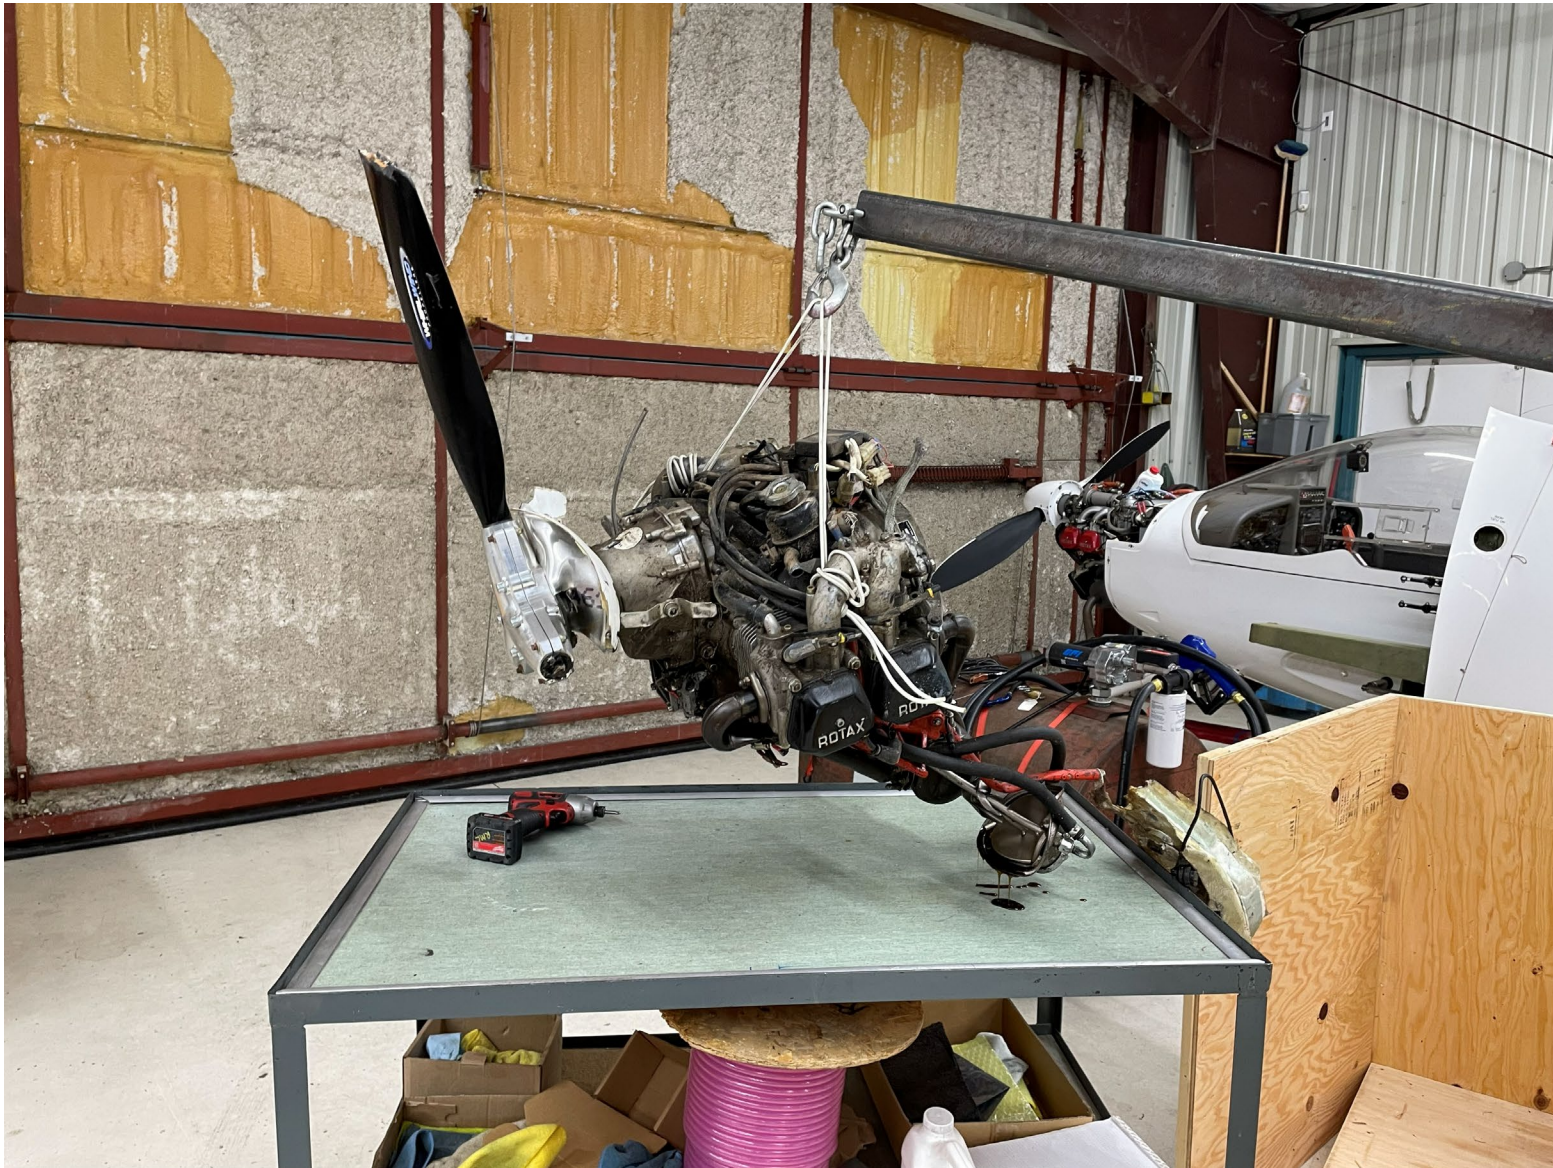
**Photograph 3 - View of engine examination**
