# National Transportation Safety Board

WPR24FA277

## **ENGINE EXAMINATION SUMMARY**

Location: Eureka, Utah  
Date: 07/07/2024  
Time: 1800 Local  
Airplane: N969RC FANTASY AIR SRO

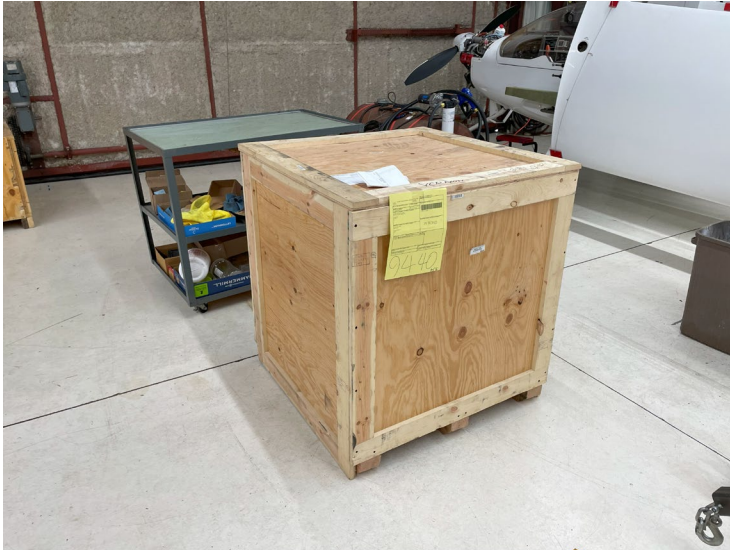
**Figure 1 Crated Engine**

The engine was removed from the main wreckage under NTSB oversight at the co-owner's hanger in Spanish Fork, UT, crated and shipped from Utah Helicopters in Spanish Fork, UT. The engine was shipped to Rotech Motor Ltd, at the Vernon Regional Airport, Vernon, British Columbia, in Canada. The follow-up examination was conducted on March 25, 2025, with the NTSB-IIC and Rotax investigator in attendance. The shipping box was undamaged in Canada.

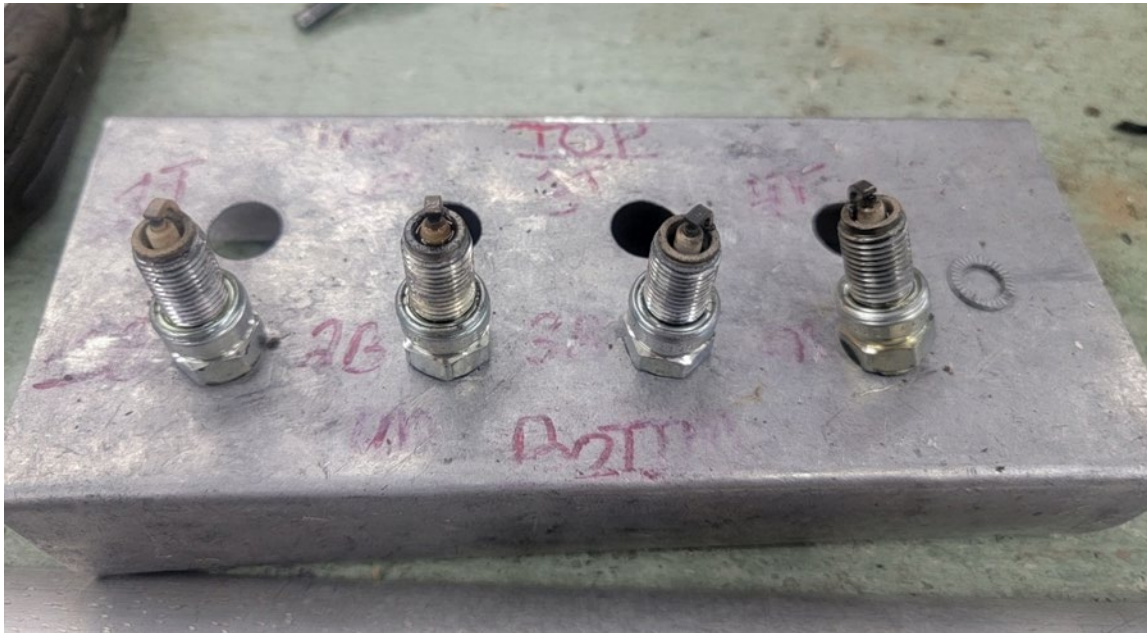
The spark plugs were removed from the bottom of each of the cylinders. All spark plugs were model NGK DCPR7E type. The spark plug electrode areas had normal amounts of combustion deposits and coloring. Due to engine position the spark plug electrode areas were oil saturated.

**Figure 2 Bottom cylinder spark plugs**

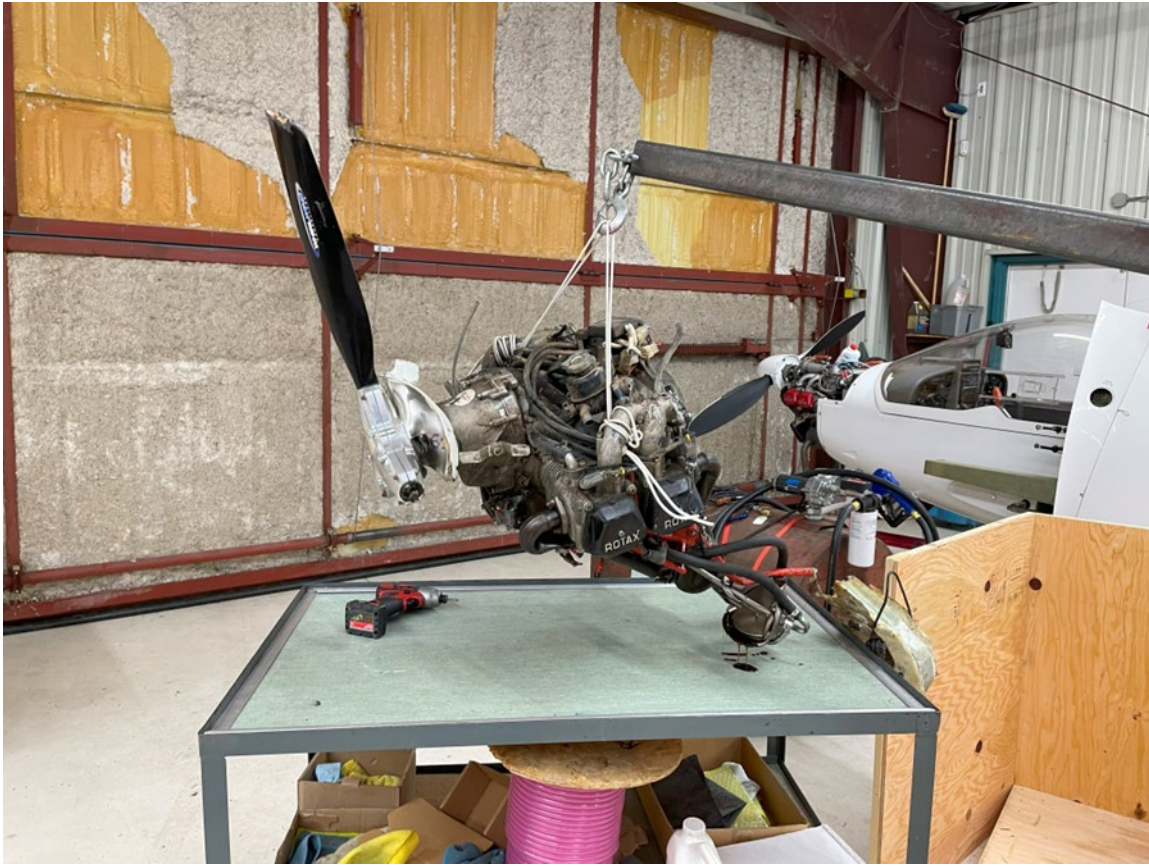
**Figure 3 Engine with reduction gearbox attached**

The propeller assembly remained attached to the crankshaft propeller flange. The reduction gearbox had a one-inch hole on the upper portion of the casing. The ignition system was damaged and displaced from its mounts. A portion of the engine support structure remained attached to the engine mounts. The carburetors were missing from the intake manifolds and not available for testing. The mechanical fuel pump was missing from its mounting pad and not available for testing. The engine was oil soaked and about a ½ quart of oil drained out of the top oil tank area as the engine was manipulated. The oil tank was not attached to the top lid portion of the tank and was not available for inspection. The oil filter was broken off and displaced from impact damage and was not available for inspection. The oil lines were breached, and the oil cooler was damaged from the impact. Evidence of proper oil lubrication was observed during the engine examination and breakdown. The coolant lines were found breached, and the coolant radiator was not available for inspection. However, there was no evidence of overheating or an issue with the cooling system.

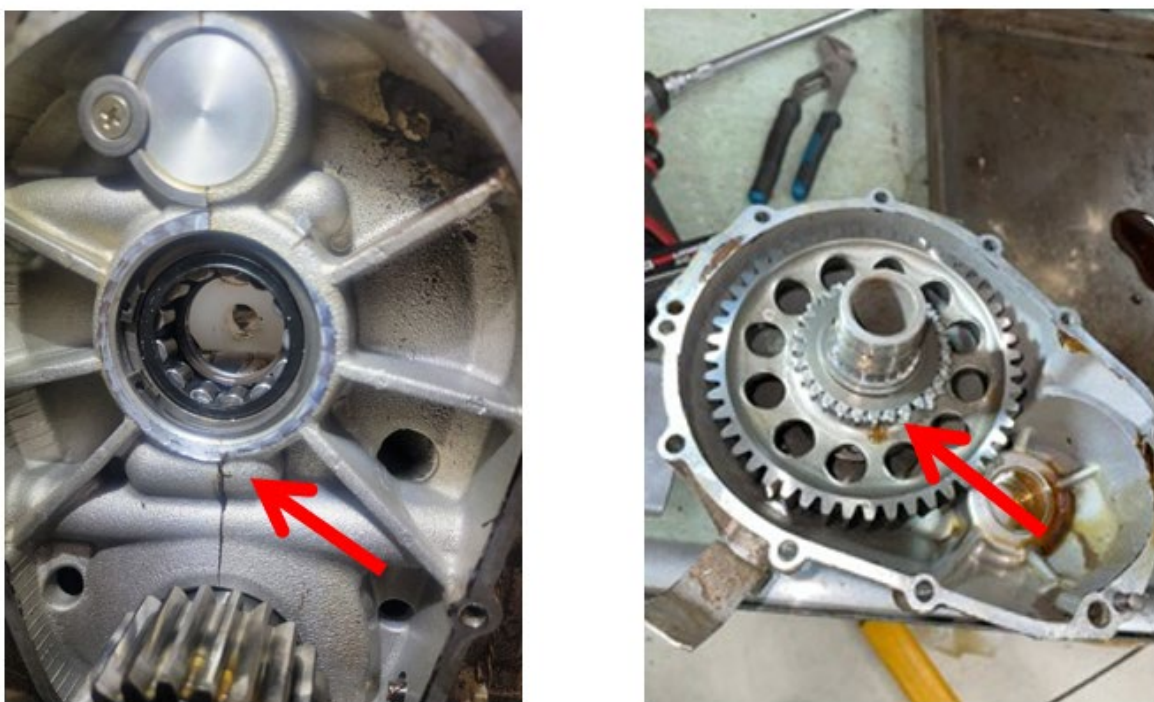
Internal wearing was noted on components in the reduction gear box due to impact damage. Once the propeller and reduction gear box was removed the crankshaft moved freely by hand and engine continuity was established.

The propeller assembly was attached to the crankshaft propeller flange. Initially the engine could not be rotated by hand. Only one of the composite blades remained and was fractured mid-span with the other two sheared off during impact. This evidence likely suggests the engine was developing power at the time of impact. The gearbox assembly had been pushed into the engine case restricting engine movement. Once the reduction gearbox was removed, the engine could be rotated by hand.

**Figure 4 View of reduction gear box assembly and engine case contact**
