# National Transportation Safety Board

WPR24FA227

## **ACCIDENT SITE EXAMINATION**

Location: Eureka, UT  
Date: July 7, 2024  
Time: 18:00 MDT Local  
01:00 UTC  
Airplane: FANTASY AIR SRO ALLEGRO 2007

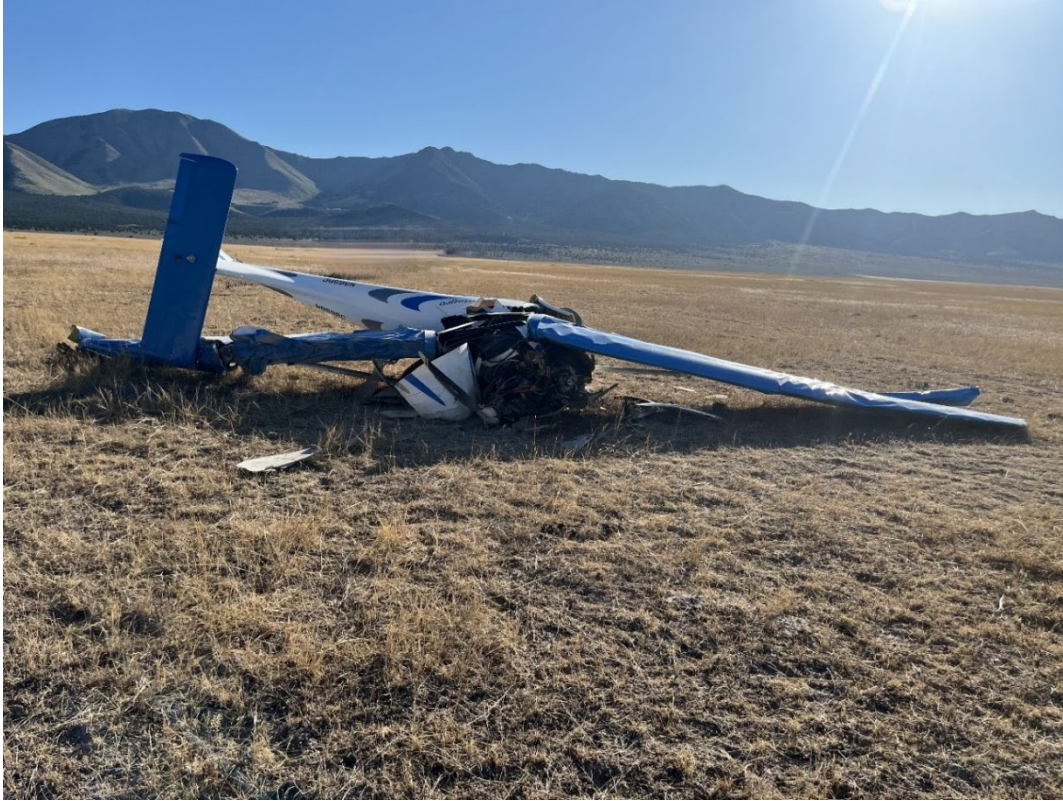
The accident site was located in dry soil terrain. Ground scars were present and consistent with initial contact by the right wing. The distribution and condition of the wreckage were consistent with a descending, left-turning impact sequence.

The airplane came to rest up right in an open prairie about 1,200 ft west of Holmansville Pass Road. The wreckage was oriented on magnetic heading of about 090°. The nose of the airplane was fracture separated, displaced about 90° to the right and the left and right wings remained attached to the fuselage at the wing root. The cockpit exhibited torsional twisting to the right.

**Figure 1: Accident site (Courtesy of Utah Co Sheriff)**

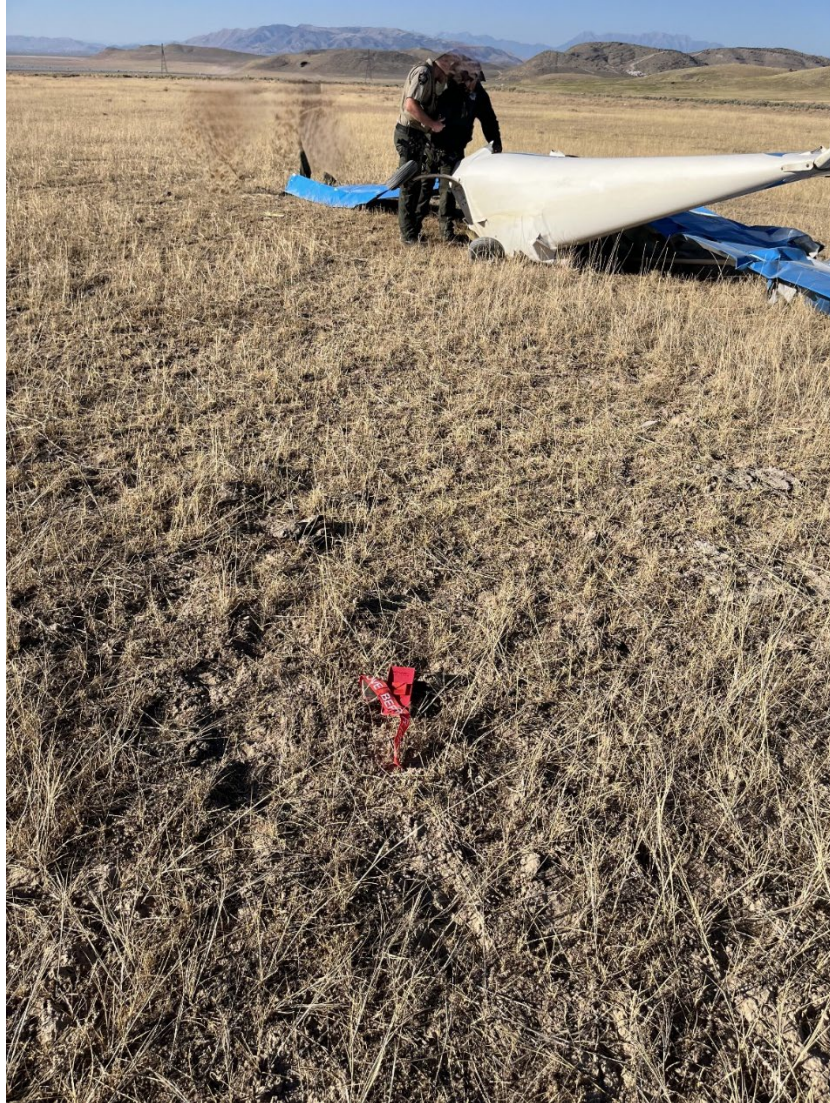
The first identified point of contact (FIPC) with terrain was a ground scar/impression about 1.5 ft in diameter and 6 inches deep collocated with the nose of the main wreckage. The debris field was located on a flat open field, radiating about 40 ft from the center of the FIPC. All parts of the airplane were accounted for near the accident site including an airplane control locking device, gust lock found 22 feet, 230° from the impact site.

**Figure 2: View of gust lock location on site (Courtesy of Utah Co Sheriff)**

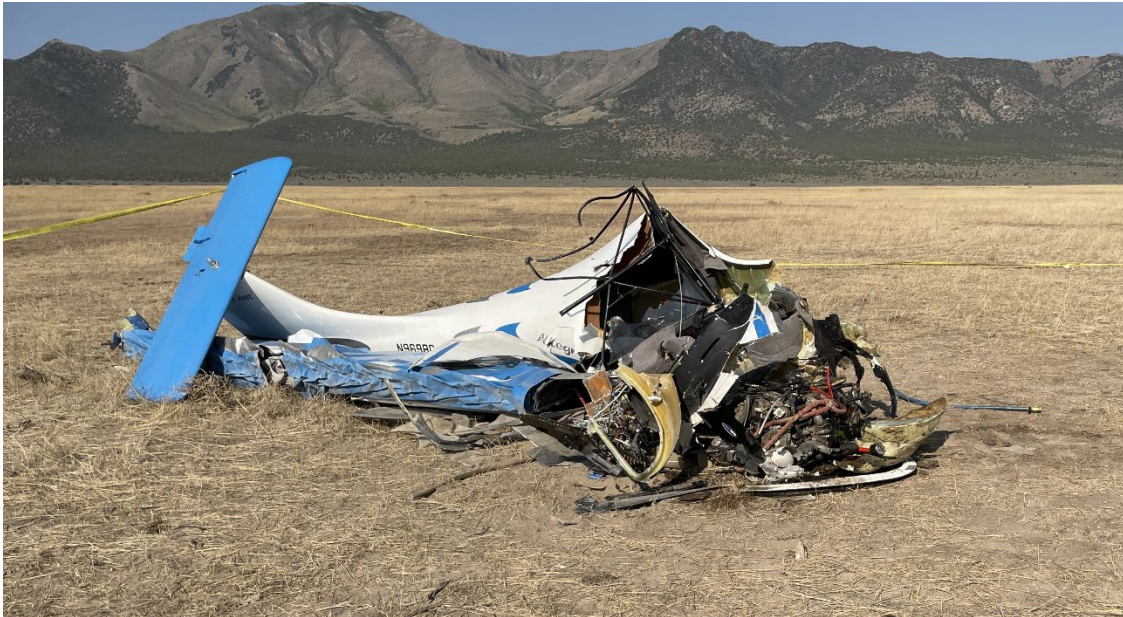
Examination of the wings revealed that both were constructed of aluminum. The right wing exhibited leading-edge accordion-type compression extending from the wingtip to the wing root. Light ground disturbance beneath the right

The left-wing outer section exhibited skin twisting deformation of the upper and lower wing skins consistent with torsional loading. The outboard portion of the left wing, from approximately mid-span, was bent upward about 6 inches.

**Figure 3: View of right side of airplane wreckage.**

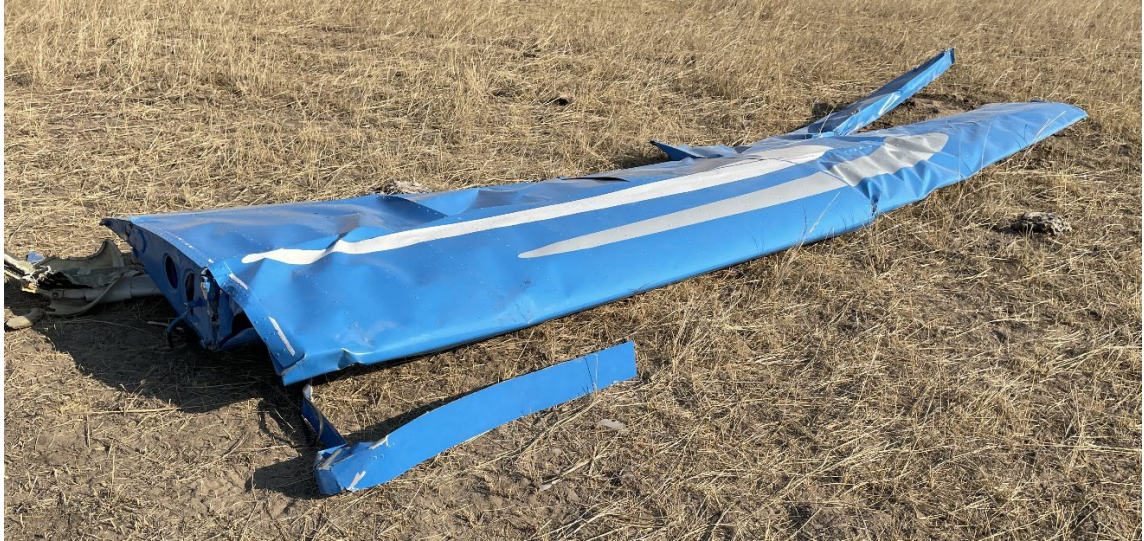
The upper wing carry-through cage remained largely aligned with the wings in the as-found position. During recovery, the left wing was removed to facilitate occupant extraction and was relocated approximately 20 feet from the main wreckage.

Flight control continuity was established from the cockpit controls to their respective flight control surfaces. The left aileron control rod and associated attachments were continuous from the cockpit to approximately the mid-wing area and continued to the left aileron. The left aileron control arm was separated at the wing root. All separations in the flight control push rods were consistent with overload or separations during recovery operations. The left aileron remained attached at the inboard hinge only.

**Figure 4: Front view left wing separated from fuselage.**

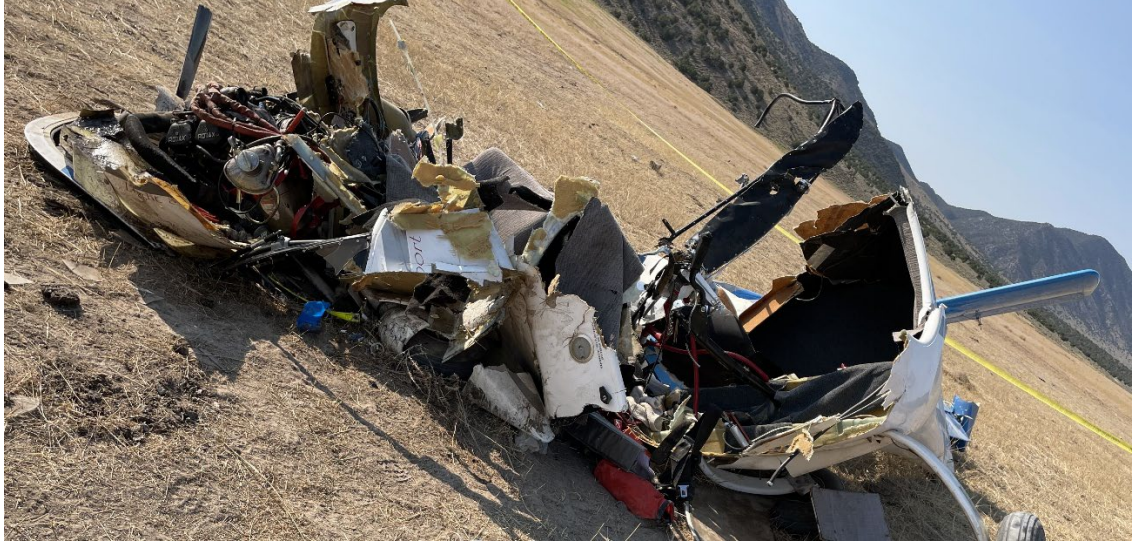
The overall wreckage and deformation patterns were consistent with a left-turning, descending impact in which the right wing contacted the terrain first, followed by progressive structural failure aft of the passenger seating of the fuselage due to impact forces.

**Figure 5: Forward view of wreckage.**

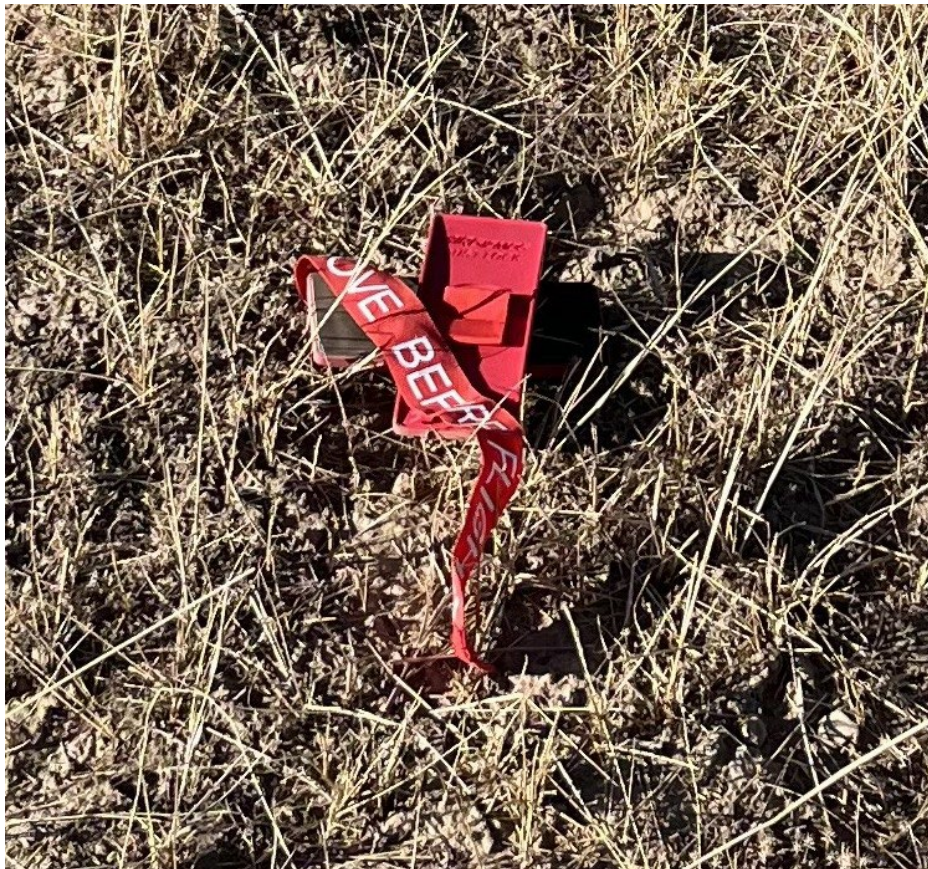
Additionally, a co-owner of the airplane mentioned that finding the gust lock in the locked position would be unusual. Typically, you remove the lock by unlocking the latch then stowing it. You would not re-lock the latch prior to storing it. Videos online demonstrated that the device was found unlocked.

**Figure 6: View of AIRGIZMOS Gust lock**
