**Prop Model: HC-B5MA-3D/M11691NS**

**S/N: HBA1961**

**Installation Data Sheet No.: 1789**

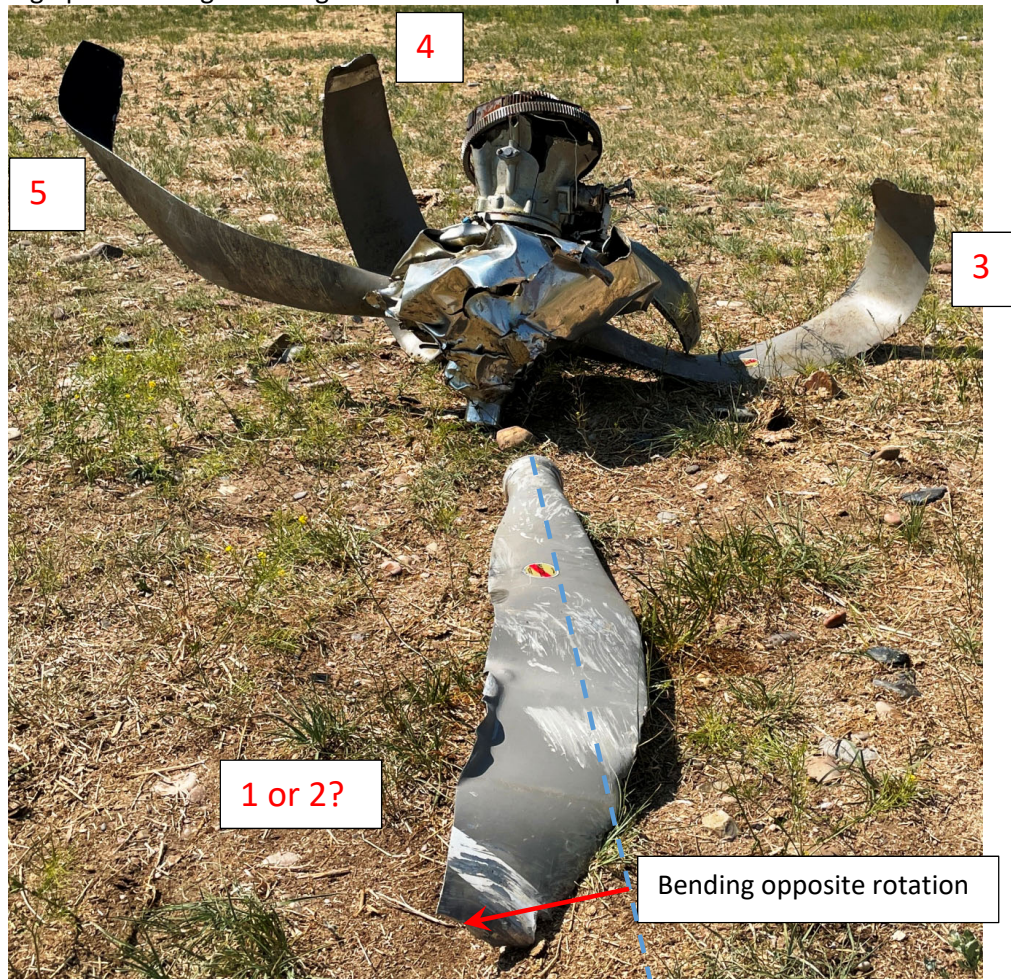
The propeller impact separated from the engine with a portion of the engine RGB still attached. Two of the five blades impact-separated from their retention clamps; one of those two blades was recovered. The spinner dome was crushed and formed around the propeller assembly. The propeller piston impact-separated. All four blades recovered exhibited tip fractures and chordwise/rotational scoring. Two blades were bent forward in the thrust direction with chordwise/rotational scoring on the face side. One blade was bent in the aft direction with chordwise/rotational scoring on the camber side. The separated blade had chordwise/rotational scoring and remarkable bending opposite rotation in the major axis. These impact signatures indicate rotation at high RPM, high power and generating thrust at the time of impact.

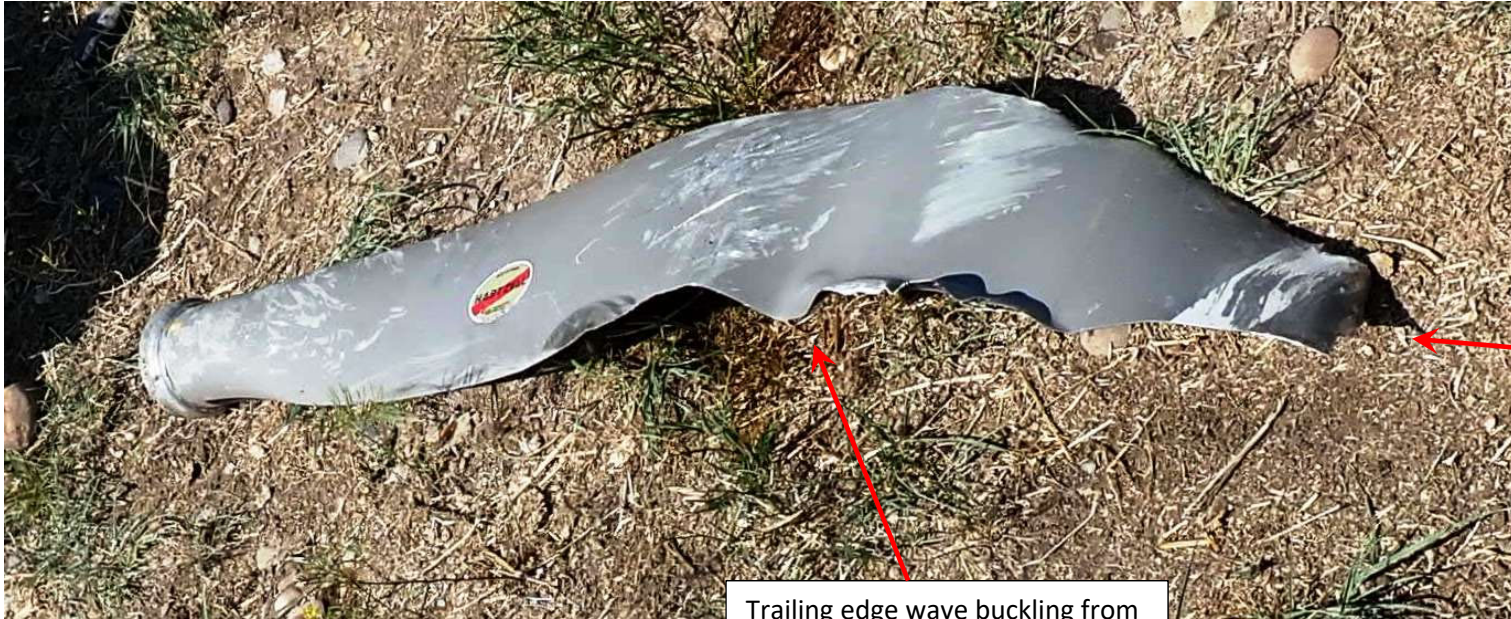
**Blade #1 or #2?**

Trailing edge wave buckling from  
bending opposite rotation in the  
major axis

Tip fracture

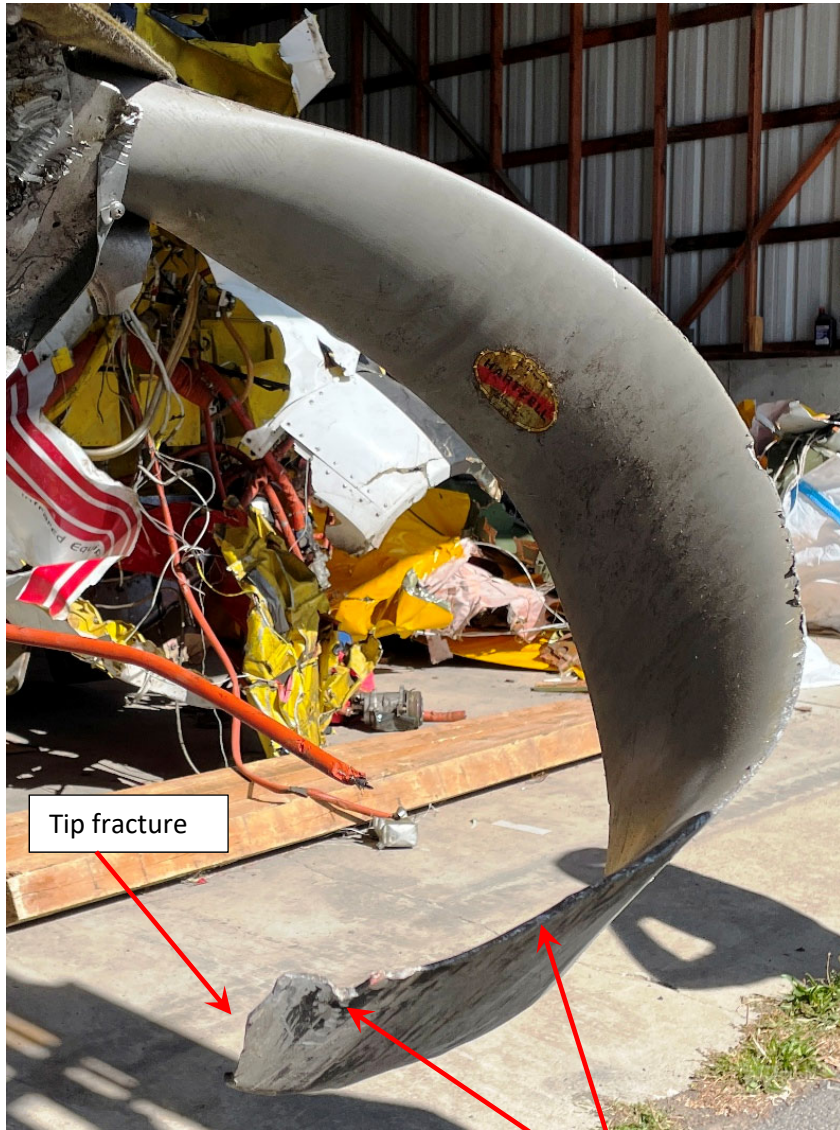
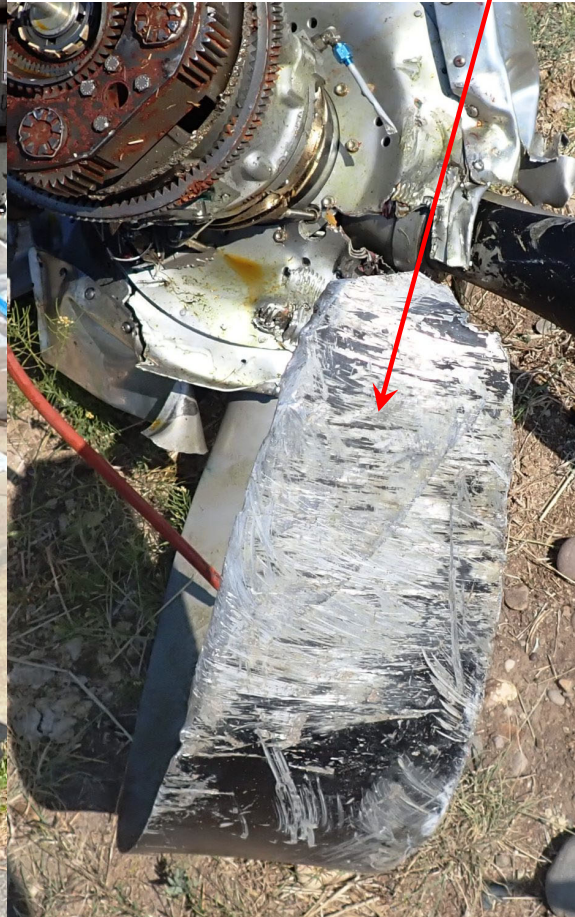
## Blade #4

Tip fracture

Leading edge gouges and chunking

Chordwise/rotational scoring on the face side, compound bend and twist forward and towards high pitch.

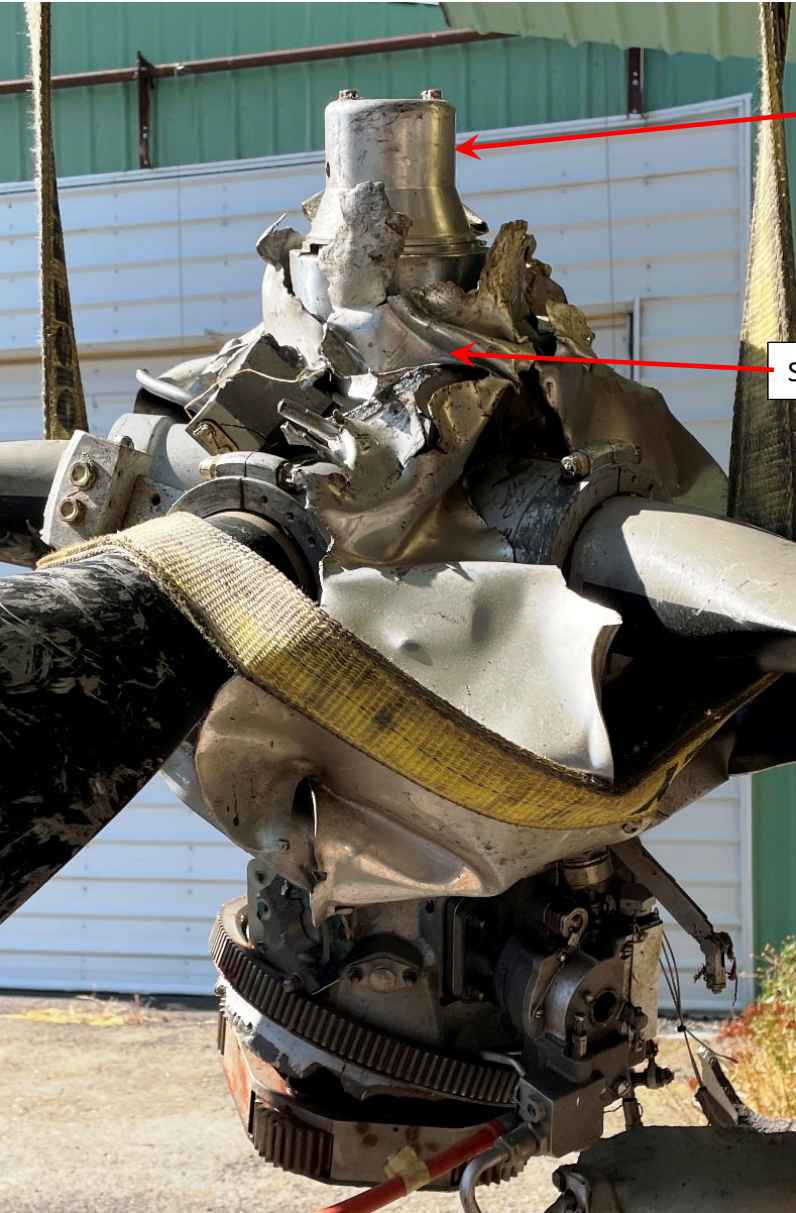
Missing piston an forward end of pitch change rod

Spinner dome crushed and formed around assembly
