# National Transportation Safety Board

WPR24FA238

## **FIELD REPORT**

Location: Helena, Montana  
Date: July 10, 2024  
Time: 12:10 mountain daylight time  
Airplane: N10122, Air Tractor AT-802

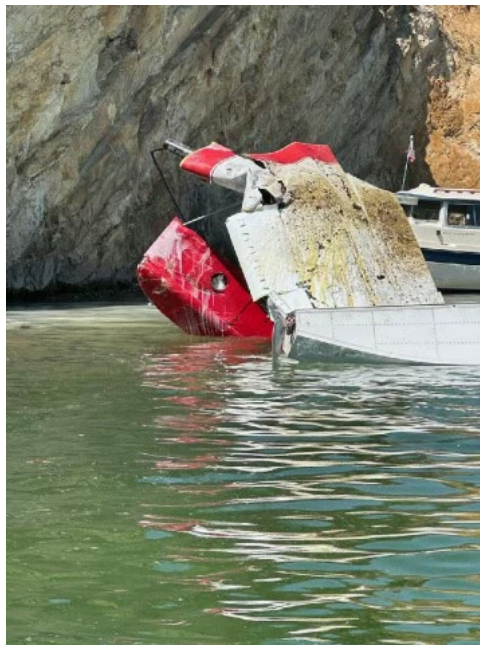
Witnesses to the accident attempted to render aid before the airplane sank.

Figure 2. Accident Airplane before it Sank. (Photo Courtesy of local law enforcement)

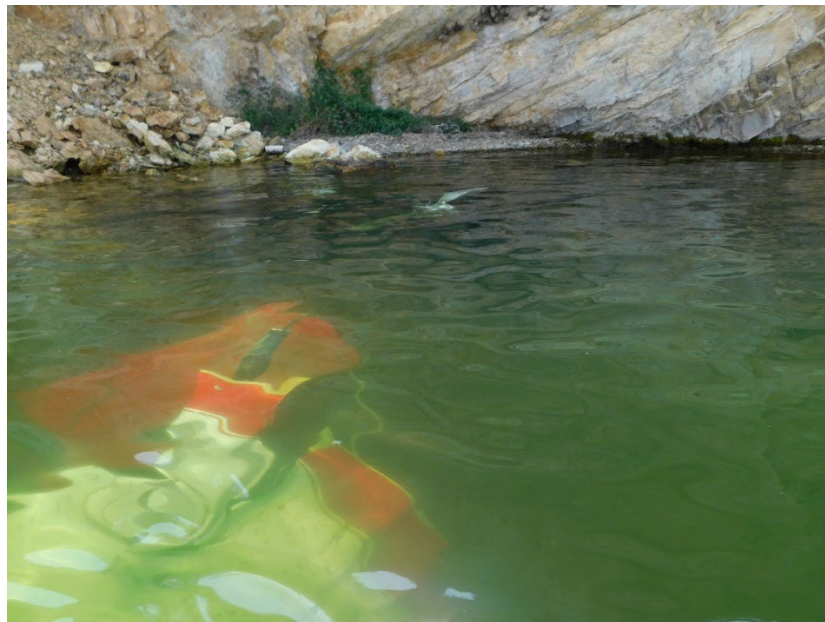
Examination of the accident site revealed that the airplane impacted a vertical rock face along the edge of a lake and came to rest upright and submerged approximately 20 ft offshore, adjacent to the rock face.

Figure 3. Accident Airplane Fully Submerged.

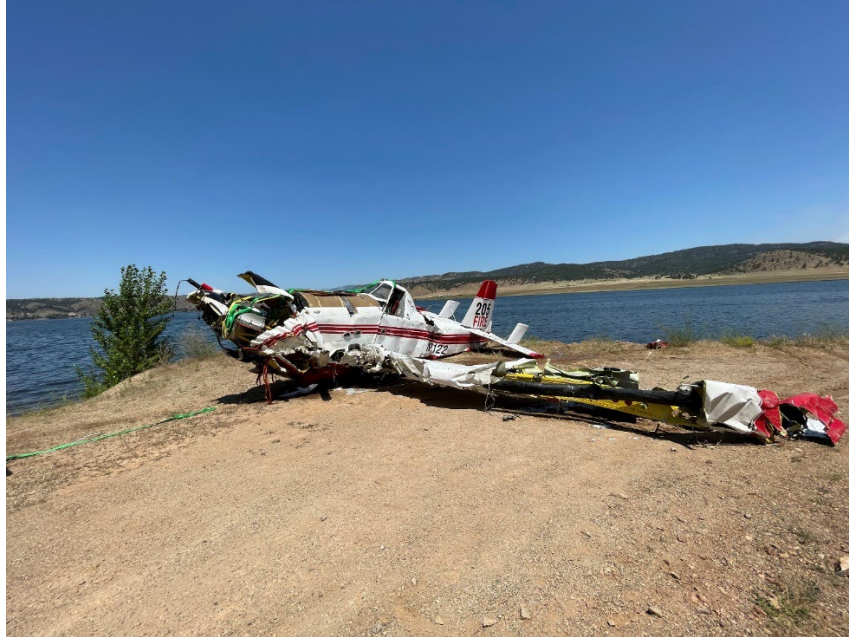
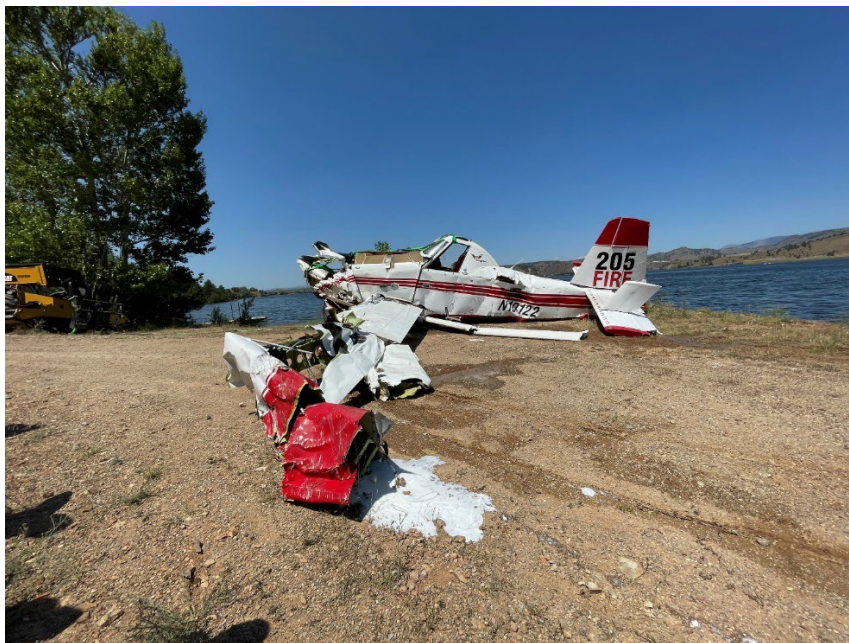
The left flap's control continuity was established from the flap actuator to the flap. The left aileron's wing mounted steel pushrod assembly was found with a separation. The outboard half of the left aileron and its counterweight separated from the wing.

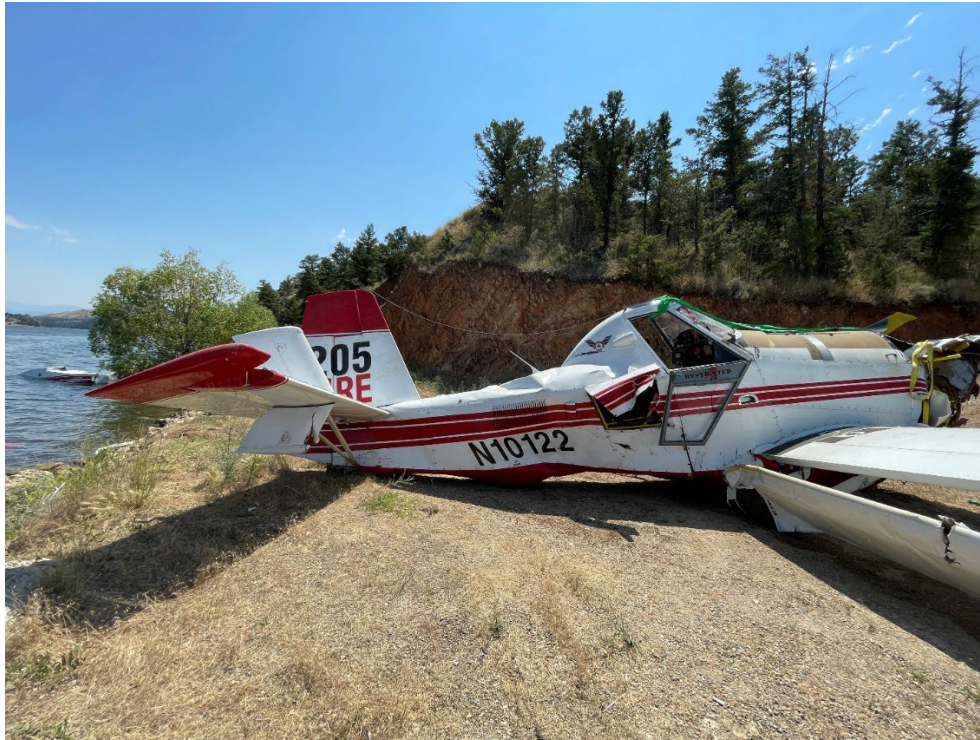
The right flap's pushrod was separated at the forward, threaded end of the pushrod.  
The right aileron's control continuity was continuous from the control stick to the aileron.

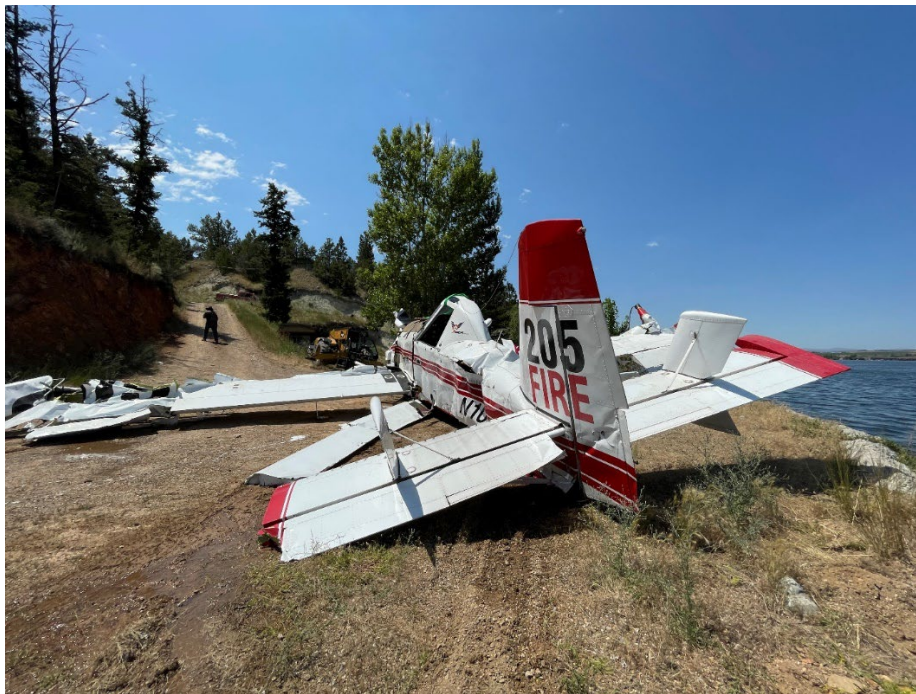
The empennage had slight accordion damage near the air conditioning plenum just aft of the cockpit.

The vertical and horizontal stabilizers remained attached to the empennage. The elevator remained attached at each of its connection points. The outboard section of the left elevator, which included its counterweight had separated. The rudder remained attached at each of its connection points. The elevator controls were continuous from the control stick to the elevator.

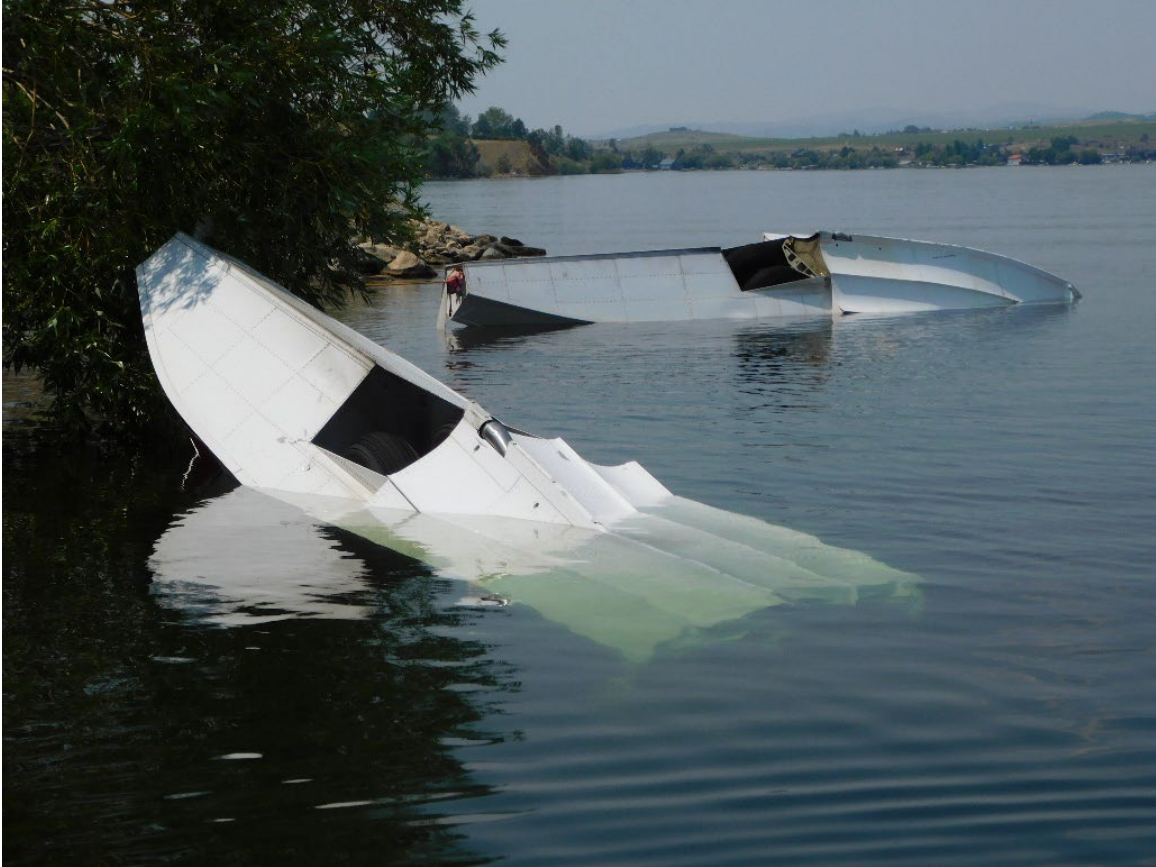
The left and right floats detached from the airframe. The landing gear was in the retracted position. Both scoops were in the retracted position. One float was damaged/separated at the forward section. The other float remained intact.

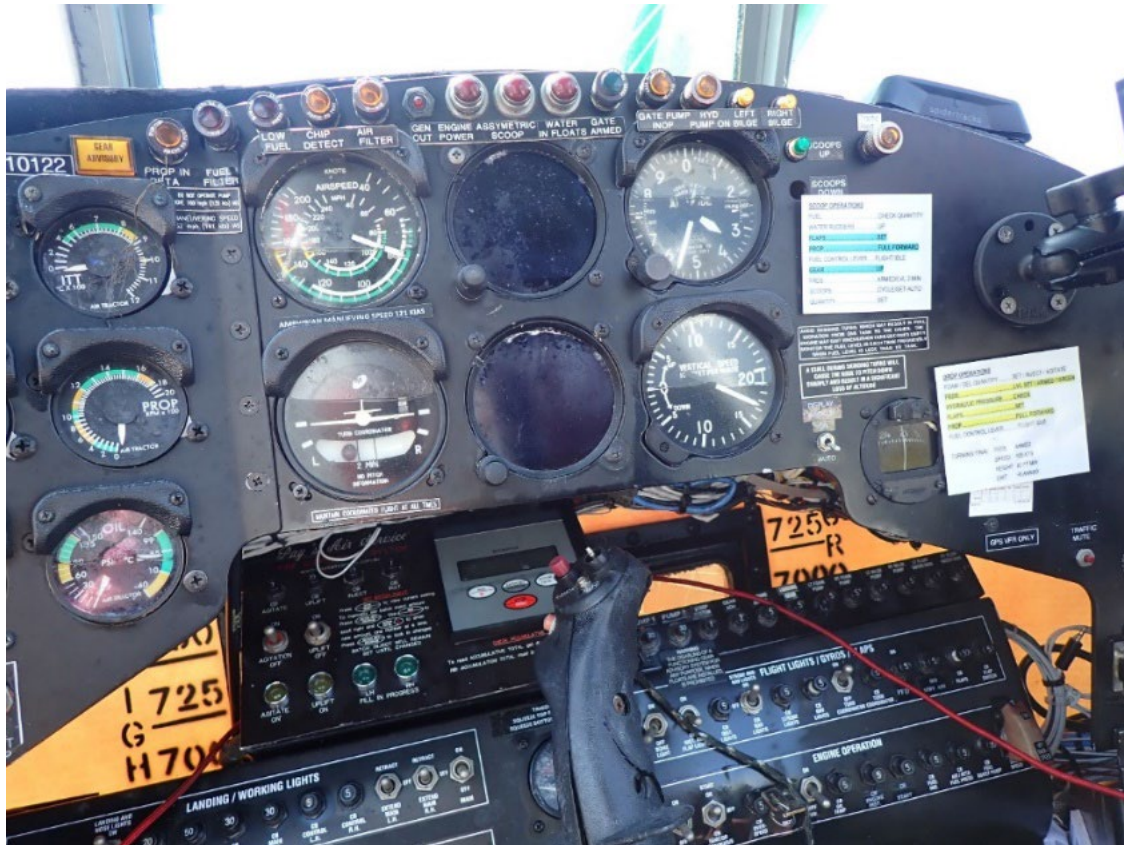
Throttle: aft of the idle stop position.  
Propeller: near the feather position.  
Fuel Selector Lever: ground idle position.  
Emergency jettison handle: stowed and locked.

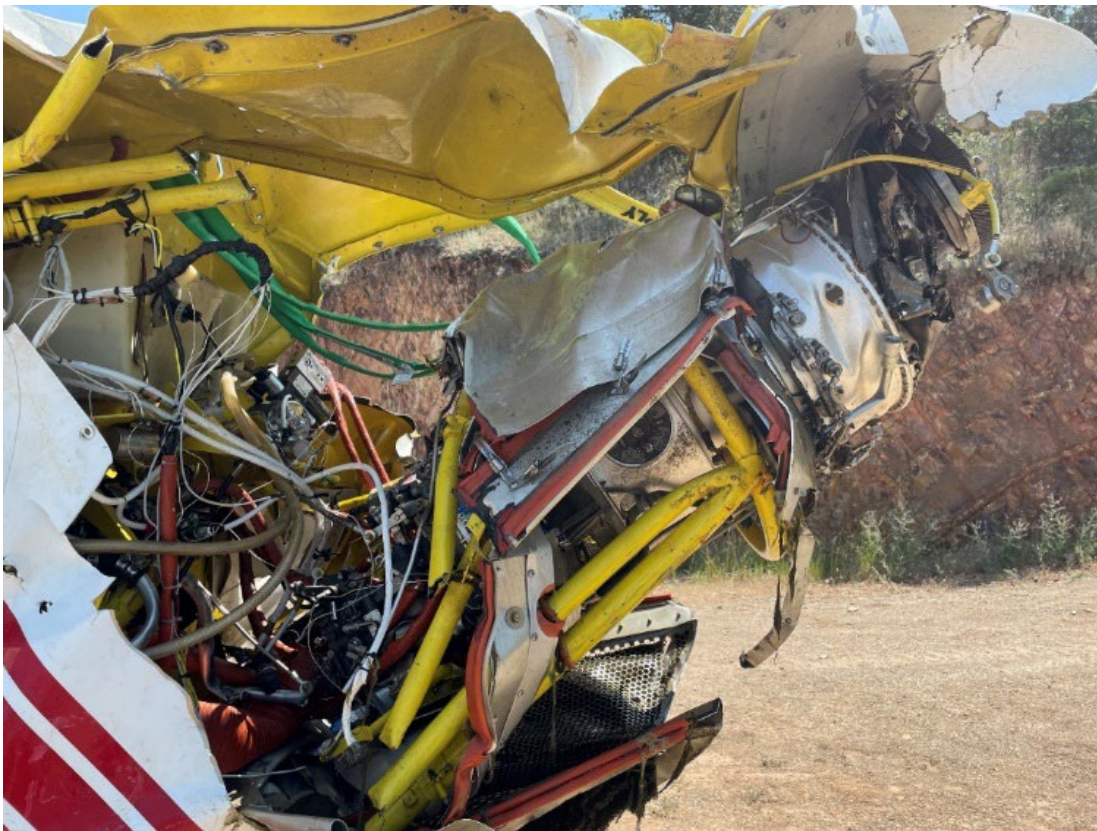
The engine remained attached to the airframe via the engine mounts and firewall. The lower arms of the engine mount were displaced up at a 45° angle.

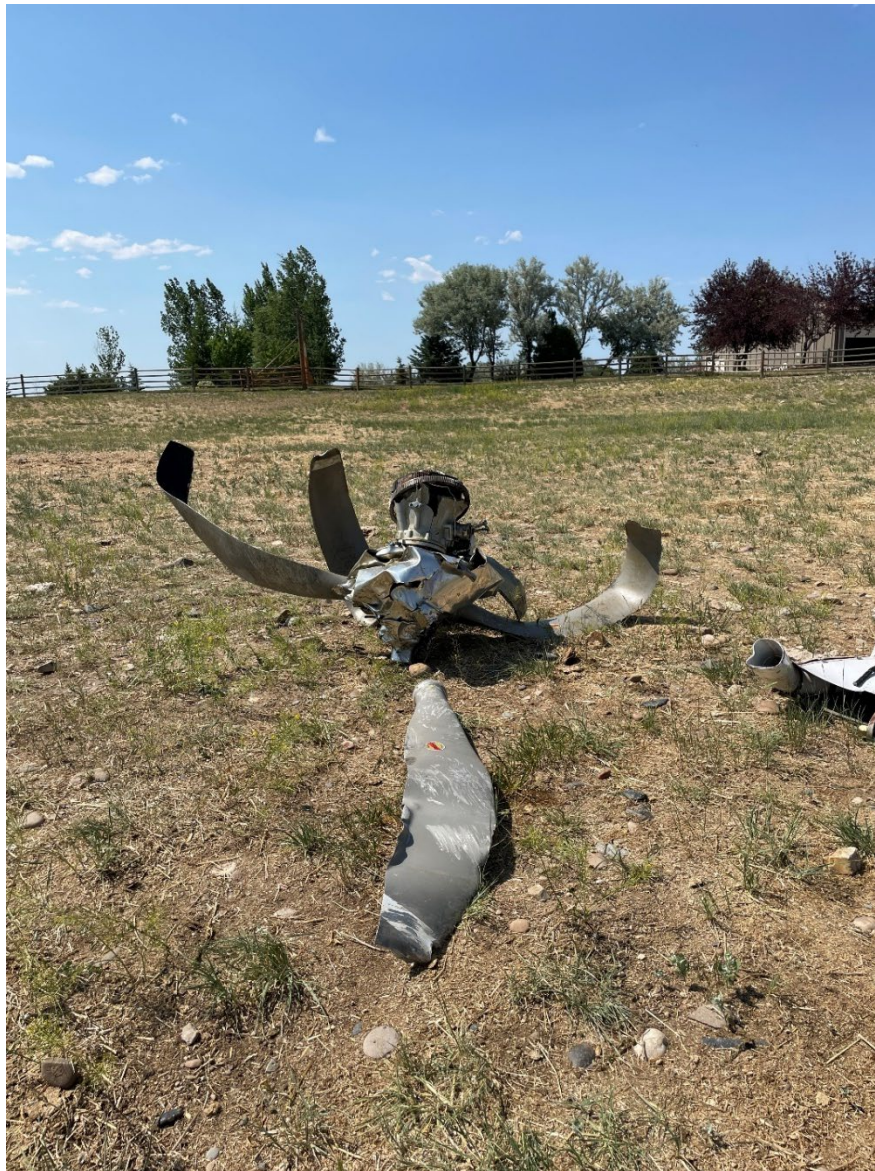
The propeller assembly separated from the engine. Three of the five blades remained attached in their respective hubs. Two of the five blades separated; one blade was not recovered. The three propeller blades that remained attached at the hub showed varying degrees of rotational/s-bending, nicks and gouges and chord wise scratching. Two of the blades were bent toward the cambered side and one blade was bent toward the face side. The one blade that separated from the hub was relatively straight with nicks and gouges.
