**Air Tractor, Inc.**  
Accident Investigation

**FIELD NOTES**

**WPR24FA238**

AT-802A manufactured in 2013  
802A-0495  
N10122

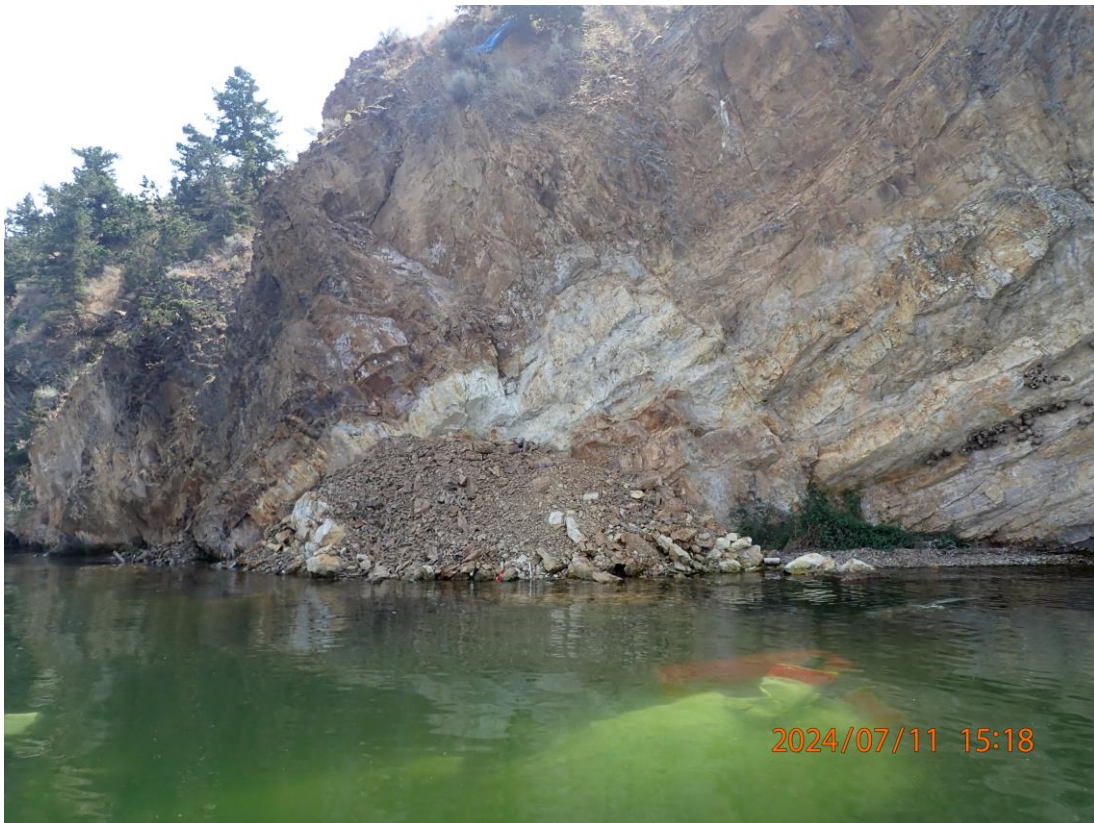
Arrival at the accident site was approximately 3:30 pm on 7/11/24. The wreckage was located submerged in the Missouri river approximately 10 miles east of Helena, MT. The main wreckage of N10122 was located submerged near a rock faced shoreline. The Wipaire floats were separated from the main wreckage. The propeller hub with 3 attached propellers was found separated from the main wreckage and laying closer to the shoreline submerged in water.

**Shoreline Rockface and Debris**

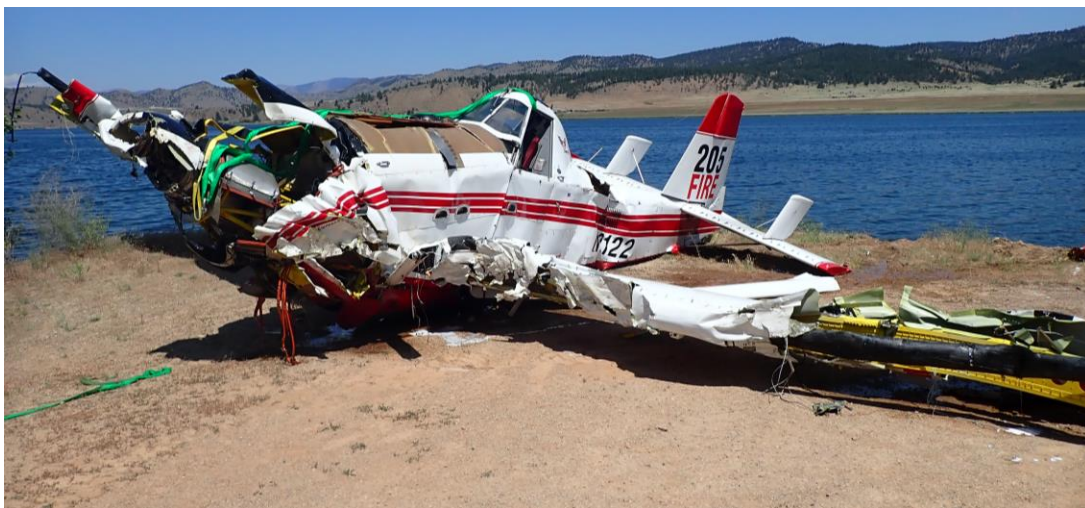
**Main Wreckage**

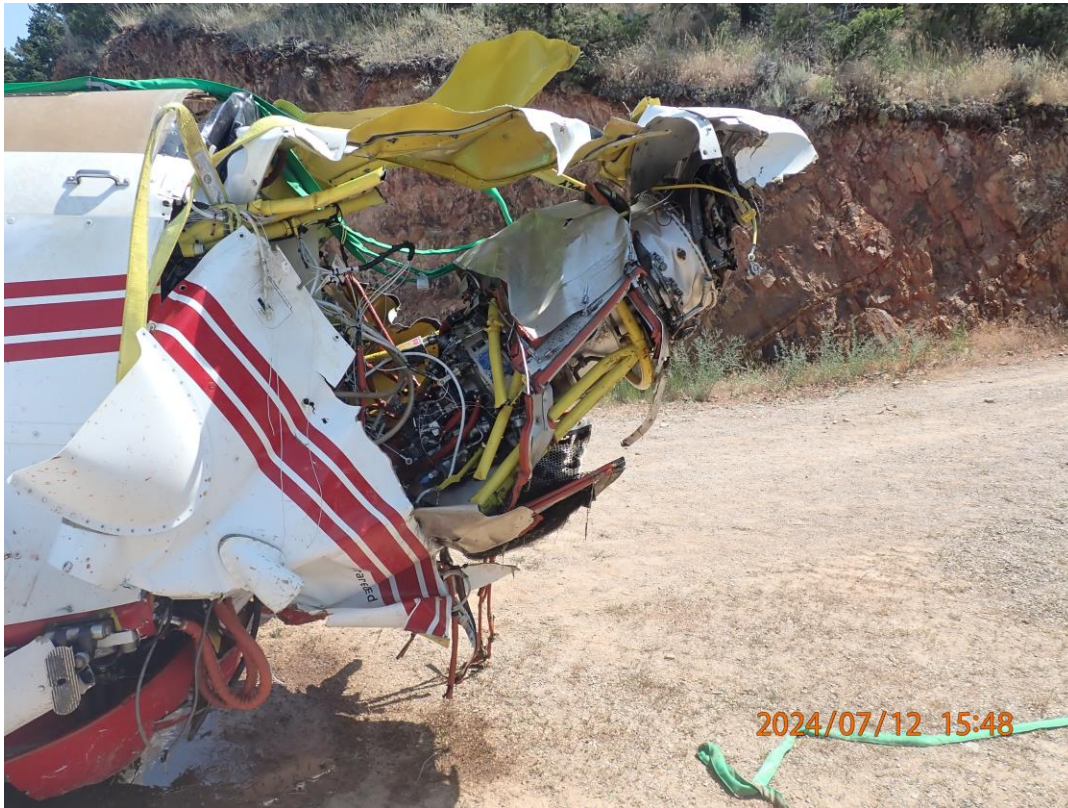
The fuselage forward of the cockpit was crushed aft and upwards consistent with a collision with the rockface. The tail section aft of the cockpit canopy was found bent to the left.

**Forward Fuselage**

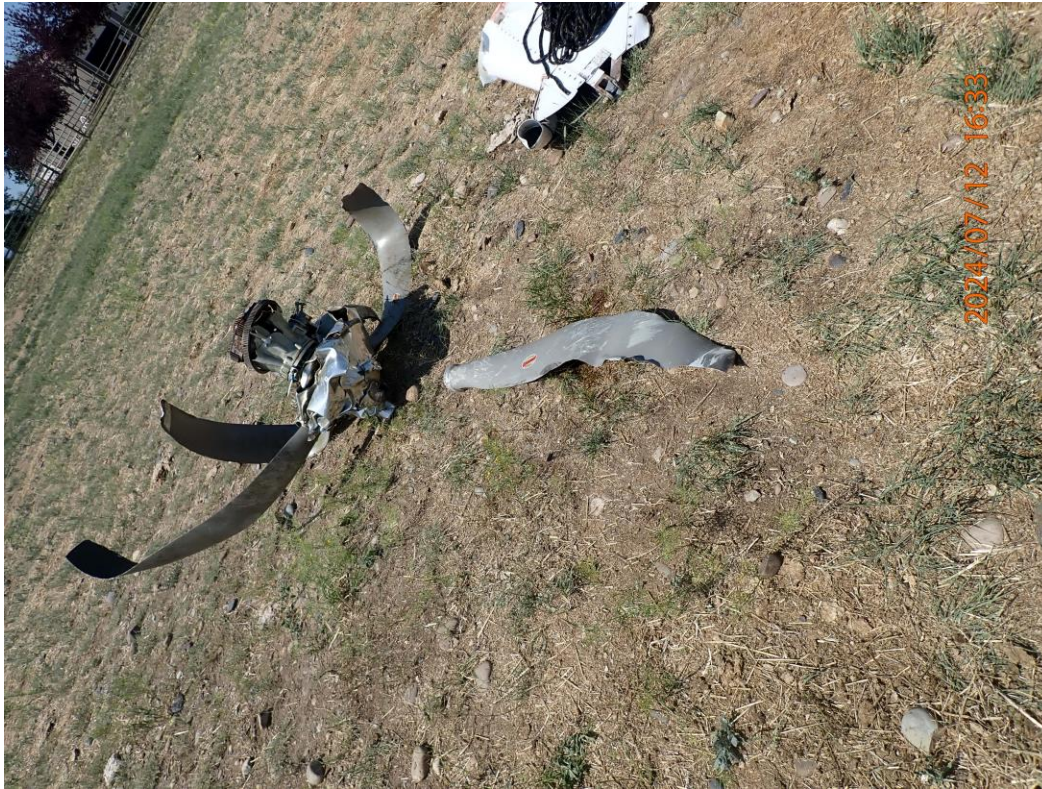
The engine was equipped with a five-bladed constant speed, fully reversable, propeller. Two blades were separated from the hub. One of the blades was not recovered at the time of the examination. One of the three blades that remained attached to the propeller hub was found bent toward the face side of the blade. The other two blades that remained attached to the propeller hub were found bent toward camber of the blades. The blade found separated was bent towards the face side. The four recovered blades exhibited chordwise scratches.

The engine was confirmed to be a PT6-67F S/N PCE-RZ0118. The engine remained attached to the engine mount. Reduction gearbox separated at the "A" flange.

**Propeller Wreckage**
