# National Transportation Safety Board

WPR24FA238

## **AIRFRAME AND ENGINE EXAM**

Location: Helena, Montana  
Date: July 10, 2024  
Time: 1210 mountain day light time  
Airplane: Air Tractor Inc. AT-802A, N10122

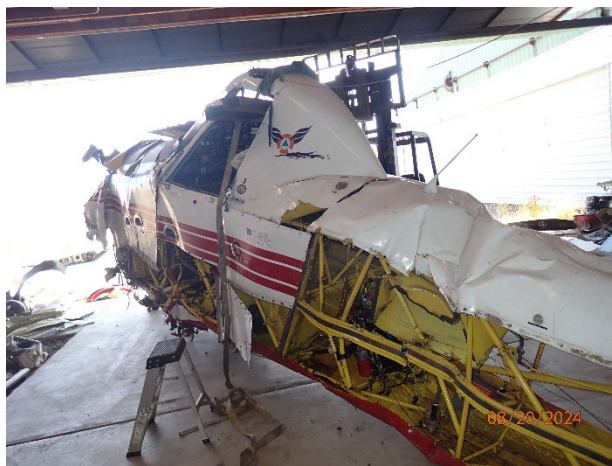
Figure 1. Side View of Fuselage

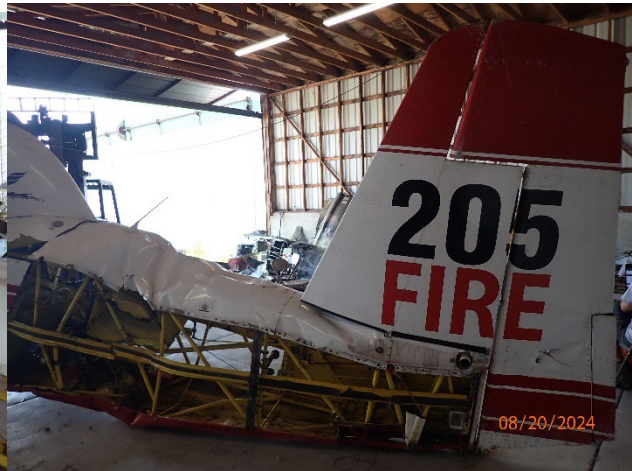
Figure 2. Side View of Tail

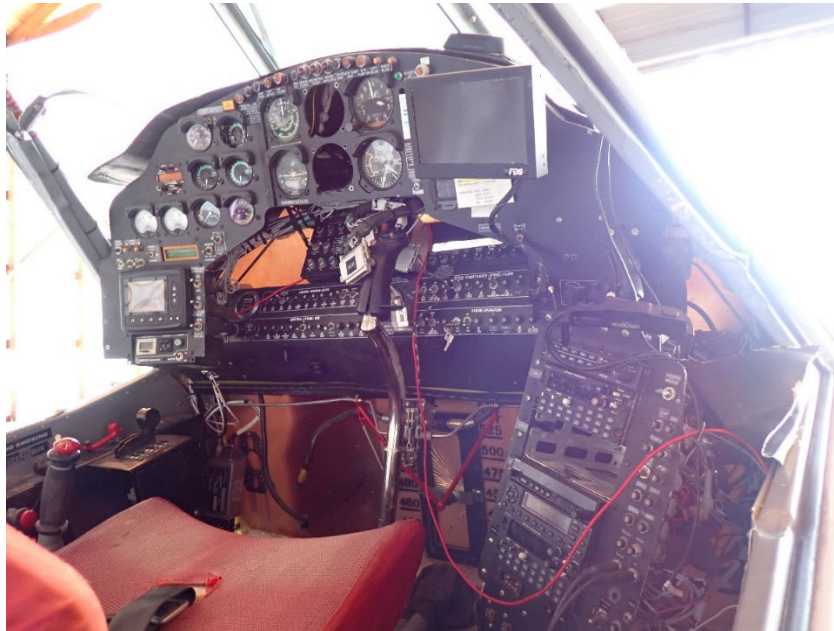
The instrument panel was displaced forward and the hydraulic PUMP 1 and hydraulic PUMP 2 circuit breakers were observed tripped and displaced forward.

Figure 3. View of Instrument Panel (Photo courtesy of Air Tractor)

It's likely that the displacement and damage to the instrument panel, and the control stick grip were because of the impact sequence.

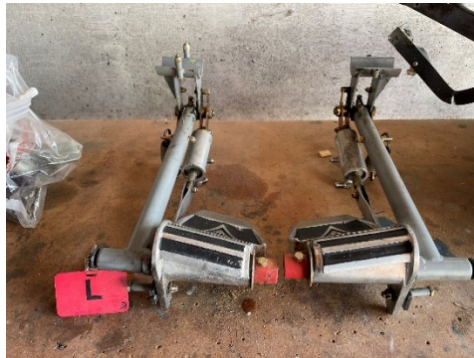
The left rudder pedal had separated from the fuselage attach location. The right rudder pedal remained secure at the fuselage attach location.

Figure 4. Rudder Pedal Assembly

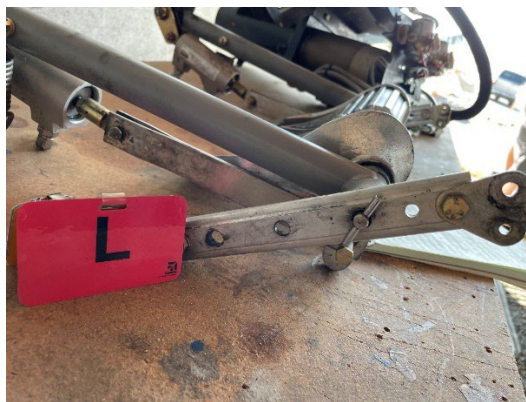
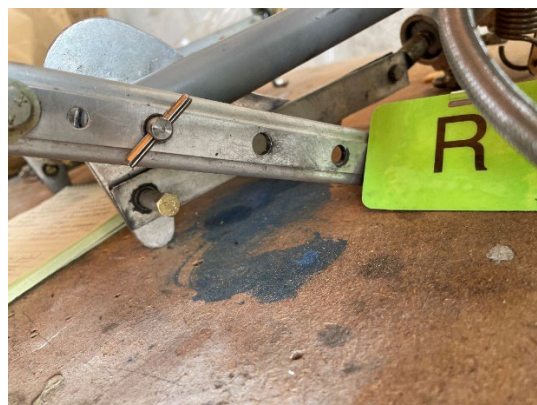
The pedal adjustment pin at the rudder adjustment channel for both rudder pedals was set to the most aft position and both pins were installed in the pedals through the rudder pedal attachment channels. There were no witness marks on either rudder pedal.

Figure 5. Left View Rudder Pedal adjustment channel

Figure 6. Left View Rudder Pedal adjustment channel

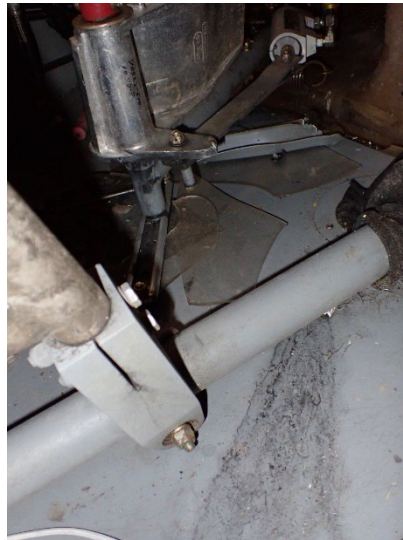
The control stick remained secure to the torque tube and the torque tube remained attached to the frame. Impact damage was observed on the torque tube forward of the control stick socket.

Figure 7. Control Stick Torque Tube (Photo Courtesy of Air Tractor)

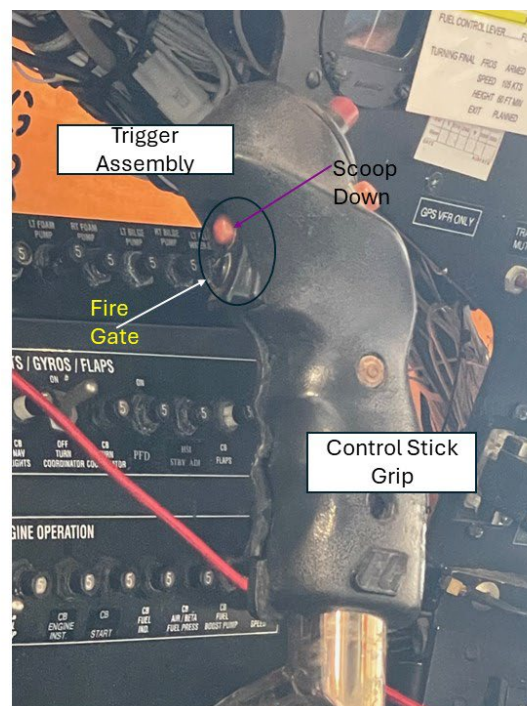
The control stick grip has a Wipaire installed trigger assembly that remained attached to the control stick. The trigger assembly has red button to activate the "scoop down" function and the black button to activate the "fire gate" for the hopper. The trigger assembly was displaced aft into the control stick grip.

Figure 8. Control Stick Grip Trigger Assembly (Photo Courtesy of Wipaire)

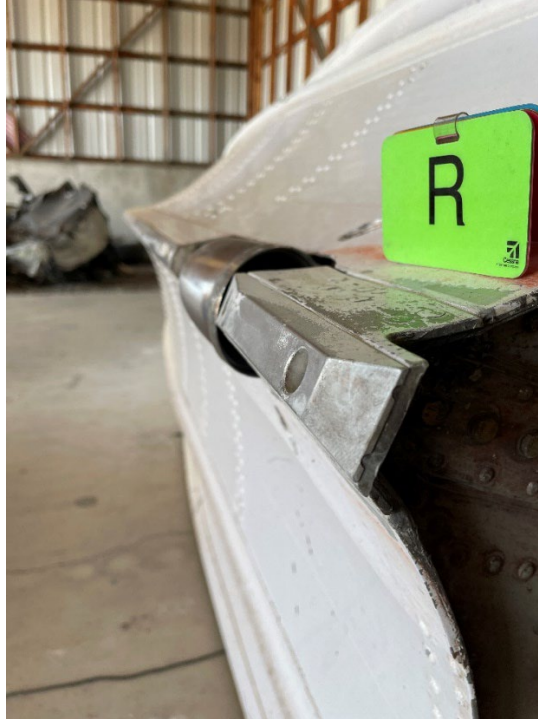
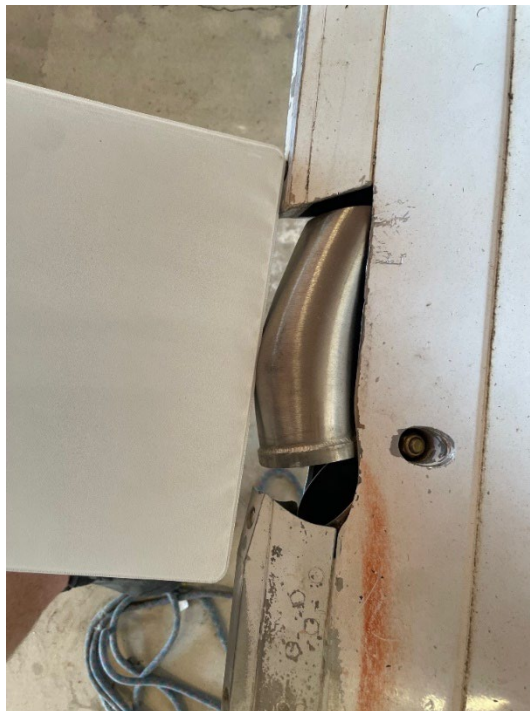
The right float remained relatively intact with the nose portion crushed inboard. The underside/bottom of the float was minimally damaged. The scoop was observed to be deployed about 1/8 inch below the main keel.

Figure 9. Side View of Right Float Scoop

Figure 10. Overhead view of the Right Scoop (Photo Courtesy of Wipaire)

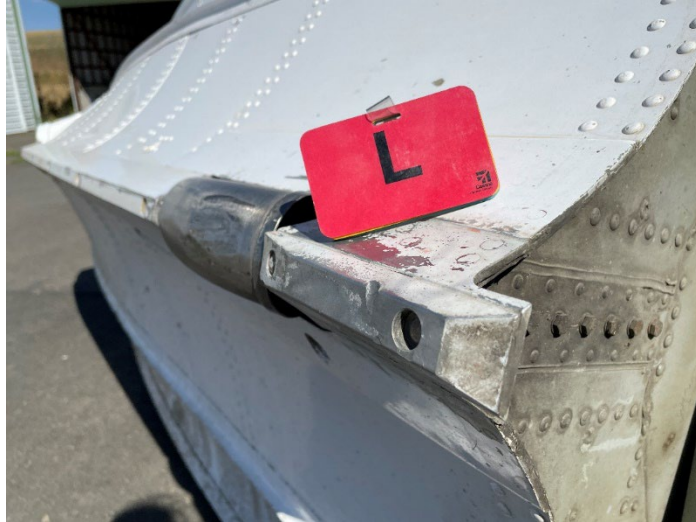
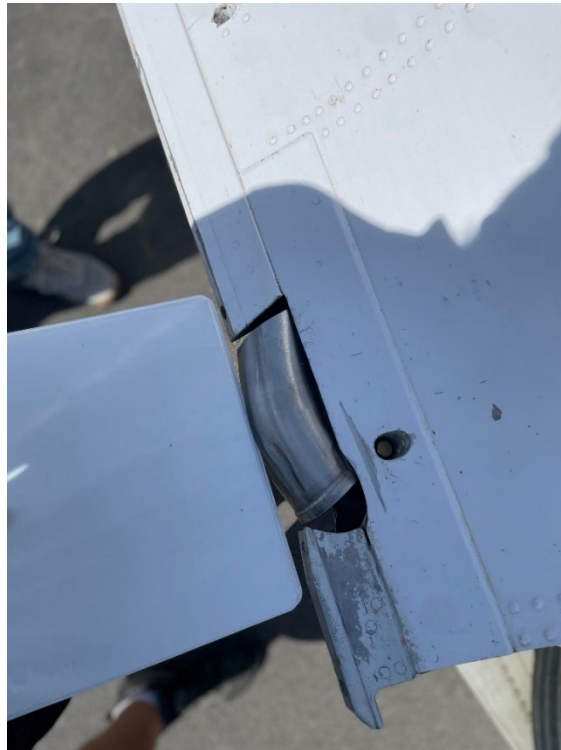
The left float remained relatively intact with the nose portion crushed inboard and upward. The underside/bottom of the float was minimally damaged. The scoop was observed deployed about 1/4 inch below the main keel. The water rudder remained attached at the aft float bulkhead. The landing gear was observed in the retracted position. The side skins of float had several punctures, consistent with impact damage.

Figure 11. Side View of Left Scoop

Figure 12. Overhead View of Left Scoop  
(Photo Courtesy of Wipaire)

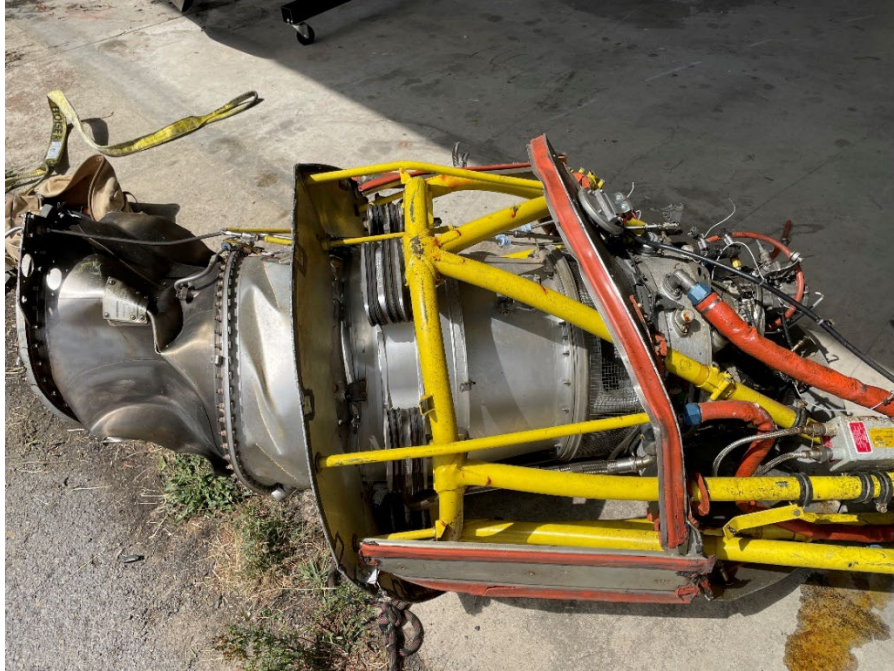
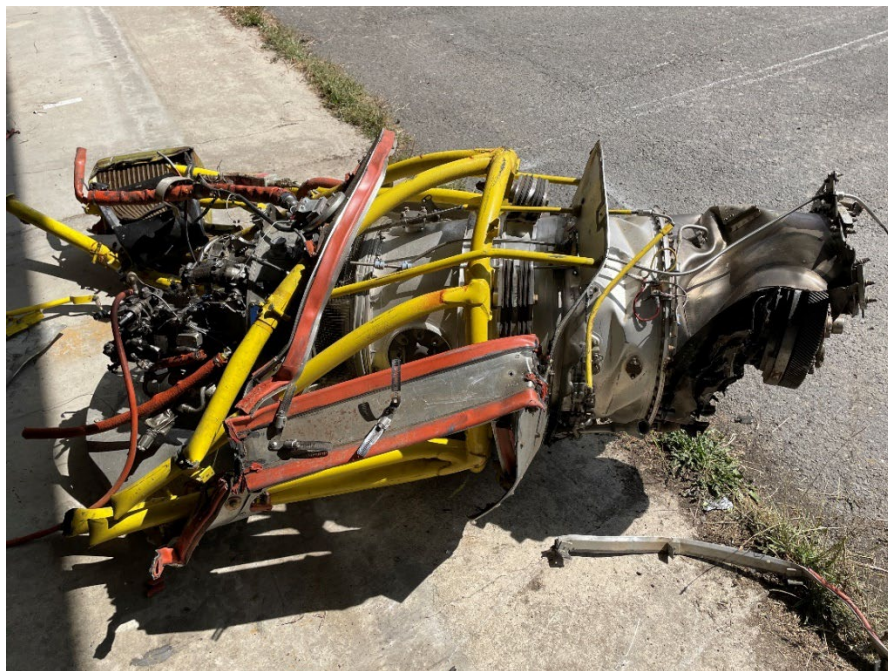
Recovery personnel reported that the engine remained attached to the airframe via the hoses and cables. For recovery purposes, the engine was separated from the airframe.

Figure 13. Side View of Engine

Figure 14. Side View of Engine

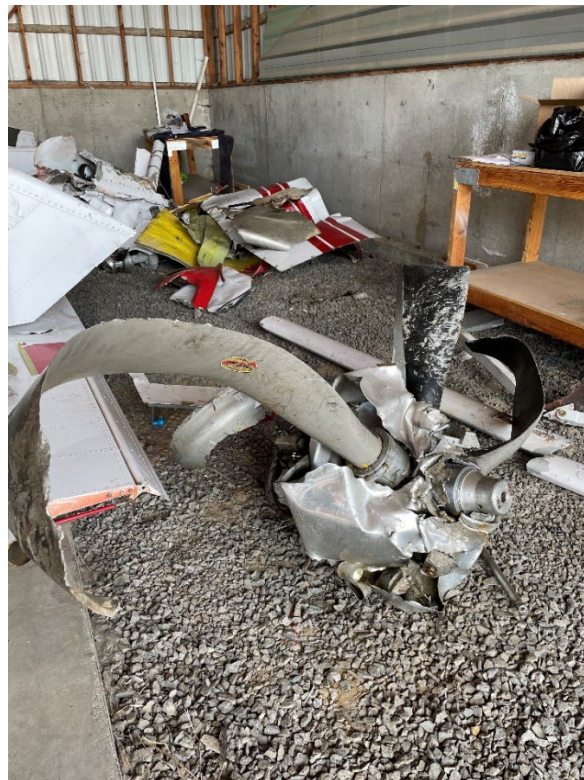
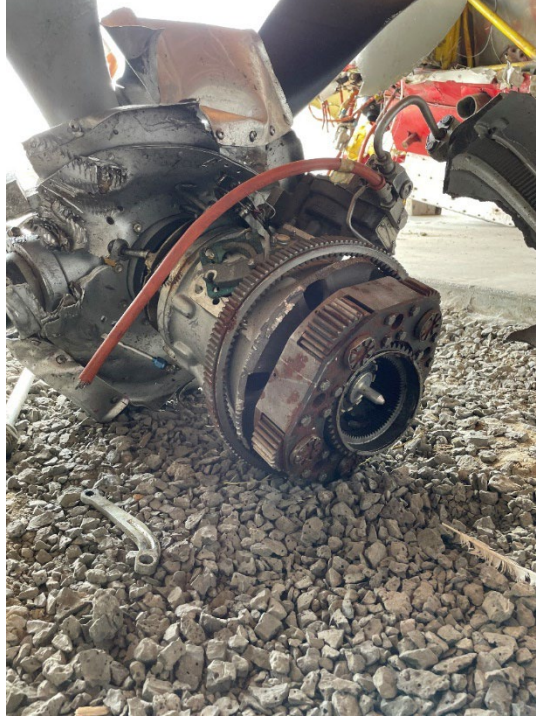
The 5-bladed propeller assembly as well the second stage planetary gears of the reduction gearbox separated from the main engine.

Three of the five blades remained attached to the propeller assembly at the hub; however, the blades were loose in the respective hub attachments. All three blades exhibited S-bending, chordwise scratching, and leading and trailing edge nicks and gouges on both the cambered and face sides of the blades.

Figure 15. Front View of Propeller

Figure 16. Rear View of Propeller

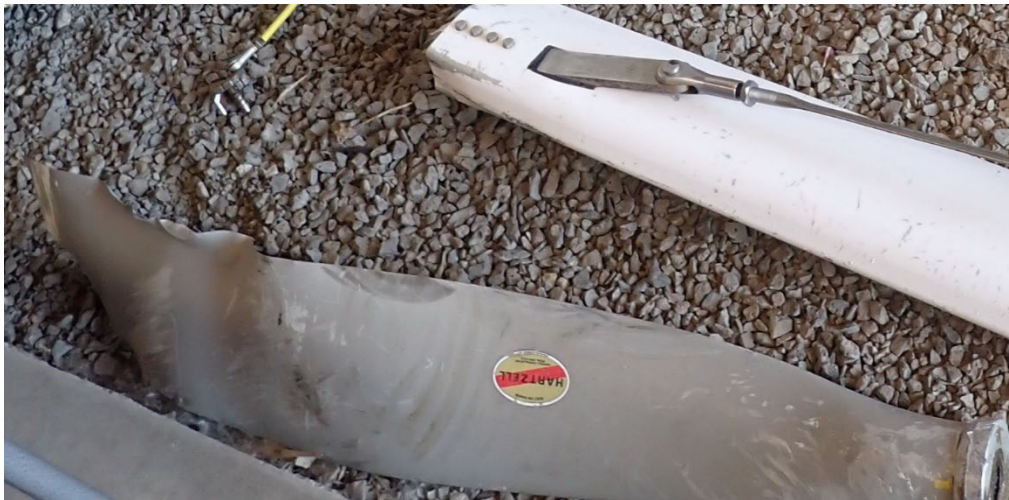
The fourth blade had separated at the hub and was relatively straight with some curling and leading and trailing edge nicks and gouges at the tip area.

Figure 17. Propeller Blade
