# National Transportation Safety Board

WPR24FA252

## WRECKAGE EXAMINATION REPORT

Location: Kneeland, California  
Date: July 23, 2023  
Time: 1104 Pacific Daylight Time  
Airplane: Cessna T206H, Registration N460DC

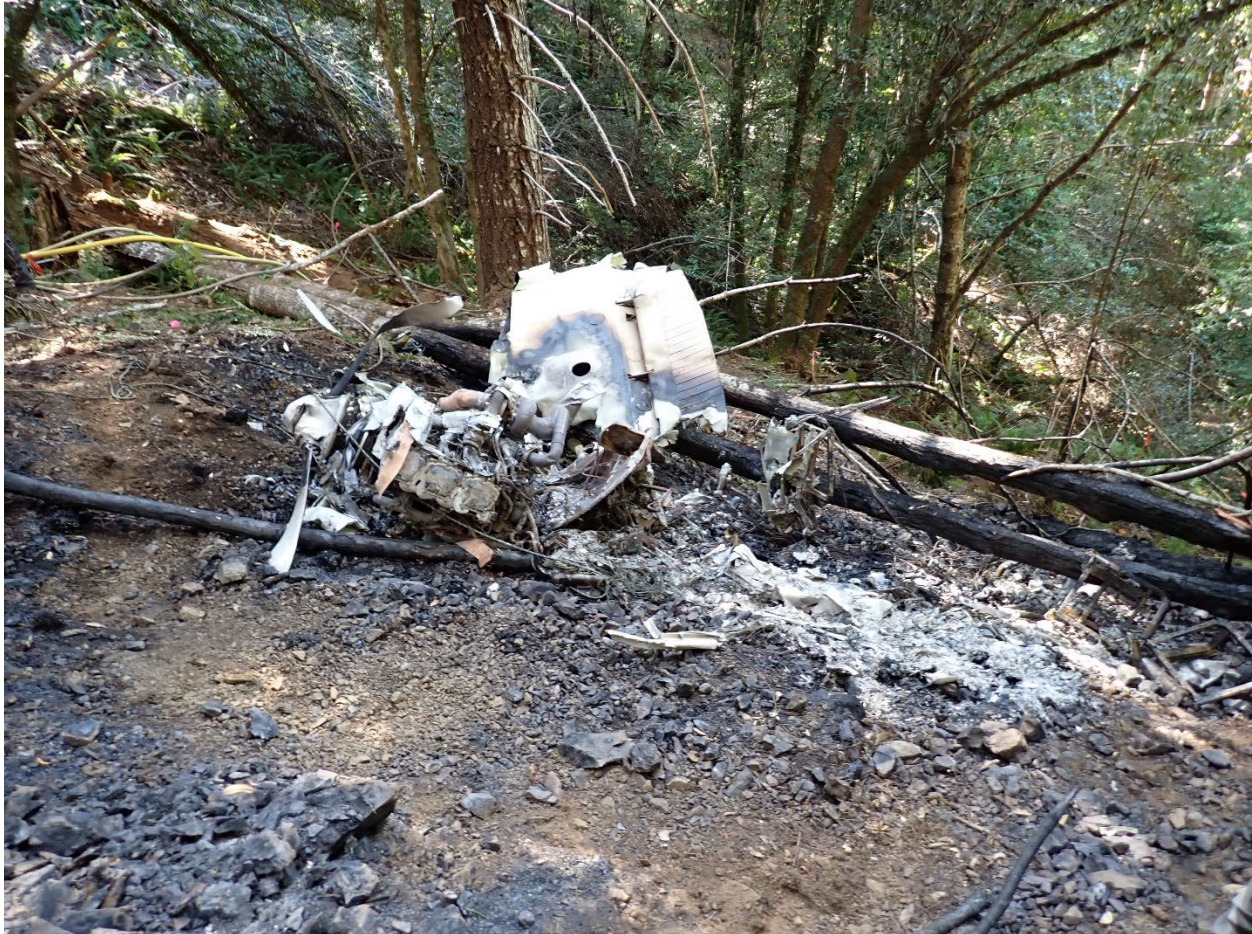
The airplane was mostly consumed by post crash fire. Post accident examination of the wreckage did not reveal any preimpact mechanical anomalies with the airframe or engine that could have precluded normal operation. The flight control cables were traced to their termination points or to separations from either recovery personnel or due to overload separation. The fuel system components were destroyed or thermally damaged. The engine did not exhibit any evidence of catastrophic failure or other anomalies.

**Figure 1: Main wreckage**

The airplane came to rest inverted in a wooded area approximately 700 ft from the departure end of runway 33 at a field elevation of 2,570 ft mean sea level. The wreckage was mostly consumed by postcrash fire and the empennage was not identified within the main wreckage of the accident site or in the surrounding terrain. A debris path was marked by several broken tree branches and broken tree tops. The

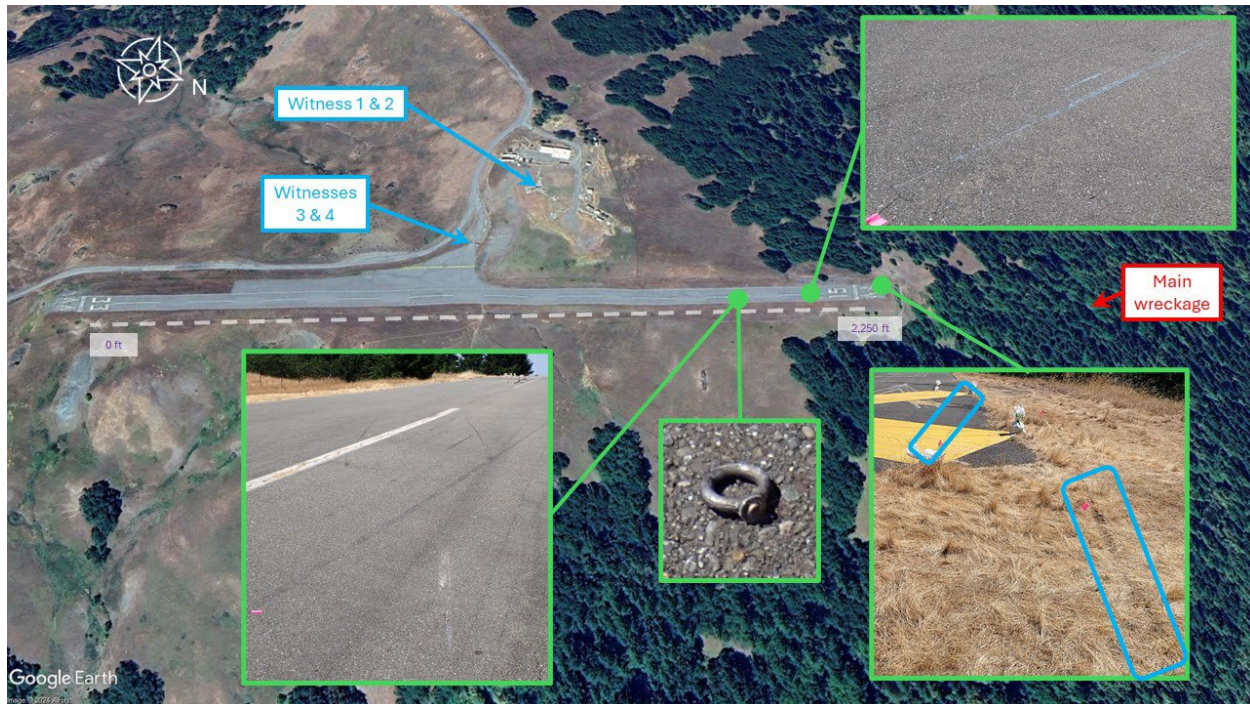
**Figure 2: Images of runway contact signatures**

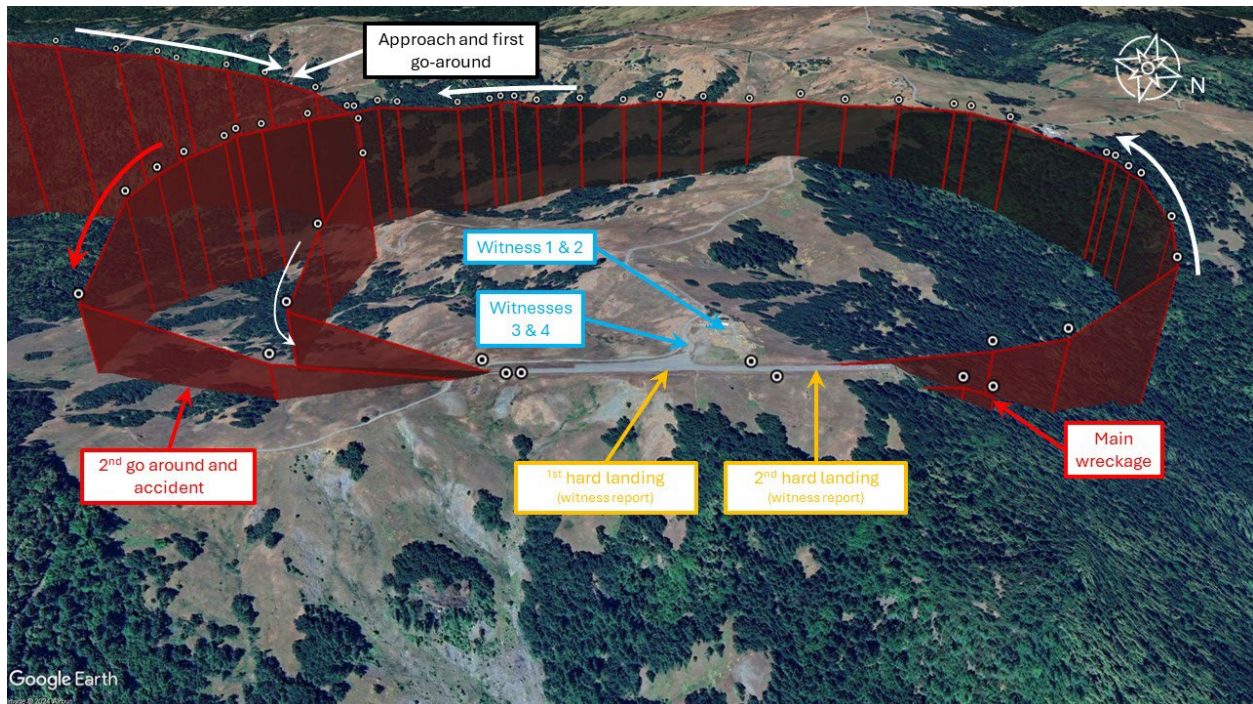
**Figure 3: Flight track with witness positions and runway contact points**

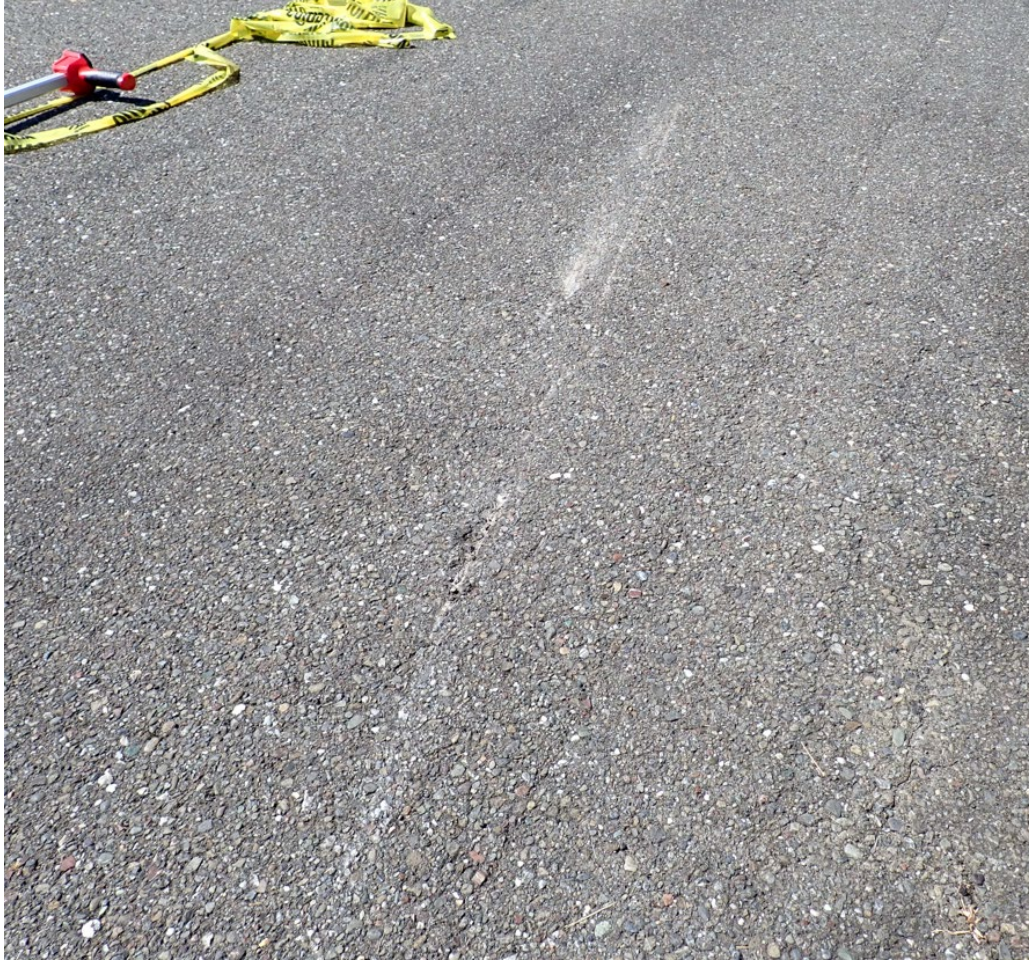
A gouge was located about 400 ft from the runway end on the left side of the runway centerline with an adjacent scrape mark. A tie down ring was located near the gouge on the right side of the runway centerline. Two parallel tire marks were observed about 12 ft forward of the gouge, which was lined up between the tire marks. The gouge, scrape, and tire marks were oriented approximately 25° left of the runway centerline. A 22 foot long white scrape mark was located on the left side of the

**Figure 4: Gouge mark and adjacent scrape**

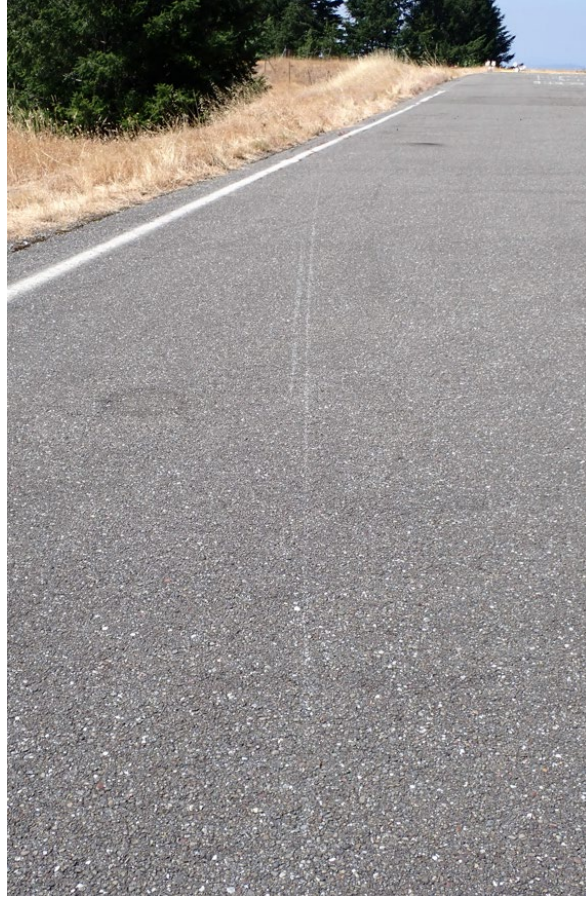
**Figure 5: Long white runway contact mark**

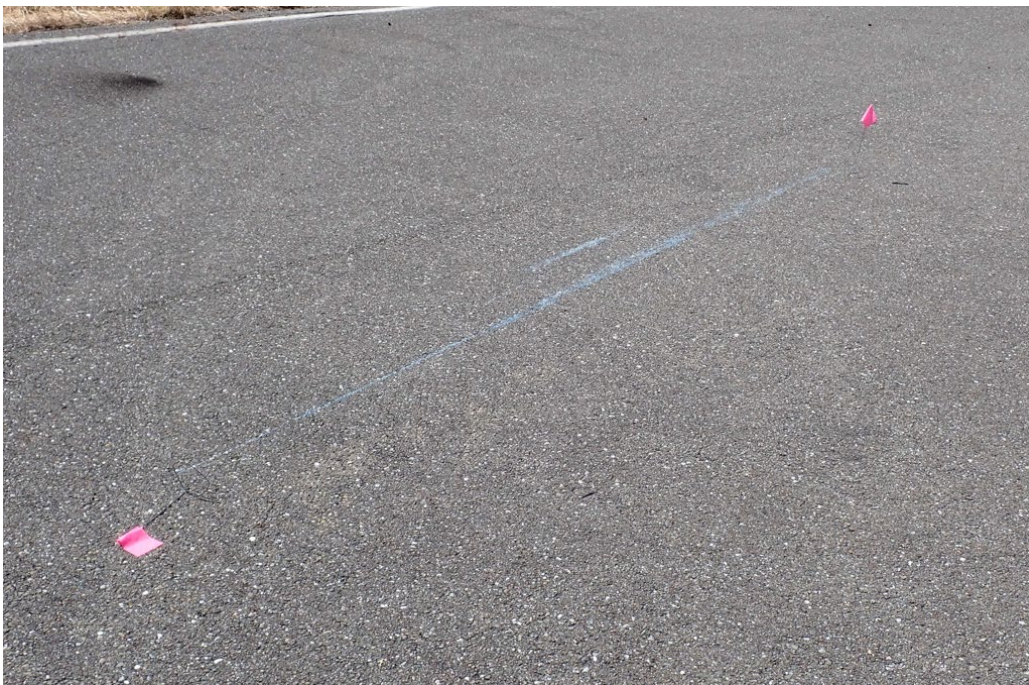
runway adjacent to a set of blue scrape marks oriented about 10° left of the runway centerline. Another parallel scrape mark was located next to the blue marks and was comprised of metallic fragments.

**Figure 6: Blue runway contact marks**

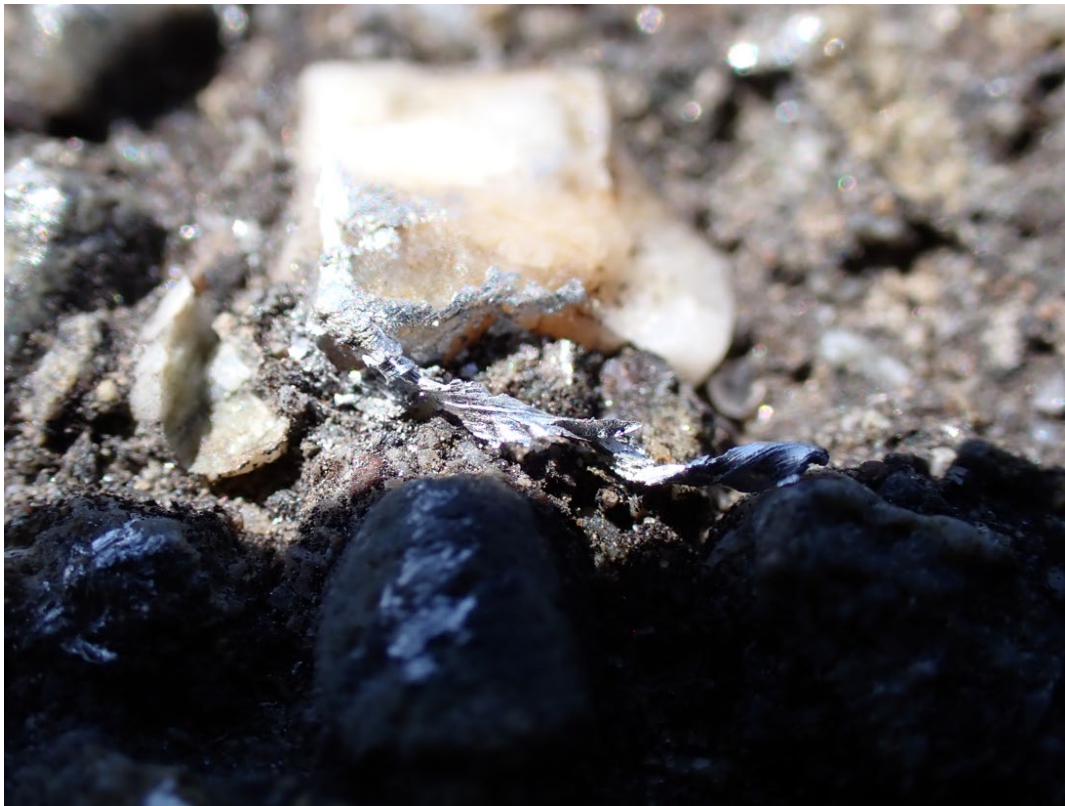
**Figure 7: Metal fragment located next to blue contact marks**
