# National Transportation Safety Board

WPR24FA255

## **FIELD NOTES & EXAMINATION SUMMARY**

Location: Izee, Oregon  
Date: 7/25/2024  
Time: 1830 local (PDT)  
Airplane: N850DG

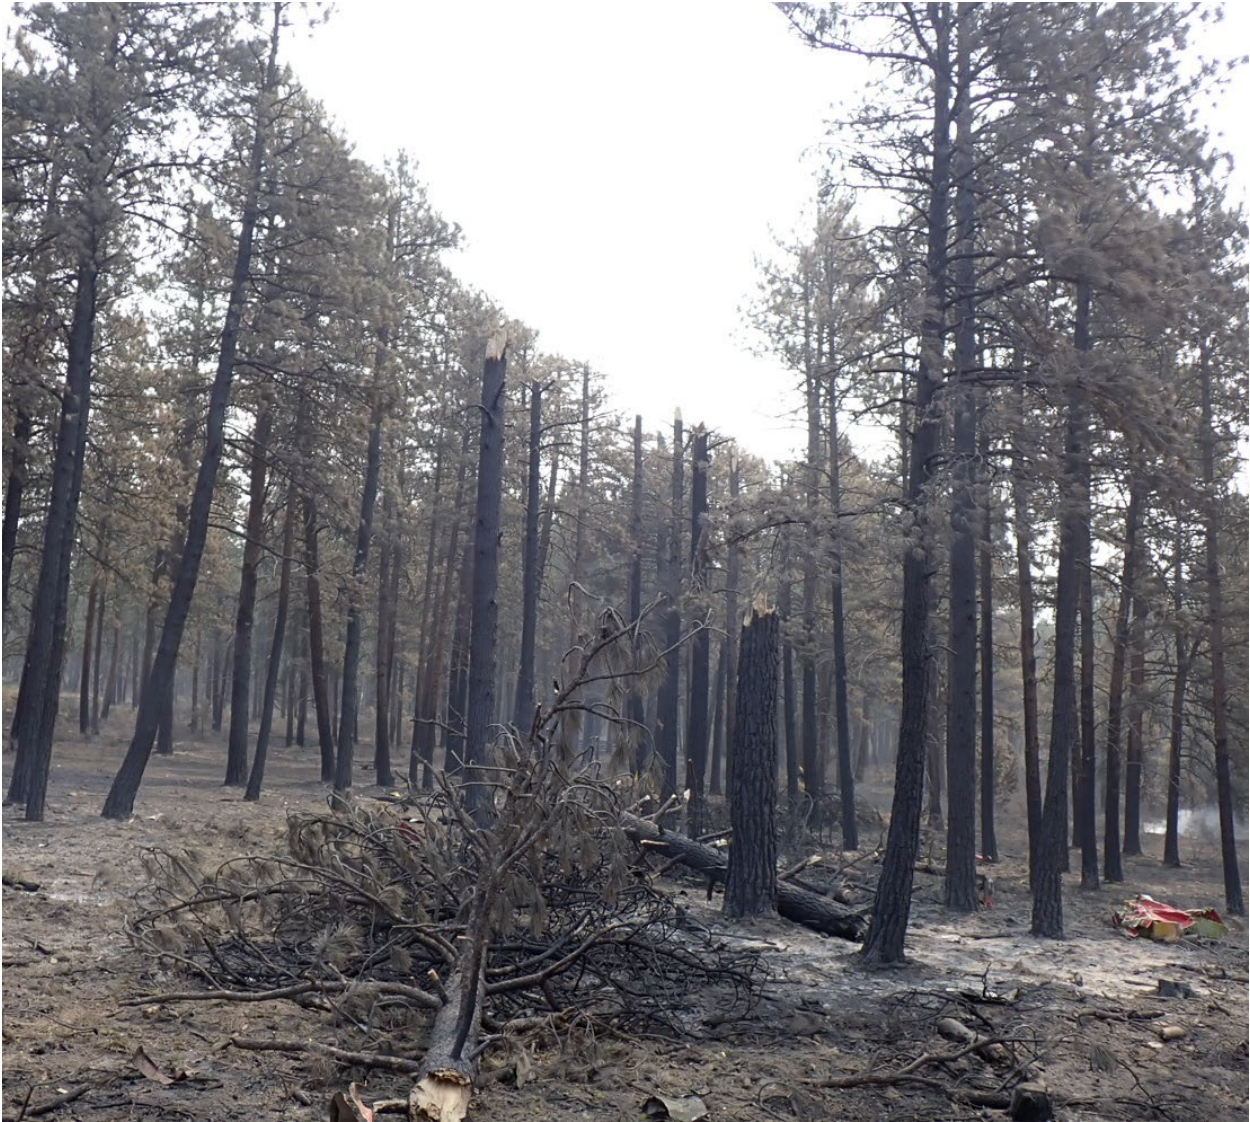
The main wreckage was found in wooded mountainous terrain about 7.2 miles southeast of Izee, Oregon in an area that had been burned during the "Sand Fire". Trees leading up to the wreckage site were found with impact damage. Wing, fuselage, and empennage components were found following the impacted trees leading up to an initial ground scar located 290 ft west of the initial tree impact. Initial impact with trees was consistent with a left-wing low attitude.

**Figure 1. Accident flight path through trees (looking East)**

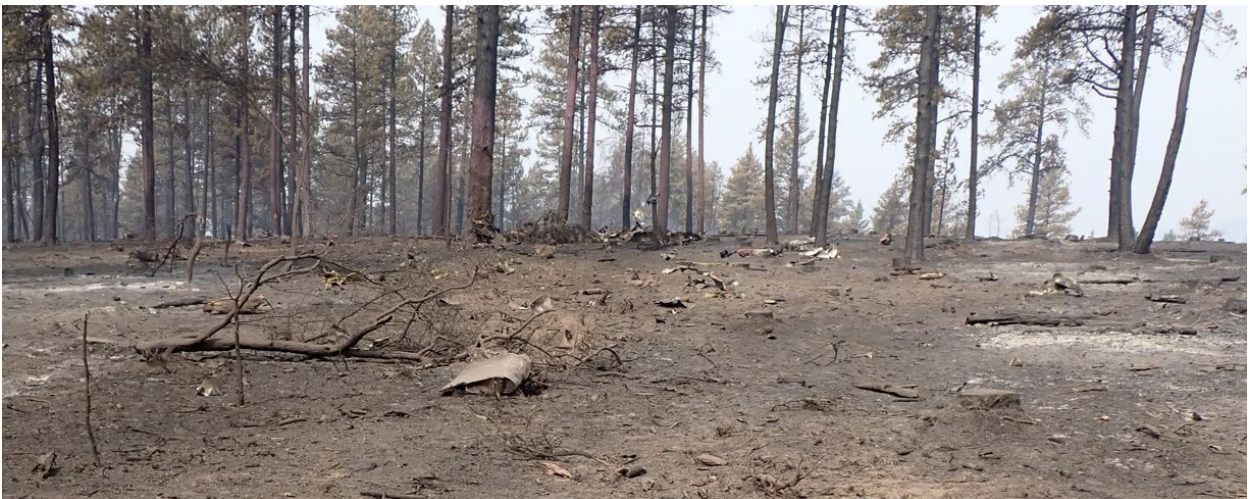
**Figure 2. Accident flight path and wreckage site (looking West)**

The ground scar was found to contain the inboard half of the left aileron, the left aileron counterweight, a segment of the right V-strut, and a segment of frame tube. West of the initial ground scar, the airplane was found to be highly fragmented. Tree trunks along the debris path were found with impact marks. The main fuselage wreckage was found 890 ft west of the initial tree impact. The main fuselage wreckage consisted of the aft cockpit frame, overturn structure, and the seat. The main fuselage wreckage was found upright with significant fire damage.

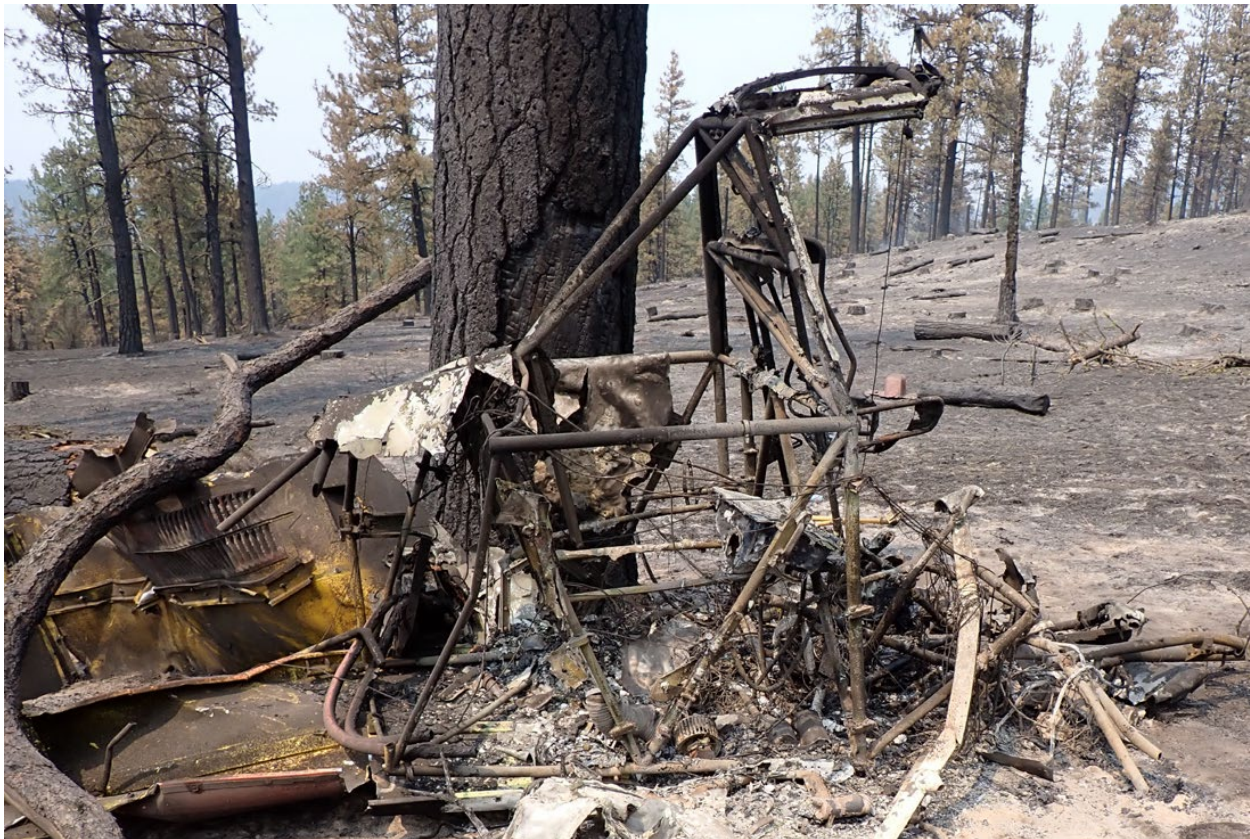
The forward fuselage was found highly fragmented. A section of fuselage consisting of aft cockpit frame, overturn structure, and the seat was found near the end of the debris trail. The aft fuselage was found fragmented along the debris trail.

**Figure 3. View of main fuselage resting against a tree**

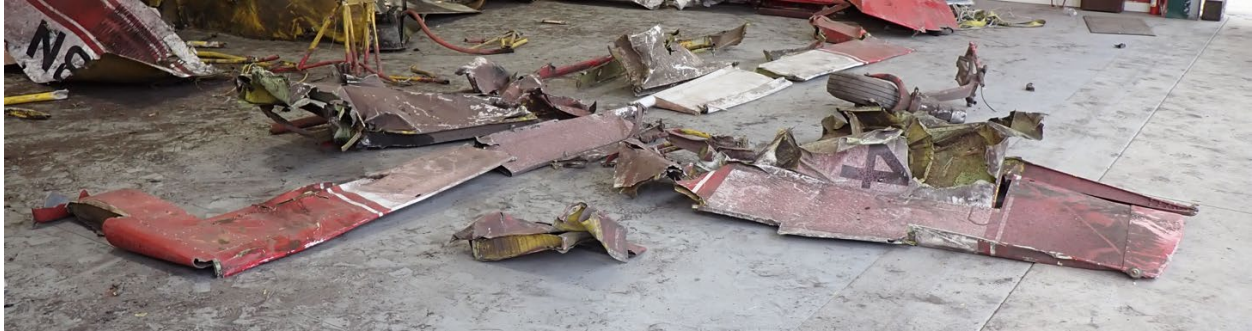
The empennage surfaces were separated from the fuselage and located along the wreckage path. The right horizontal stabilizer was fragmented. The right elevator was separated from the horizontal stabilizer and found with a separation at elevator station 50.0". The right elevator counterweight separated from the elevator and found along the debris path. The left horizontal stabilizer was found separated from the fuselage. The left elevator was found separated from the stabilizer with a separation at elevator station 50.0".

The vertical fin was found separated from the fuselage and found near the main fuselage wreckage. The rudder was found separated from the vertical fin and found near the main fuselage wreckage with a separation near water line 20.0".

**Figure 4. View of empennage layout**

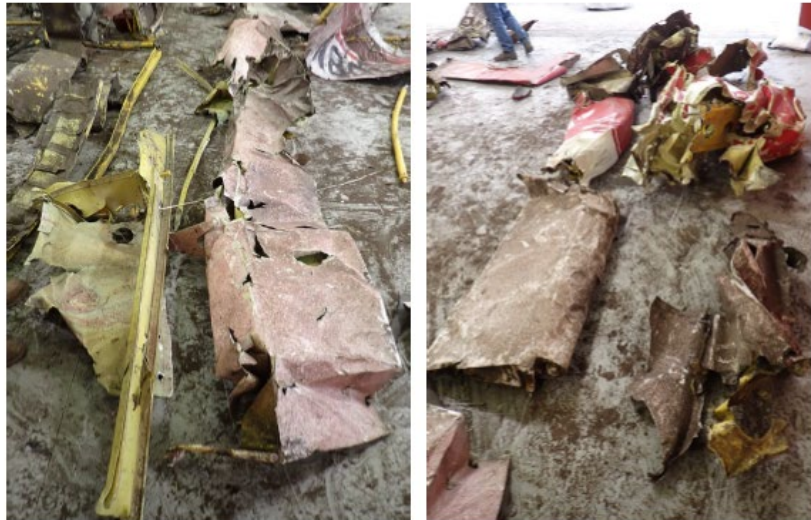
**Left Wing Layout**

The wings were highly fragmented along the debris path. The main spar was found 590 ft west of the initial tree impact attached to fragments of the fuselage frame. The center splice was found intact. The left rear spar attach plate was found separated from the wing, attached to the fuselage frame. The right rear spar was found separated from the fuselage frame.

**Figure 5. Top left and right photos: view of left-wing layout; Bottom left and right photos: view of right-wing layout**

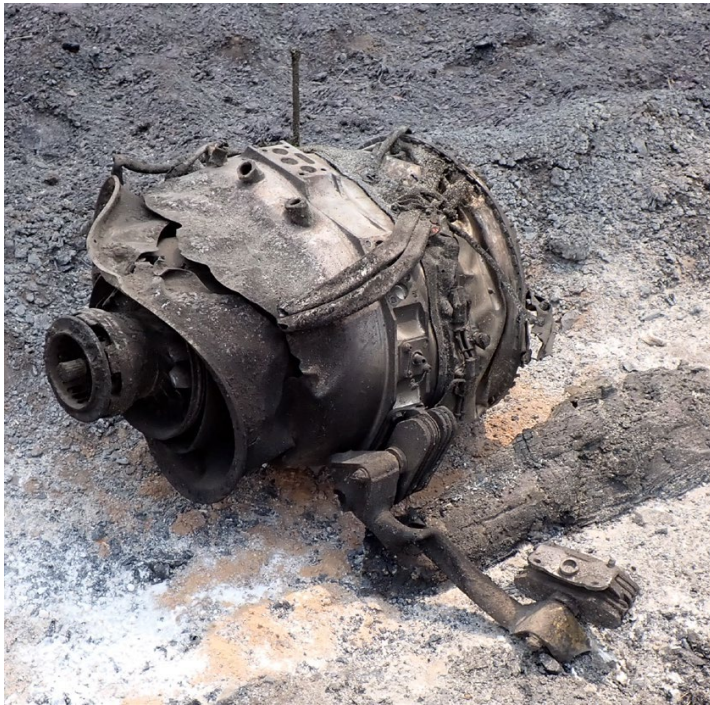
The powerplant was found separated from the engine mount. The engine was found with impact damage and separations at the "C" and "F" flange. The main engine wreckage was found 470 ft west of the initial tree impact. Twist and compression damage was seen on the engine case.

**Figure 6. View of engine at accident site**

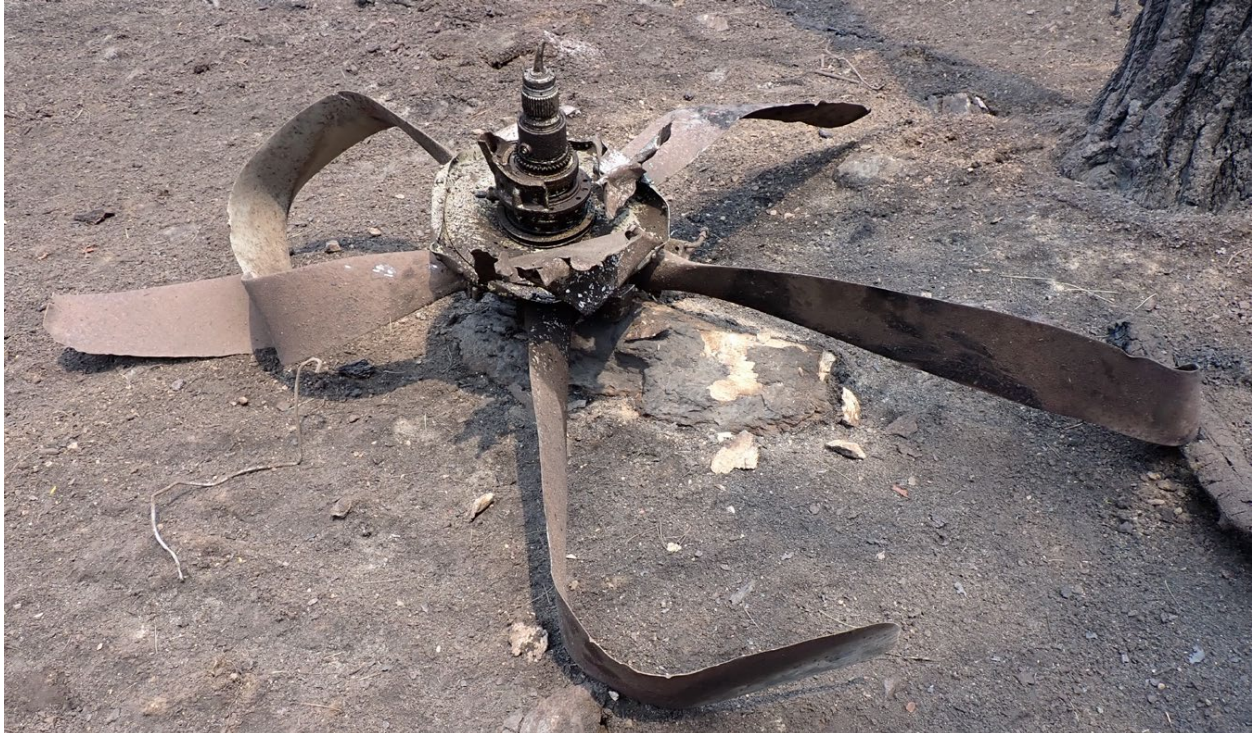
The engine was equipped with a five-bladed Hartzell fully reversible propeller. The propeller hub was found attached to the propeller shaft which was separated from the engine 500 ft west of the initial tree impact. The feathering spring assembly was found separated from the hub. Each of the five propeller blades were found attached to the hub. One blade was found bending towards the camber side at the blade tip. One blade exhibited "S" bending and was found with a separated tip. One blade exhibited bending to the face side. The remaining blades exhibited bending to the camber side.

**Figure 7. View of propeller wreckage at accident site**
