National Transportation Safety Board

WPR24FA270

**INVESTIGATIVE SUPPLEMENTAL MATERIAL**

Location: Augusta, Montana  
Date: August 08, 2024  
Time: 1200 mountain daylight time  
Airplane: Cessna 182K

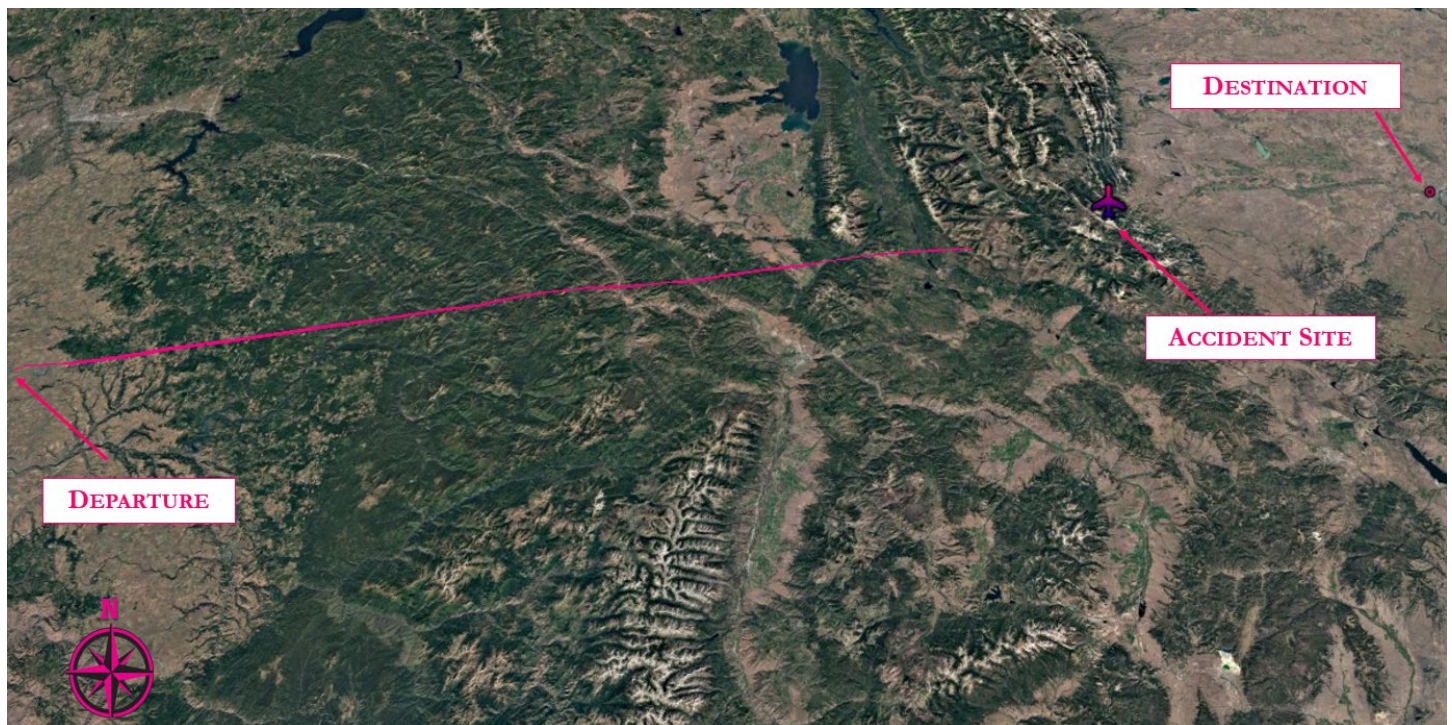
Figure 1: Flight track identified from the ADS-B

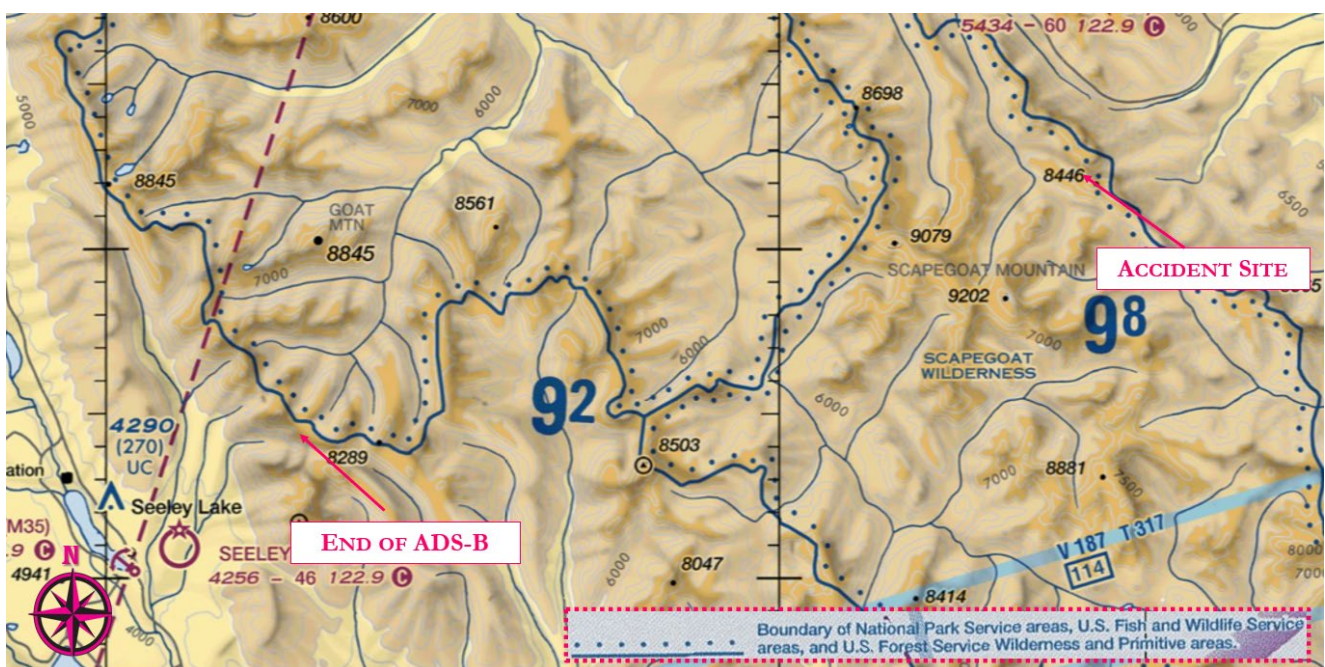
Figure 2: Flight section from the end of the ABS-B information to the accident site from sectional

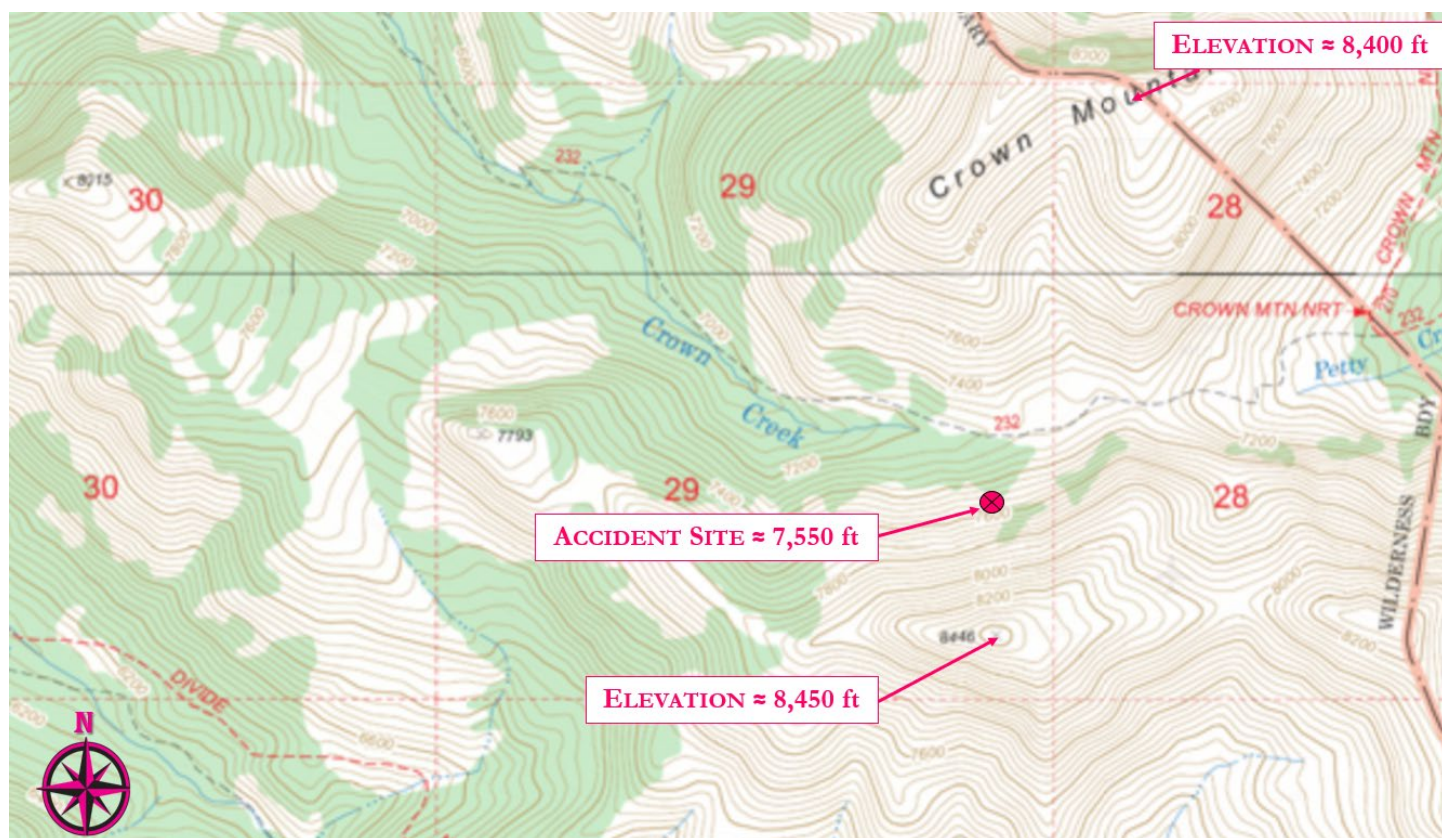
The accident site was located in a rugged, mountainous canyon 17 nautical miles west of Augusta, Montana, at coordinates 47.369797/-112.766089. The terrain consisted of loose scree beneath firmer ledges and rocky outcrops, bisected by a gradual central gully with forest vegetation. The south canyon wall reached an elevation of 8,450 feet, while the north wall, known as Crown Mountain, peaked at 8,400 feet. The airplane came to rest on a steep south-facing slope at an elevation of 7,550 feet.

Figure 3: Accident site showing surrounding elevation

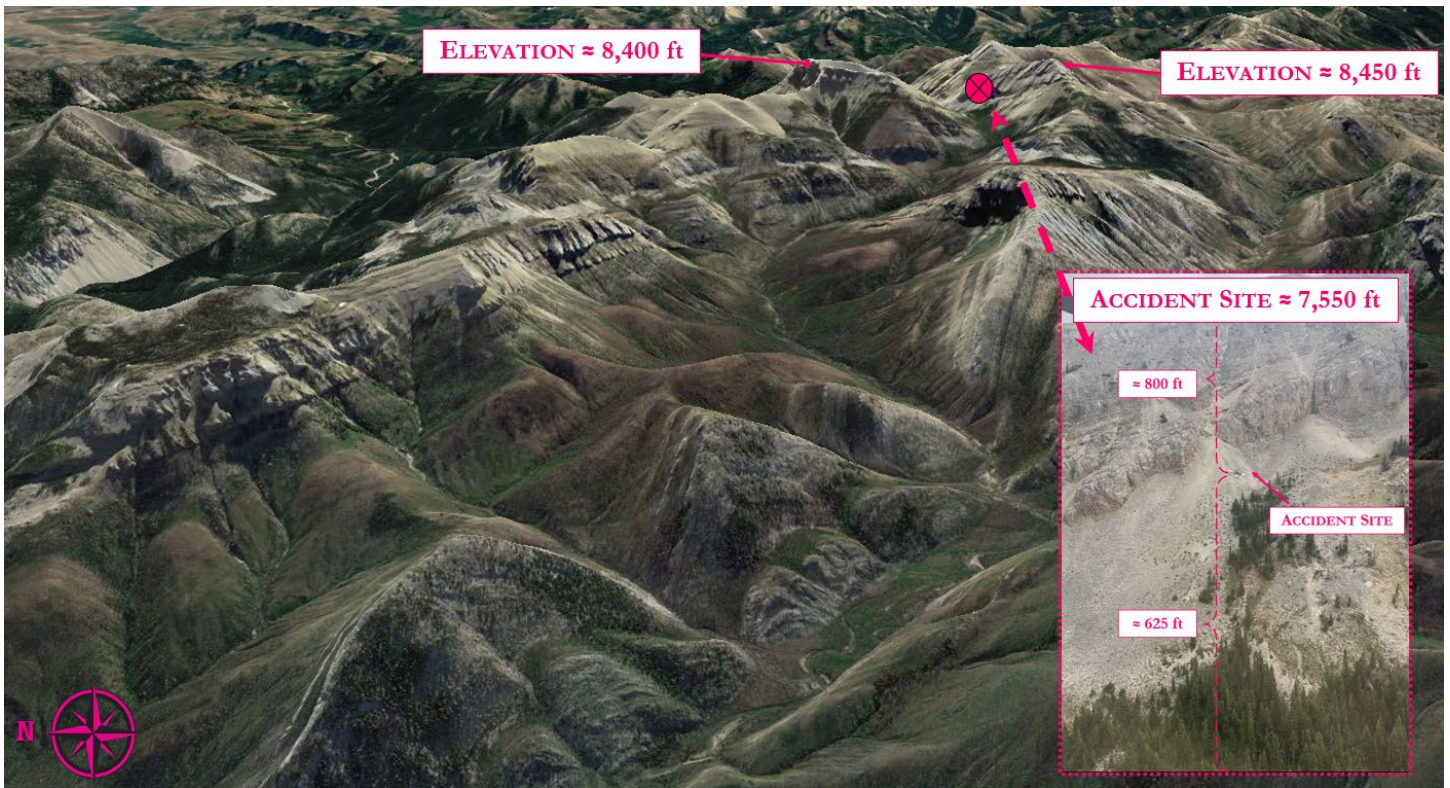
The airplane's nose was oriented upslope on a magnetic bearing of approximately 140°. The wreckage was scattered over a 90-foot area, with the most distant debris, primarily windscreen fragments, located east of the main wreckage. The main wreckage, which included all major control surfaces, was found 800 feet below the cliff's top and 625 feet above the canyon floor. The fuselage and inboard sections of the wings had been consumed by fire.

Figure 4: Accident site location

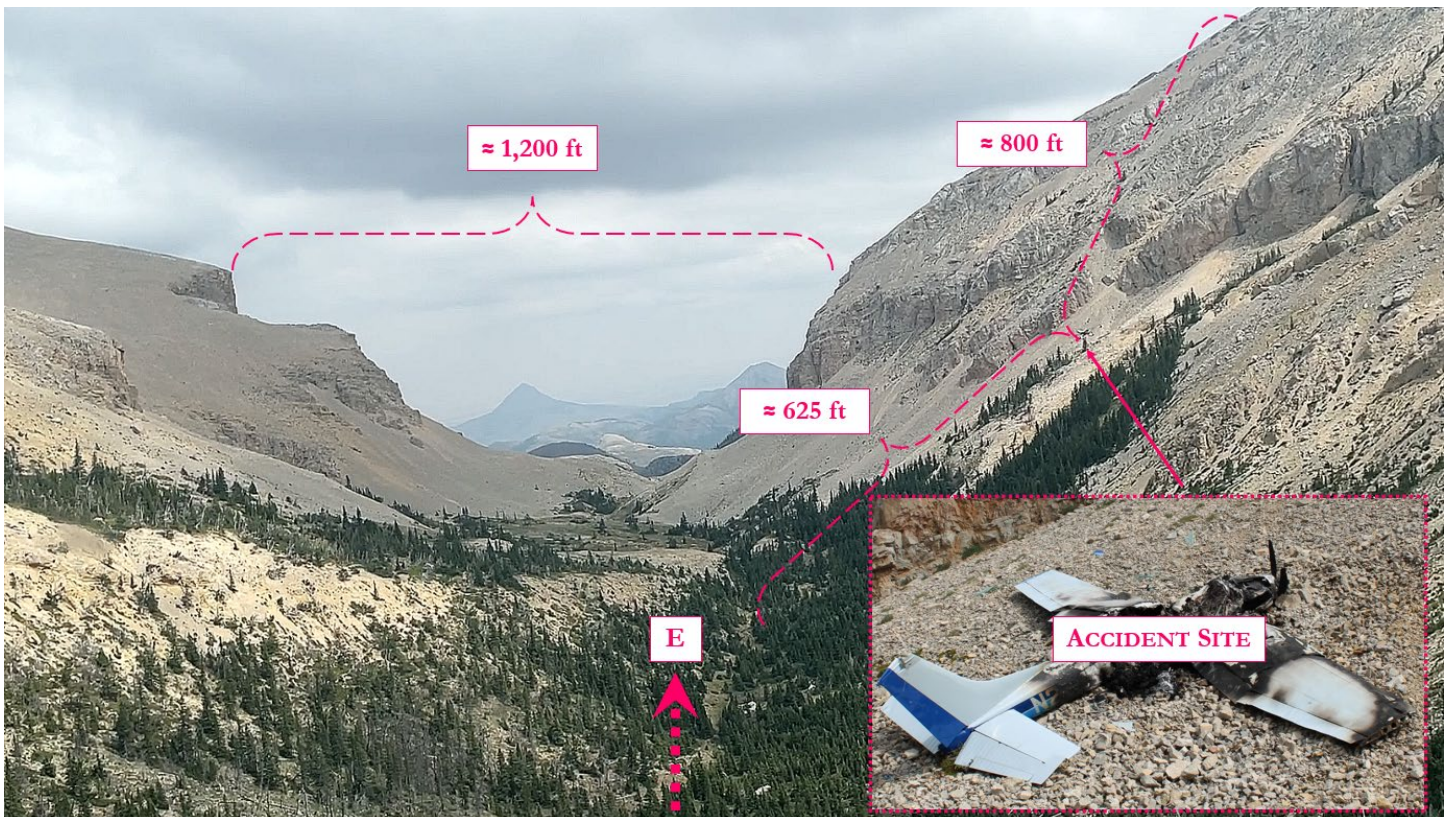
Figure 5: Accident site in reference to surrounding terrain

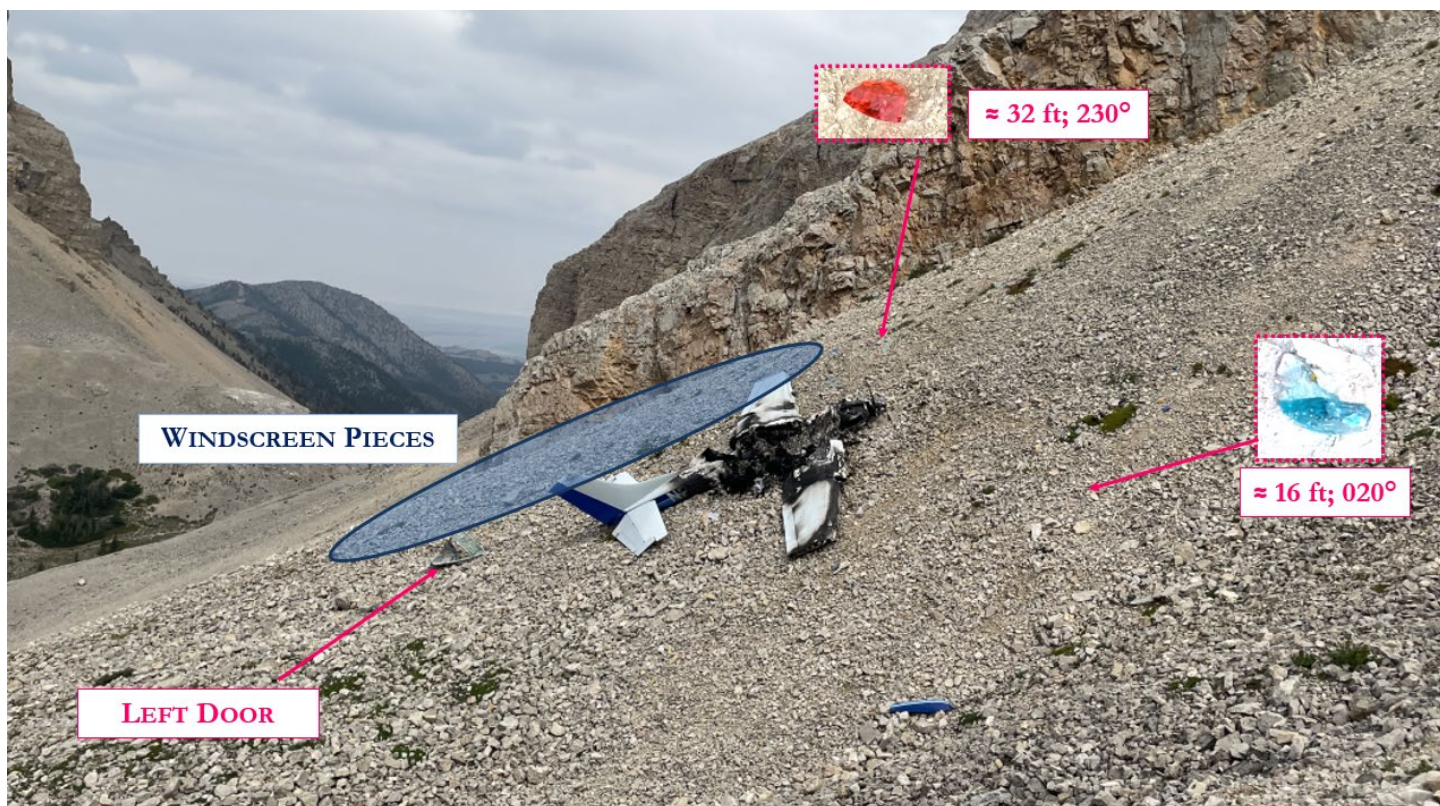
Within the debris field, fragments of red and blue/green plastic lens covers were found east and west of the main wreckage, respectively, consistent with the wings impacting the terrain with the airplane in a nearly level attitude. The farthest piece of wreckage, a windscreen fragment, was located 90 feet from the main wreckage on a heading of 040°. The left door was found 35 feet downslope from the main wreckage, with the latch still in the closed position.

Figure 6: Accident site showing position lights

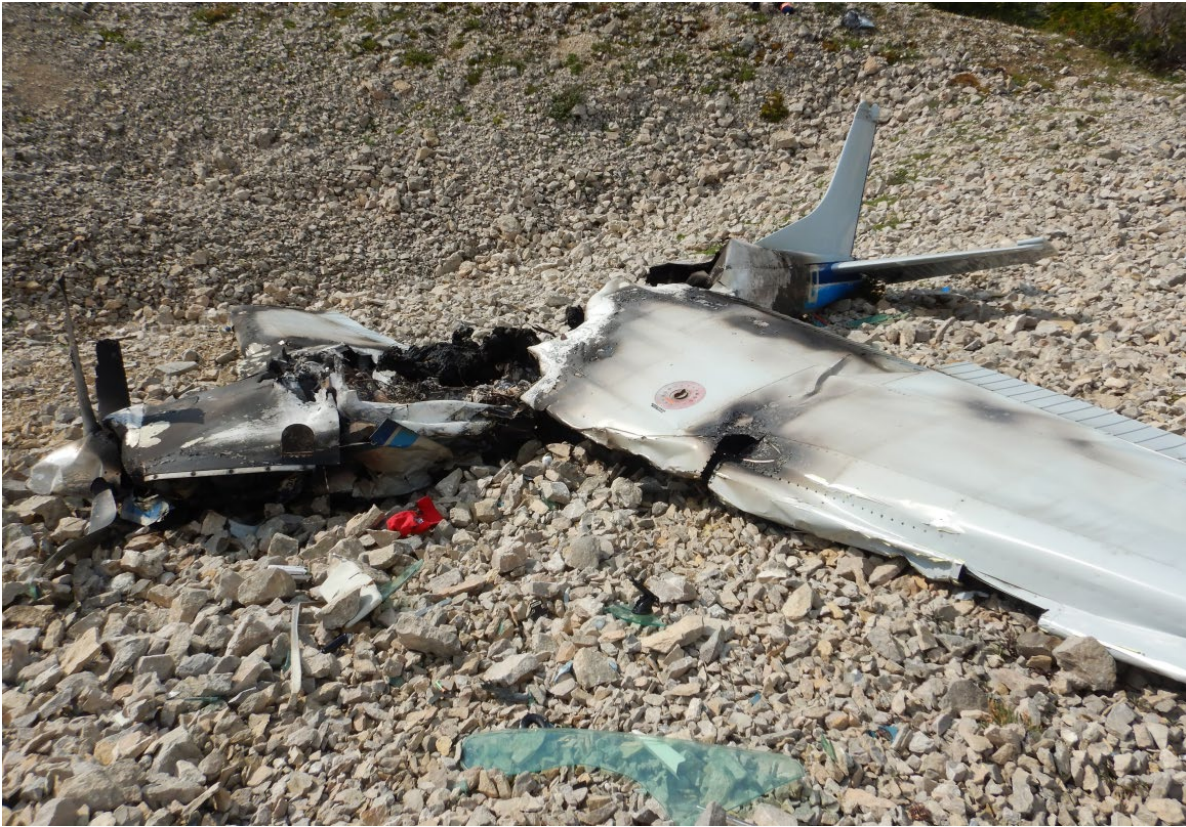
*Figure 7: Wreckage*

The right and left wing came to rest upright and the flap and aileron control surfaces remained attached at their respective hinges. The leading edges of both wings sustained aft crush damage with the bottom wing incurring the most damage. The skin folded over on itself in an accordioned appearance. The right aileron direct cable was continuous from the right cable drum in the cockpit to the bellcrank. The left aileron direct cable was continuous from the left cable drum in the cockpit to the bellcrank. The carry-through cable was attached to the right bellcrank and continuous to the left bellcrank, where it was secured. The flaps cables were attached at the drive pulley. Investigators measured the flap actuator extension, which the Textron representative stated was consistent with the flaps fully retracted.

The elevator cables were connected in the cockpit, continuous through the fuselage, and attached at the aft bellcrank. The push-pull tube was connected to the aft bellcrank (mounted on the aft bulkhead and to the elevator control arm).

The rudder cables were attached in the cockpit and were continuous through the fuselage to their respective arms on the rudder horn; the pulleys throughout the airframe were consumed by fire. The rudder stops were intact with no evidence of deformation.

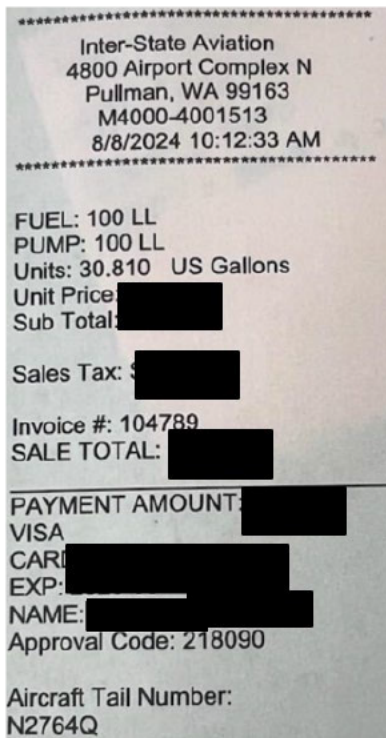
Fuel records indicated 30.81 gallons of 100LL fuel was sold to the pilot in Pullman, Washington at 1012 on the morning of the accident flight.

Figure 8: Fueling receipt

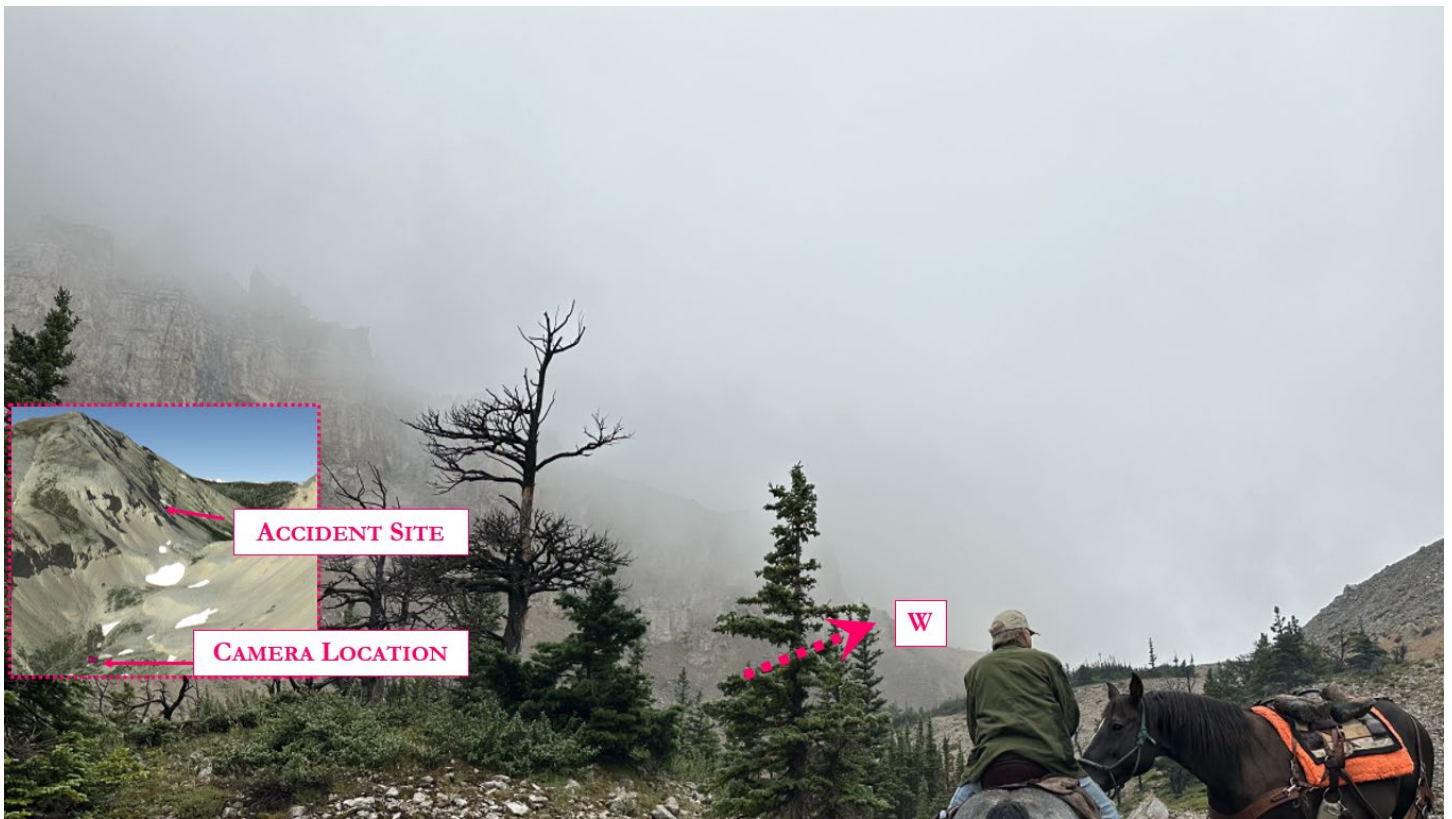
The Area Forecast, GFAs, HRRR sounding, and weather conditions reported by eyewitnesses were consistent in indicating that cloud ceilings were below, and therefore clouds obscured, the mountain peaks and ridges. This effect became progressively more so as one travelled further east into higher terrain, where the data indicated there was a likelihood of clouds/mist reaching valley floors, especially in the higher mountain pass areas.

Figure 9: Picture from after the accident
