# National Transportation Safety Board

WPR24FA285

## **GEAR ADVISORY UNIT EXAM NOTES**

Location: Kent, Washington  
Date: August 24, 2024  
Time: 1010 PDT  
<Enter HHMM coordinated universal time (UTC)>  
Airplane: Cessna A185F, N61323

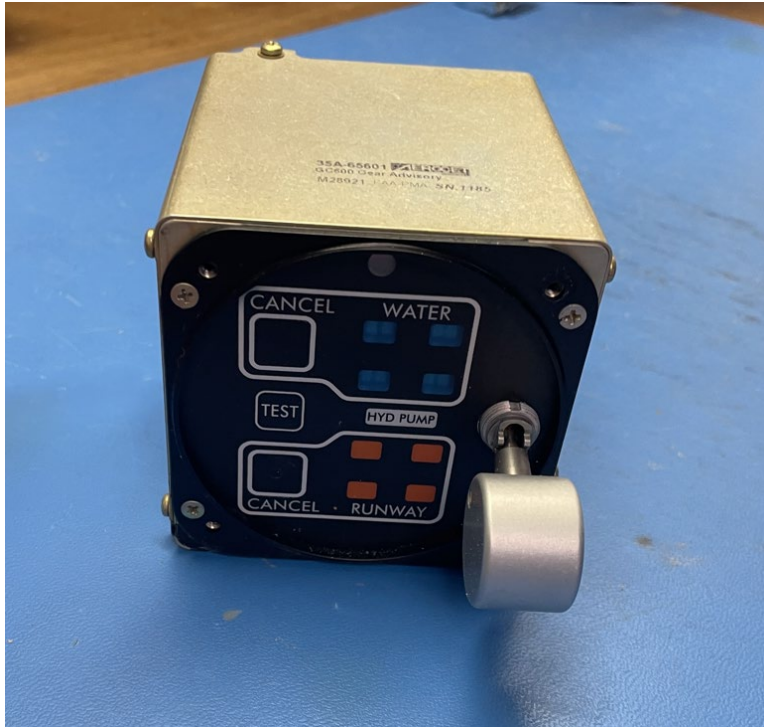
The device was undamaged but displayed corrosion to the electrical connectors. Figures 1 and 2 show the front and back of the device. The unit was powered using a 24 volt external power supply, and functions were tested using air pressure and electrical switches.

Figure 1. View of front of Gear Advisory Unit.

The Gear Advisory Unit passed all functionality tests per Aerocet Inc. reference specification A-31013. During the bench test, all display indicator lights illuminated correctly when the "TEST" button was pressed, and the "HYD PMP" light functioned as expected upon toggling the bench pump switch. Advisory announcements for both "water landing" and "runway landing" were triggered and canceled appropriately, with both "Cancel" buttons performing as required. The aural advisory arming airspeed was found to be set at 95 MPH (miles per hour) and triggered at 77 MPH. The "TEST" button accurately confirmed gear position, and audio announcements met acceptable standards for volume and clarity. The unit also passed lighting and sensor checks, with the main switch activating green test stand lights and the photo sensor dimming and brightening the display correctly. During the test, the right nose gear down indication light was slow to illuminate about three-quarters of a second after the circuit was closed. A physical inspection verified proper assembly, intact fasteners, aligned components, correct labeling, and a clean, defect-free appearance aside from the visible corrosion of the electrical connectors. After testing, the unit was removed from the test stand and returned to its packaging.

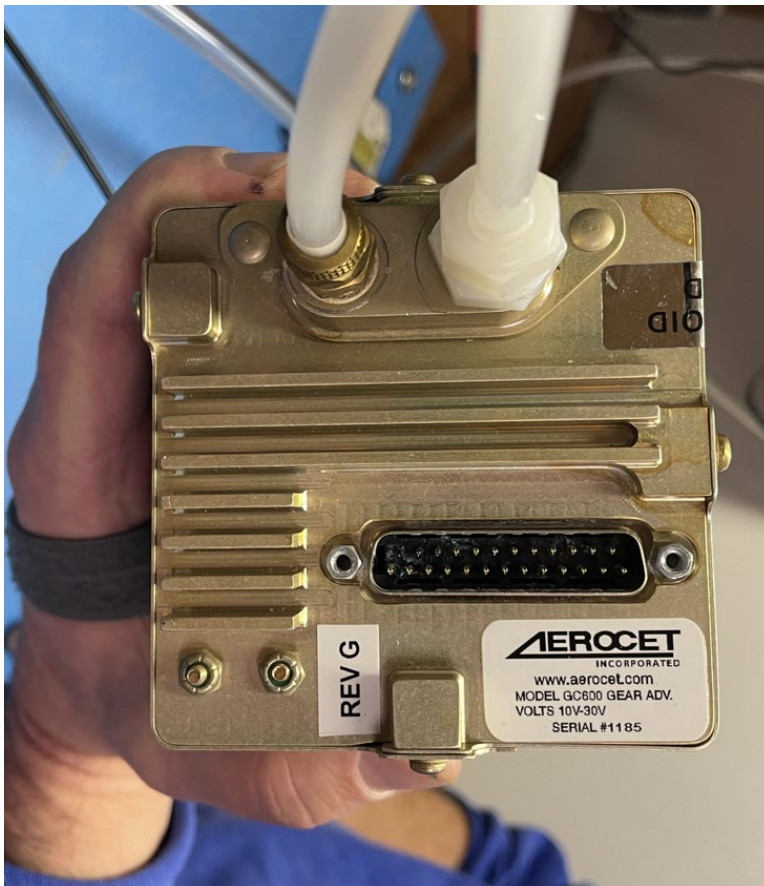
Figure 2. View of back of Gear Advisory Unit.
