# National Transportation Safety Board

WPR24FA285

## **AIRFRAME & ENGINE EXAM SUMMARY REPORT**

Location: Kent, Washington  
Date: August 24, 2024  
Time: 10:10 Pacific daylight time  
Airplane: N61323, Cessna A185F

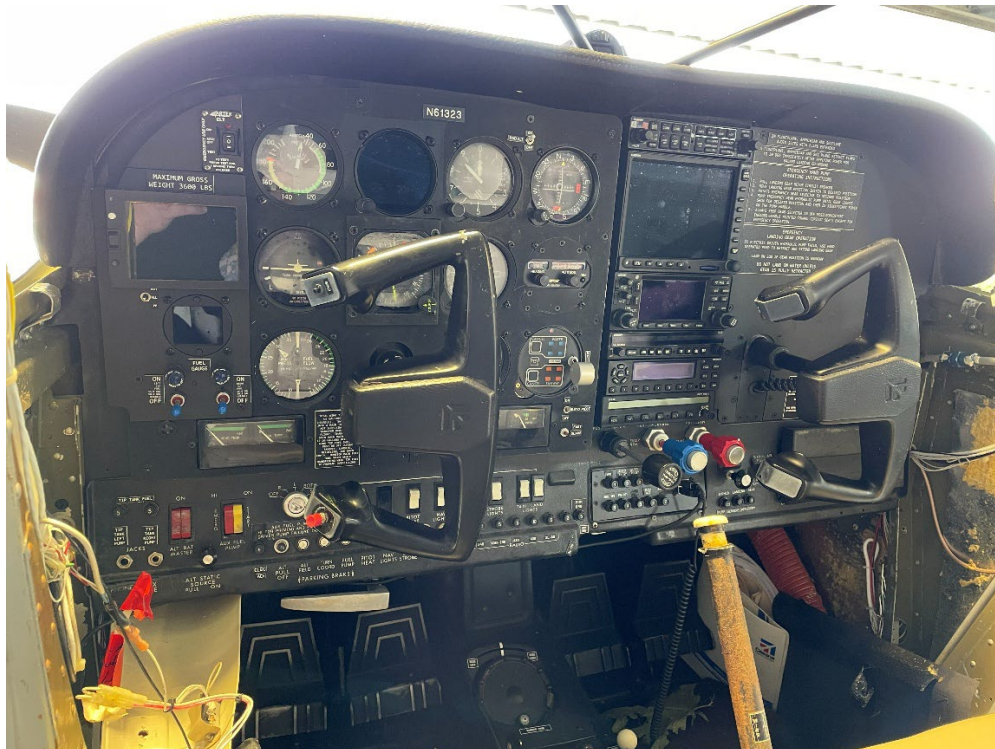
Throttle: Idle  
Mixture: Full rich  
Propeller: Full forward  
Ignition: Both  
Fuel Selector: Both  
Fuel Boost Pump: Off  
Tachometer: 0155.5  
Cowl Flaps: Open  
Flaps: 30°  
Landing Gear Handle: Down  
Elevator trim: 1/8 in aft of takeoff setting  
Rudder trim: Neutral  
Water rudder: Stowed/Retracted

Figure 1. Control panel at wreckage exam.

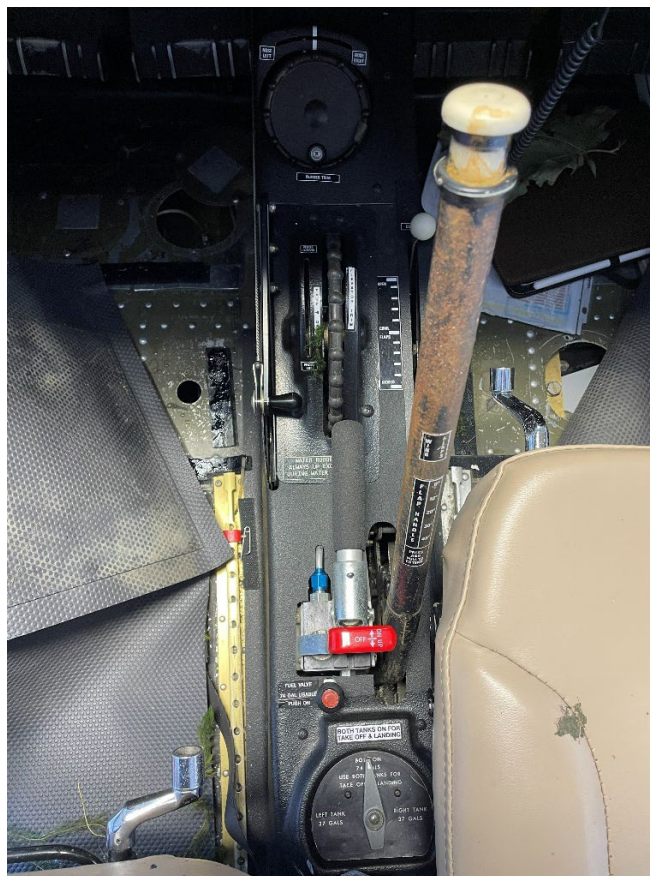
Figure 2. Additional cabin controls at wreckage exam.

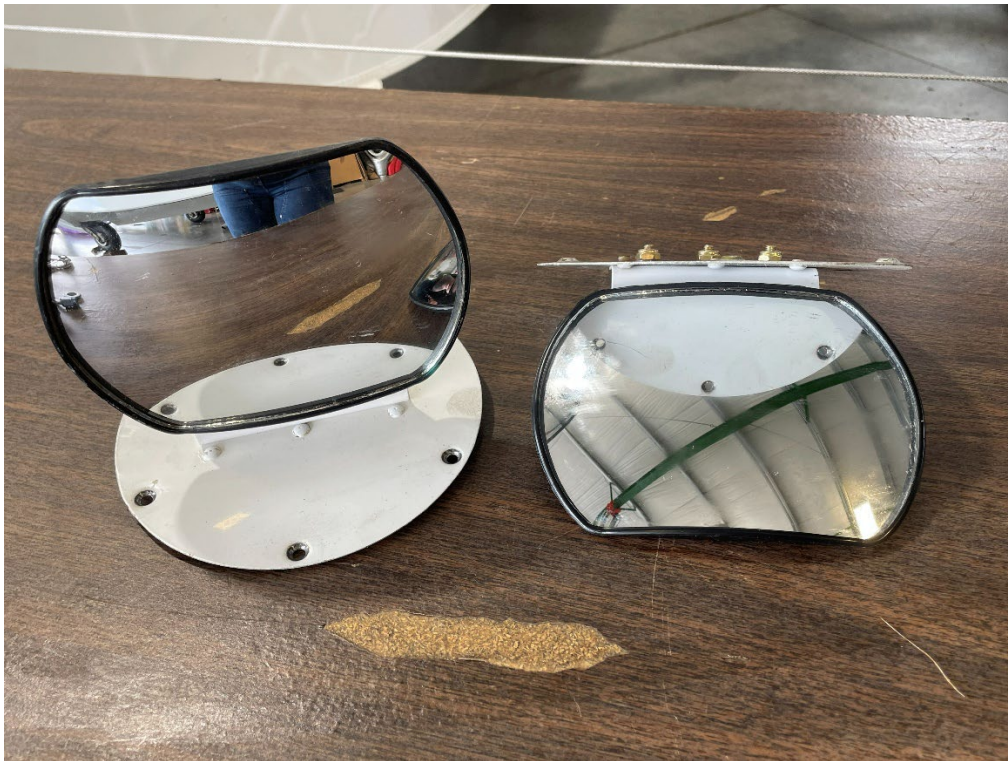
Flight control cable continuity was established between the control yoke and both ailerons. Each wing was equipped with a mirror, installed to provide the pilot with a view of the landing gear position. Both wing mounted mirrors were observed securely installed at the time of water recovery, and later removed by wreckage recovery personnel. (See figure 3.)

Figure 3. Wing mirrors, as observed at the wreckage exam.

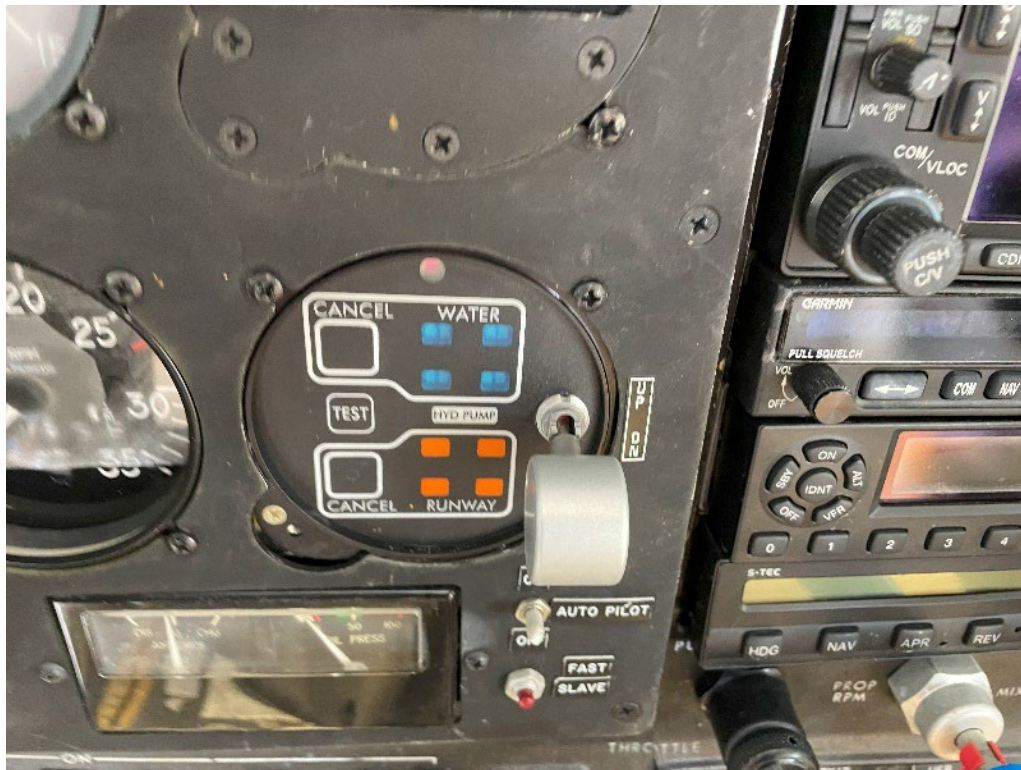
The airplane was equipped with Aerocet 3400 series amphibious floats. The left and right amphibious floats remained attached to the fuselage at their strut attach points. The floats appeared undamaged. All four points of the landing gear were in the extended position. The cabin mounted landing gear handle was observed in the down position. (See figure 4.)

Figure 4. Landing gear handle in down position.

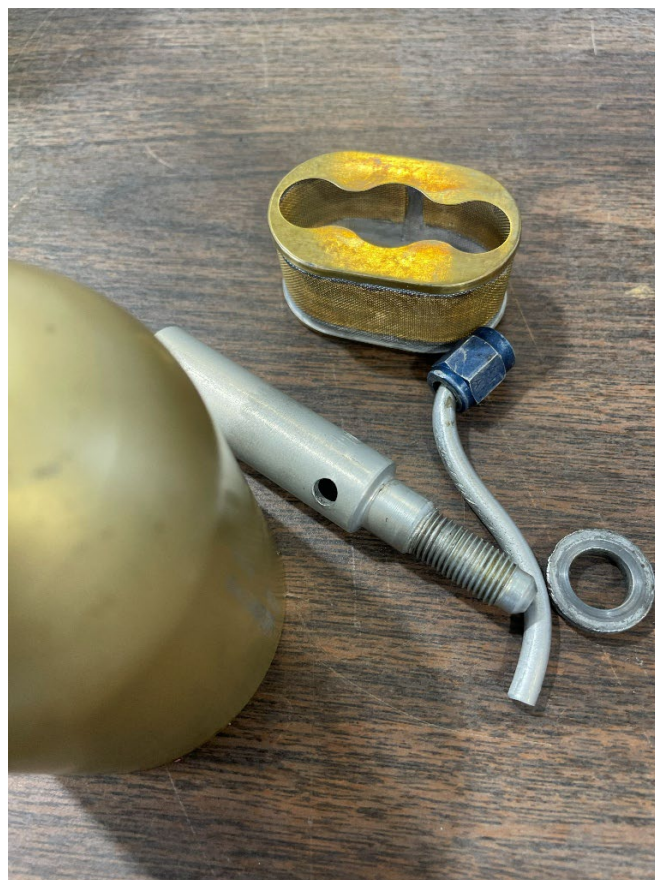
Both main fuel tank strainer screens, the fuel strainer screen, and the fuel strainer bowl were clean and free of debris. (See figure 5.) The airplane was equipped with two main fuel tanks and two STC installed Flint Aero tip tanks. They all contained fuel and water, consistent with water submersion. Operation of the fuel selector and fuel shutoff valves were verified in all positions by blowing air from the wing roots to the fuel strainer.

Figure 5. Fuel strainer bowl and filter.

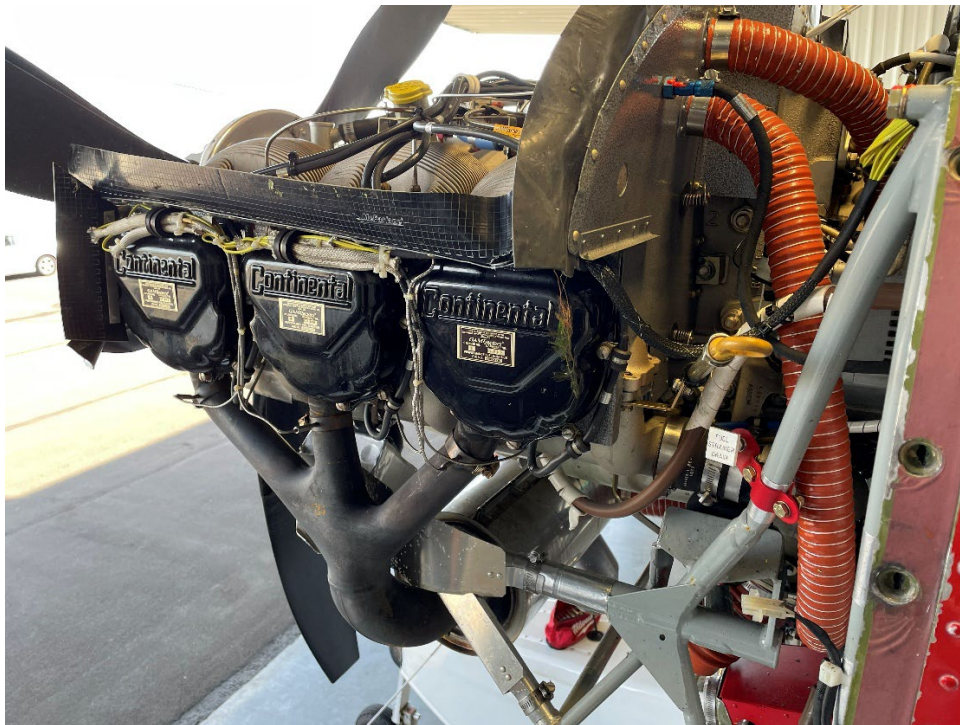
The engine remained attached to the firewall and airframe via its engine mounts. (See figure 6.)

Figure 6. Left side of engine.

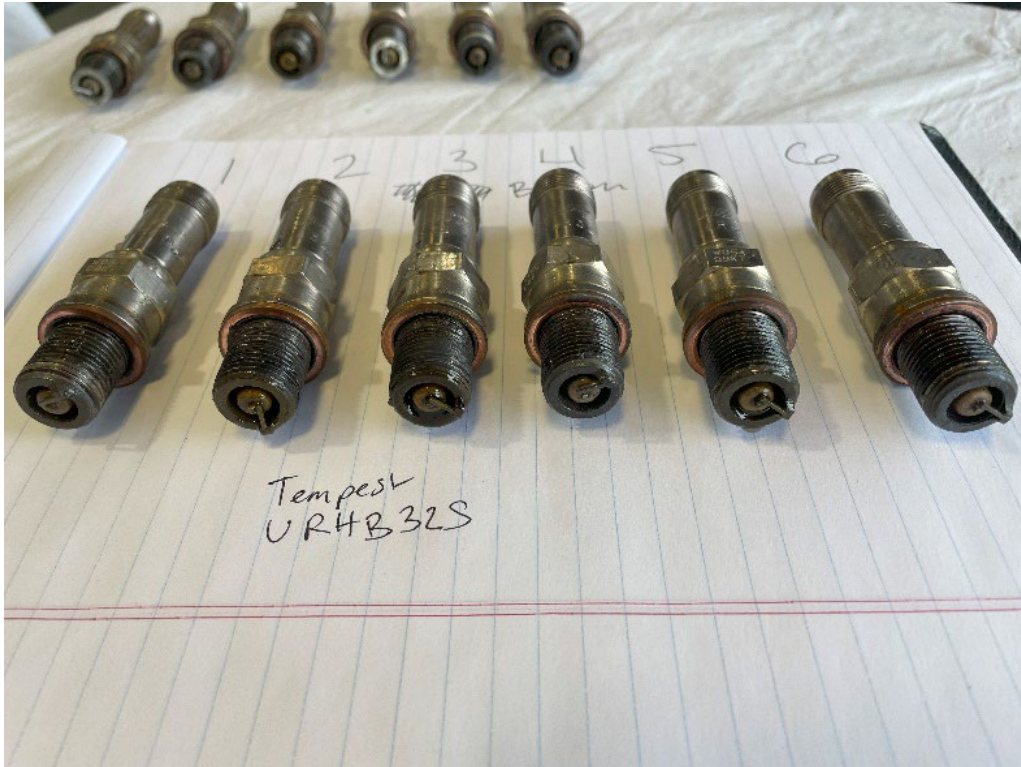
Tempest URHB32S Fine Wire spark plugs were installed. The upper and lower spark plugs were removed. Normal wear was noted, when referencing the Champion Aviation Check-A-Plug chart, with some being oil and/or water coated, consistent with being inverted. (See figure 7.) Upper spark plugs #1 and #4 displayed additional white colored residue, consistent with the initiation of corrosion development after water submersion.

Figure 7. Upper and lower spark plugs.

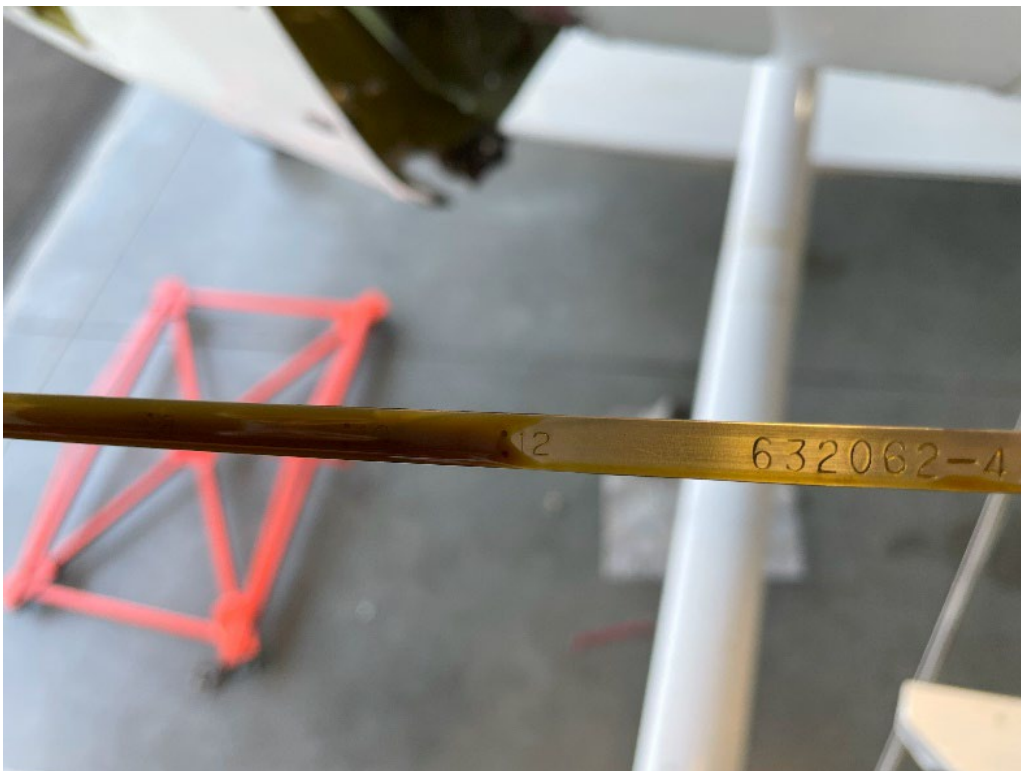
The oil sump contained 12 quarts of oil. The oil filter was not removed. (See figure 8.)

Figure 8. Oil dip stick.

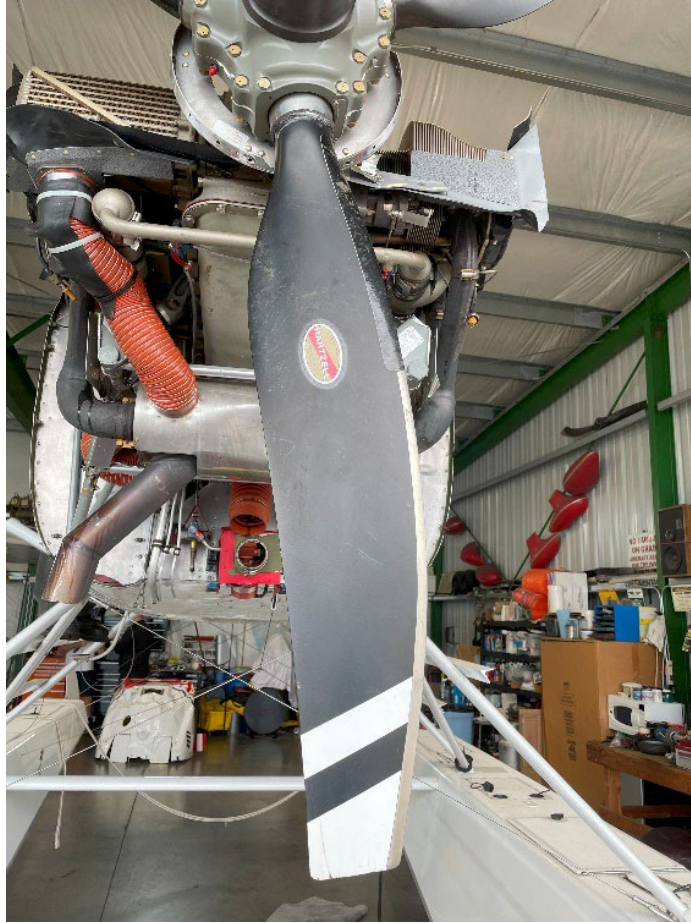
None of the propeller blades exhibited bending or delamination. (See figures 9, 10, 11.)

Figure 9. Propeller blade A.

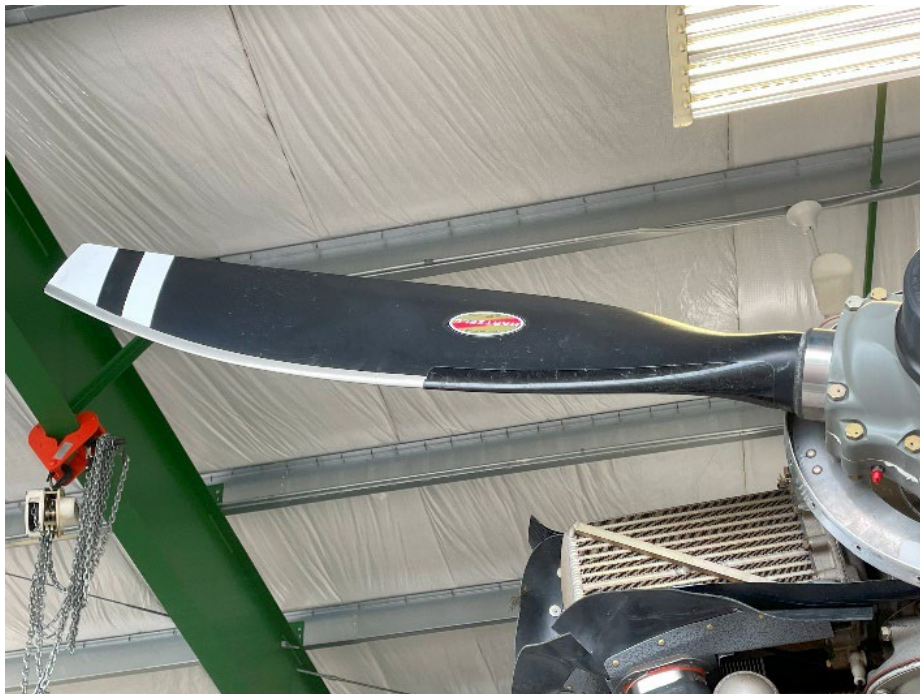
Figure 10. Propeller blade B.

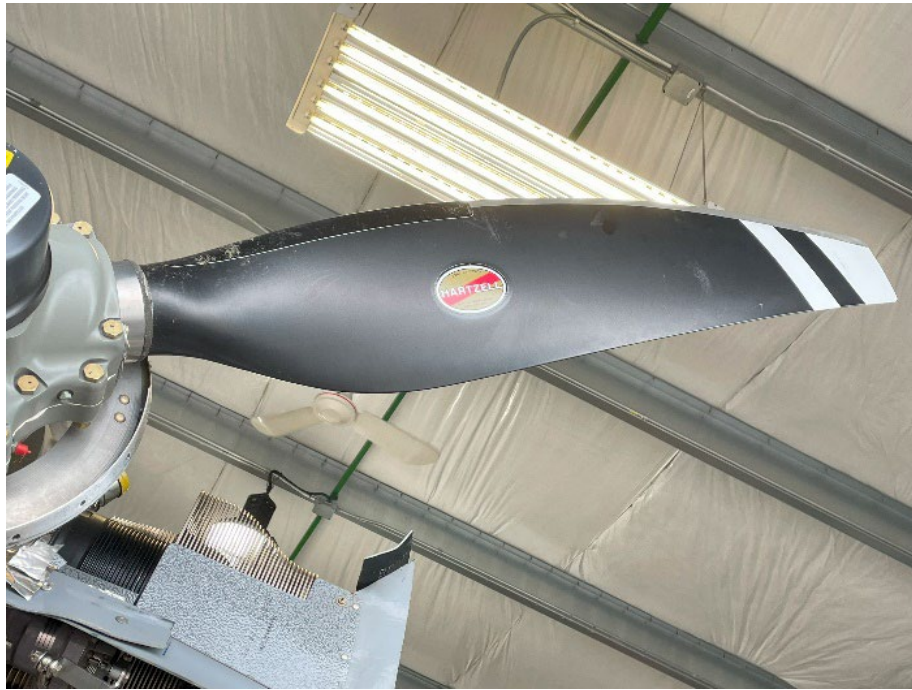
Figure 11. Propeller blade C.
