# National Transportation Safety Board

WPR24FA285

## **ON SCENE SUMMARY REPORT**

Location: Kent, Washington  
Date: August 24, 2024  
Time: 10:10 Pacific daylight time  
Airplane: N61323, Cessna A185F

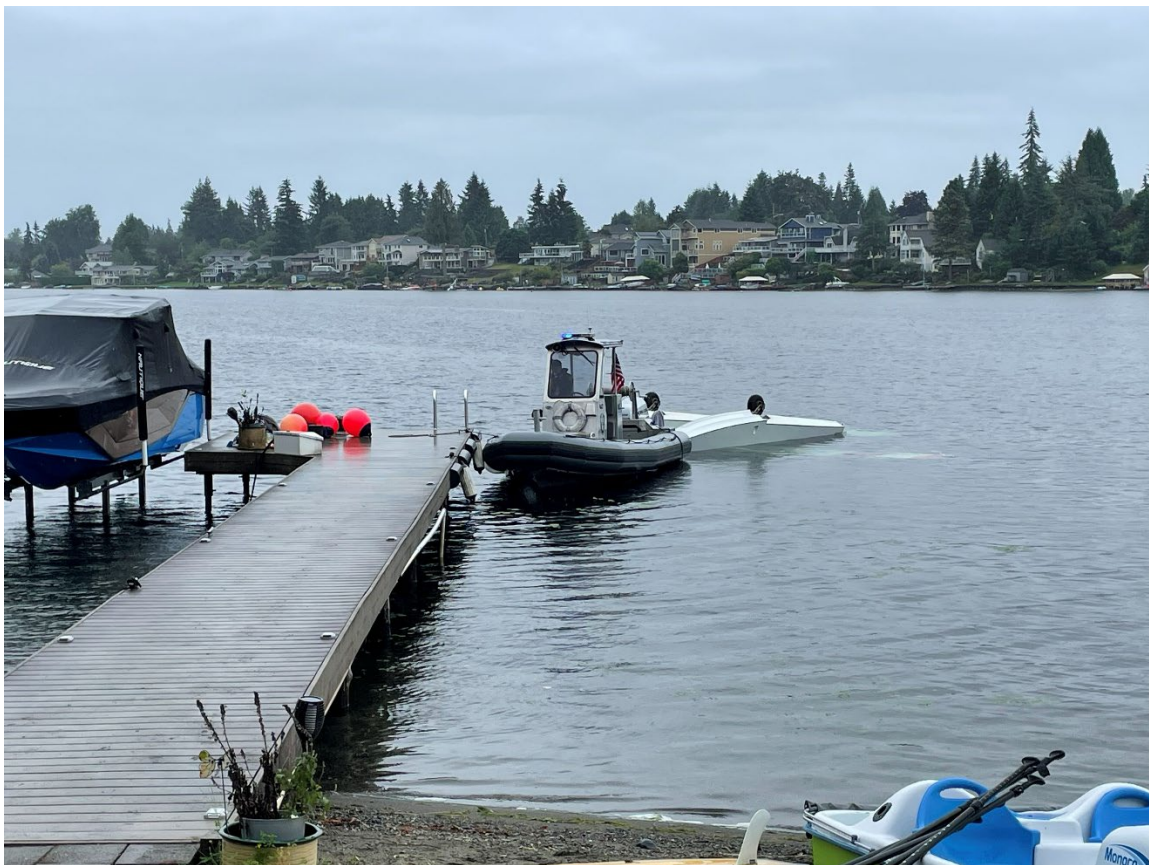
The airplane was observed tethered to a law enforcement boat at the end of a residential dock, inverted in the water, with the inverted floats visible above the water's surface. (See figures 1 and 2.)

Figure 1. Accident airplane tethered to LEO boat at dock.

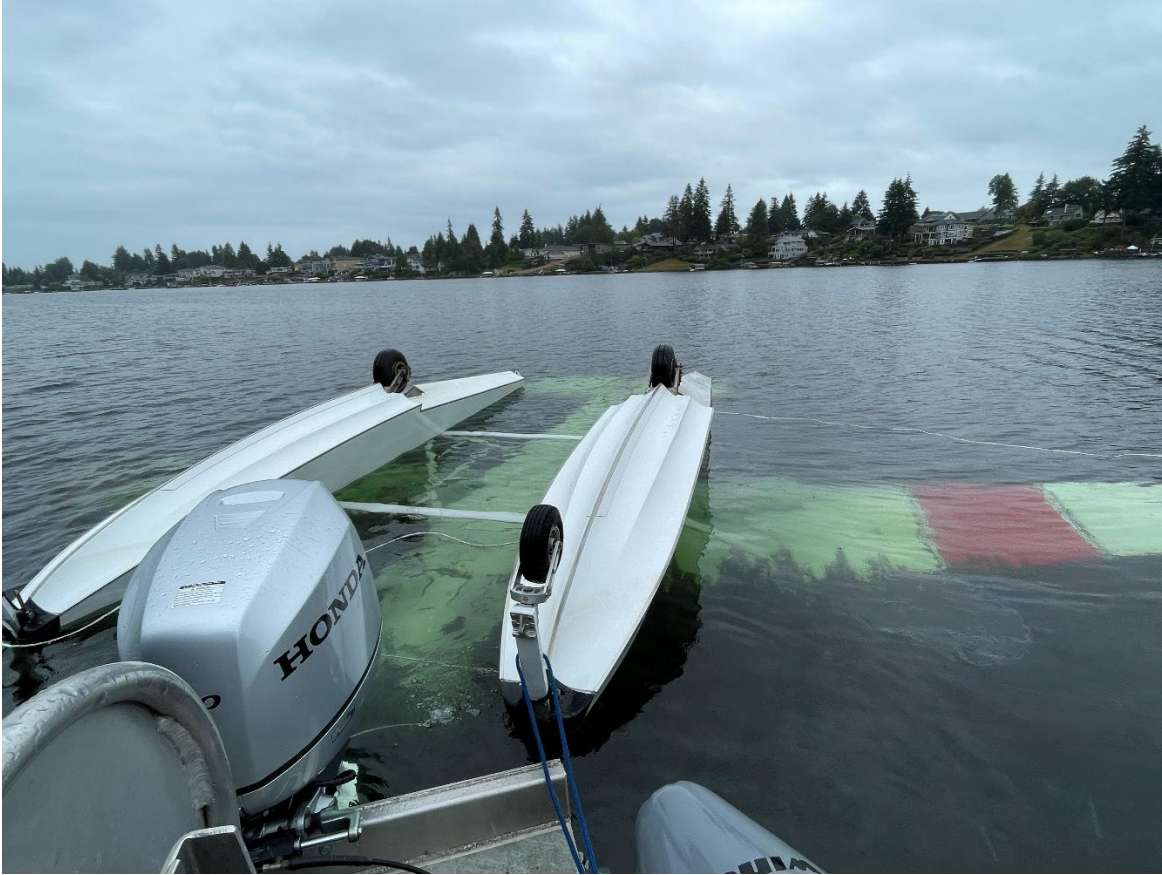
Figure 2. Accident airplane tethered to LEO boat prior to removal from lake.

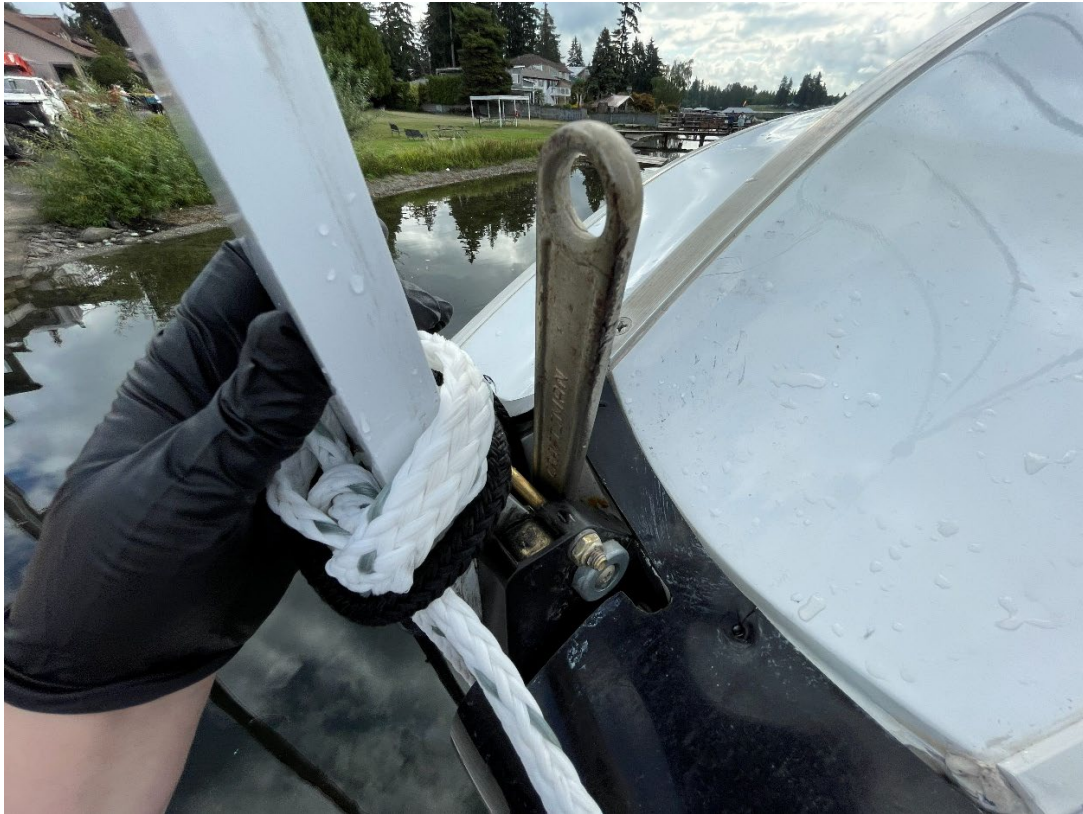
Both forward and both rear points of the landing gear were observed extended. A crescent wrench was observed resting in the gear well of the left forward landing gear assembly.

The airplane was towed to a nearby boat launch and lifted from the lake utilizing a land crane. During the lift, the left forward landing gear well and assembly was documented, with a crescent wrench observed resting in the gear well. The wrench was observed resting loosely in the well. When the engine was above the water's surface, an additional tool was observed resting loosely inside the lower engine cowling. (See figures 3 and 4.)

Figure 3. Wrench observed in gear well.

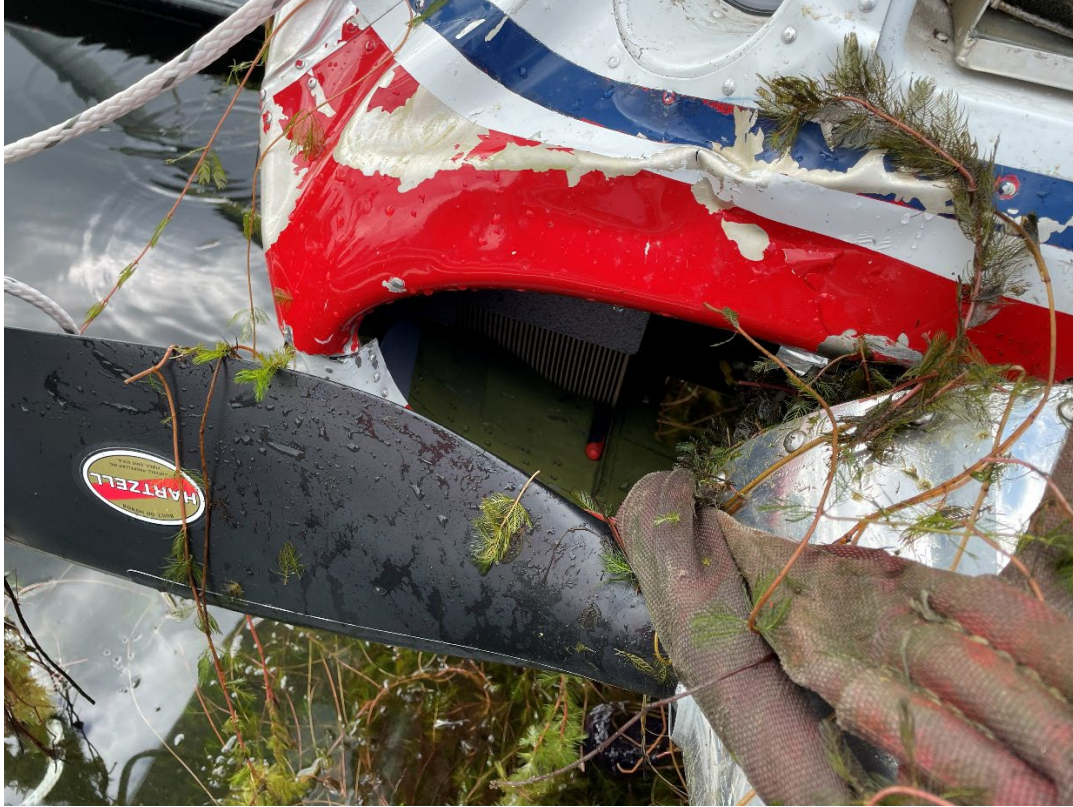
Figure 4. Tool observed resting inside engine cowling.

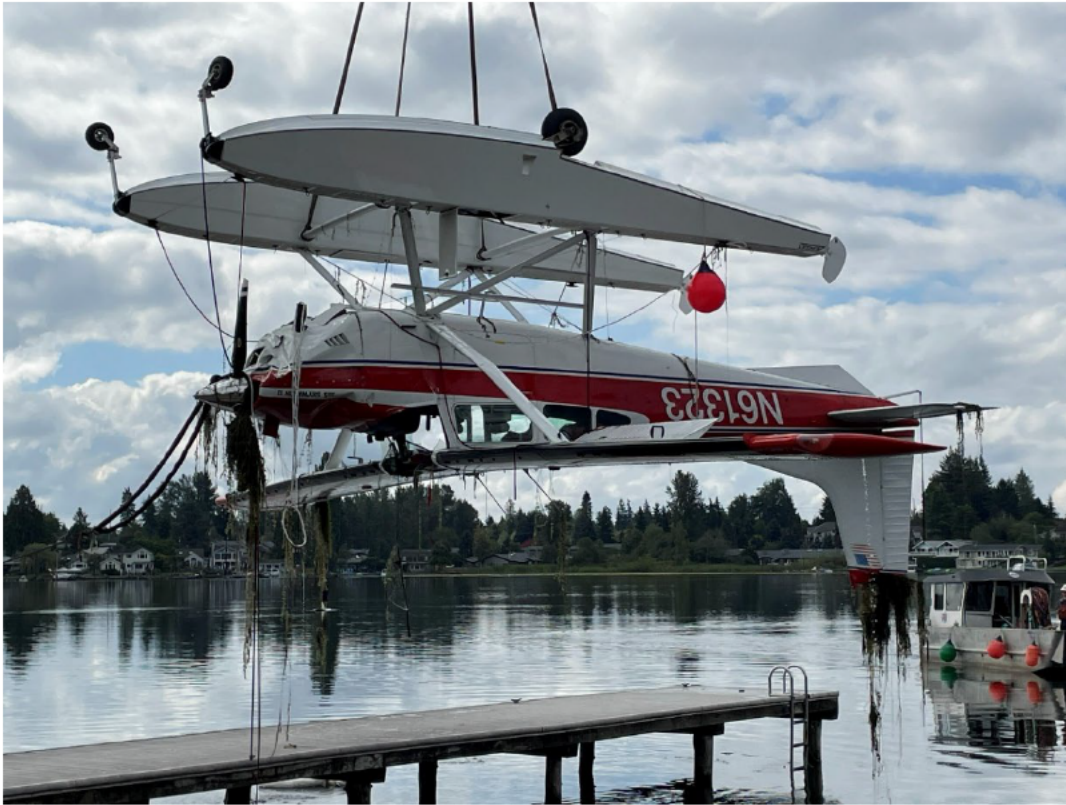
Both wings remained attached to the fuselage. Each aileron remained attached to its respective wing. Both wing flaps remained attached to their respective wings and were observed extended. The right wing lift strut was observed buckled.

Figure 5. Right side of airplane during removal from lake.

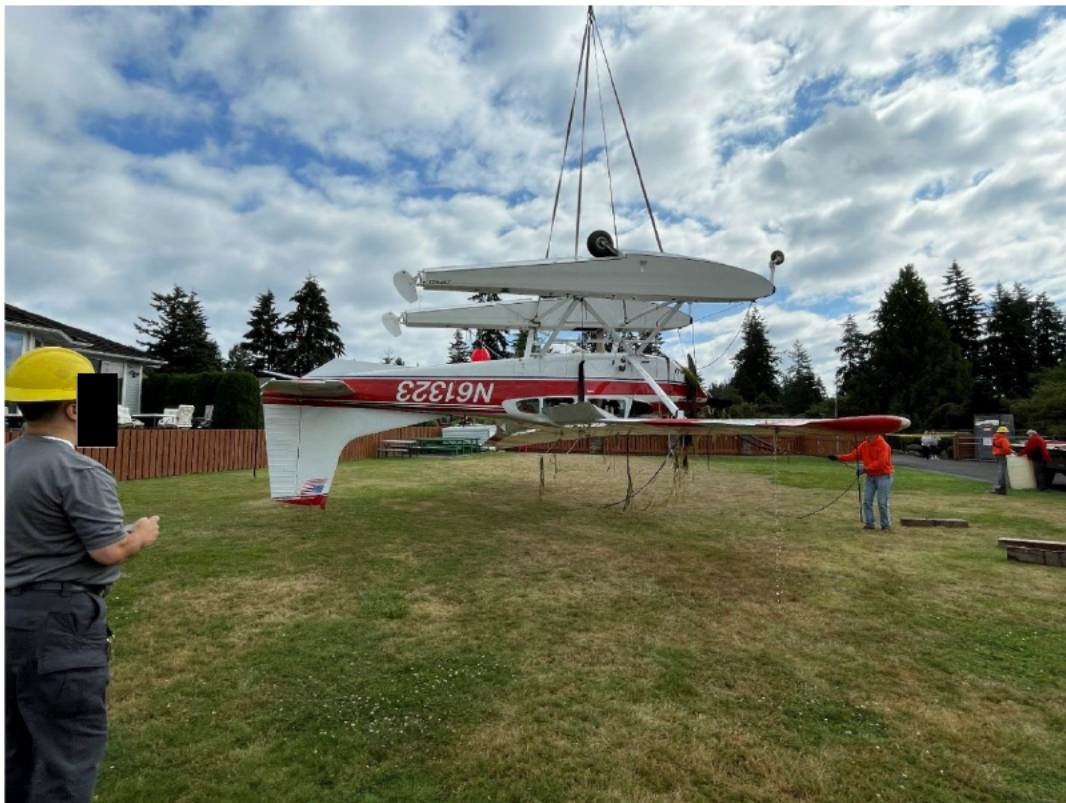
Figure 6. Left side of airplane during removal from lake.

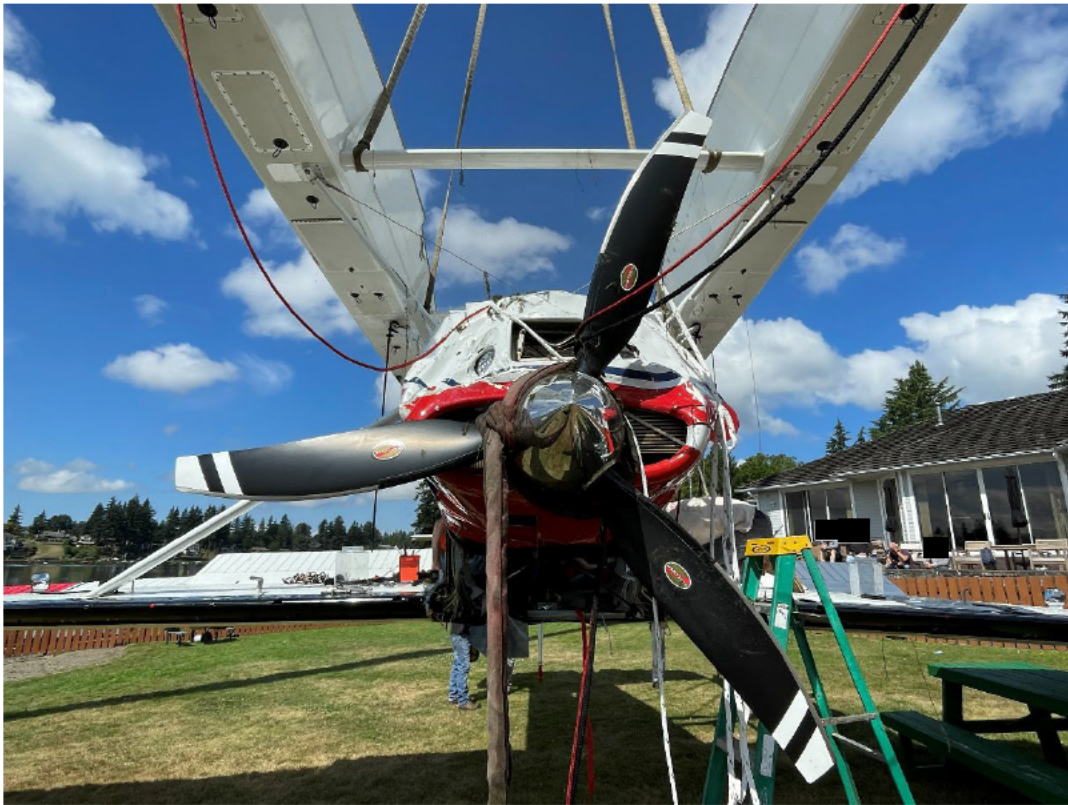
The engine remained attached at the firewall. The propeller assembly remained attached to the engine. The upper and lower engine cowling displayed denting and crushing, consistent with water impact.

Figure 7. Propeller assembly during removal from lake.

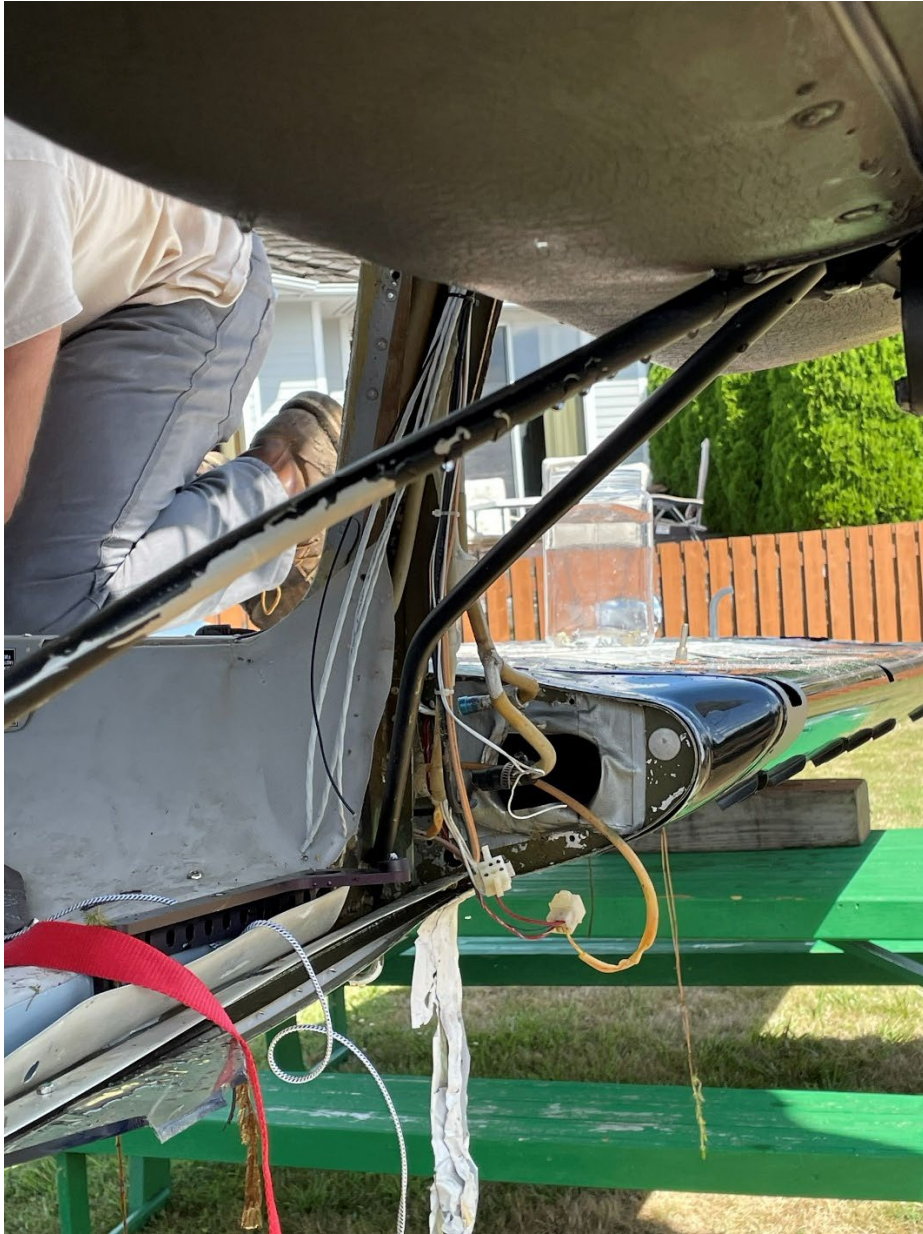
The forward V brace displayed bent/buckled arms.

Figure 8. Forward fuselage V brace.

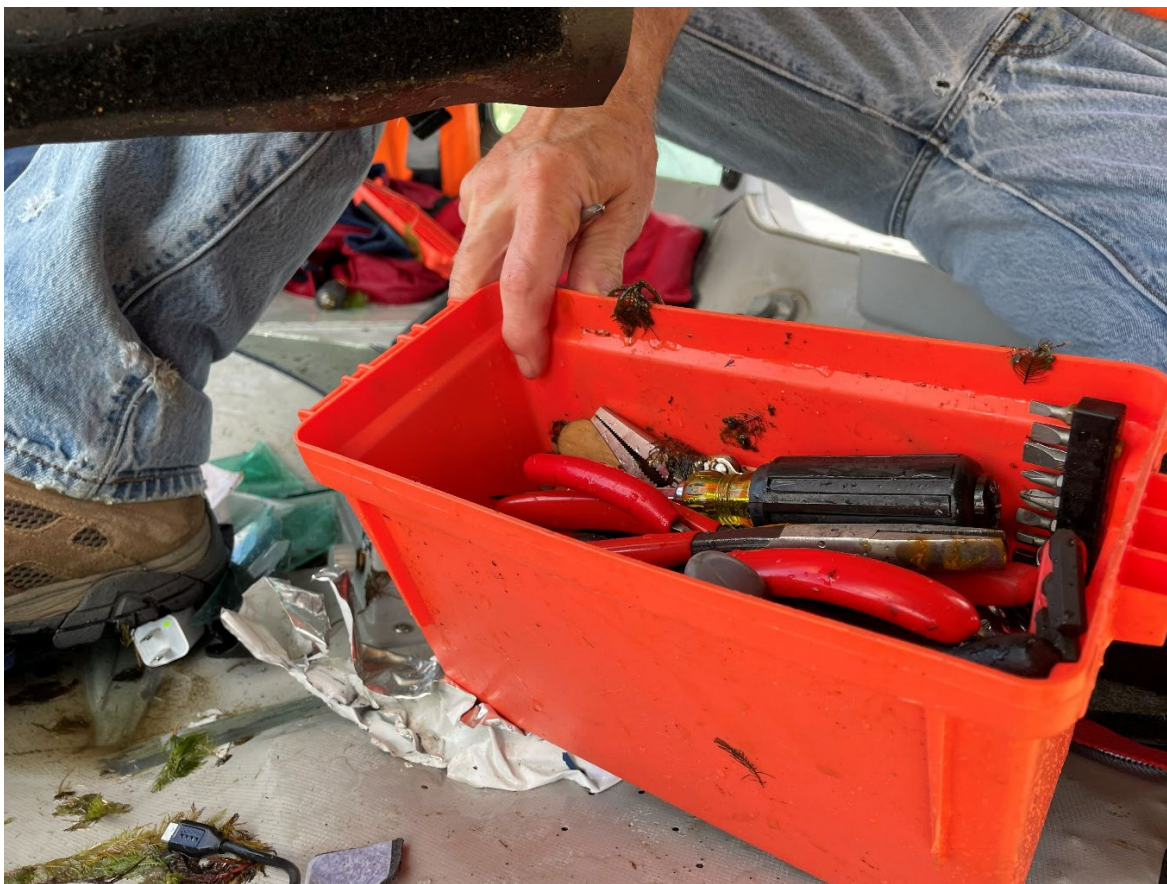
An uncovered bin of various tools was observed in the cabin, with additional tools located throughout. (See figures 8 and 9.)

Figure 9. Uncovered bin of tools in cabin.
