# National Transportation Safety Board

WPR24FA287

## **ACCIDENT SITE AND WRECKAGE EXAMINATION SUMMARY REPORT**

Location: Santa Paula, California  
Date: August 25, 2024  
Time: 1224 Pacific Daylight Time  
Airplane: Pitts S-1 (N42JF)

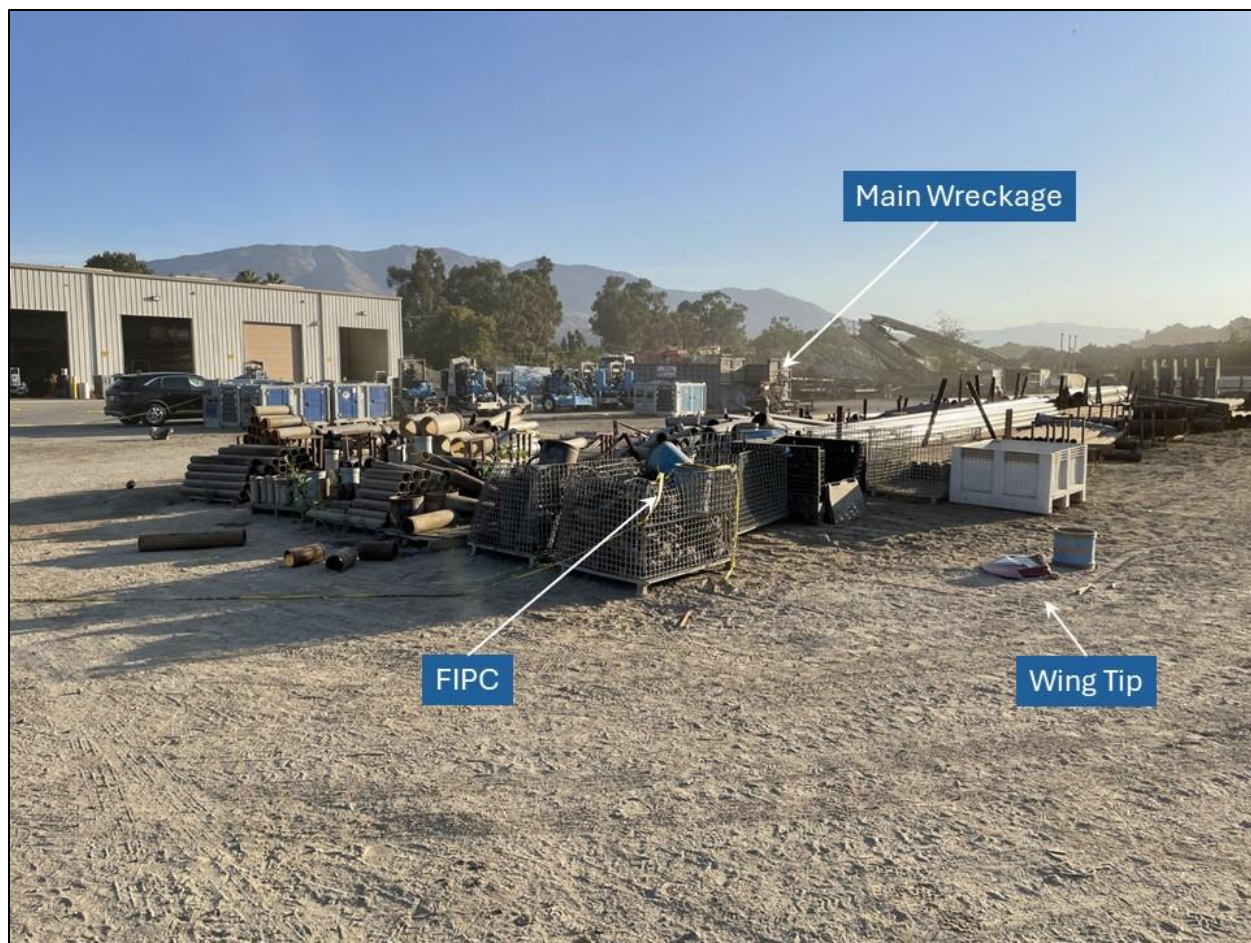
The accident site was located in an irrigation storage facility about 1/3 mile east (249°) of runway 22 at SZP. The debris field was about 120 ft long and on a heading of about 30°. The airplane's initial impact point were two large wire baskets containing steel 12-inch irrigation fittings. Red paint transfer marks were found on the damaged wired baskets. Adjacent to the baskets was a section of a right wing tip fairing. In the immediate area were small portions of wing structure and wing fabric. The debris field continued over the top of multiple baskets and steel racks containing steel and aluminum irrigation pipes. Three 12-inch aluminum pipes showed impact damage and were partially covered in wet oil and dirt. These pipes were displaced from their original location from about 20 to 50 ft along the debris field. Red paint transfer marks were found on pipes and broken racks that were displaced throughout the debris field. Small sections of the airplane's internal wood wing structure were also found throughout the debris field. The right main landing gear, including the wheel hub, tire and a section of the wheel pant fairing, separated from the wreckage was found on the left side of the debris field.

Figure 1-Accident site, first identified point of contact (FIPC).

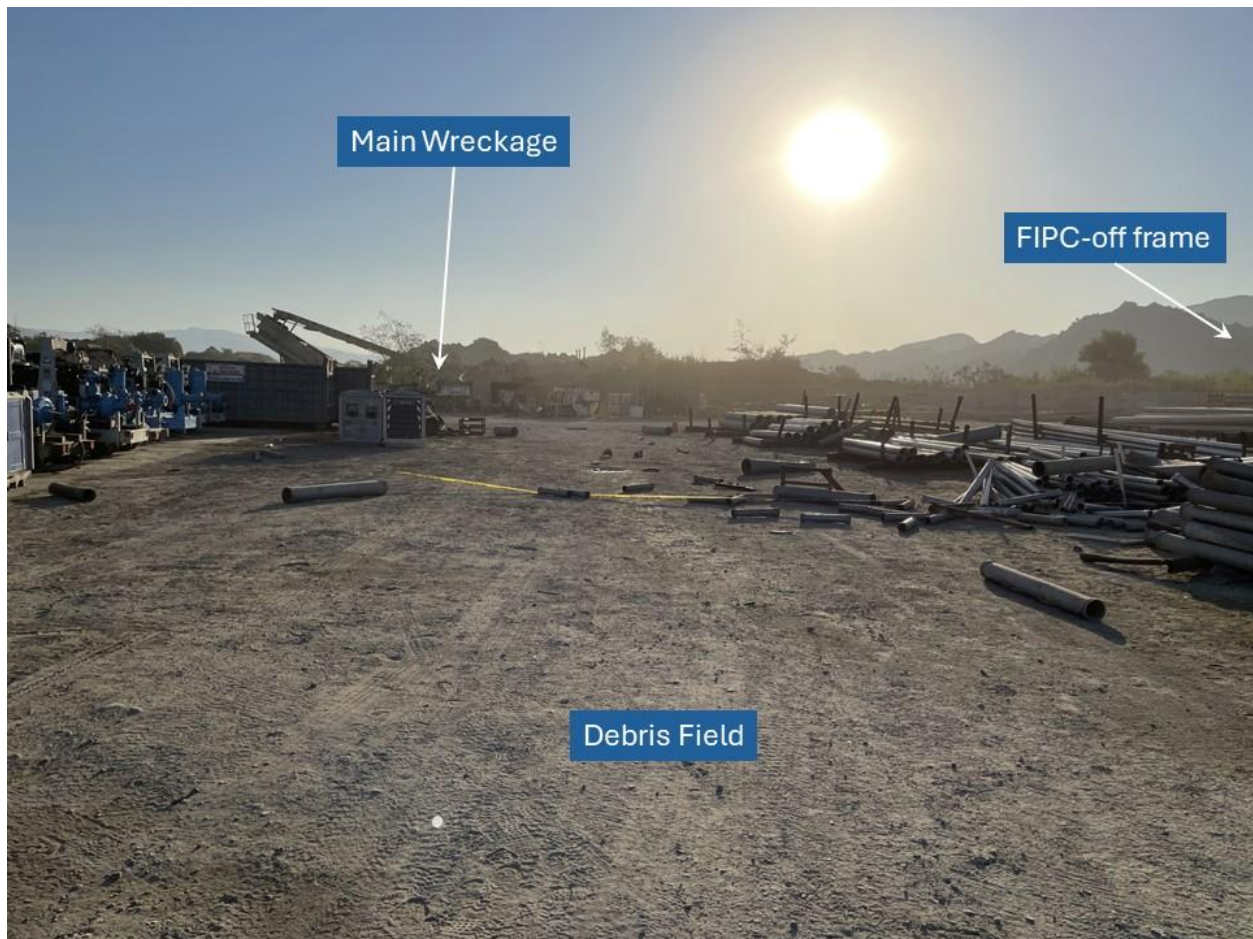
Figure 2-Accident site, debris field.

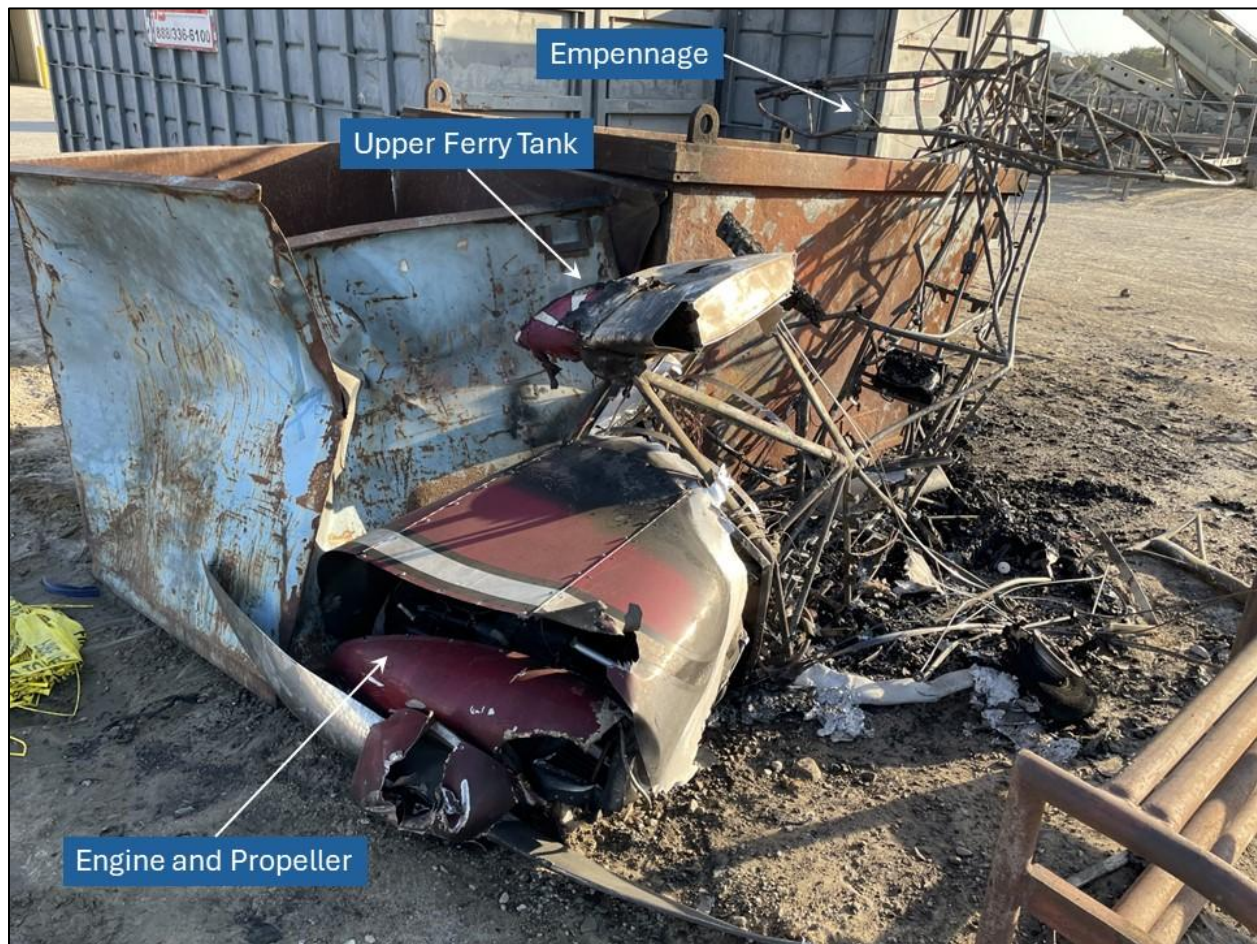
The main wreckage was found positioned sideways alongside two metal waste containers. Most of the main wreckage was consumed by postimpact fire.

Figure 3-Accident site, main wreckage.

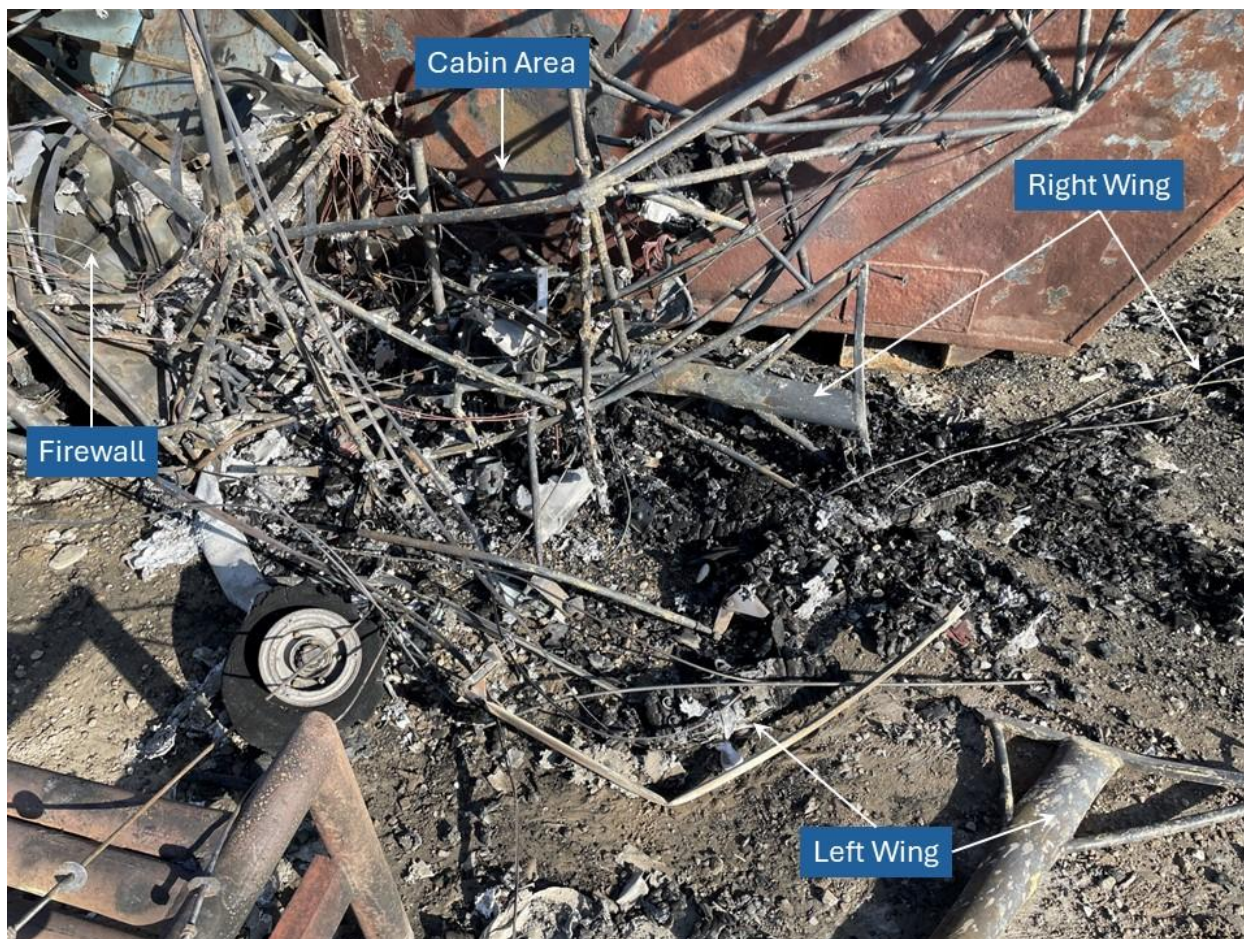
Both wing forward and aft spars were mostly consumed by postimpact fire. Charred wood resembling the wing spars were noted alongside the main wreckage. Both Weldment I-Struts were found near the main wreckage. Wing streamlined tie rods were found for both wings and remained attached to portions of the charred wing spar sections. The right wing streamlined tie rods had impact damage. Internal wing round tie rods were found for both wings. The right side of the fuselage structure and remnants of the right wing were crushed between the containers and the fuselage. Aileron control rods, control arms, and bellcranks and both aileron inter-connect assemblies were found in the debris near the main wreckage. The bellcrank and control arm brackets were found attached to burned fragments of the wooden wing spar. The aileron control tubes remained attached to the control stick torque tube and separated from the aileron linkage at both outboard ends. The control stick moved freely with the torque tube assembly.

Figure 4-Accident site, wings and fuselage.

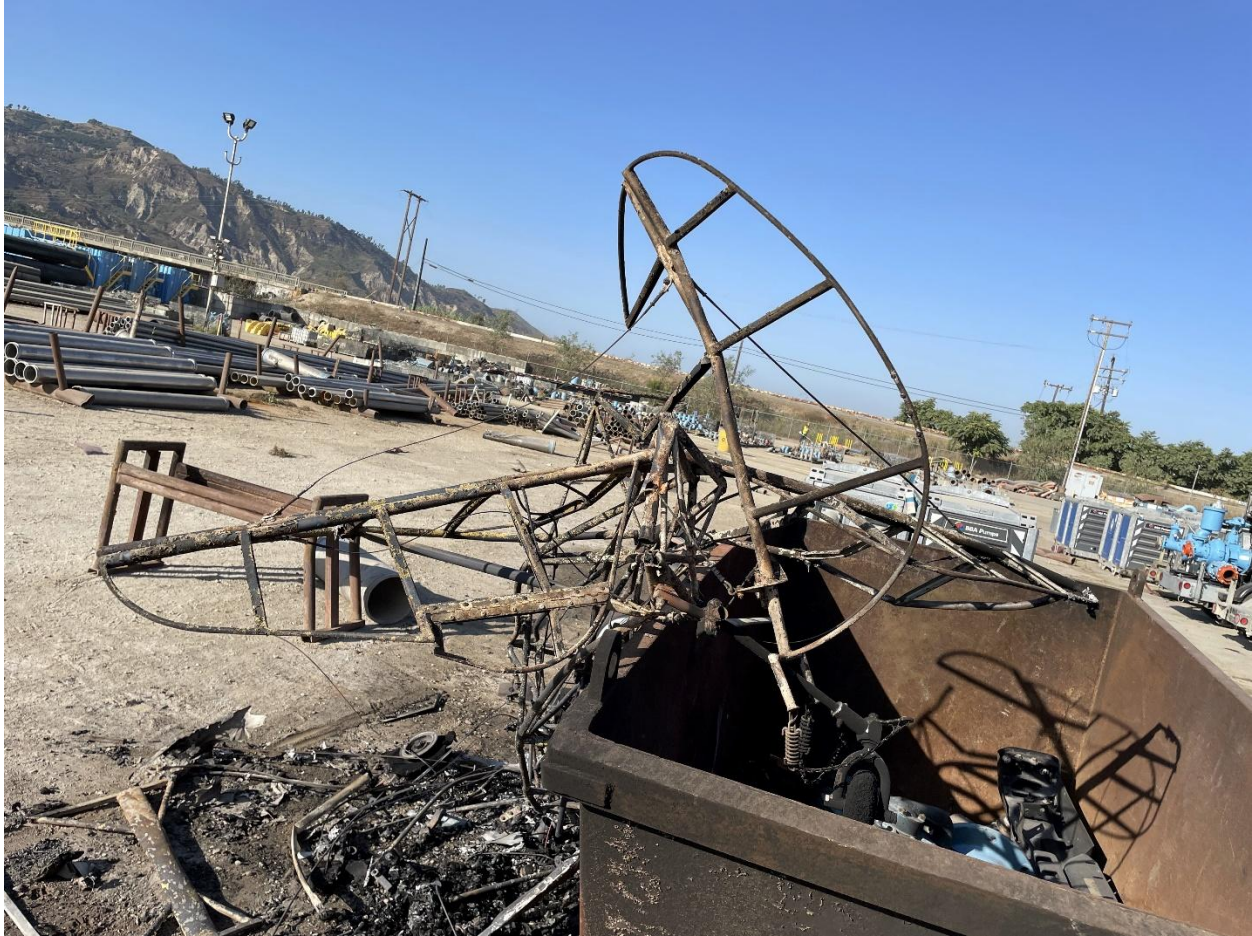
The empennage remained intact and had impact damage to several structural tubing locations. The tail wheel remained partially attached to the empennage. The rudder and vertical stabilizer structural tubing had impact damage and the rudder control cables remained secured to the rudder attach points. Rudder cable control continuity was established to the rudder pedal attach points in the cabin area. The elevators and horizontal stabilizers structural tubing had impact damage. Elevator control tube continuity was established from the elevator attach points to near the separation of the control tube at the aft side of the control stick torque tube. The elevator trim tab was found in the down position and control cable continuity was established to the cockpit control. The elevator trim control was loose from its cabin attachment.

Figure 5-Accident site, empennage.
