# National Transportation Safety Board

WPR24FA287

## **WRECKAGE FOLLOW-UP EXAMINATION SUMMARY REPORT**

Location: Santa Paula, California  
Date: August 25, 2024  
Time: 1224 Pacific Daylight Time  
Airplane: Pitts S-1 (N42JF)

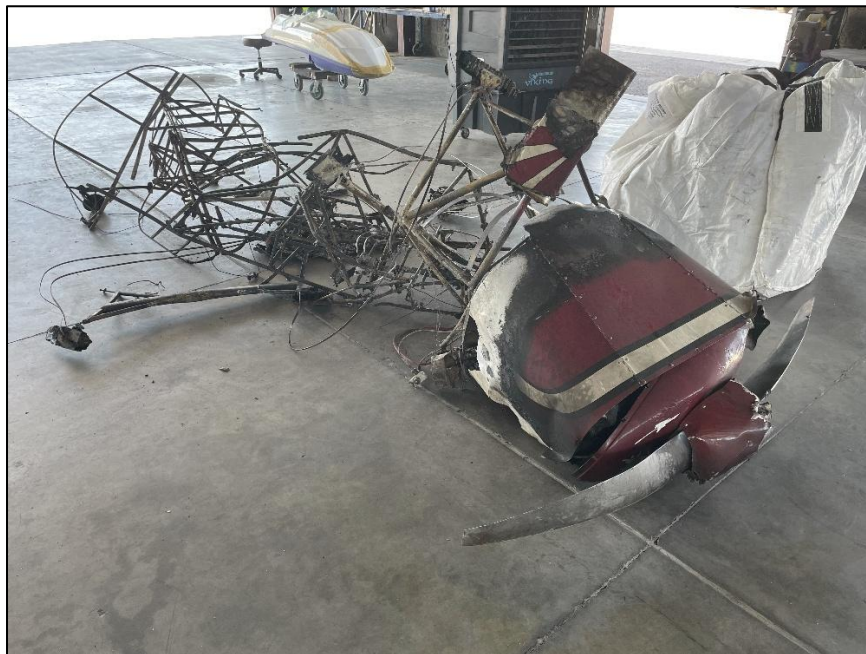
**Figure 1-Empennage, cabin structure and engine displayed on the floor.**

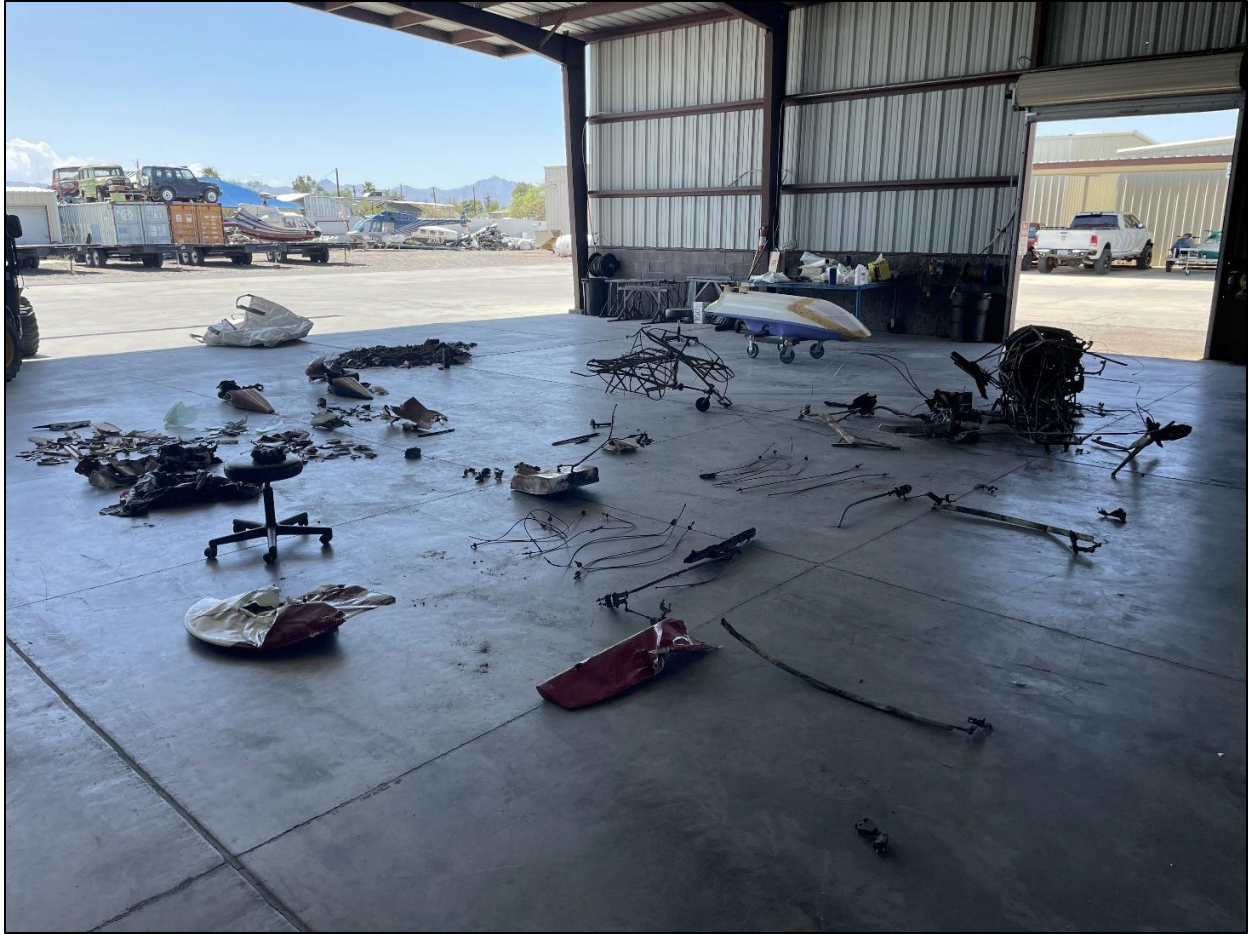
The wreckage was displayed on the floor during the examination. Portions of the wing structure and smaller airframe components were gathered in a recovery bag during the recovery process.

**Figure 2-Wreckage follow-up examination, entire wreckage displayed on the floor.**

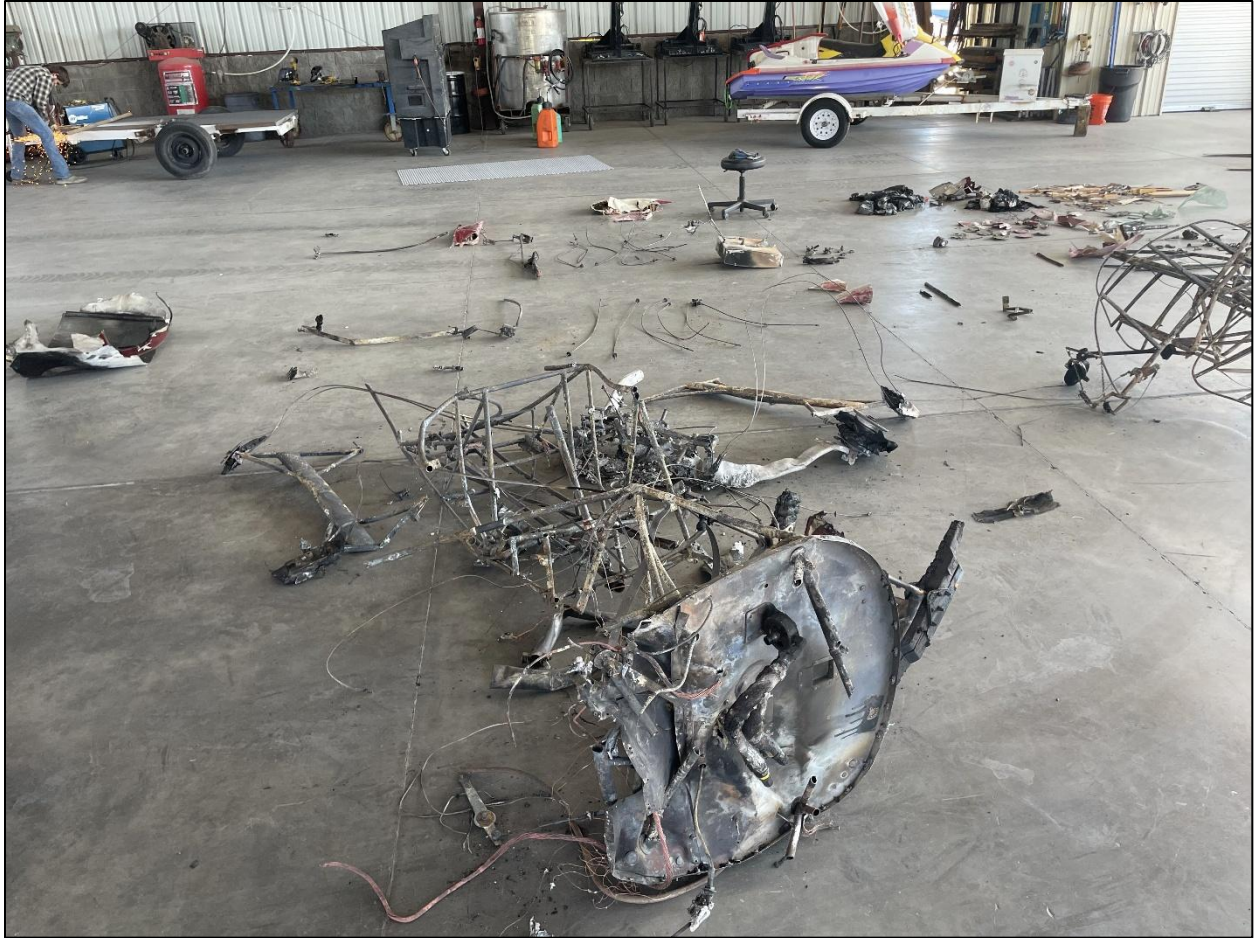
The flight control cables and pushrods were identified, and all connections remained attached to their fittings. The aileron control rods, control arms, bellcranks and both aileron inter-connect assemblies were identified in the wreckage. The aileron control tubes remained attached to the control stick torque tube and separated from the aileron linkage at both outboard ends. The cockpit control stick moved freely with the torque tube assembly.

**Figure 3-Wreckage layout, cabin area and forward fuselage structure.**

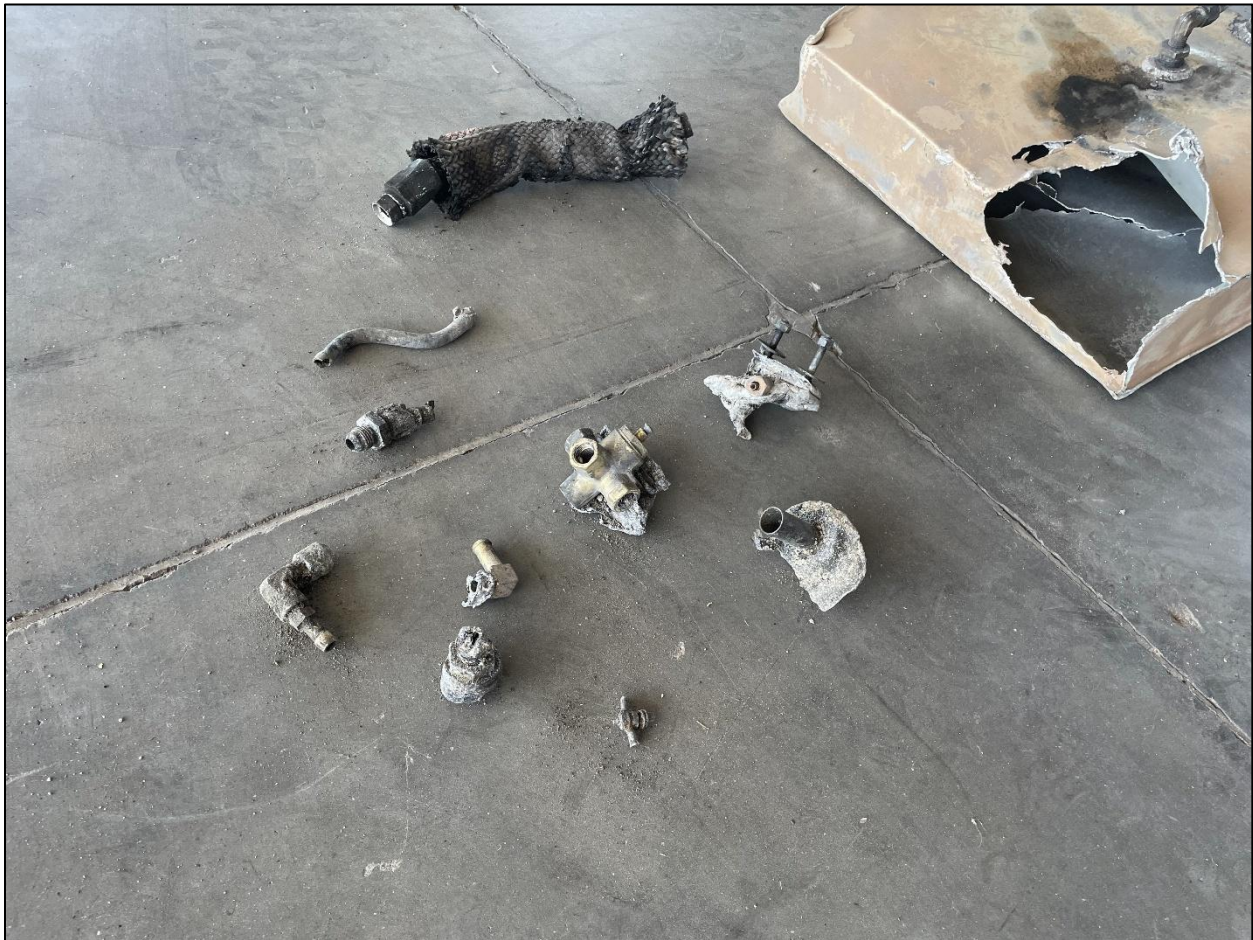
The ferry tank located on the upper forward wing spar, remained attached and had thermal damage. The tank was breached and had thermal damage. The tank cap was locked and remained attached to the tank and had thermal damage. The main tank was mostly consumed by post impact fire. Small fragments of melted aluminum were found near the steel bracket assembly that holds the tank in place. The main tank fuel cap was not found during the onsite examination. The smoke tank, forward of the right rudder pedal area, was also consumed by postimpact fire.

**Figure 4-Wreckage layout, fuel system components.**

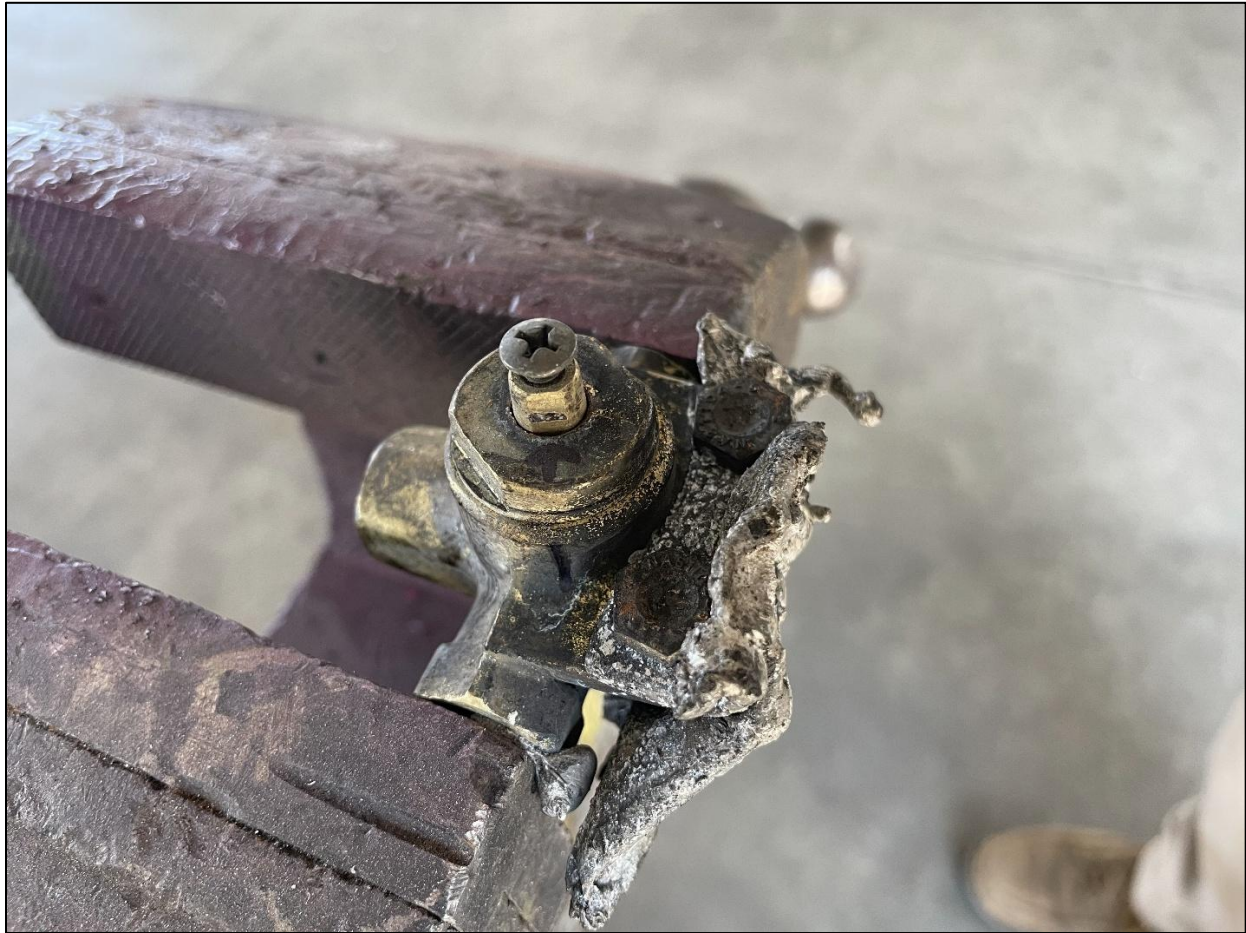
The fuel selector was found separated from mounting bracket and lines. The handle melted from the control shaft and the control shaft was found near the "wing" (3 o'clock) tank position. The valve was disassembled and no anomalies were noted.

**Figure 5-Fuel selector valve.**

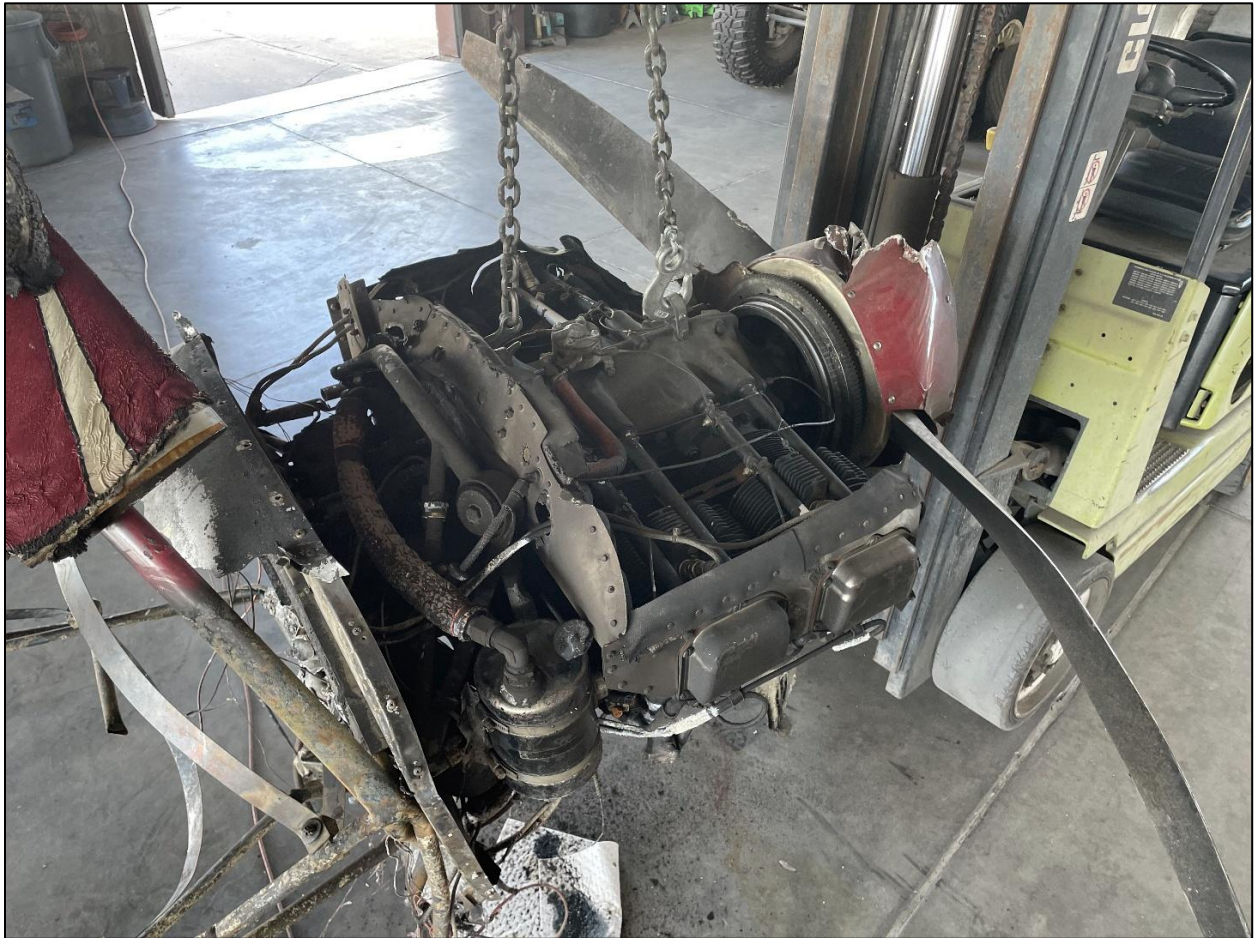
The damaged upper cowling remained partially attached to the Lycoming IO-360-B4A engine. The engine mounting carriage remained attached to the engine and fuselage. The propeller remained attached to the crankshaft flange and both blades were bent slightly aft. No rotational signatures were noted on the blades.

**Figure 7-Propeller, engine and firewall.**

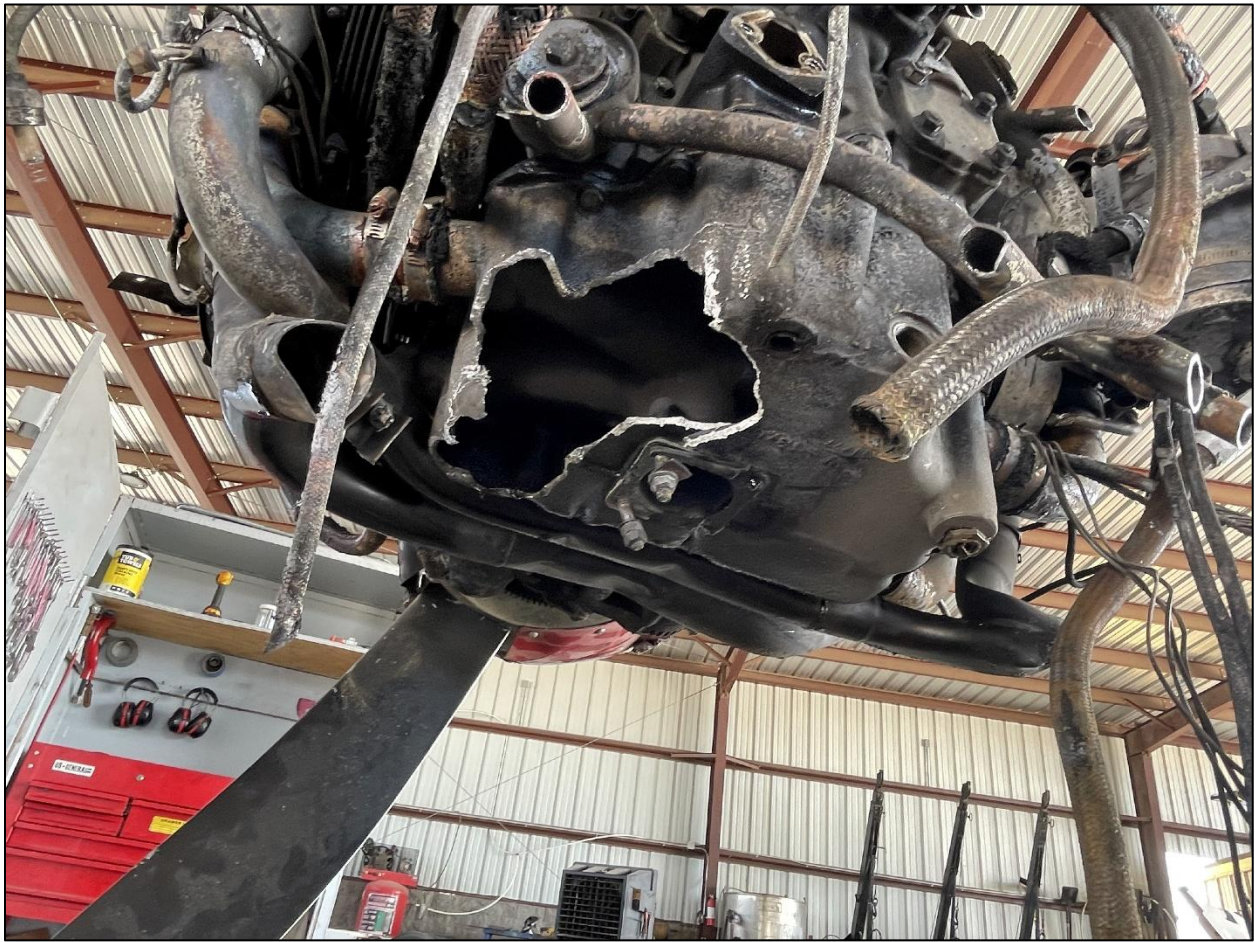
The fuel servo separated from the thermally damaged oil sump. The throttle control was found securely attached at the control arm of the fuel servo. The mixture cable had been pulled from the end of the linkage arm. The throttle and mixture arm castellated nut and cotter pin remained secure with the serrated interface securely mated. The plug on the side of the injector body was secure with the safety wire in place. The fuel servo was disassembled and the internal diaphragms had thermal damage and the fuel metering stem and ball remained intact and undamaged.

**Figure 8-Engine oil sump damage.**

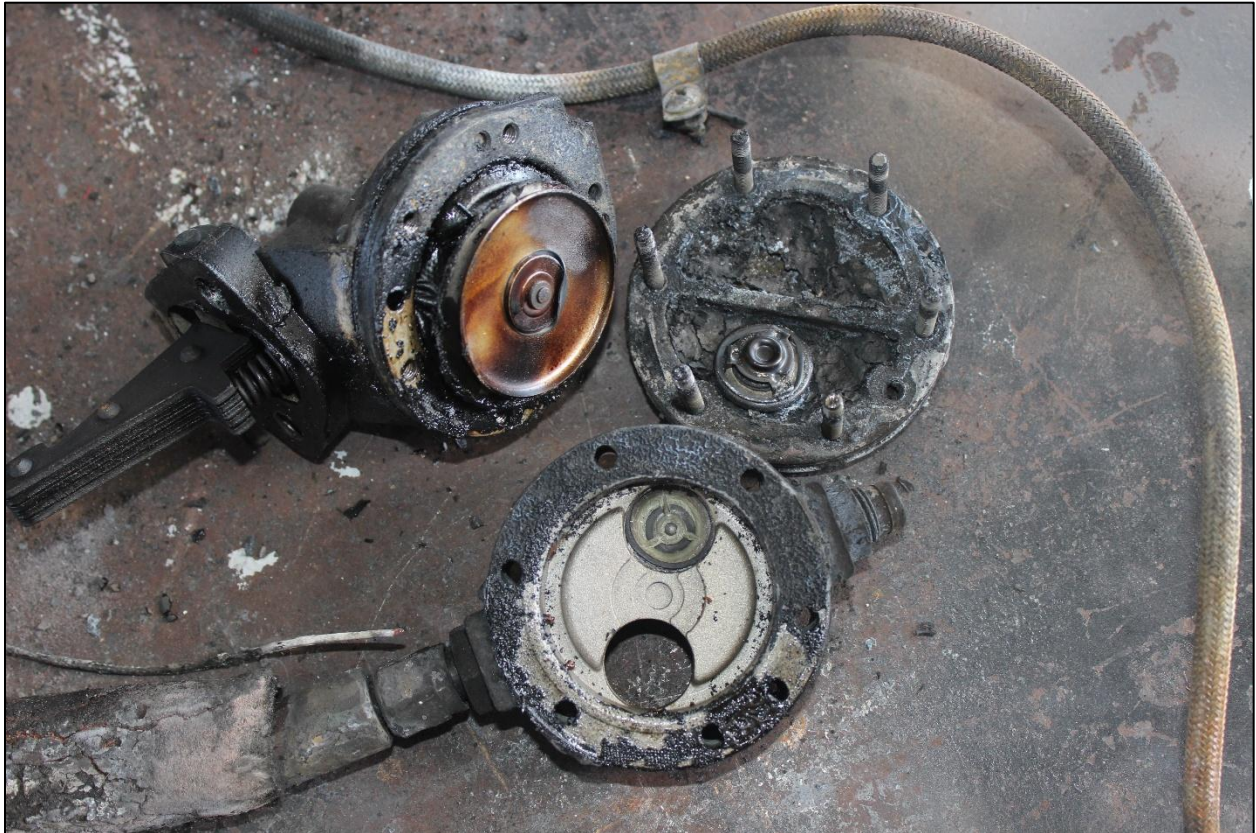
The fuel pump remained attached to the engine and thermal damaged fuel lines remained secure at their respective fittings. The fuel pump was removed and disassembled. The fuel pump internal diaphragms had thermal damage.

**Figure 9-Engine driven fuel pump.**

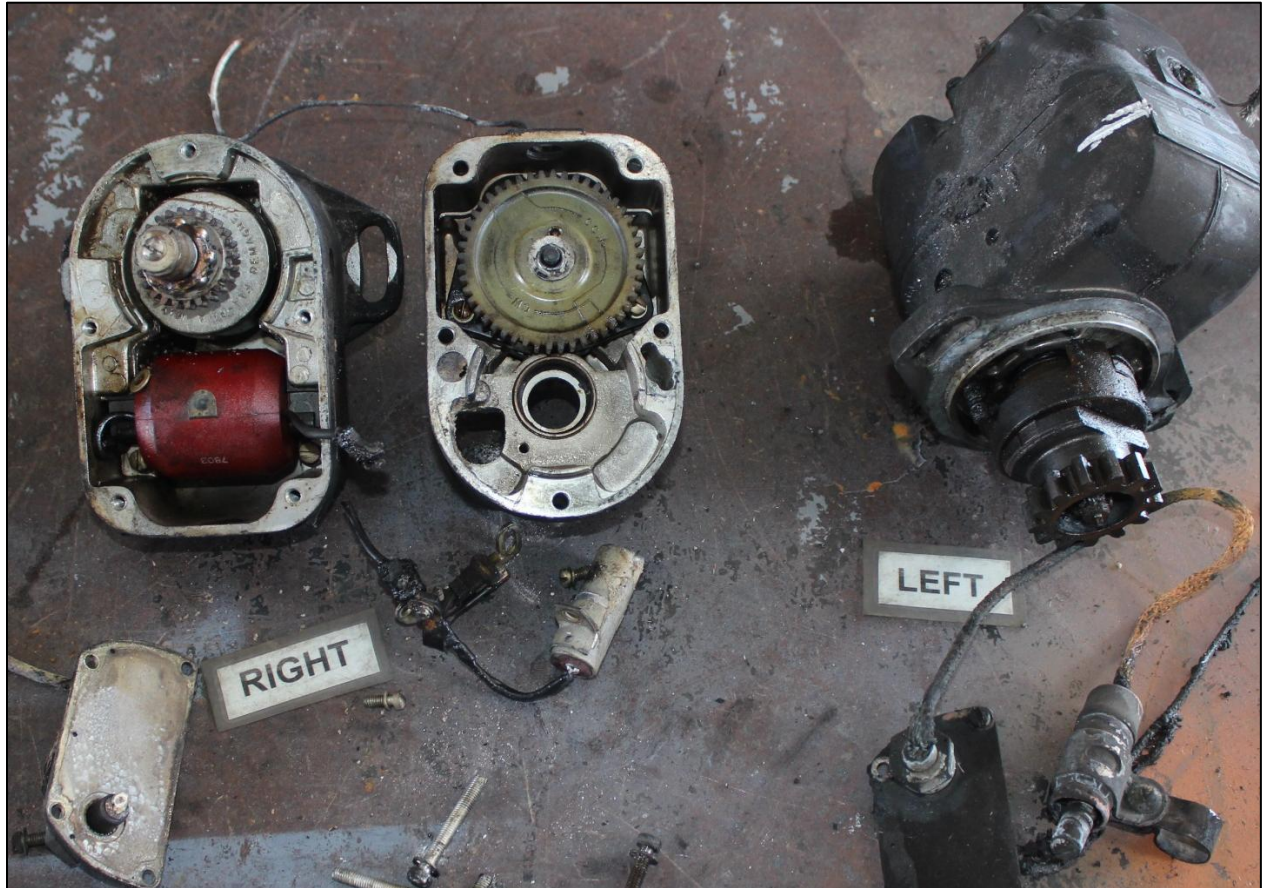
The magnetos remained secure to each of their engine mounting pads. The magneto housings had thermal damage and discoloration. The magneto to engine timing was observed at about 25-degrees before top dead center (BTDC) of the No. 1 cylinder. The left magneto produced spark at each of the lead ends. The right magneto would not produce spark. The magneto was disassembled and its internal components sustained thermal damage.

**Figure 10-Magnetos**
