# National Transportation Safety Board

WPR24FA290

## **ACCIDENT SITE AND WRECKAGE EXAMINATION- FACTUAL REPORT**

Location: Novato, California  
Date: August 31, 2024  
Time: 1550 Pacific Daylight Time  
Airplane: Aero Commander 200D (N2912T)

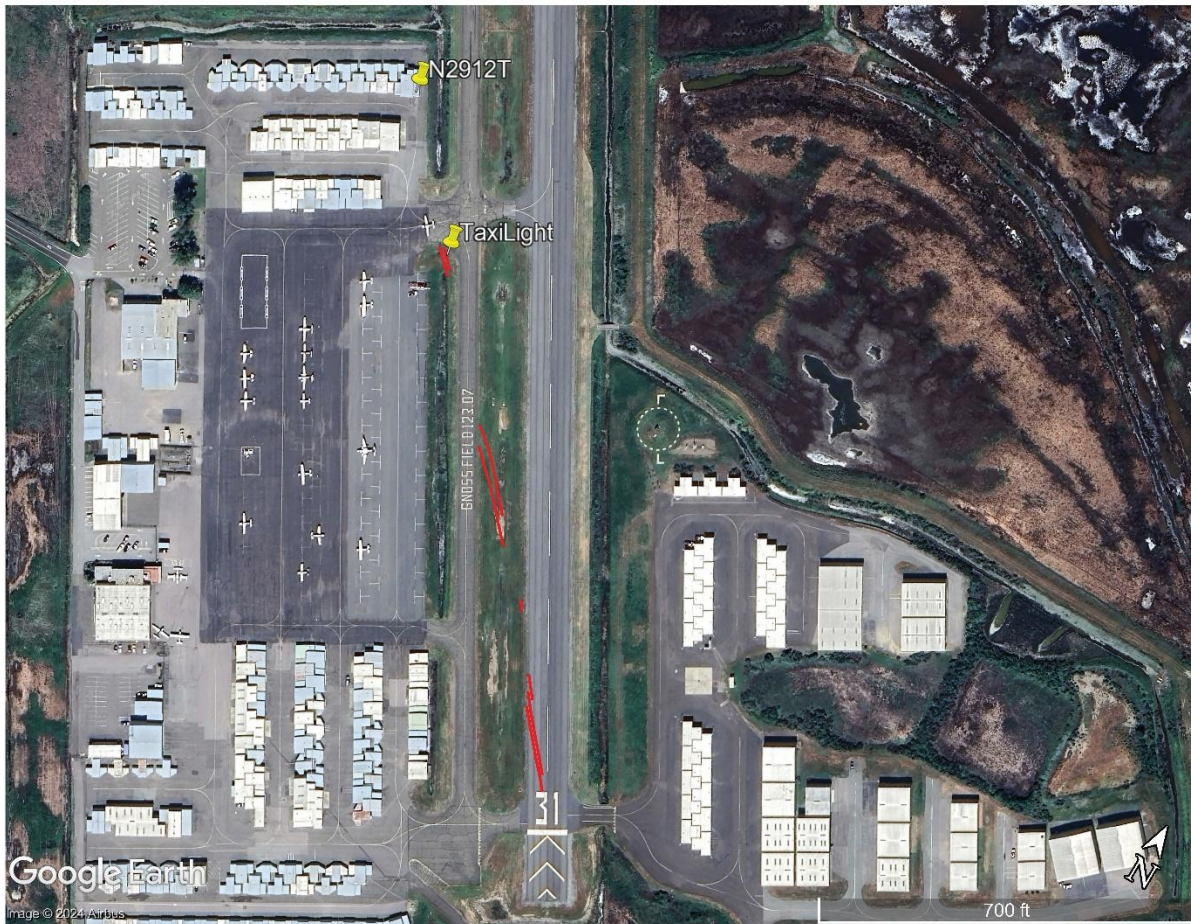
The accident site involved runway tire marks, runway safety area (RSA) terrain marking, and damage to an end hangar on the northwest side of Gness Field Airport (DVO), Novato, California. From the first tire marks near the approach end of runway 31 to the main wreckage was about 1/4 mile long and on a heading of about 318°. The rubber marks veered off the left side of the runway about 285ft from the runway threshold. The tire marks continued through the runway safety area (RSA) and exited about 480ft from where they entered at a heading of about 320°. The next tire marks were found through terrain near taxiway C in the north end of the RSA dividing taxiway 13-31 and the parking ramp. A taxiway light separated from its ground attachment and was found on taxiway C. The airplane impacted a hangar about 300 ft from the last ground marks on a heading of about 319°. (See figure 1)

Figure 1-Gross Field Airport, ground marks.

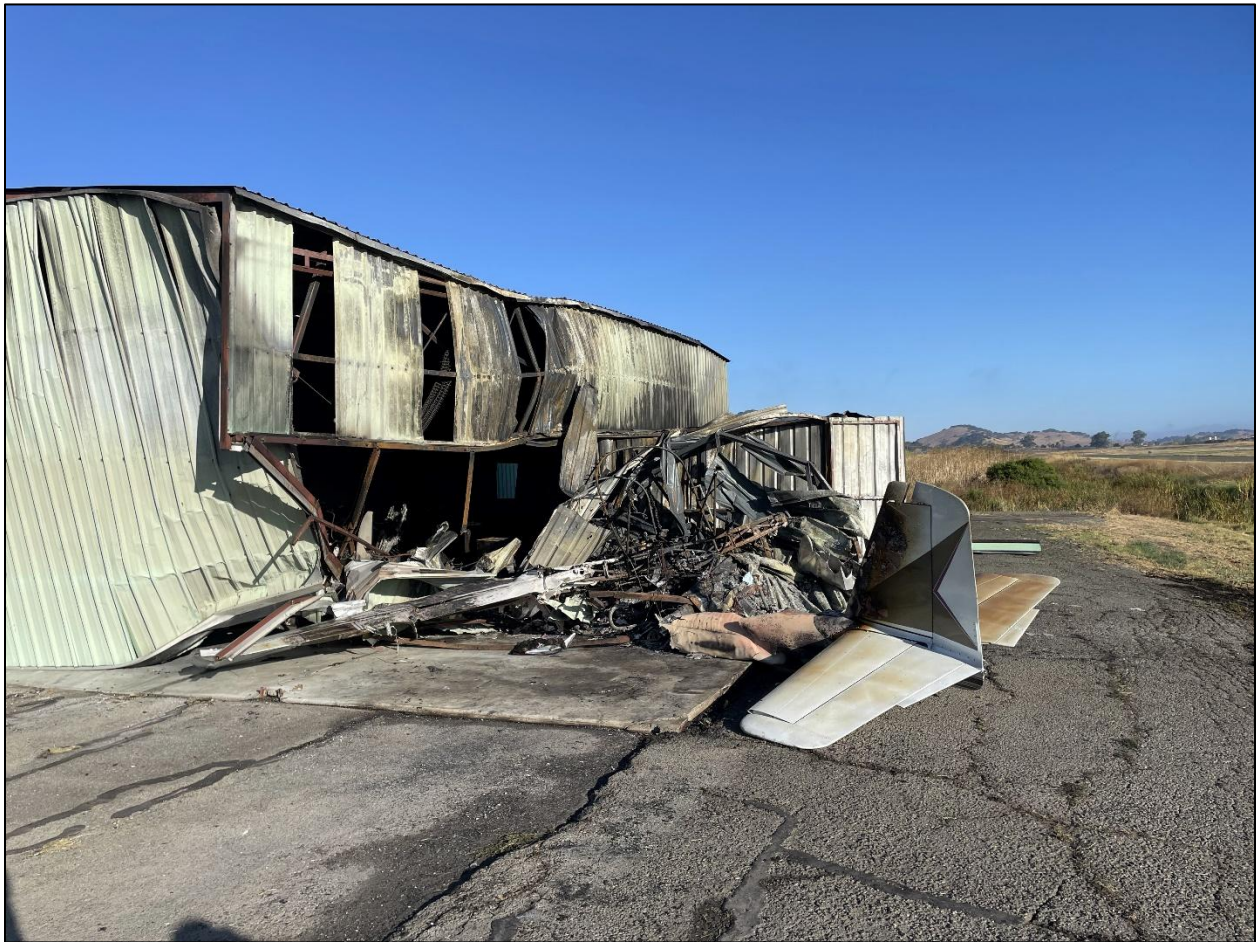
The airplane wreckage was found in a hangar located on the end of a row of hangars. The metal hangar had impact and thermal damage and contained a motorcycle, two vehicles and a Cessna 340 multiengine aircraft which were damaged from postimpact fire. The accident airplane's empennage separated from the fuselage steel structure and remained near its relative position with the main wreckage. The vertical and horizontal stabilizers, rudder and elevators had thermal discoloration. The right wing was mostly destroyed by postimpact fire. The main wreckage was found on top of a motorcycle and that was located in the hangar. The motorcycle had thermal and impact damage and the frame and engine were all that remained intact. A section of the right wing tank and the remains of the right wing tank were all that was identifiable with the outboard right wing. The left wing remained attached to the center wing attach fittings. The left wing tank was breached and contained about 2 gallons of blue colored fuel. The center wing steel structure remained attached to the cabin area. The cabin area was mostly consumed by postimpact fire and only the steel structure and steel components remained. The

engine and propeller assembly remained attached to the firewall and had excessive thermal damage. All three blades were melted down to near the hub.

Figure 2-Accident site, main wreckage.

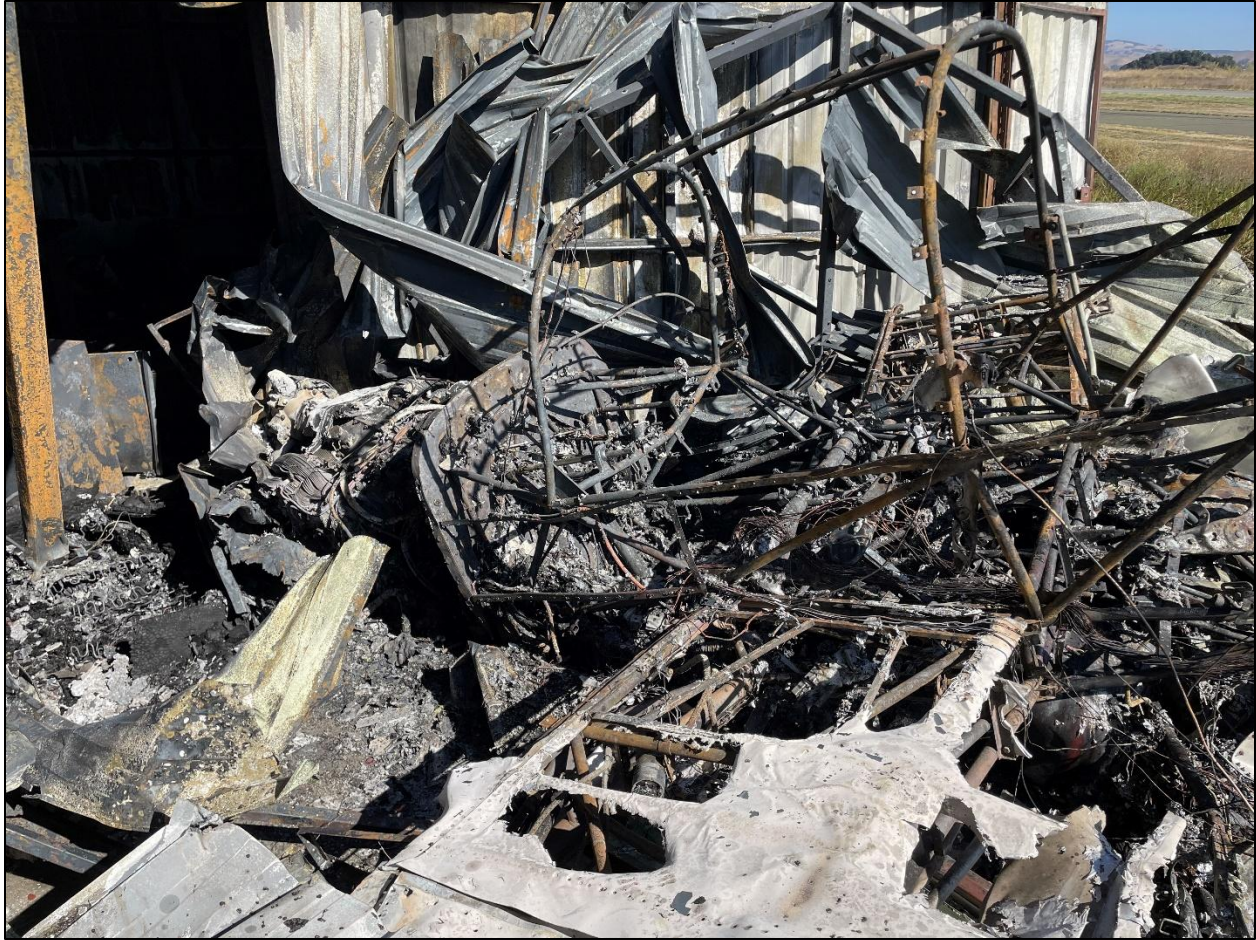
Flight control cable continuity was established from the rudder to near the mid-cabin area where melted turnbuckles would have been. The rudder cables continued forward to the rudder pedal attach points. The rudder controls and steering control system was destroyed by postimpact fire. The elevator control tube had thermal damage near the aft bellcrank area. The elevator bellcrank and a steel control tube had thermal and impact damage and were found loose in the cabin area. The left flap position was undetermined, and the control linkage had thermal damage. The right flap was not found. The left aileron remained attached to the wing and moved freely when the remaining control tube and bellcrank were moved by hand. Most of the aileron control tube was destroyed by postimpact fire. The right aileron and control assembly were not found. The aileron steel torque tube remained in the cabin area and moved freely by hand. The aileron control yoke pushrod tubes were destroyed by postimpact fire.

Figure 3-Accident site, main wreckage cabin and center wing area.

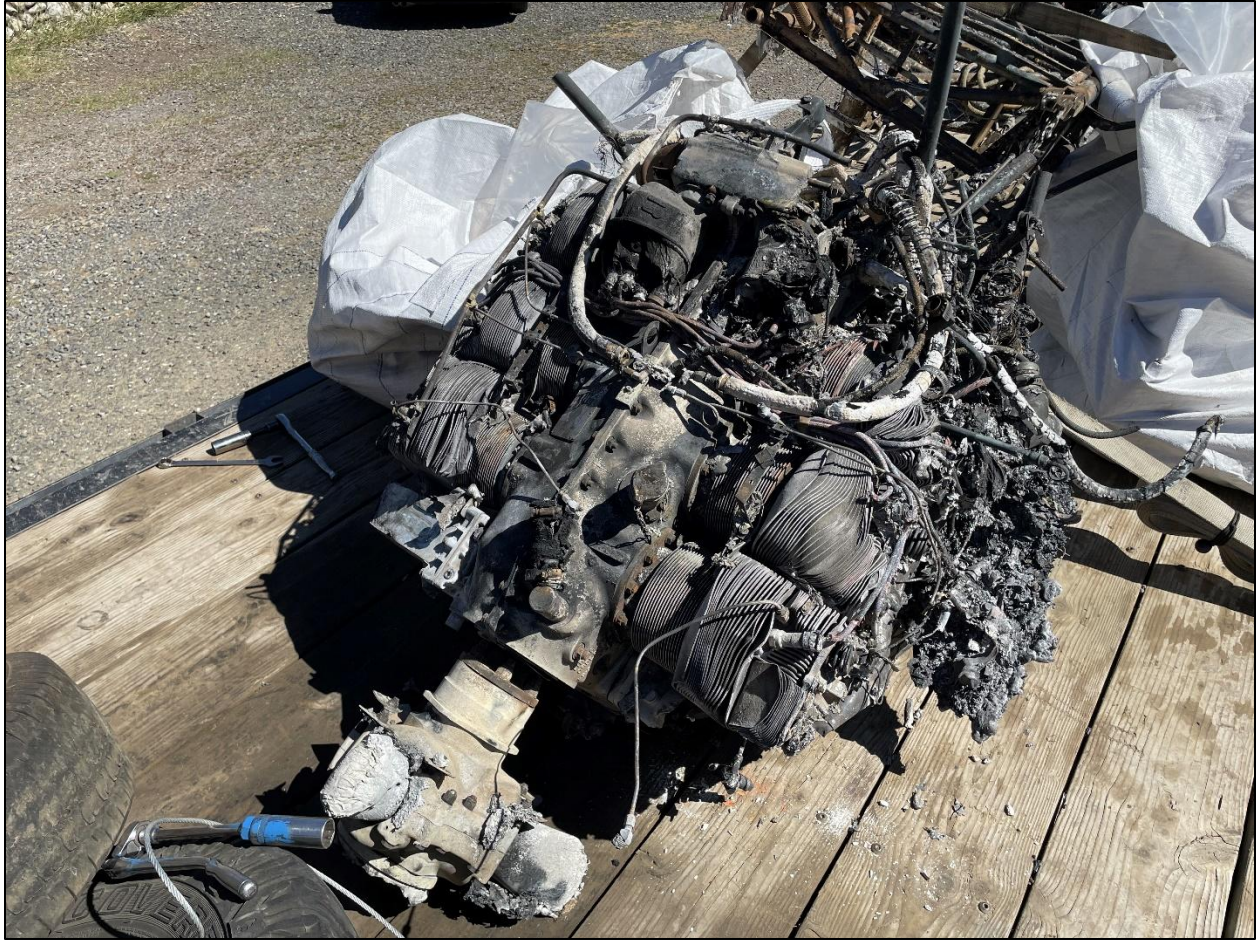
The engine was removed from the firewall during the recovery process. The engine control cables were found partially attached to the instrument panel area and lever positions were undetermined. The engine control cables had impact damage and separated from the engine. The engine accessory section had excessive thermal damage and most of the attached components separated and were destroyed. The accessory section housing had thermal damage and internal gearing was visible. The upper left accessory drive gear separated and the magnetos had excessive thermal damage. The fuel manifold valve was destroyed by postimpact fire. The induction assembly was destroyed by postimpact fire. The exhaust assembly had impact damage. Spark plugs were removed from cylinders No. 1, 3, 4, 5 and 6. The spark plug electrode areas showed normal deposits and the electrodes showed minimal wear. The No. 2 cylinder had excessive thermal damage. The cylinder's overhead components including the spark plugs were found in melted aluminum beneath the engine. The cylinders were boroscoped and the combustion chambers revealed normal operating conditions.

Figure 4-Engine and propeller assembly.

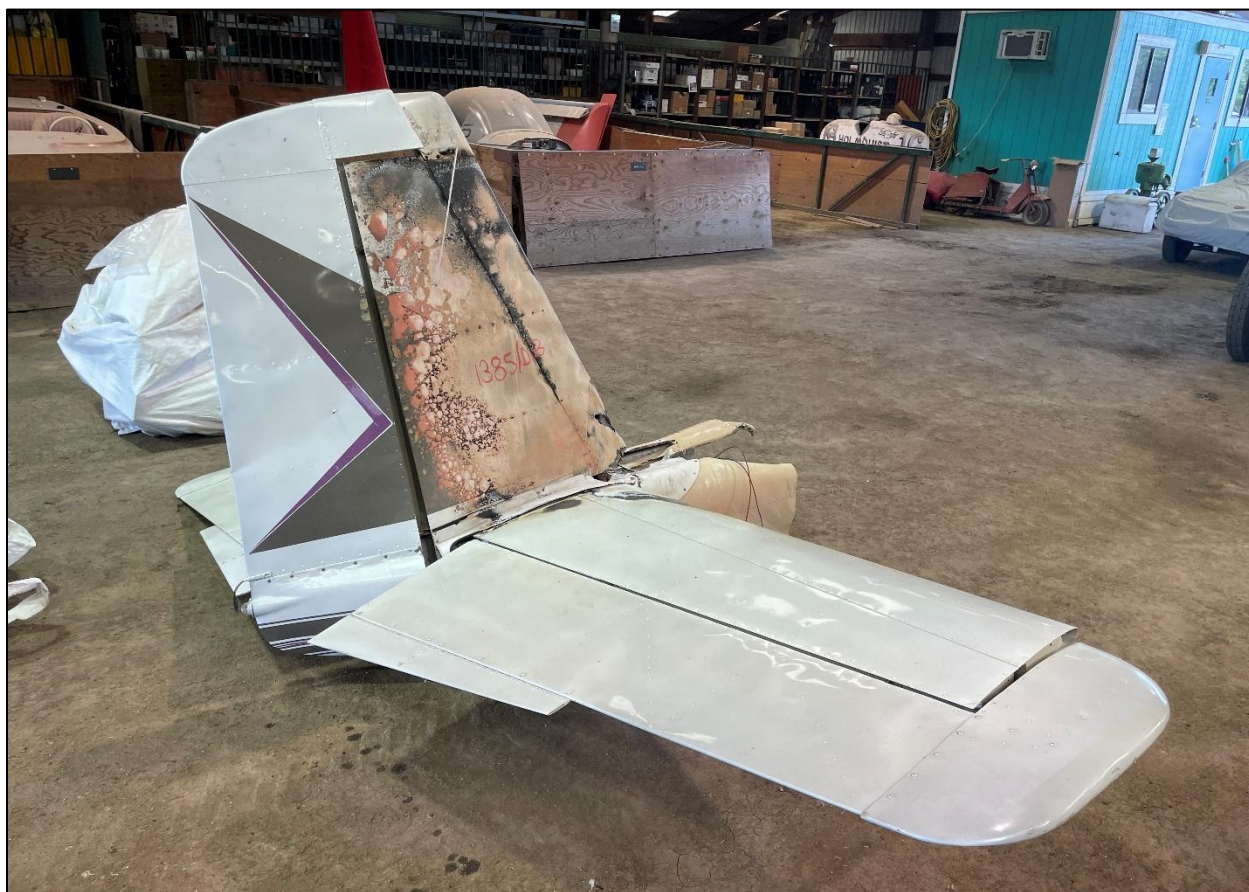
The wreckage was relocated to a secured facility and a follow-up examination was completed. The empennage remained complete with thermal damage to the vertical stabilizer and fuselage area. The rudder control cables were cut during the recovery process and the elevator control tube was thermally separated near the rear bellcrank. Both the rudder and elevator control surfaces moved freely from their cables and control tube, respectively. The elevator trim tabs were found near their neutral position. The trim tab torque tube was thermally damaged and separated near the trim jack screw. The torque tube rotated multiple times around, actuating the jack screw block but was unable to move the connected control cables to the trim tabs. The control cables were complete, properly attached and were covered in corrosion deposits.

Figure 5-Follow-up examination, empennage.

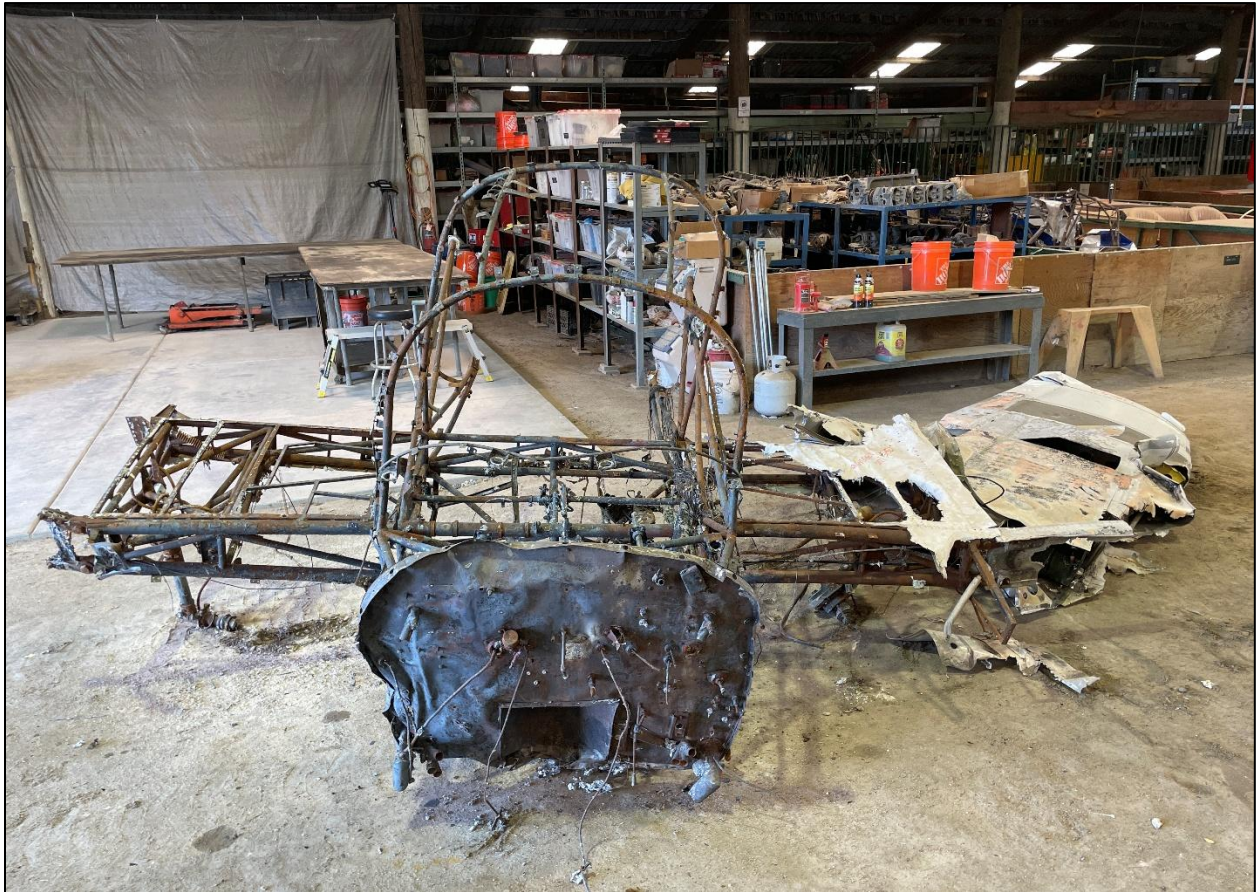
The left wing auxiliary tank remained in the left wing that remained partially attached to the center wing and fuselage section. The tank had thermal deformation and the tank cap remained secured. The cap was removed and had thermal damage. The left wing main tank was not attached to the inboard wing area which had thermal damage and only steel tubular structure remained. The right outboard wing was

consumed by postimpact fire. The right main tank was not attached to the inboard wing area which had thermal damage and only steel tubular structure remained. Fuel tank remnants were found with the main wreckage. Three fuel tank caps and ports were found with the main wreckage and had thermal damage. The fuel selector was not found during the examination.

Figure 6-Follow-up examination, main wreckage including the left wing.

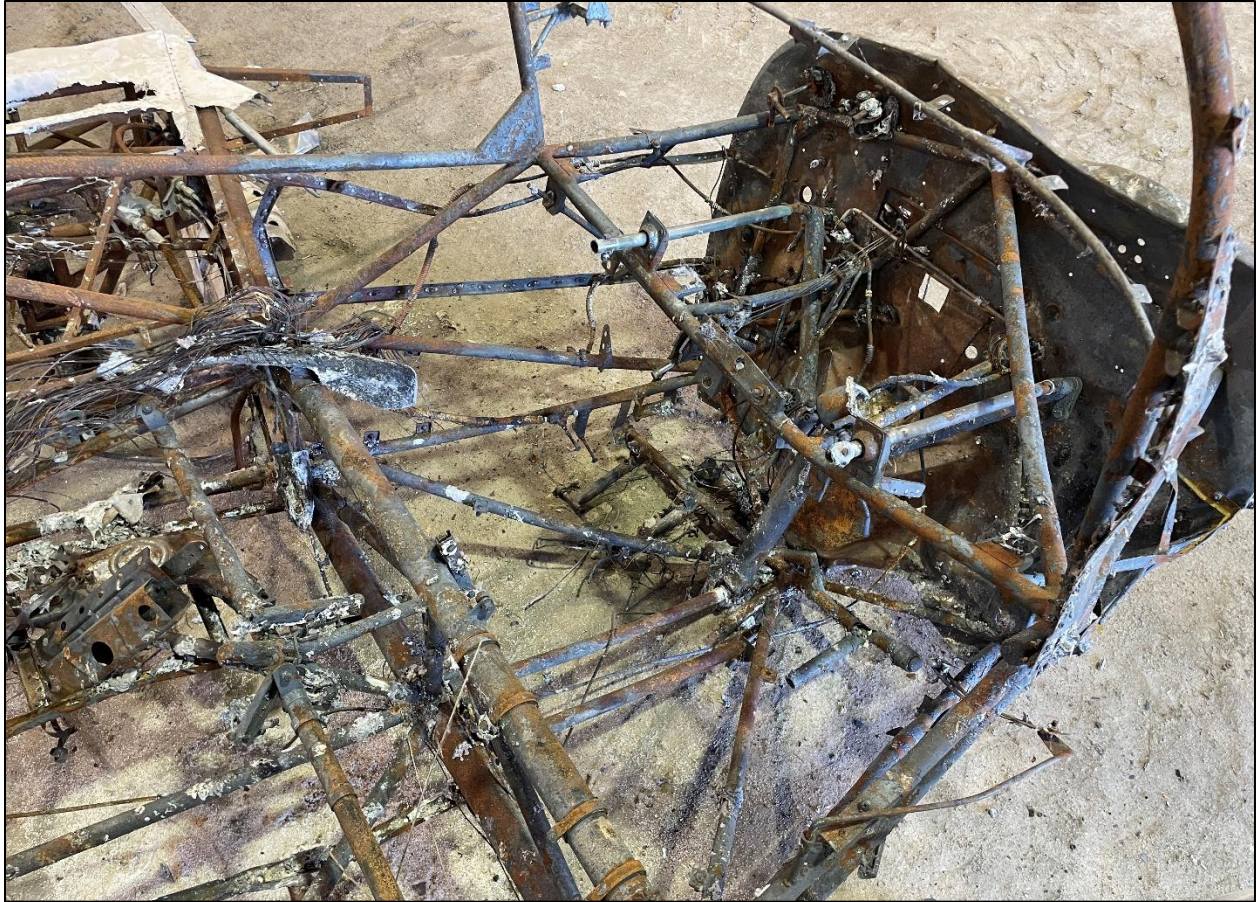
The few instruments that were found had excessive thermal damage and could not be identified.

Figure 7-Follow-up examination, cabin area.

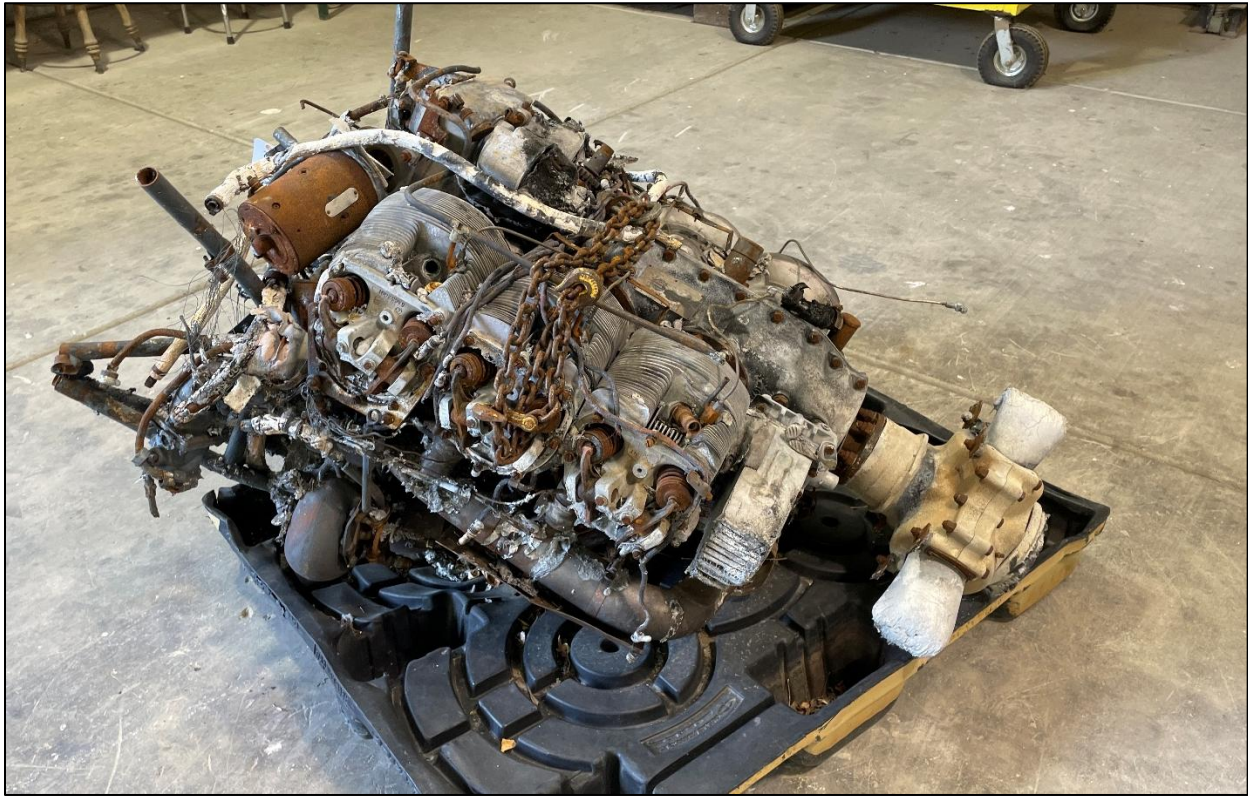
The Continental Motors TSIO-520-CcM(3), serial No. 501459, engine had excessive postimpact fire damage throughout. The No. 2 cylinder head separated, and its valve train was found loose in the main wreckage. The cylinder barrel remained attached to the crankcase and its piston was positioned about halfway in the barrel. The piston showed thermal damage. The No. 4 and 6 cylinders had excessive thermal damage to their overheads and were missing their pushrods and housings which were later found with the main wreckage. The No. 1, 3 and 5 cylinders had thermal damage and missing their rocker covers. Multiple attached accessories had thermal damage and remained partially attached to the crankcase. The oil pump housing had thermal damage, and its internal drive and driven gears were visible and undamaged. The accessory section idler gear was visible through crankcase thermal damage and the idler gears were undamaged. The induction assembly and oil sump were not found with the engine. The camshaft and interior crankcase surfaces were visible, and no mechanical damage was noted. The exhaust assembly remained partially attached and was crushed upwards at a few stacks. The turbocharger turbine side blades were visible and undamaged. The turbocharger drive shaft was unable to rotate by hand. The turbocharger compressor side was missing and only the drive shaft remained. The wastegate valve housing had thermal damage and the valve was found in the closed position. The exhaust pipe was found

with the main wreckage. The engine remained attached to the engine mount structure which was cut during the recovery process. Lines, cables and tubes were not found during the examination.

Figure 8-Follow-up examination, engine and propeller assembly.

The propeller hub and portions of each blade remained attached to the crankshaft propeller flange. Most of the blade's lengths had melted-separated and only 4-6 inch portions remained attached to the hub. The hub housing had thermal deformation. The hub cylinder had thermal damage, and the piston was visible in the bore. The piston was found near the front end of the hub.
