# National Transportation Safety Board

WPR24FA298

## **ON SCENE SUMMARY REPORT**

Location: Yacolt, Washington  
Date: September 6, 2024  
Time: 12:59 Pacific daylight time  
Airplane: N53466, Boeing A75L3

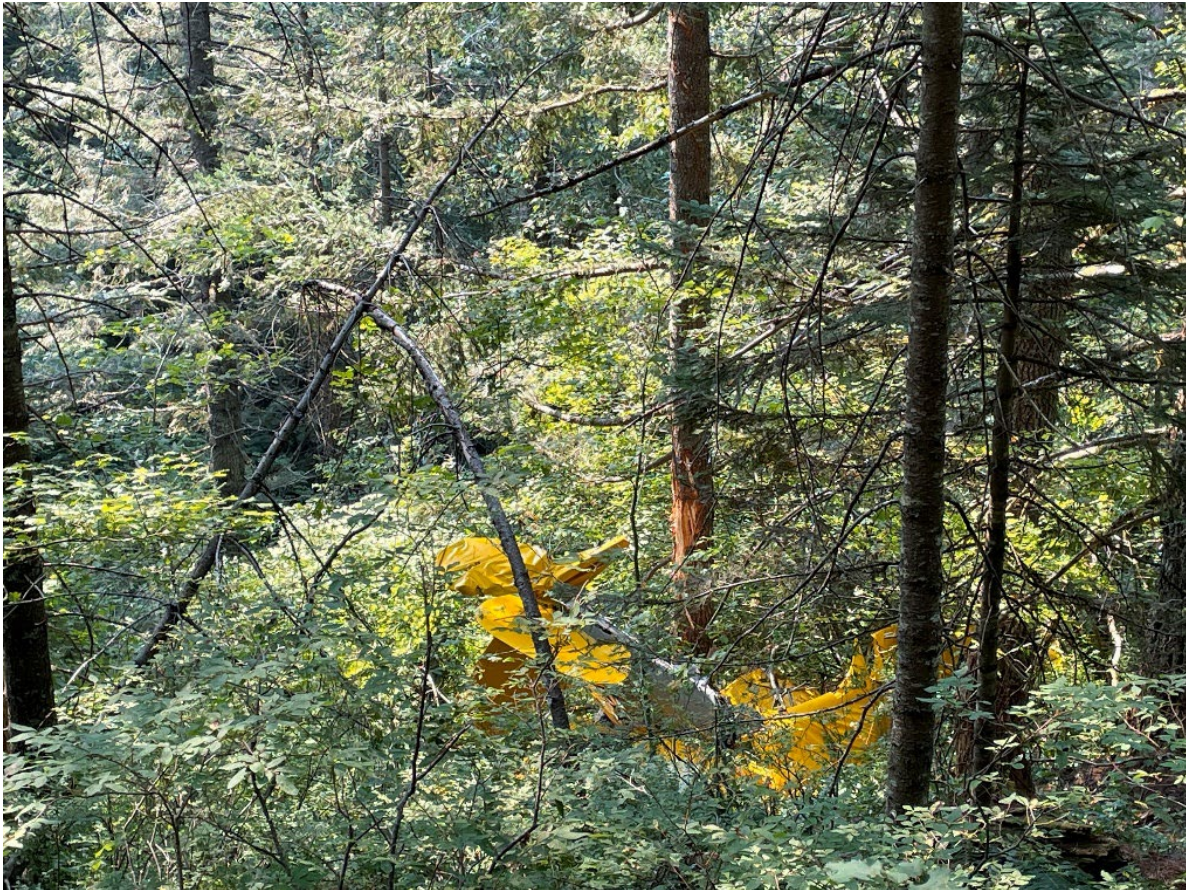
Examination of the accident site revealed that the airplane came to rest in sloped, heavily wooded, mountainous terrain, in a nose low attitude. There was no evidence of pre or post impact fire (Figure 1).

The airplane came to rest at the base of an approximately 100 ft tall tree. Multiple impact scars were observed on the tree, from the base to about 50 ft high. Multiple branches from the one tree were located within and around the wreckage. No

Figure 1. View of main wreckage.

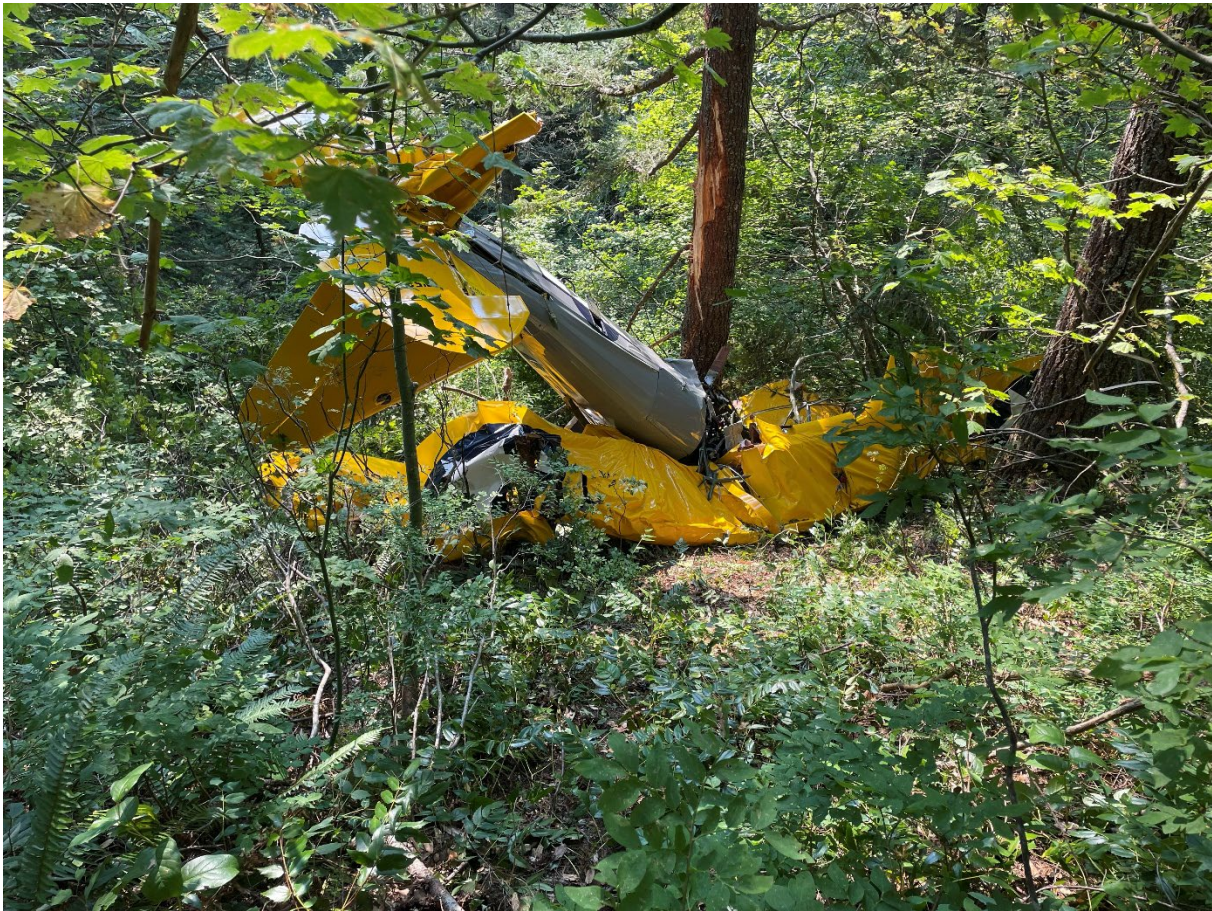
The upper wings were partially attached via struts and crushed aft. The upper right wing was crushed along its entire leading edge, and the outboard half was twisted and displaced aft. The upper left wing was crushed and buckled along the entire span. The lower right wing remained partially attached via wing strut attachments with the upper right wing and was crushed aft along its leading edge. The lower left wing was separated at the wing root and located at the base of the 100 ft tall tree,

beside the main wreckage. Its wingtip was partially torn away; the leading edge remained partially intact. (Figure 2.)

Figure 2. View of main wreckage.

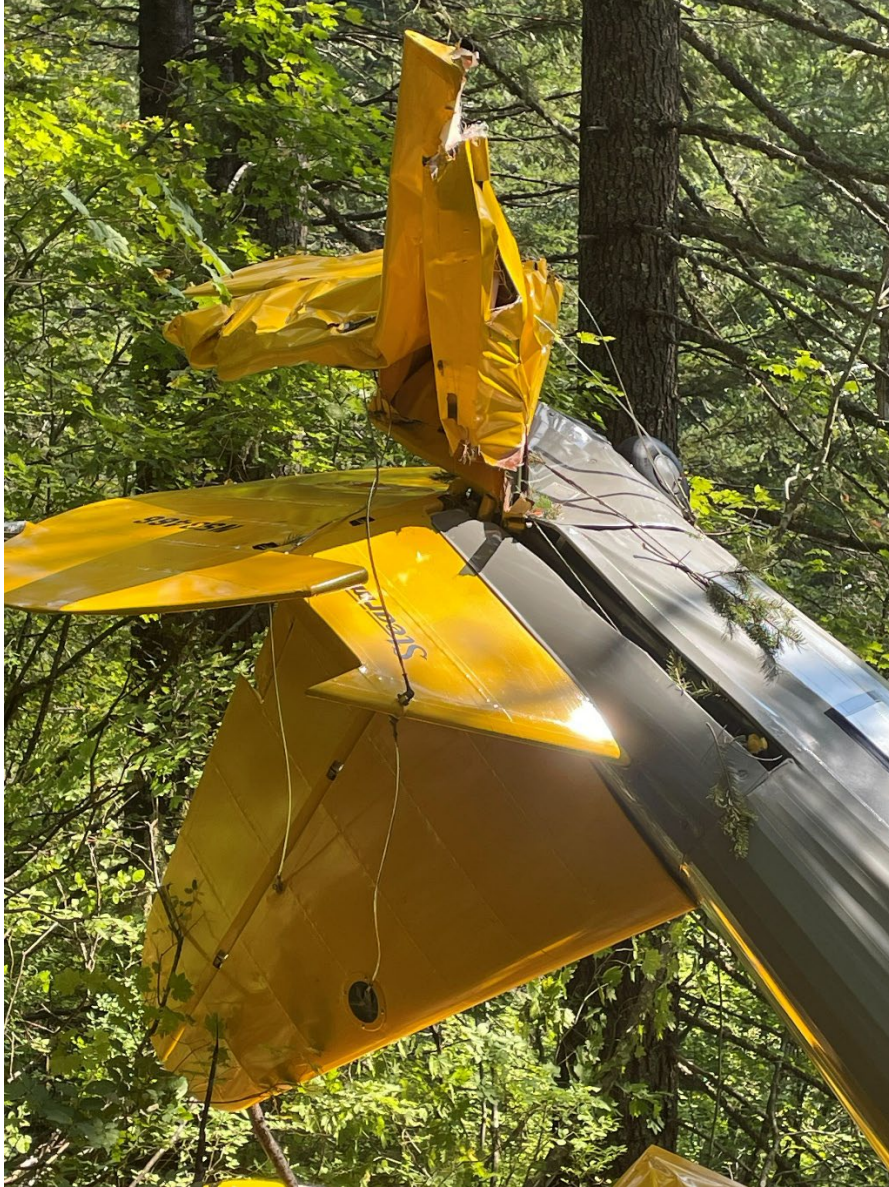
The empennage remained attached to the fuselage. The left horizontal stabilizer was crushed and displaced aft. The right horizontal stabilizer remained attached to the empennage and mostly undamaged. The vertical stabilizer remained attached and appeared mostly undamaged. The left elevator remained partially attached and was displaced aft. The right elevator remained attached and was mostly undamaged. The rudder remained attached to the vertical stabilizer and was mostly undamaged. (Figure 3.)

Figure 3. View of empennage.

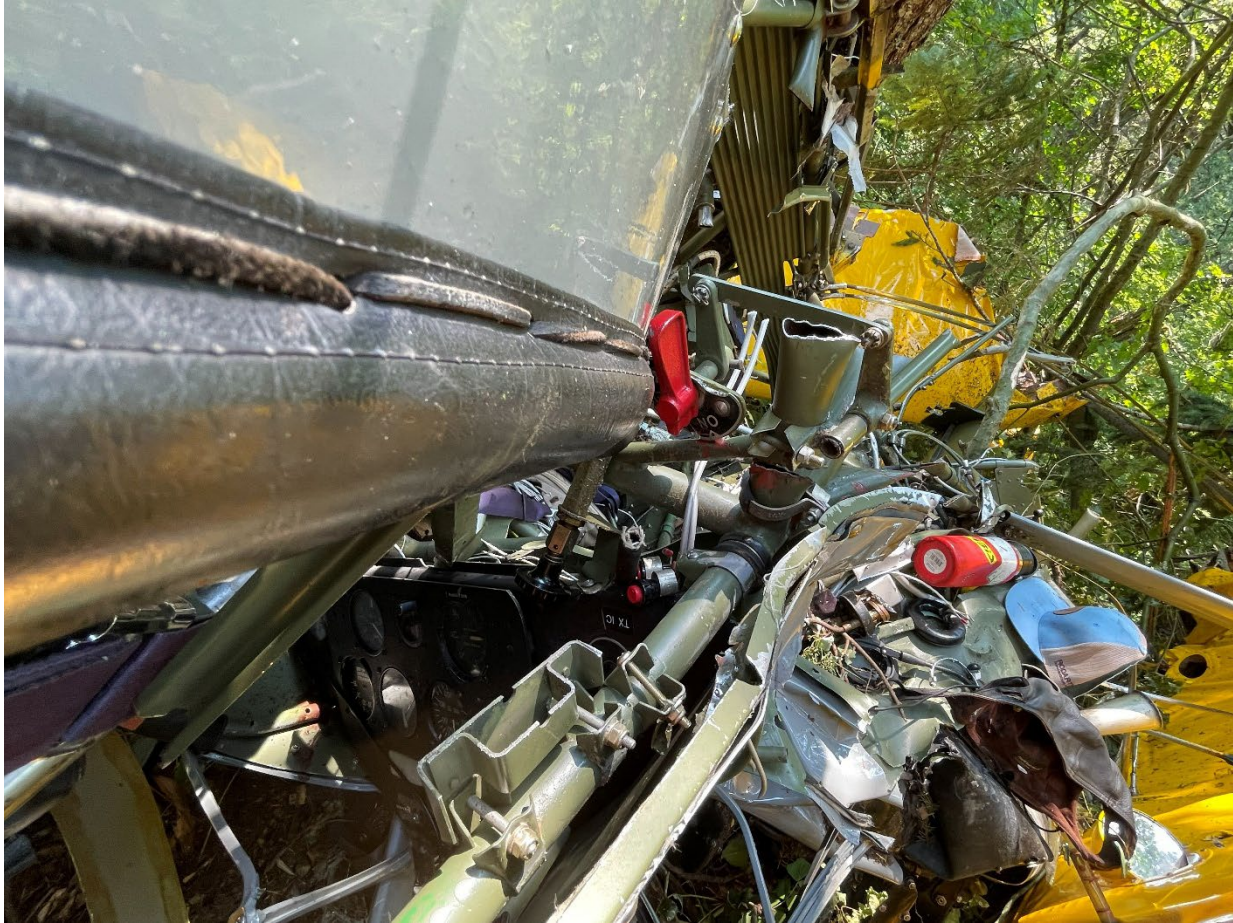
The forward cockpit displayed extensive crush damage; controls and instruments were inaccessible and/or unreliable. The rear cockpit remained partially intact and was mostly inaccessible on site. Controls and instruments were partially accessible. (Figure 4.)

Figure 4. View of cockpits.

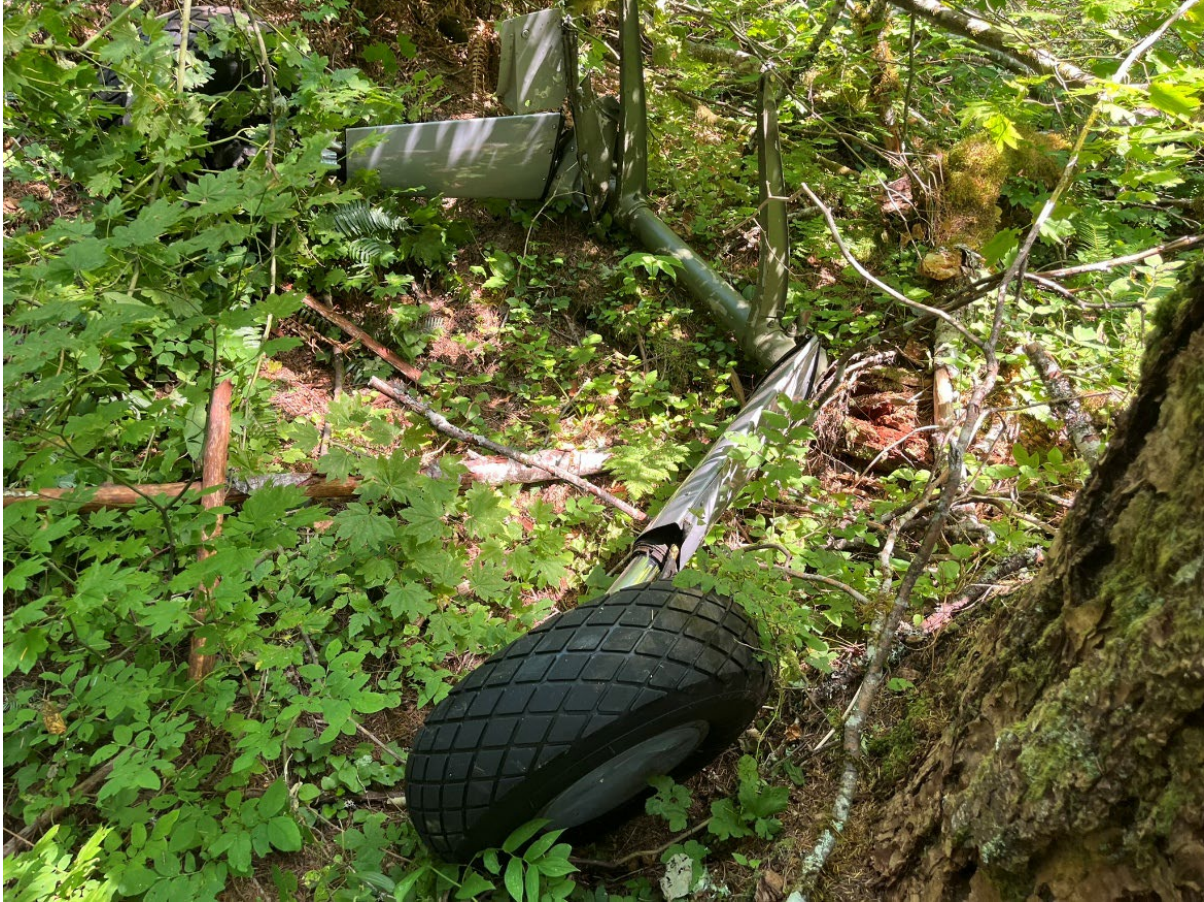
The main landing gear assembly was located intact, about 75 ft downhill from the main wreckage. (Figure 5.)

Figure 5. View of landing gear assembly (courtesy of FAA).

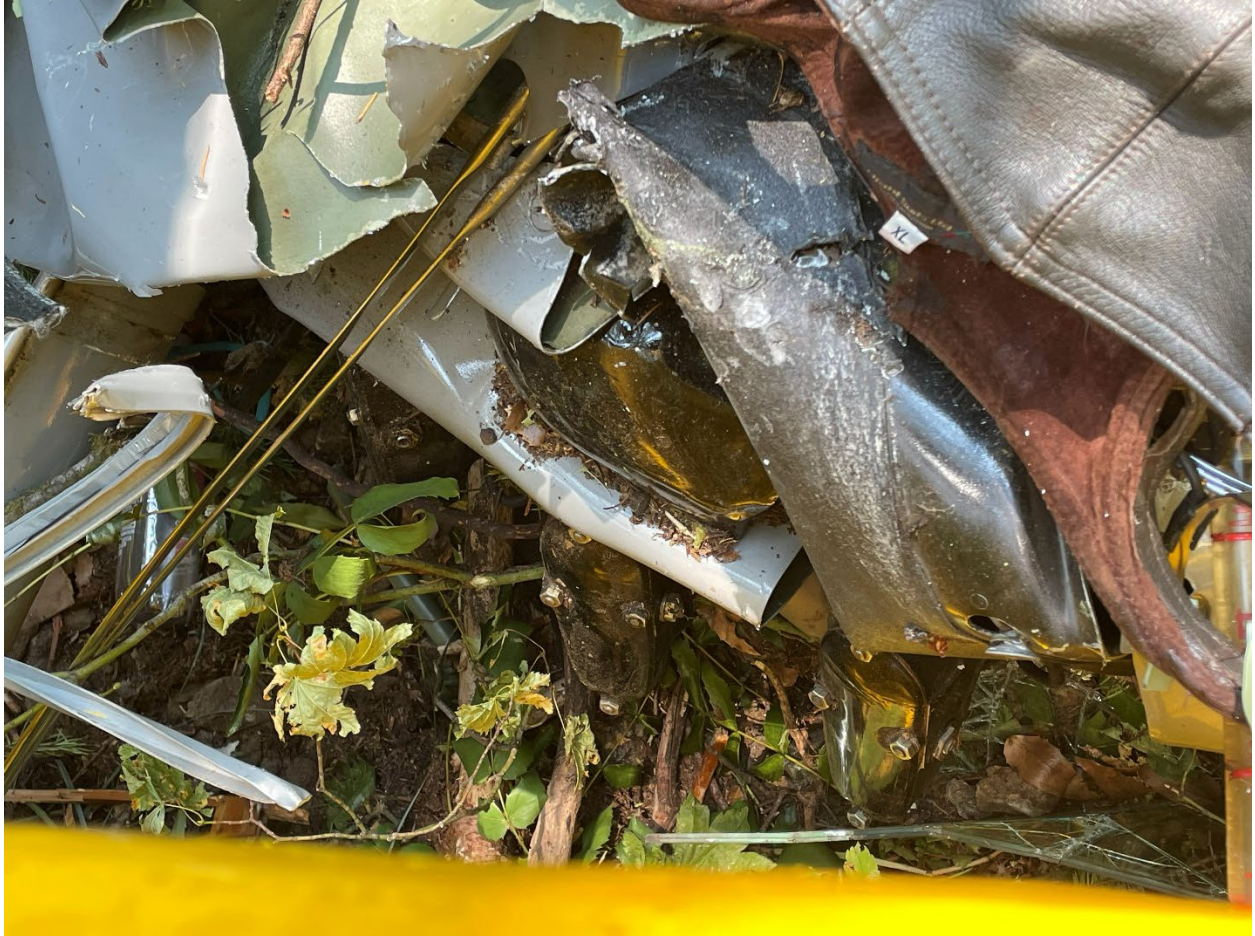
The engine was located partially buried in recently disturbed earth, and underneath the forward fuselage. It remained partially attached to the airframe and was not accessible to examine while on site. (Figure 6.)

Figure 6. Partial view of engine beneath fuselage.

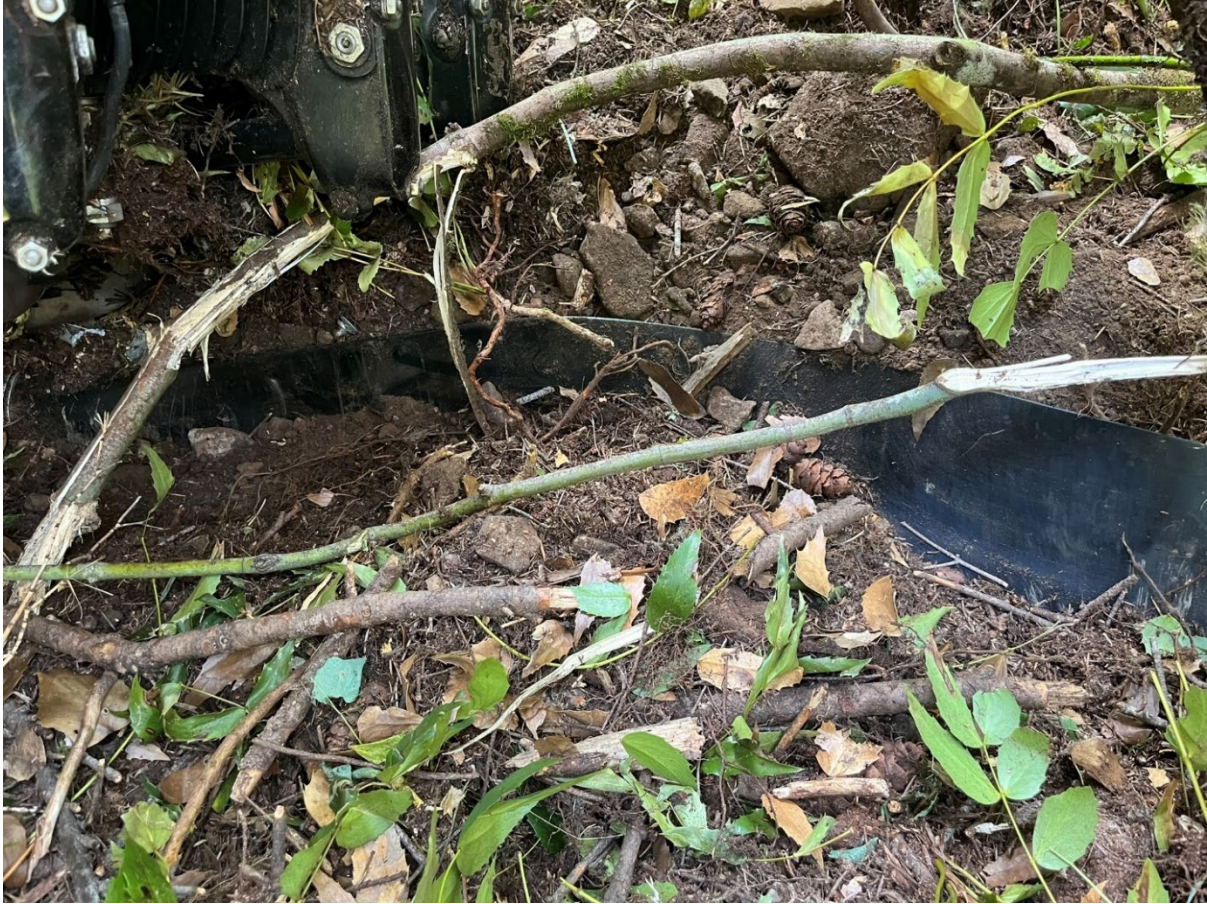
The airplane was equipped with a two bladed metal propeller. It was located beneath the surface, in recently disturbed dirt, underneath the partially buried engine. (Figure 7.) It was not accessible to examine while on site.

Figure 7. View of propeller blade, partially exposed after unearthing it on site.
