# National Transportation Safety Board

WPR24FA298

## **AIRFRAME AND ENGINE EXAM SUMMARY REPORT**

Location: Yacolt, Washington  
Date: September 6, 2024  
Time: 12:59 Pacific daylight time  
Airplane: N53466, Boeing A75L3

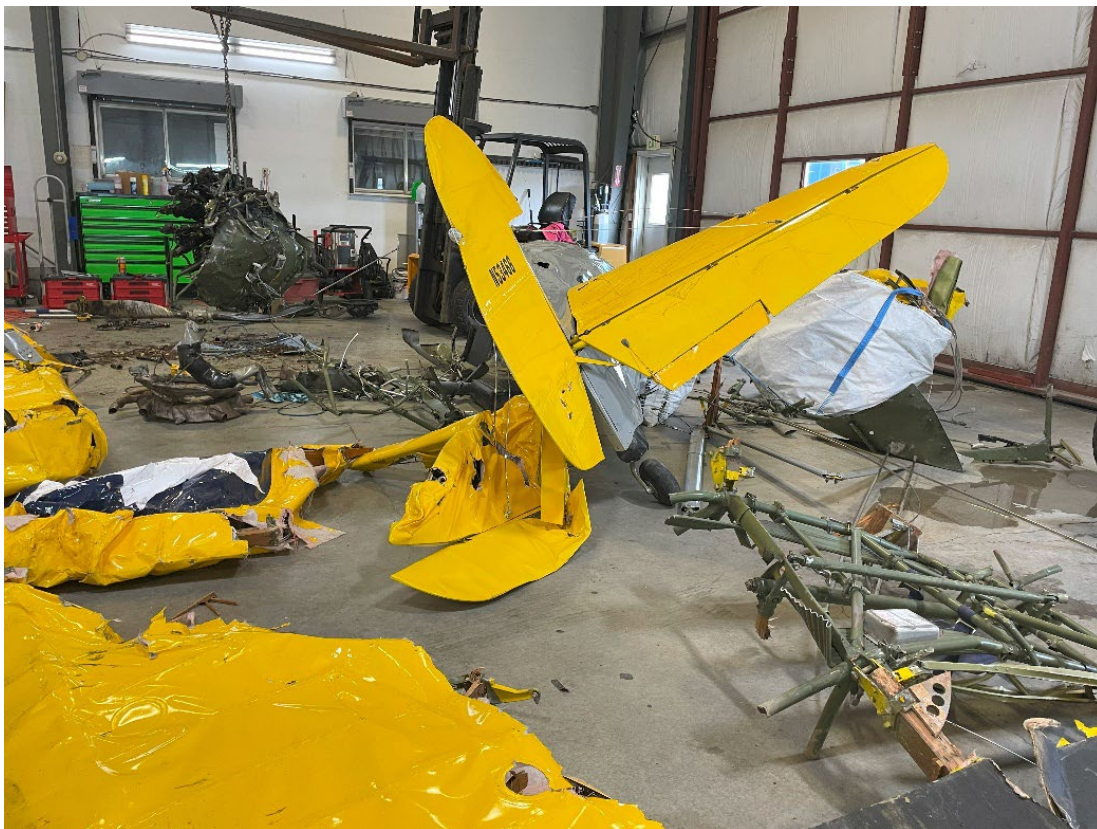
Figure 1. View of empennage.

The left side of the horizontal stabilizer was crushed aft and buckled mid span; it remained partially attached to the empennage. The right side of the horizontal stabilizer remained attached and mostly undamaged. The vertical stabilizer remained attached and appeared mostly undamaged. The left side of the elevator remained partially attached to the horizontal stabilizer, was buckled, and displaced aft. The right side remained attached to the horizontal stabilizer and was mostly undamaged. The rudder remained attached to the vertical stabilizer and was mostly undamaged. (Figure 1.)

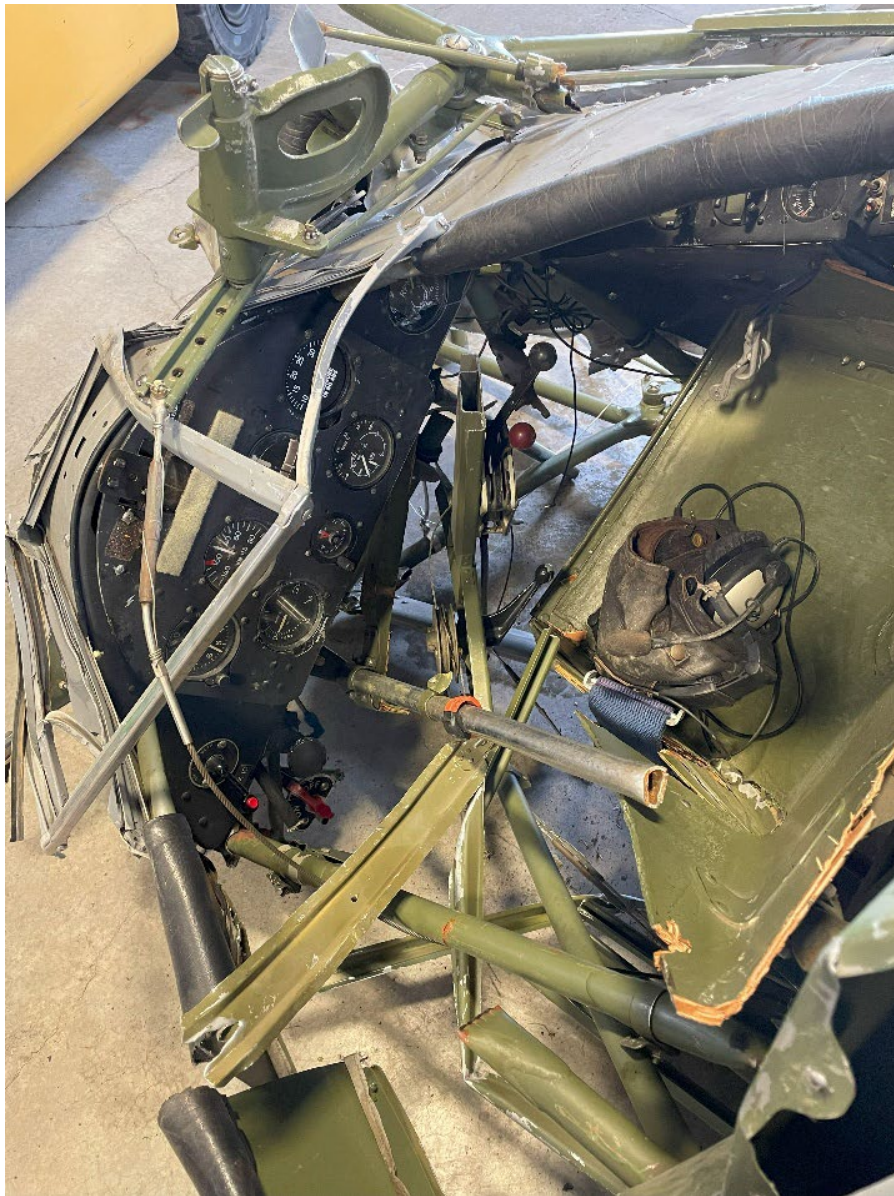
Figure 2. View of rear cockpit.

The forward cockpit displayed extensive crush damage and was separated from the fuselage. The rear cockpit remained partially intact and remained attached to the fuselage. (Figure 2.)

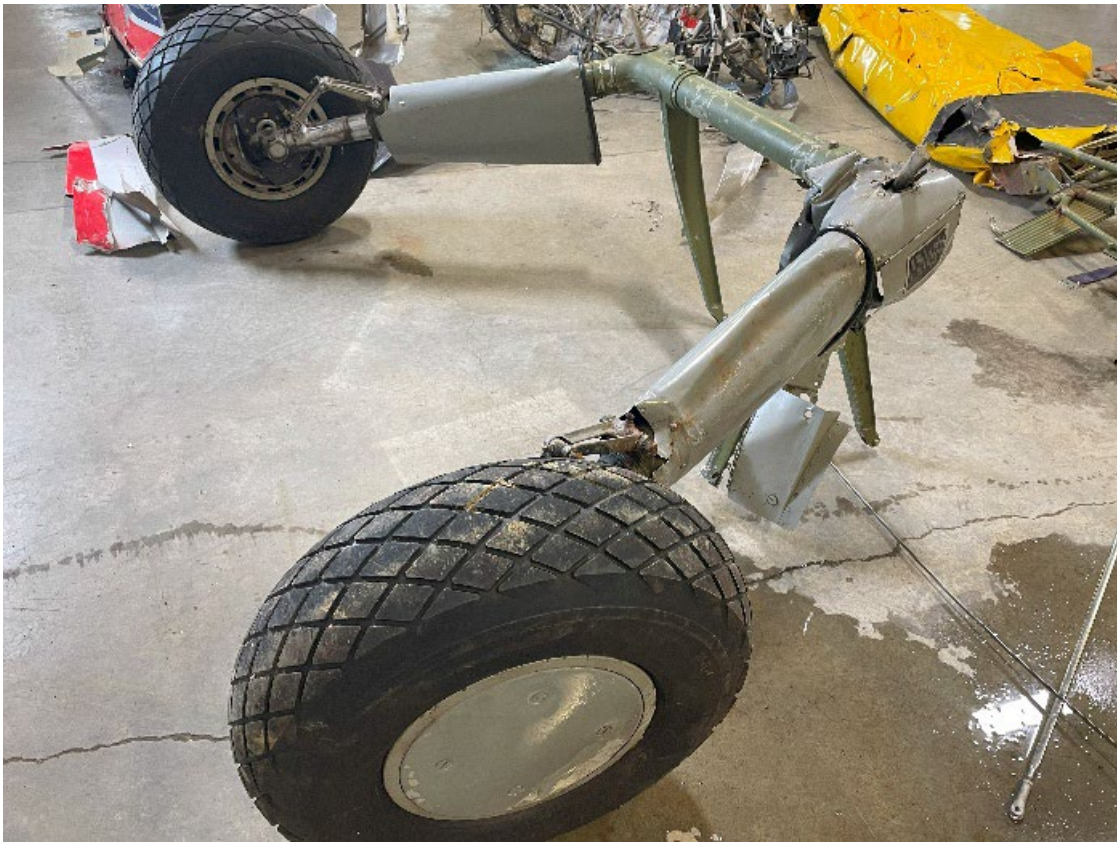
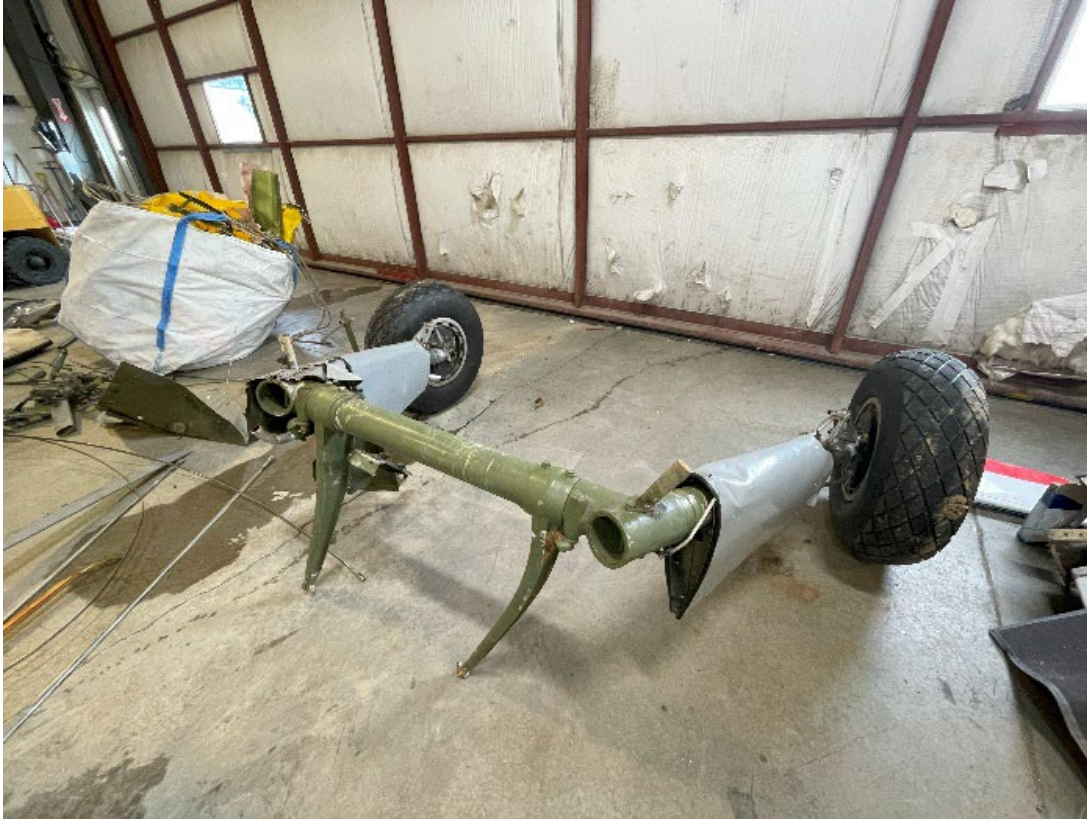
The main landing gear assembly was separated from the fuselage and remained intact. Both struts remained attached to the cross tube, and both wheel assemblies remained attached to the axles. The rear extending arms remained attached to the cross tube. The strut fairings remained attached to the struts. Both main wheel tires displayed scuffing and contained mud consistent with the accident location. The leading edge of the left strut fairing was dented lengthwise, and displayed brown colored transfer, consistent with tree bark. The right extension arm was bent inboard, near the base of the arm. (Figures 3 and 4.) The tailwheel remained attached at the empennage and was undamaged.

Figure 3. View of main landing gear assembly.

Figure 4. View of main landing gear assembly.

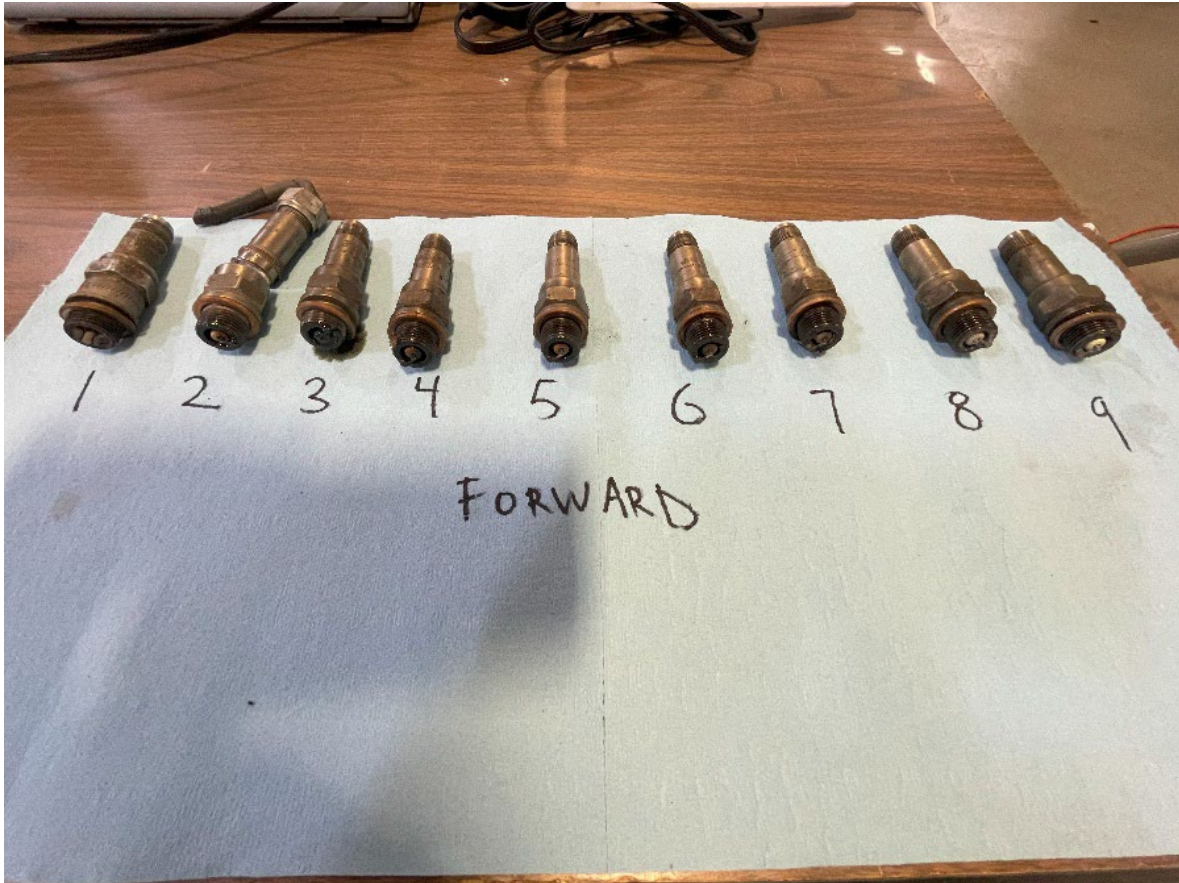
Figure 5. View of forward spark plugs.

The cylinders, spark plugs, and ignition leads remained attached. The forward spark plugs were removed. (Figure 5.)

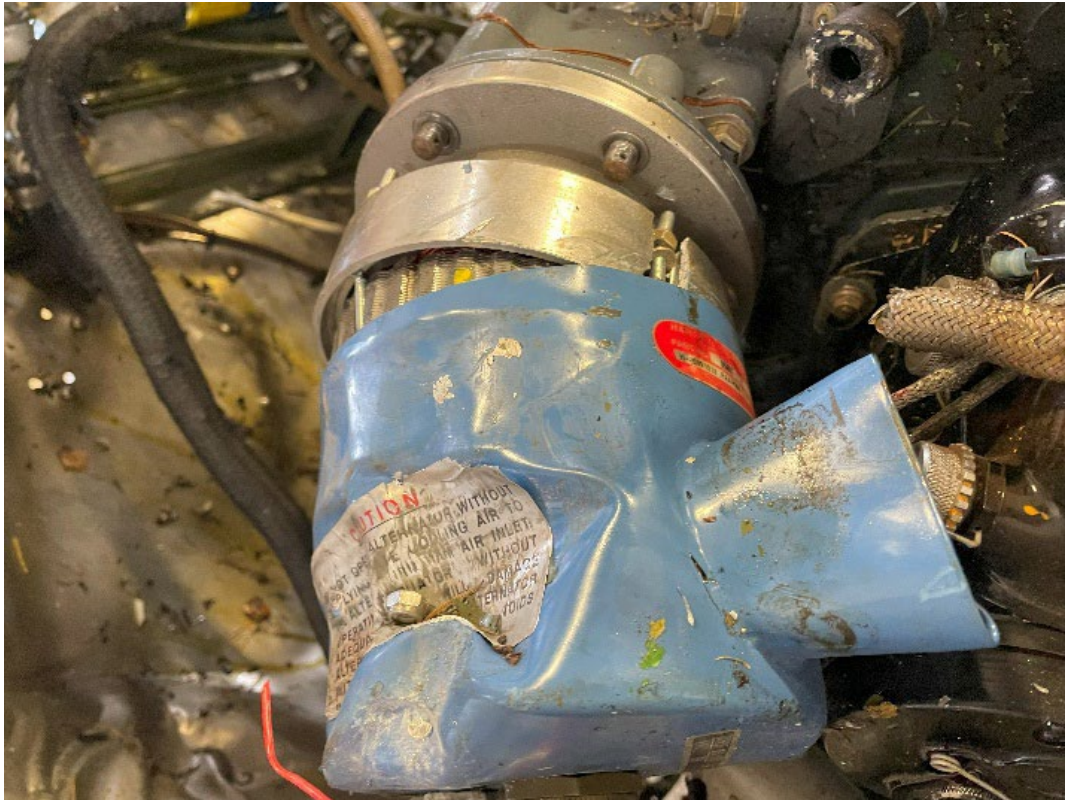
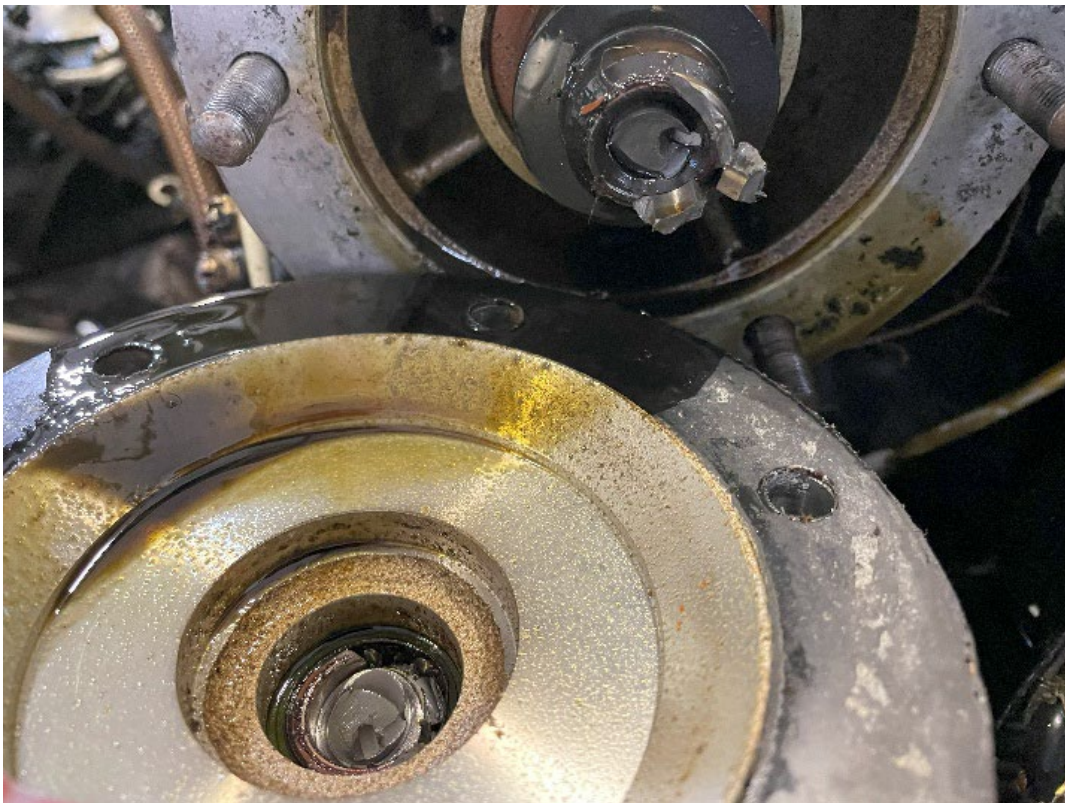
The starter, alternator, and single drive dual magneto were removed. The starter was unremarkable. Prior to removal, the alternator was observed partially separated near the flange, and removal revealed a fractured/sheared gear drive, consistent with impact damage. (Figures 6 and 7.) Spark was observed from both leads on the single drive dual magneto.

Figure 6. View of alternator prior to removal from engine.

Figure 7. View of alternator gear.

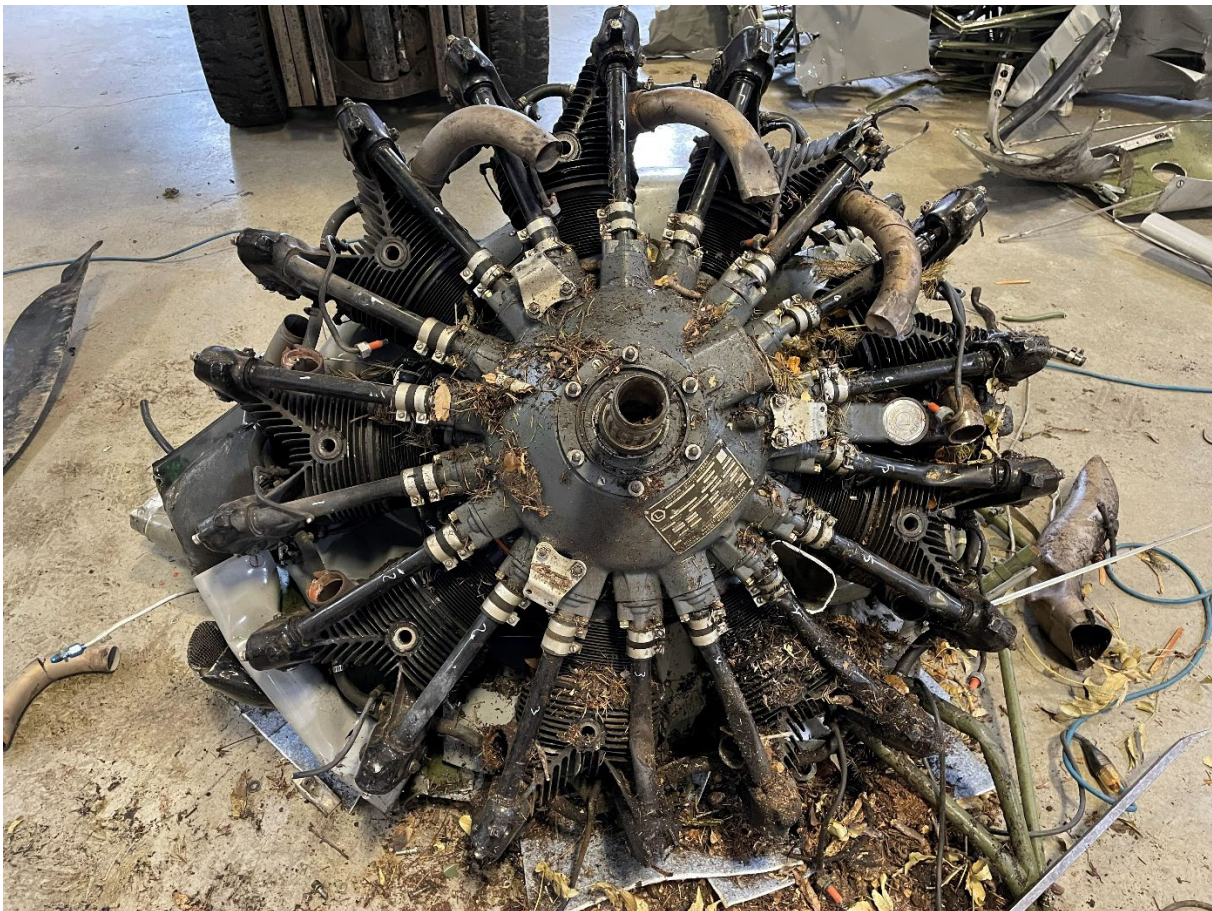
Figure 8. View of pushrod tubes.

Examination of each cylinder's pushrod tubes revealed that:

Cylinder 1: both tubes were attached and undamaged.

Cylinder 2: both tubes were attached and undamaged.

Cylinder 3: the exhaust tube was undamaged; the intake tube was damaged and dented consistent with impact.

Cylinder 4: both tubes were damaged consistent with impact; the exhaust tube was fractured at the case fitting.

Cylinder 5: both tubes were damaged and dented consistent with impact.

Cylinder 6: both tubes were damaged consistent with impact; the exhaust tube was fractured at the case fitting.

Cylinder 7: the intake tube was undamaged; the exhaust tube was impact damaged at the rocker box case, and the box and valve cover was fractured.

Cylinder 8: both tubes were undamaged.

Cylinder 9: both tubes were undamaged.

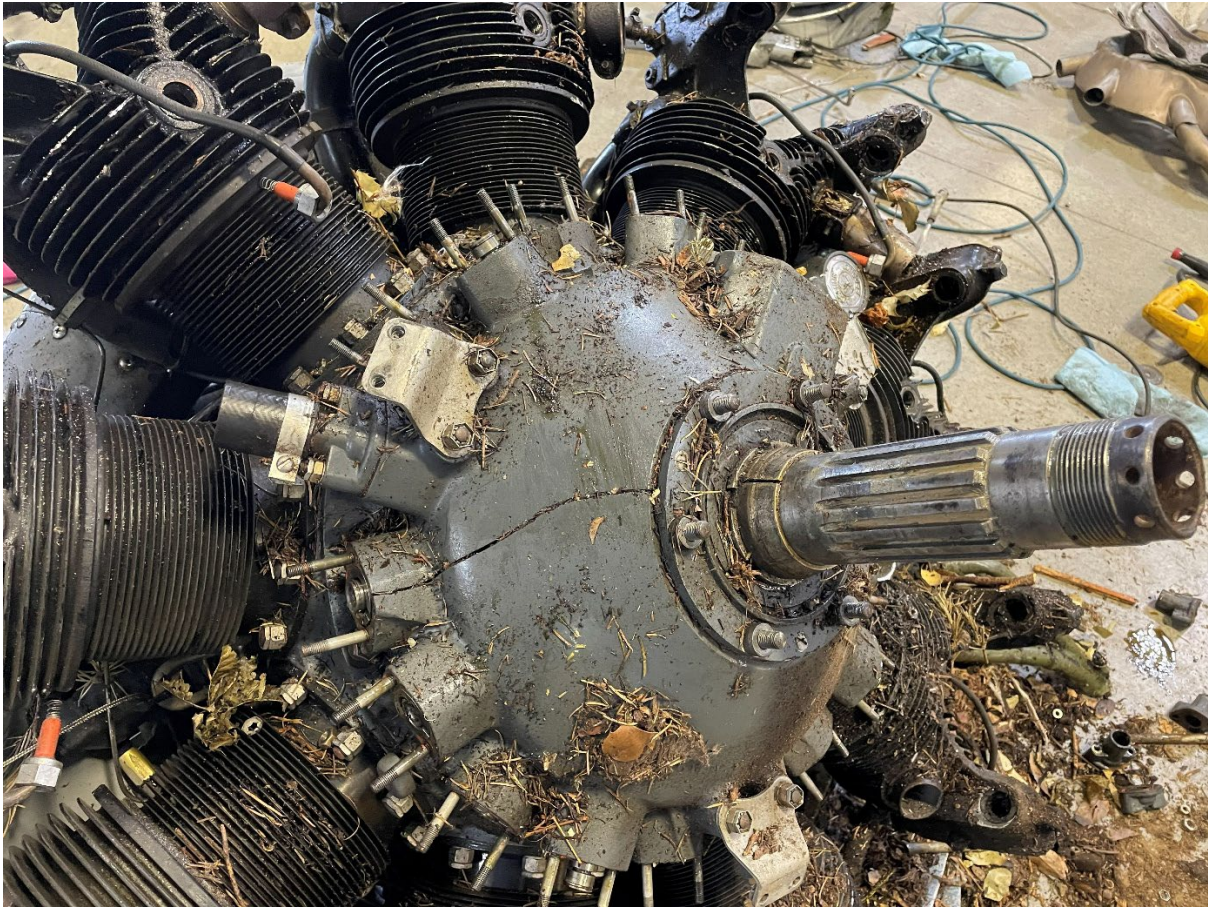
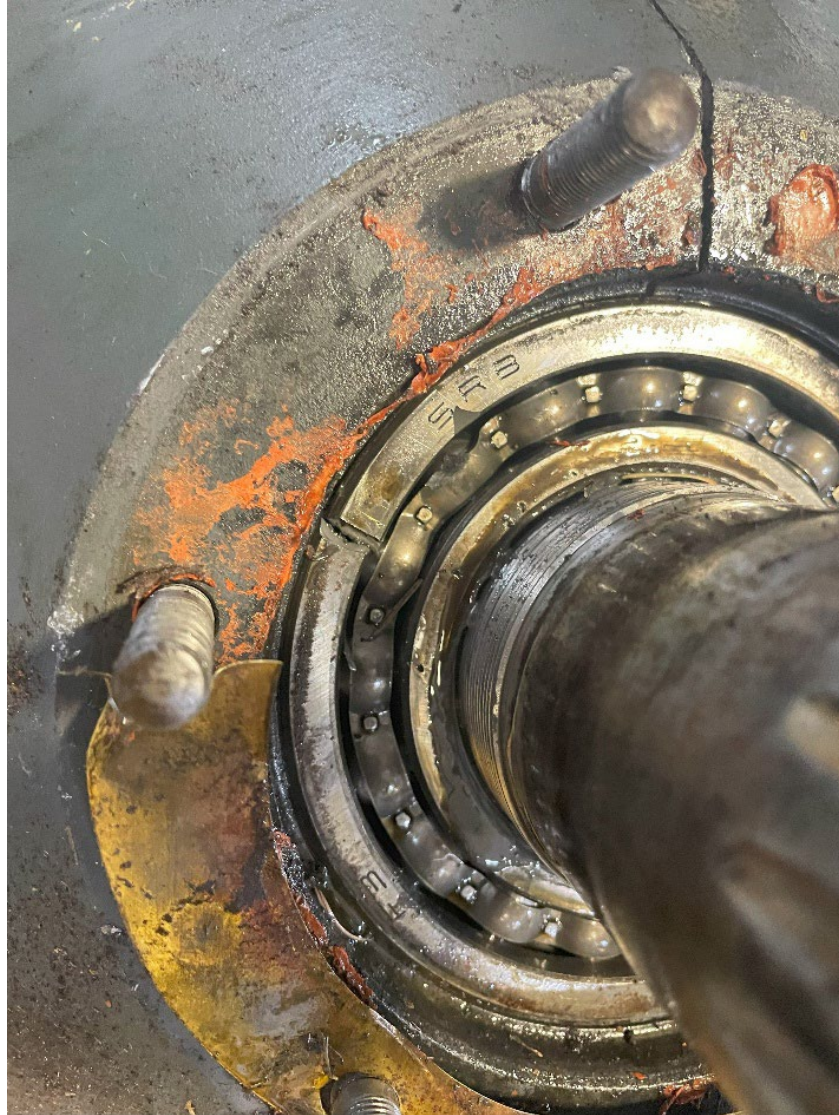
A fracture in the nose case was observed, consistent with impact. The nose case was removed and a fractured roller bearing race was noted. (Figures 9 and 10.)

Figure 9. View of fracture in nose case.

Figure 10. View of roller bearing race.

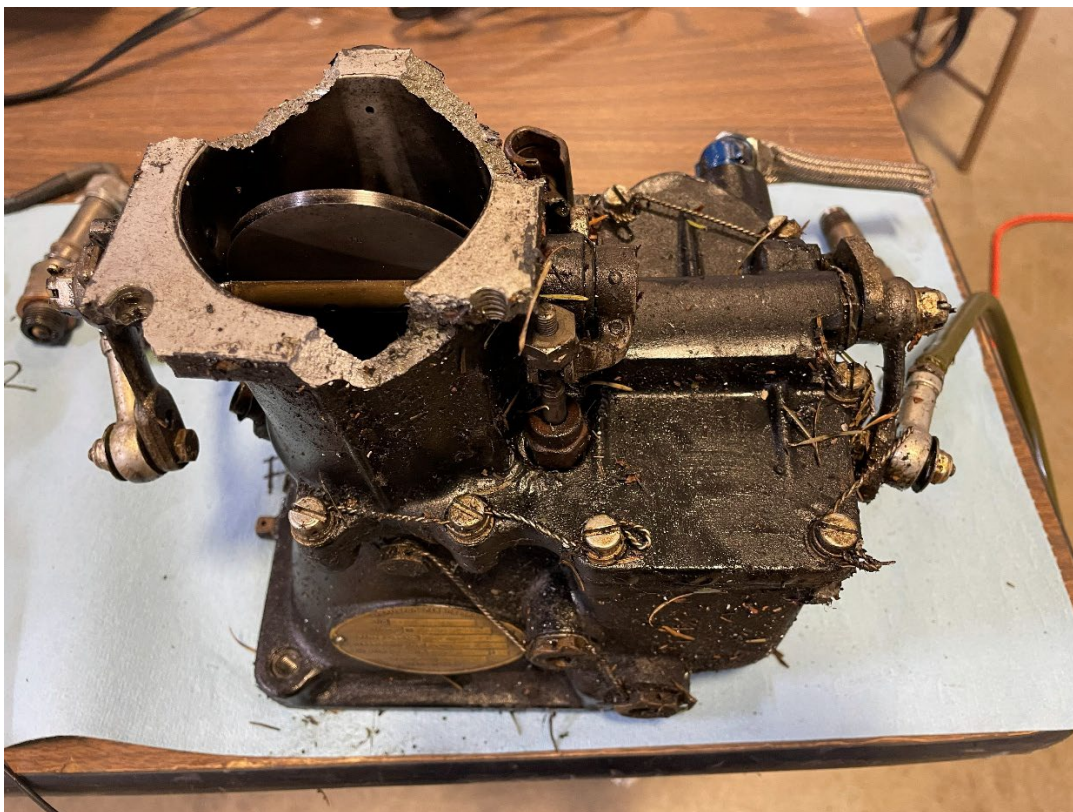
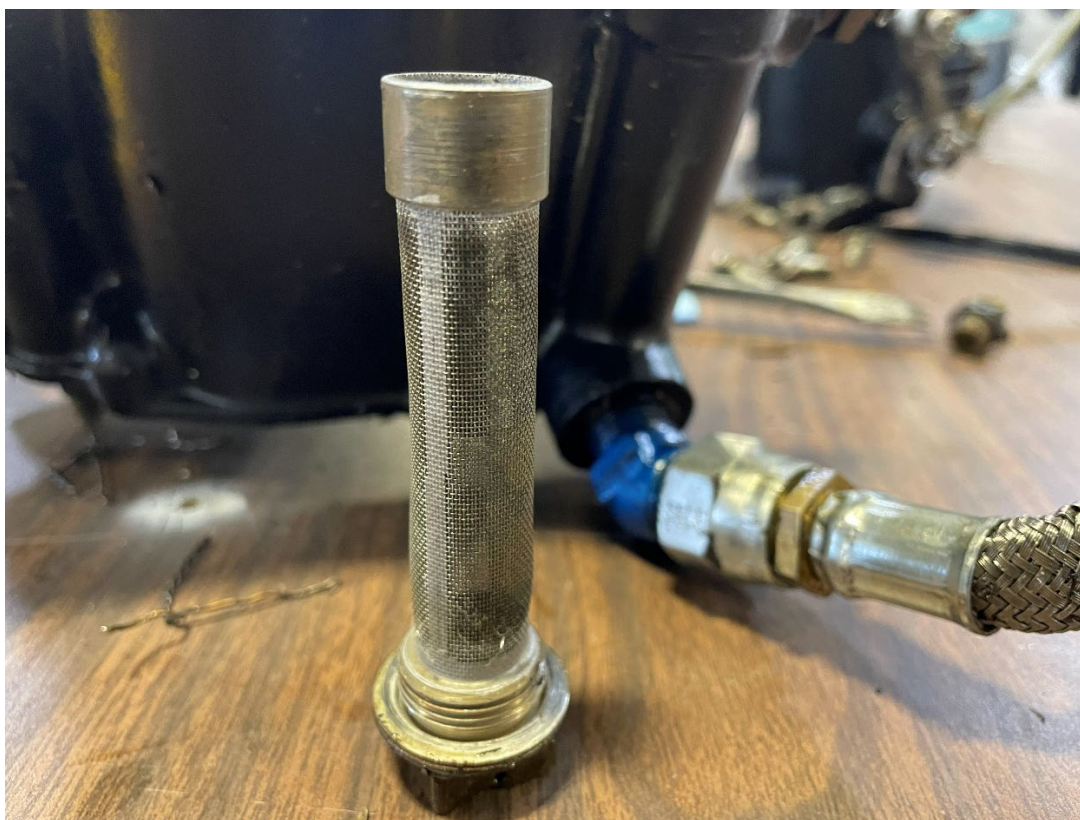
The carburetor displayed fractures at the flange, consistent with impact; it was removed and disassembled. The float assembly was observed intact, the jets were present and clear, the screen was free of debris. (Figures 11 and 12.) The gascolator was removed and disassembled. No anomalies were noted.

Figure 11. View of carburetor.

Figure 12. Carburetor screen.

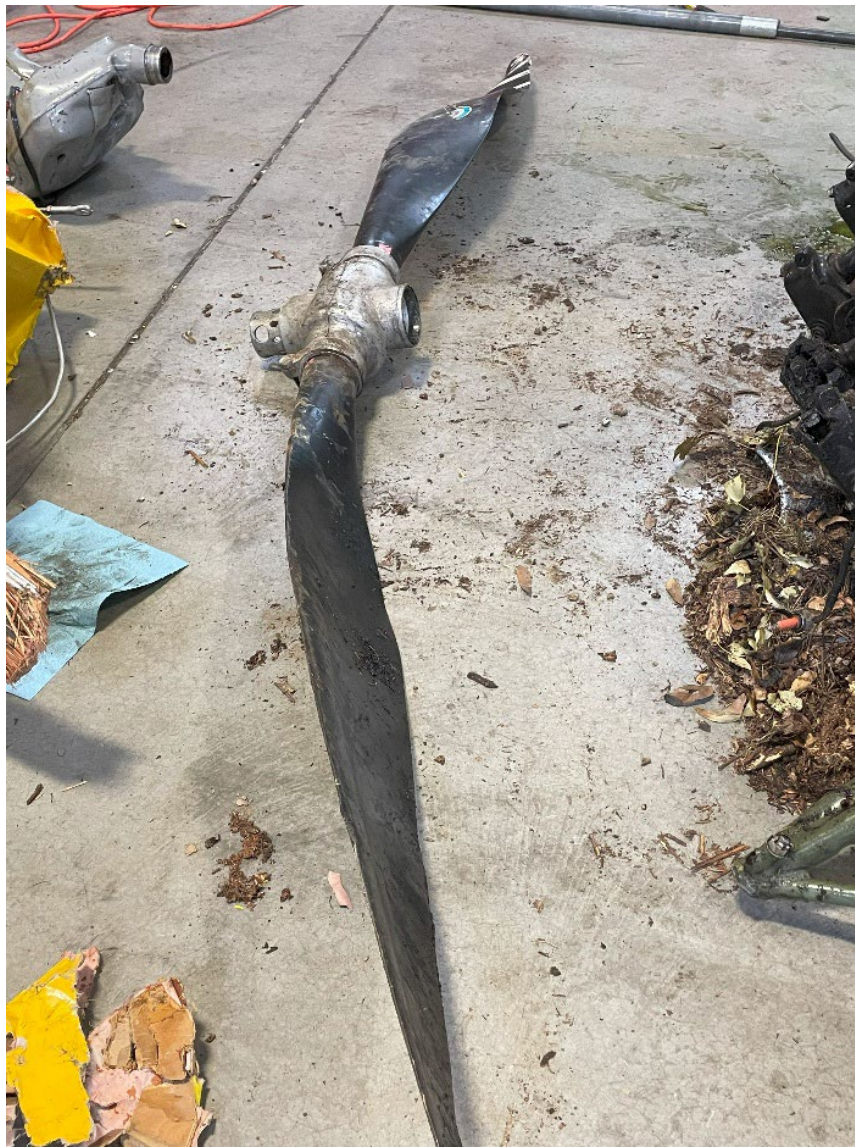
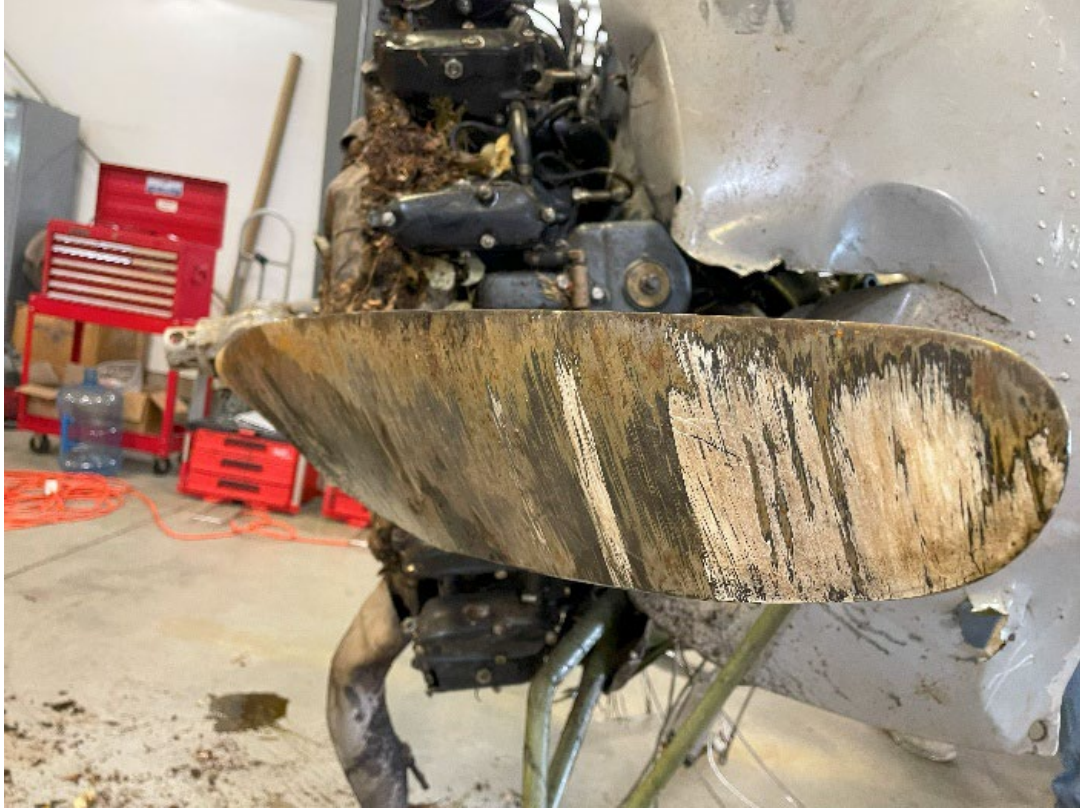
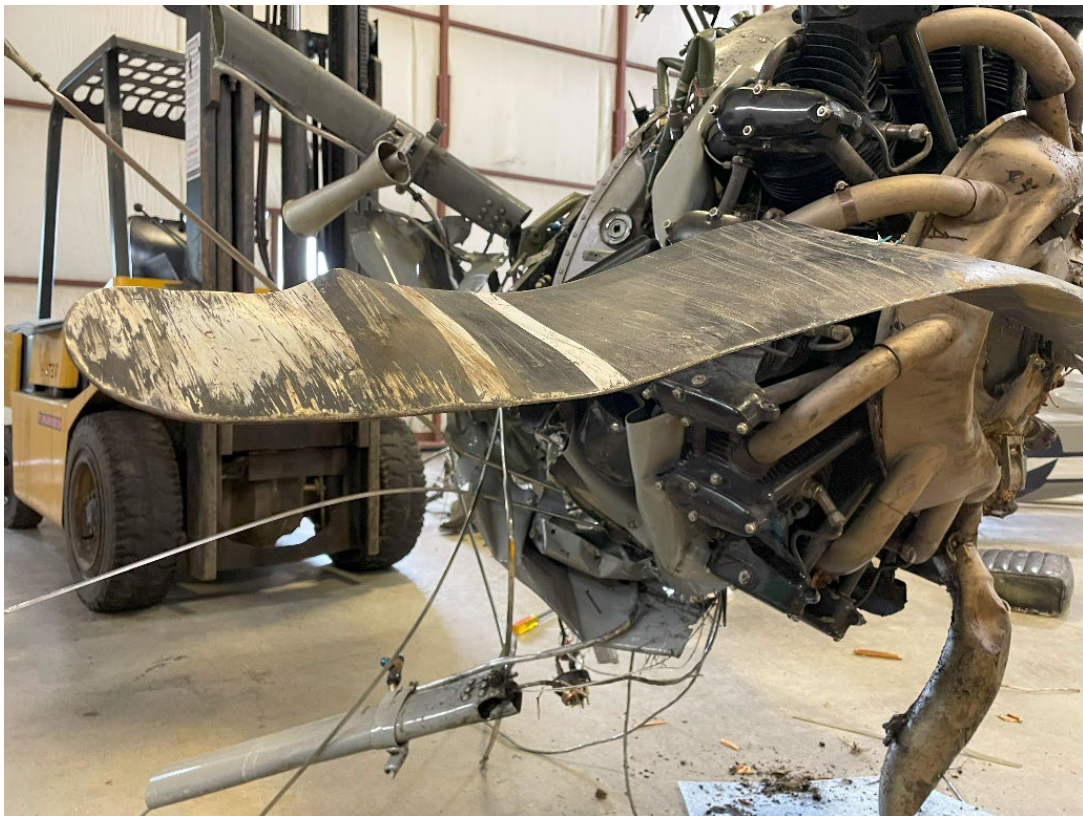
The propeller assembly remained attached to the driveshaft. Both blades remained attached at the hub. Both blades displayed chordwise striations across the full length of the blade. One blade was bent aft near the hub with scratching and gouging along the leading edge. (Figure 12) One blade displayed S-bending along the outboard half of the blade, with scratching and gouging along the leading edge. (Figures 13 - 15.)

Figure 13. View of propeller assembly.

Figure 14. View of propeller blade striations.

Figure 15. View of striations and S-bending.
