WPR24FA298

## INVESTIGATION PHOTOGRAPHS

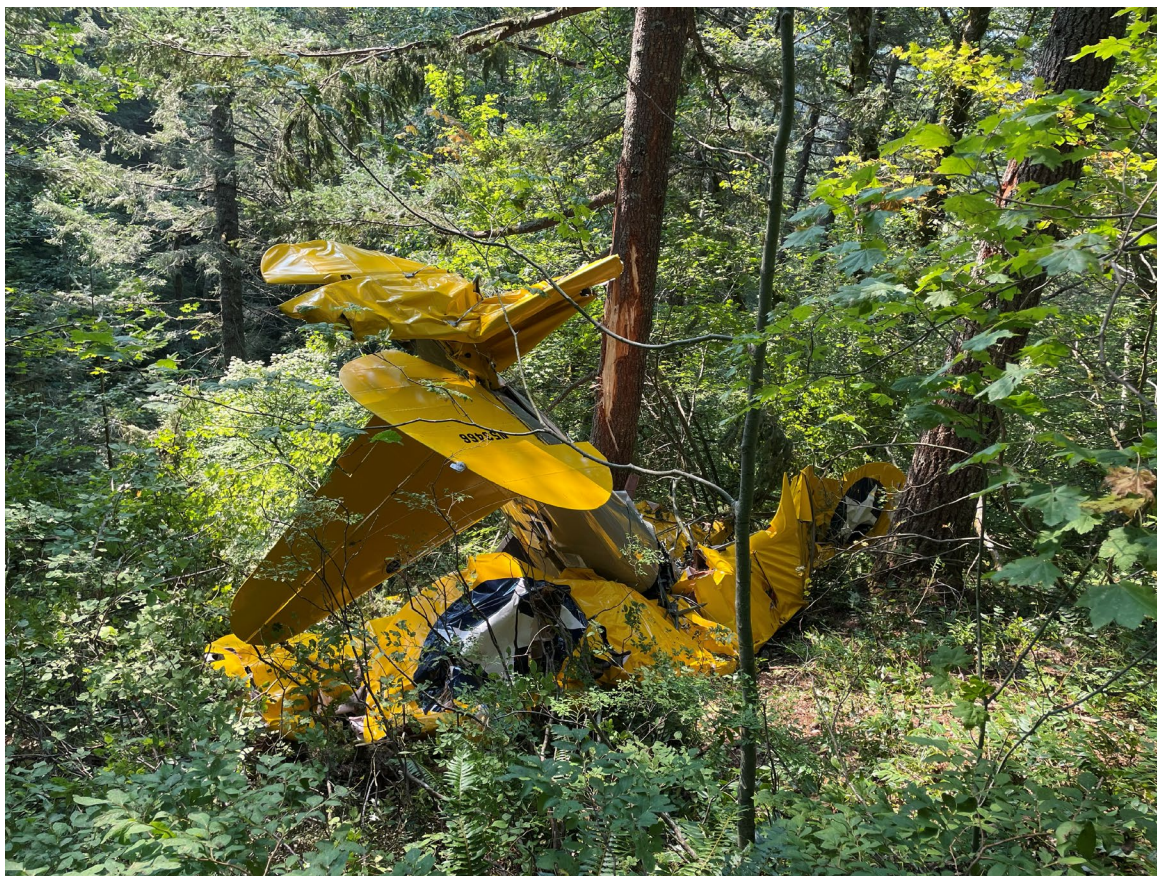
**Photograph 1 - Main wreckage at accident site.**

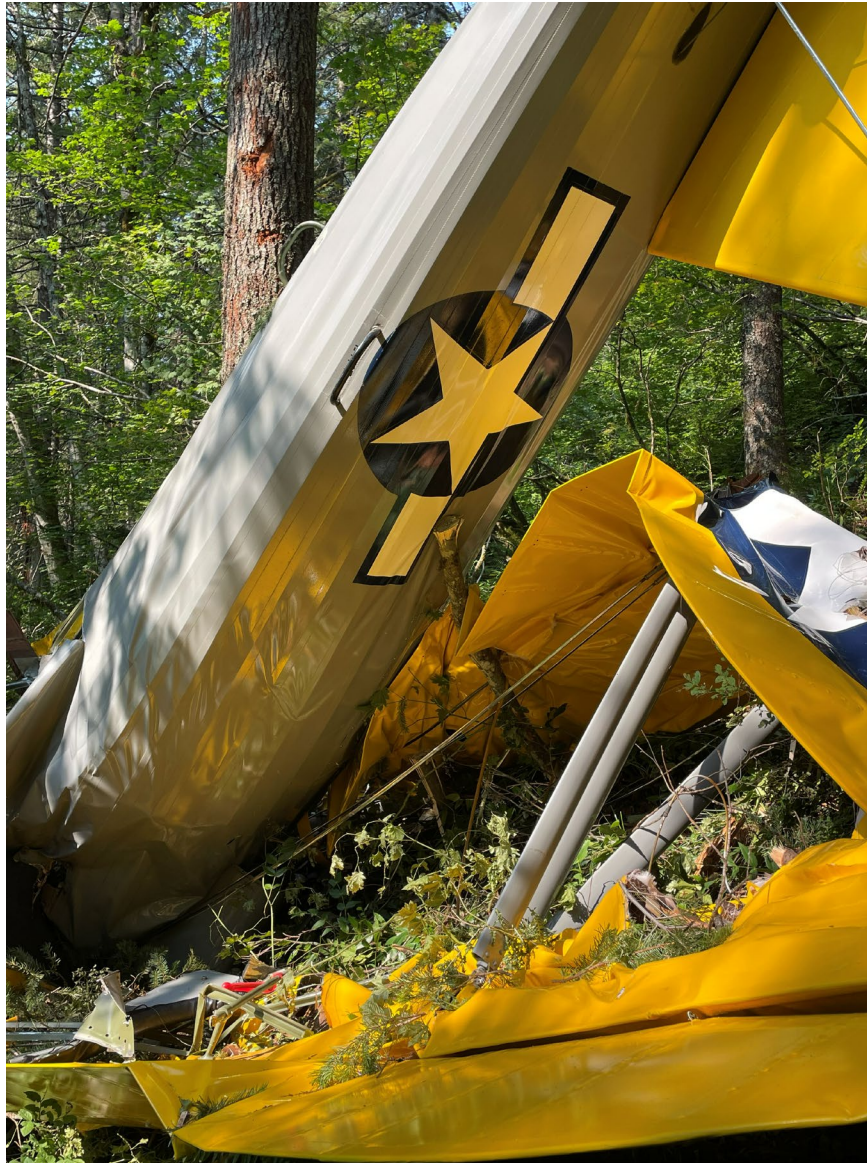
**Photograph 2 - Main wreckage at accident site.**

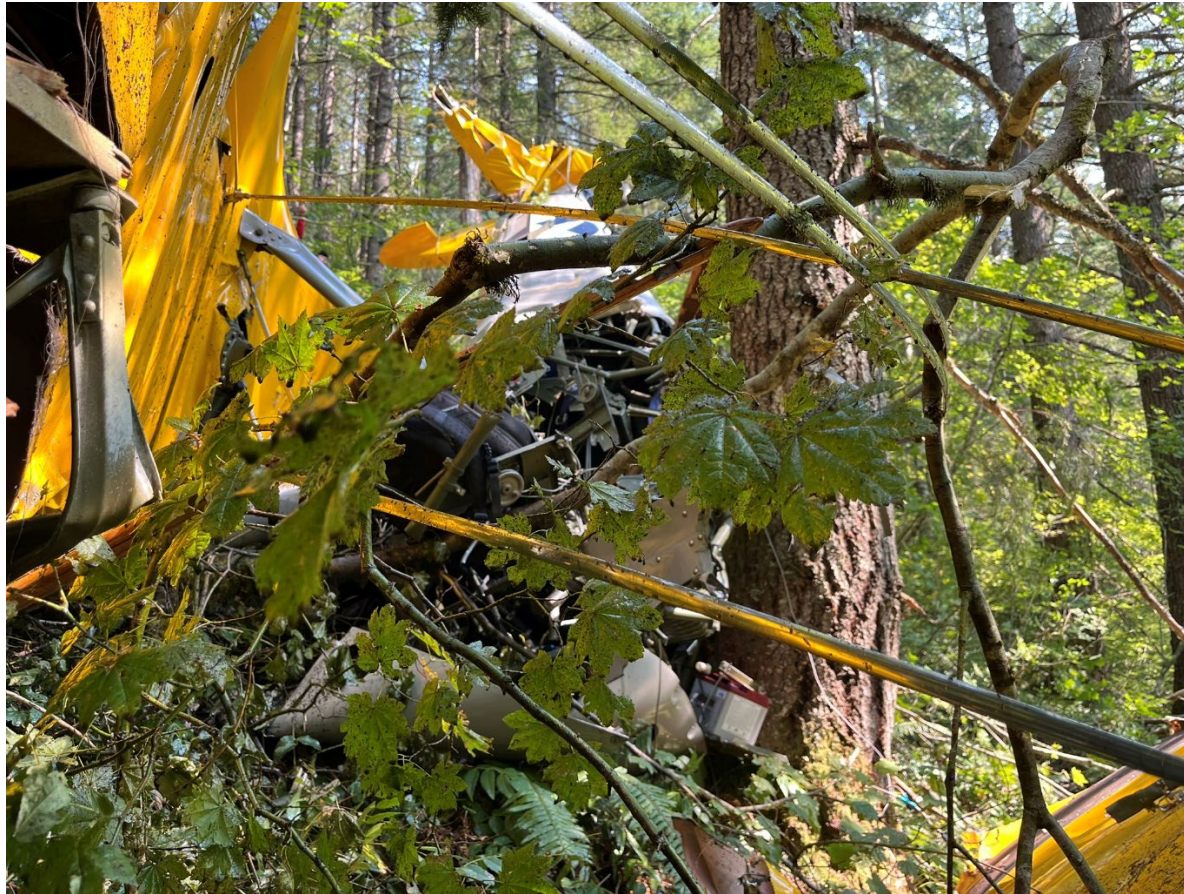
**Photograph 3 - Main wreckage at accident site. (Courtesy of FAA)**

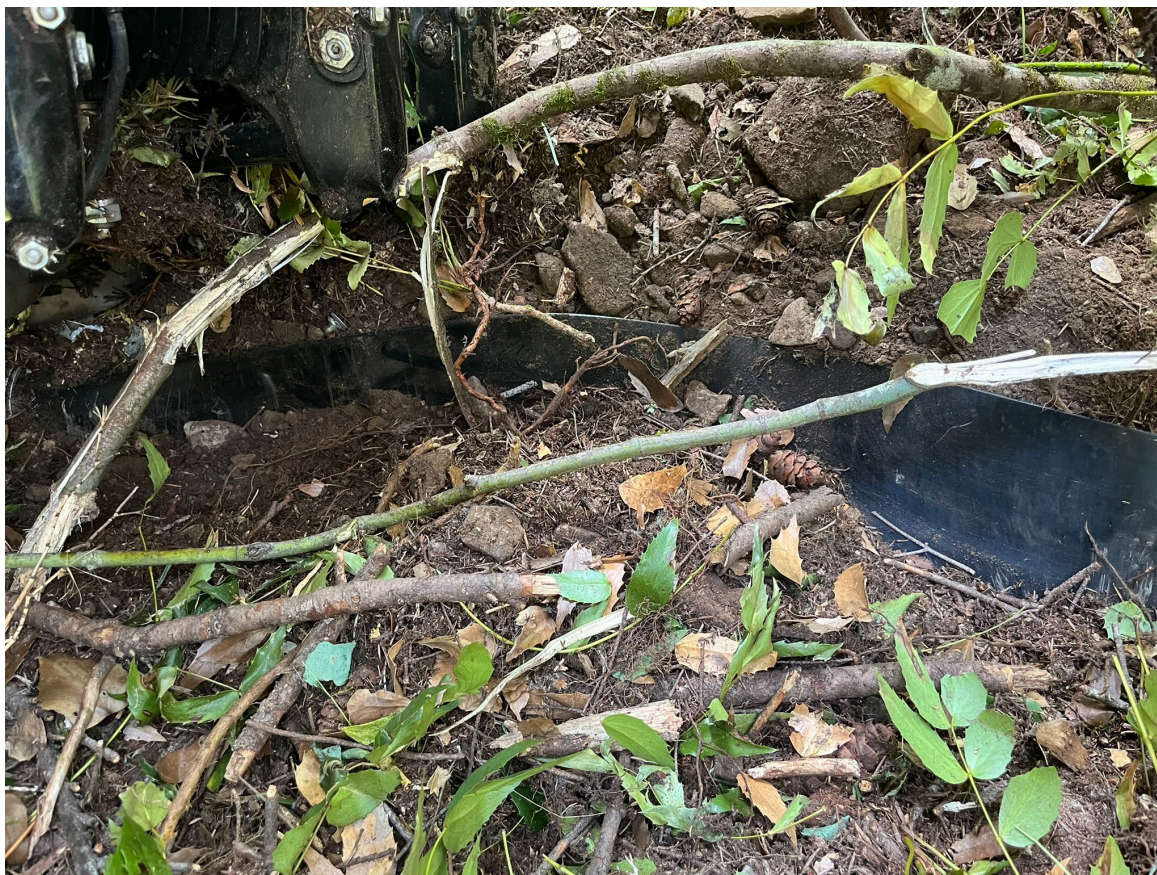
**Photograph 4 - Propeller blade partially dug out at accident site. (Courtesy of FAA)**
