National Transportation Safety Board

WPR24FA304

**INVESTIGATIVE SUPPLEMENTAL MATERIAL**

Location: Minden, Nevada  
Date: September 16, 2024  
Time: 0946 Pacific daylight time  
Airplanes: Cessna 206 and Globe Swift GC-18

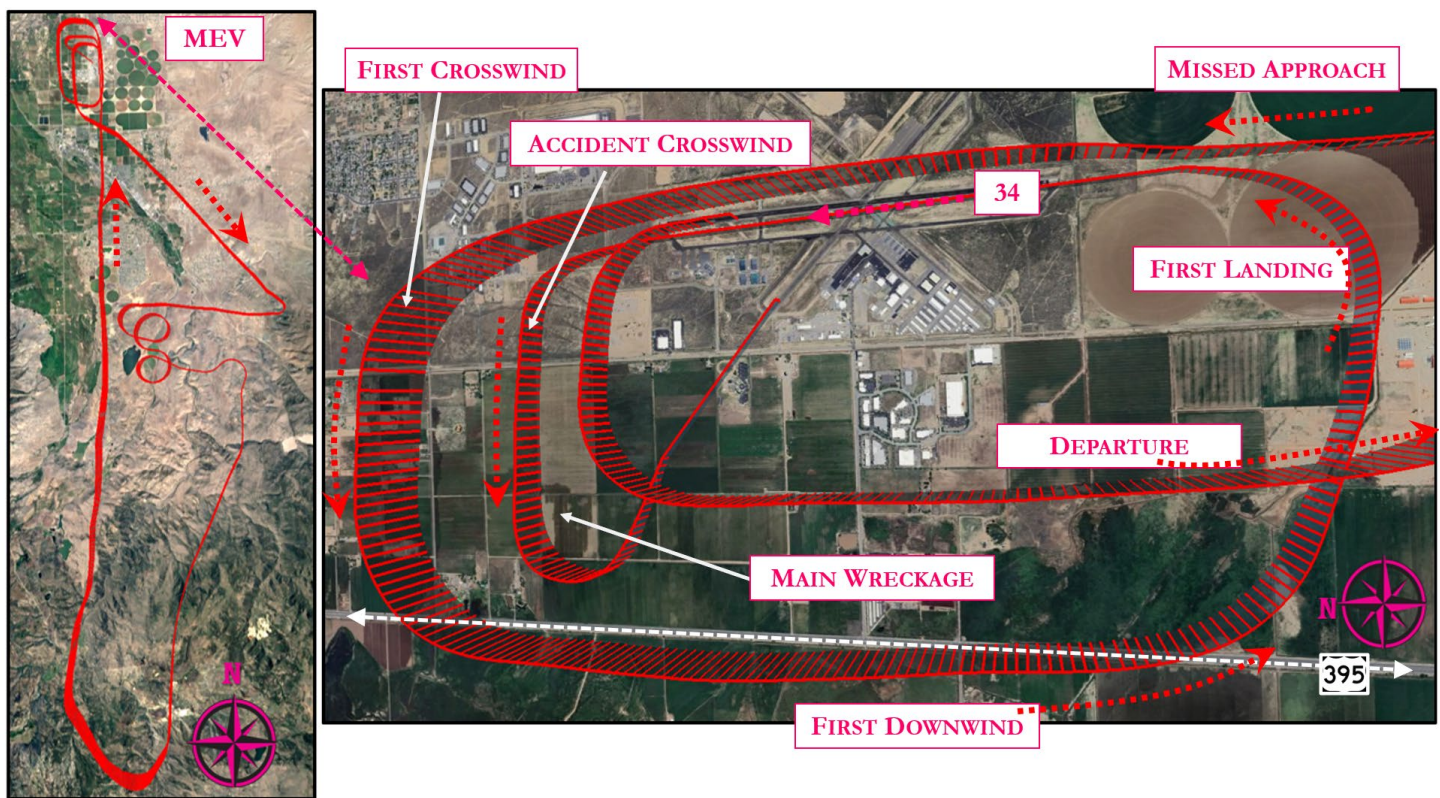
The Cessna was equipped with a Garmin G1000 system that recorded trip parameters on an SD card. The recorded data showed that the Cessna departed Minden at 0908. After departure, the airplane maneuvered south of the airport, returned, overflowed runway 34 about 0941 at 5,700 ft msl, and entered the traffic pattern. The airplane completed the touch-and-go at 0945:20 and turned crosswind about 0.4 nautical mile north of the approach end of runway 16 at 0946:25, at an altitude of 5,225 ft msl. The final recorded Cessna data point was at 09:46:42, about 11 seconds before the presumed impact time. At that time, the airplane was about 5,339 ft msl, 97 knots indicated airspeed, 104 knots groundspeed, 107 knots true airspeed, on a heading of 251°, and on a ground track of 255°.

Figure 1: Flight path of the Cessna

The Cessna's Garmin G1000 data showed the airplane's position, altitude, airspeed, groundspeed, heading, and track during the accident flight. The final recorded point was at 09:46:42. The airplane was about 11 seconds before the presumed impact time, at 5,339 ft msl, 97 knots indicated airspeed, 104 knots groundspeed, 107 knots true airspeed, heading 251°, and track 255°.

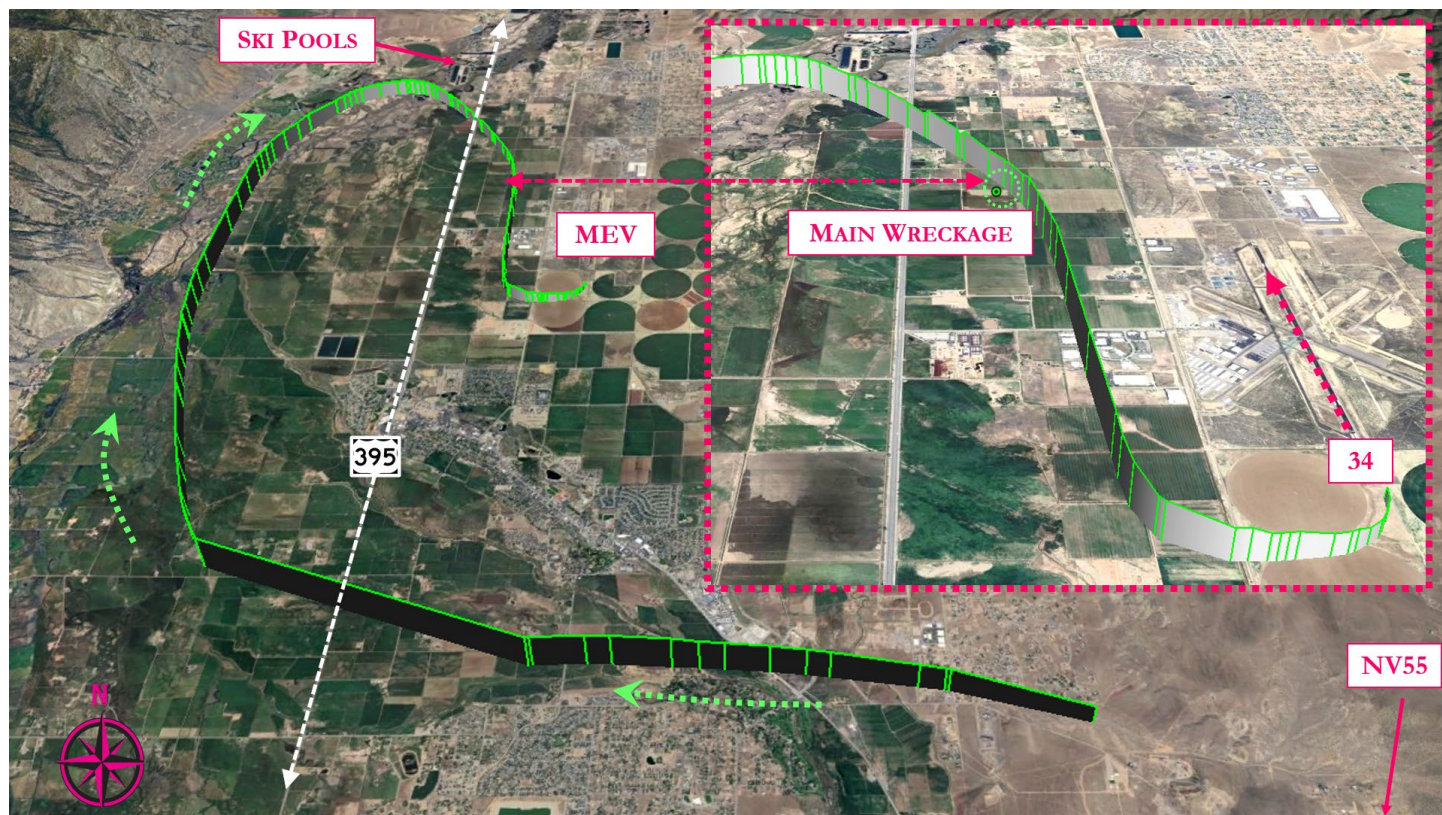
The Swift was not equipped with ADS-B, and no accident-flight radar data were available at the time of this report. The Swift pilot often flew the friend's GC-1B Swift, which was equipped with ADS-B. Investigators reviewed prior ADS-B flight tracks from that airplane, including a July 20, 2024 flight from NV55 to KMEV. The friend confirmed that the July 20, 2024 flight represented the pilot's normal arrival pattern to runway 34. The prior tracks showed a route from the NV55 area toward the mountain range west of the valley, followed by a southeast bound intercept toward the left downwind for runway 34.

Figure 2: Presumed flight path of the Swift (from June 20th flight)

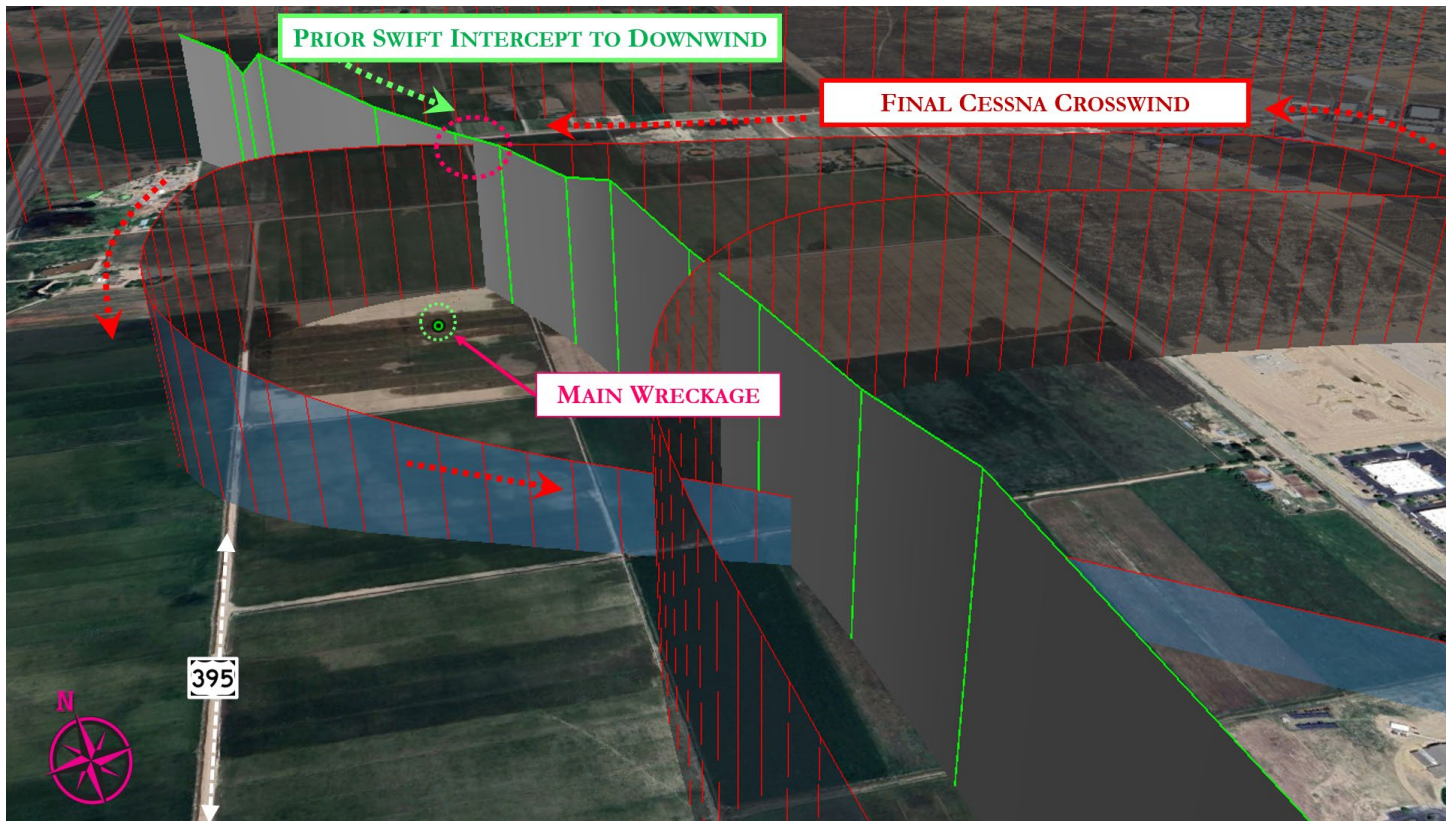
Figure 3: Flight paths showing presumed collision point in reference to the main wreckage

Just prior to the impact, the Cessna's recorded heading was about 251°, and its final recorded ground track was about 255°. The prior Swift track and video evidence were consistent with the Swift approaching from the northwest/west on a southeastbound 45° intercept toward the left downwind leg for runway 34. The July 20 prior Swift track segment near the probable intercept area showed a southeastbound course of about 145° to 170°. The tailwheel-to-engine contact was consistent with the Cessna climbing into the Swift from below and aft.

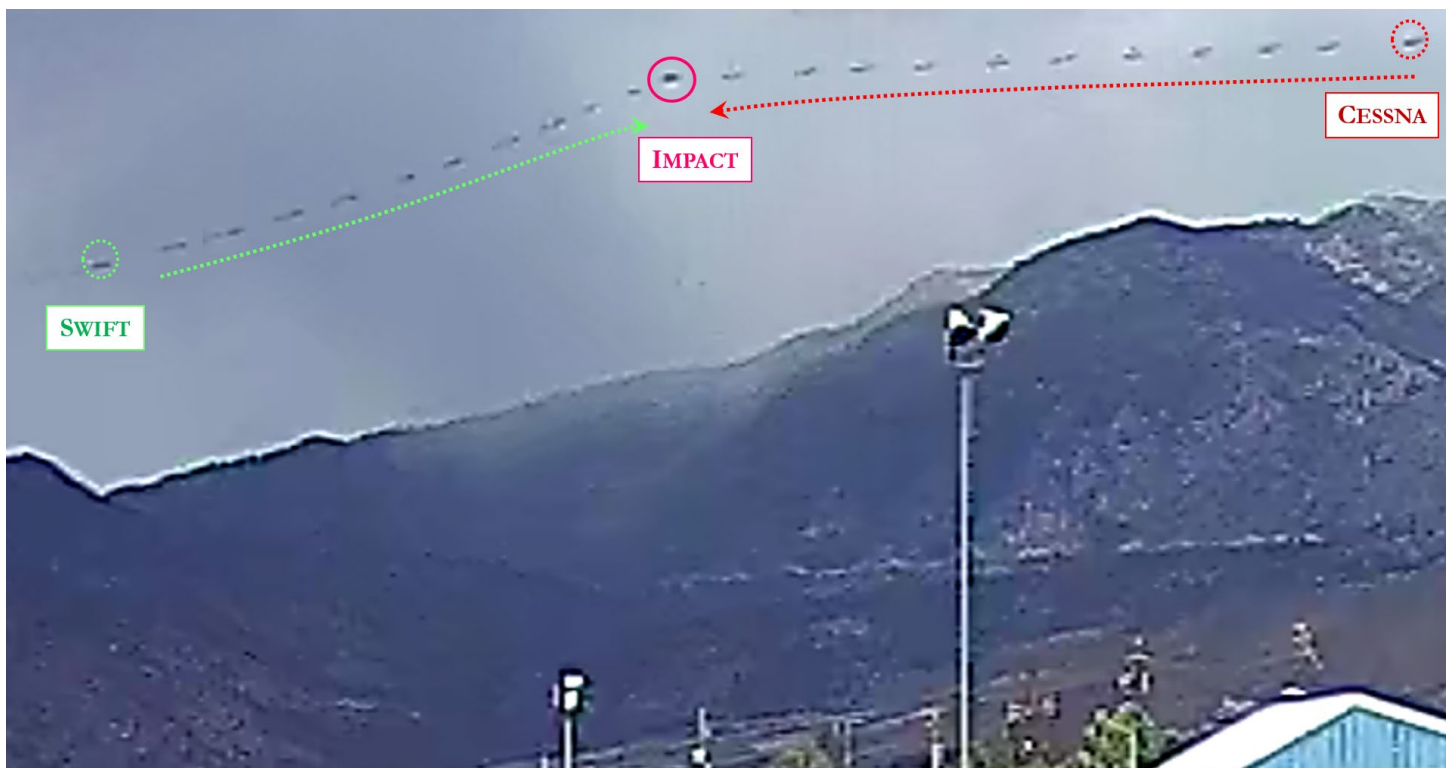
Numerous cameras captured low-quality footage of the airplanes' movements before and after the collision. An airport security camera showed the Cessna on crosswind in a gradual climb and the Swift arriving from the Jack's Valley area northwest of KMEV. A dashcam video from a vehicle traveling on US-395 showed the Swift crossing from west of the highway toward the east at a slightly higher altitude than the Cessna immediately before impact. The Swift was then observed to erupt in flames and descend toward the field below. The videos were not of sufficient quality to determine whether the Swift made an evasive maneuver before impact or whether either airplane had navigation or strobe lights operating.

Figure 4: Video footage showing impact

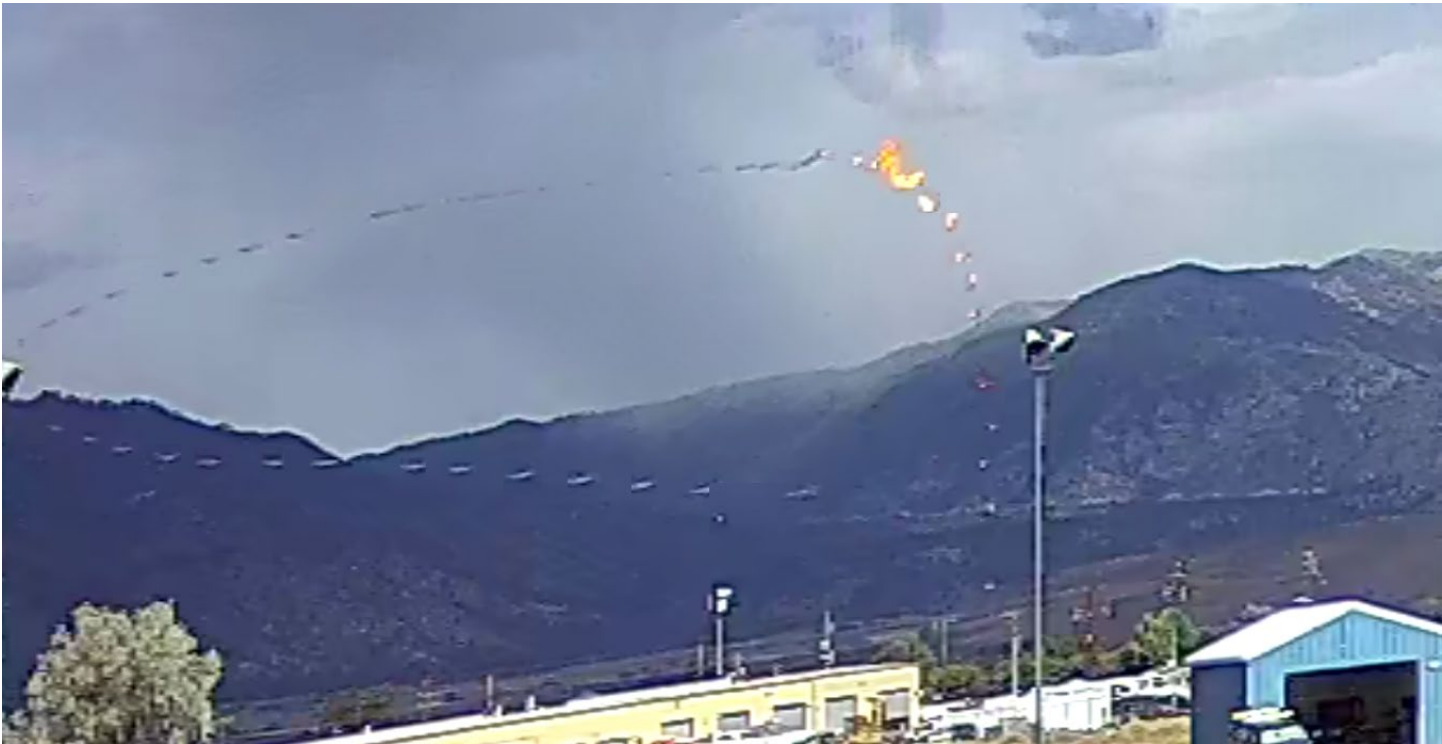
Figure 5: Video footage showing after impact

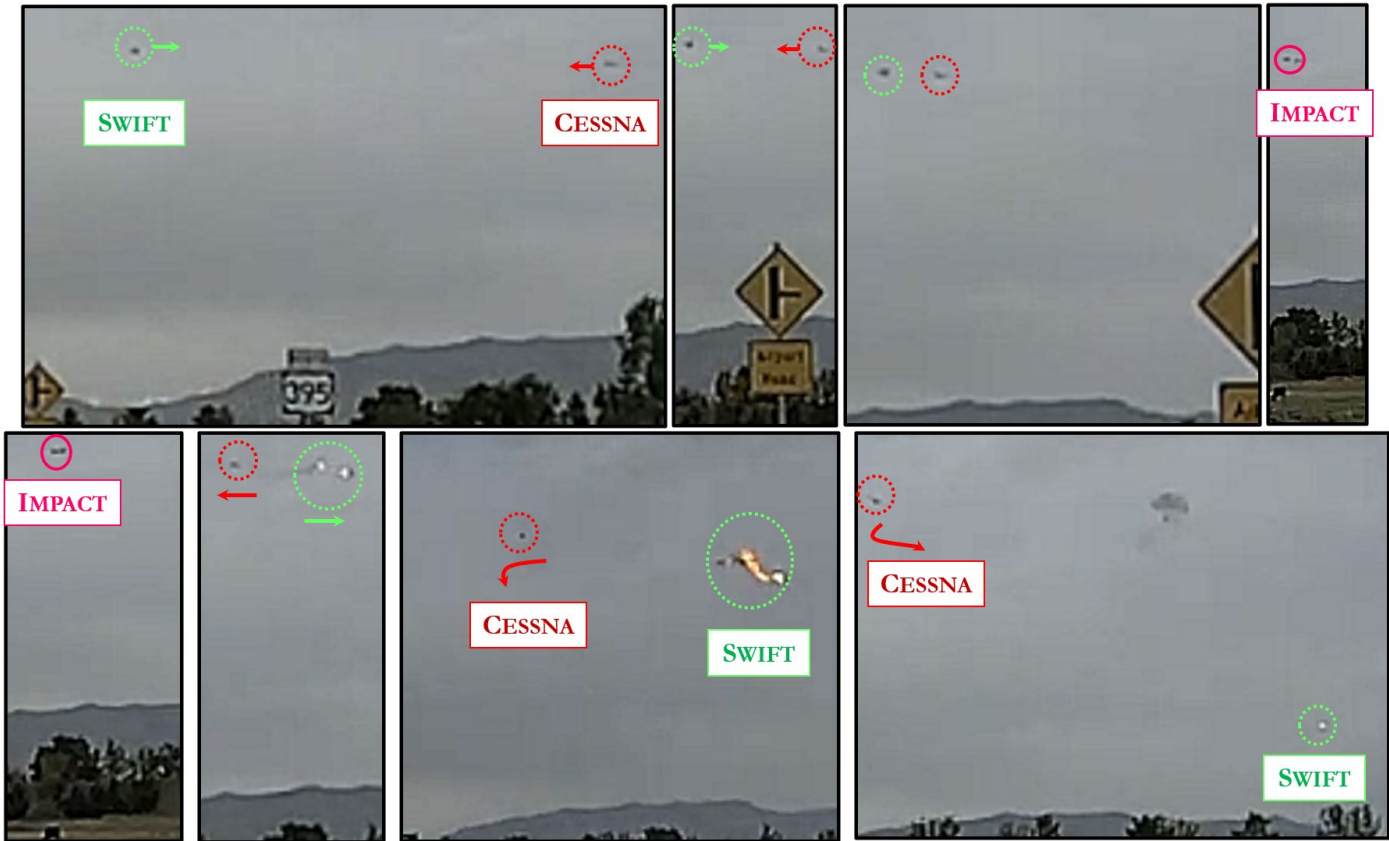
Figure 6: Video footage showing impact

The dashcam video showed the Swift slightly above the Cessna immediately before impact. The contact relationship was consistent with damage to the Cessna propeller, engine mount, firewall, and cowlings, and with separation and fragmentation of the Swift's aft lower tail section. The available evidence did not permit a precise vertical convergence angle to be calculated.

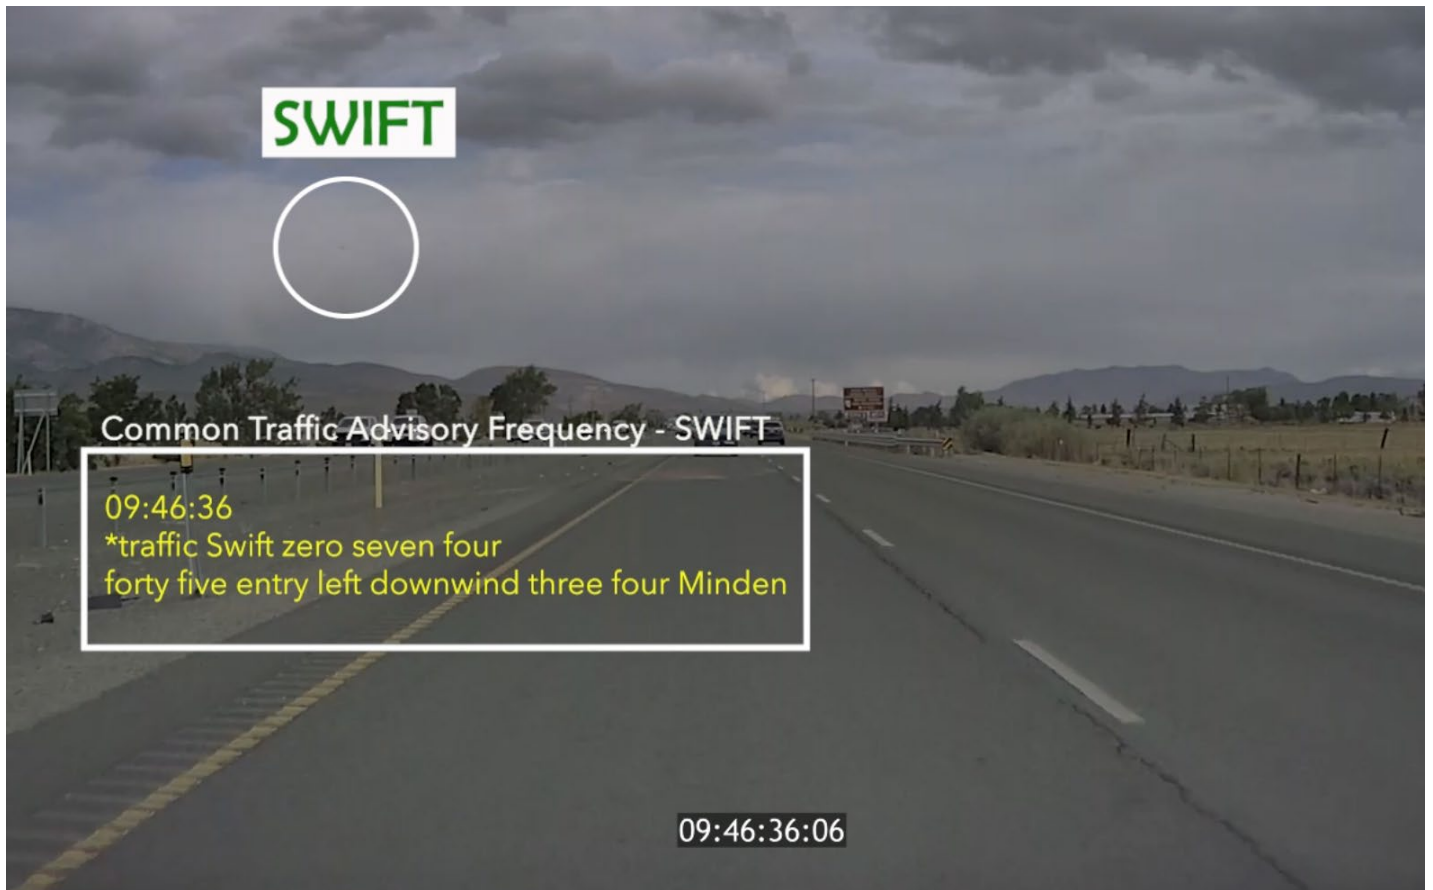
The KMEV Common Traffic Advisory Frequency was recorded. At 09:35:53, the Cessna pilot transmitted that the airplane was 10 miles from the airport and that the crew intended to perform a touch-and-go landing. At 09:40:56, the Cessna pilot reported overflying the airport and entering the left downwind for runway 34. The pilot subsequently reported being on the left downwind, left base, and final approach for runway 34. At 09:44:14, the Cessna pilot reported final for runway 34. At 09:46:36, the Swift pilot reported being on a 45° intercept to the downwind for runway 34. At 09:46:46, the Cessna pilot transmitted that the airplane was on “crosswind to left...” The collision was presumed to have occurred during or shortly after that transmission, with an impact time of about 09:46:53.

Figure 7: Video footage showing where the last Swift traffic call was made

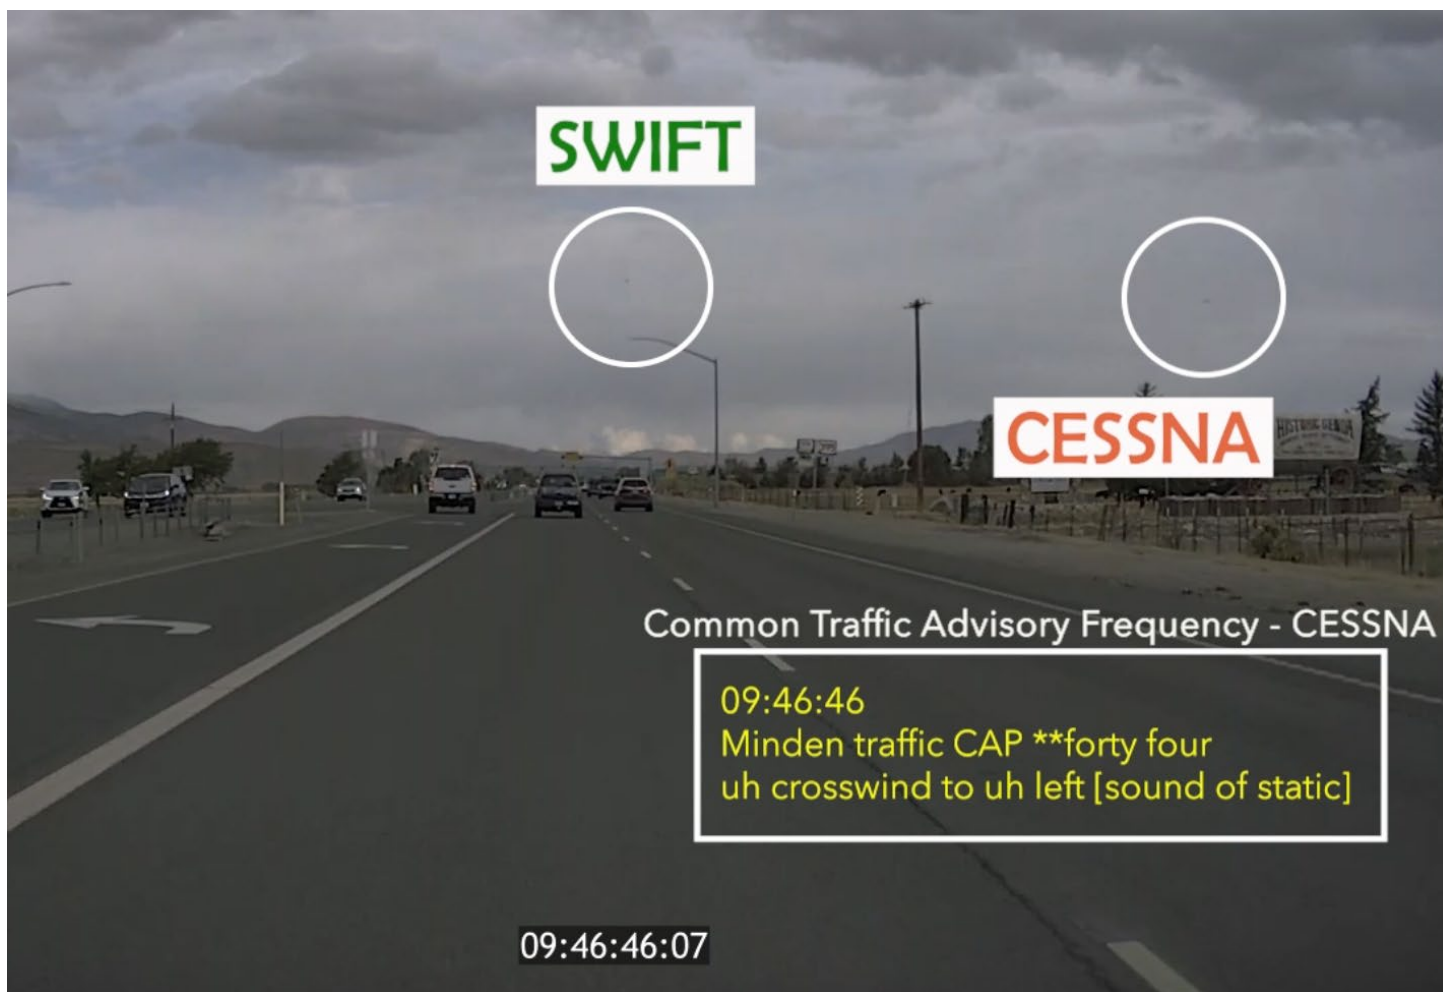
Figure 8: Video footage showing where the last Cessna traffic call was made

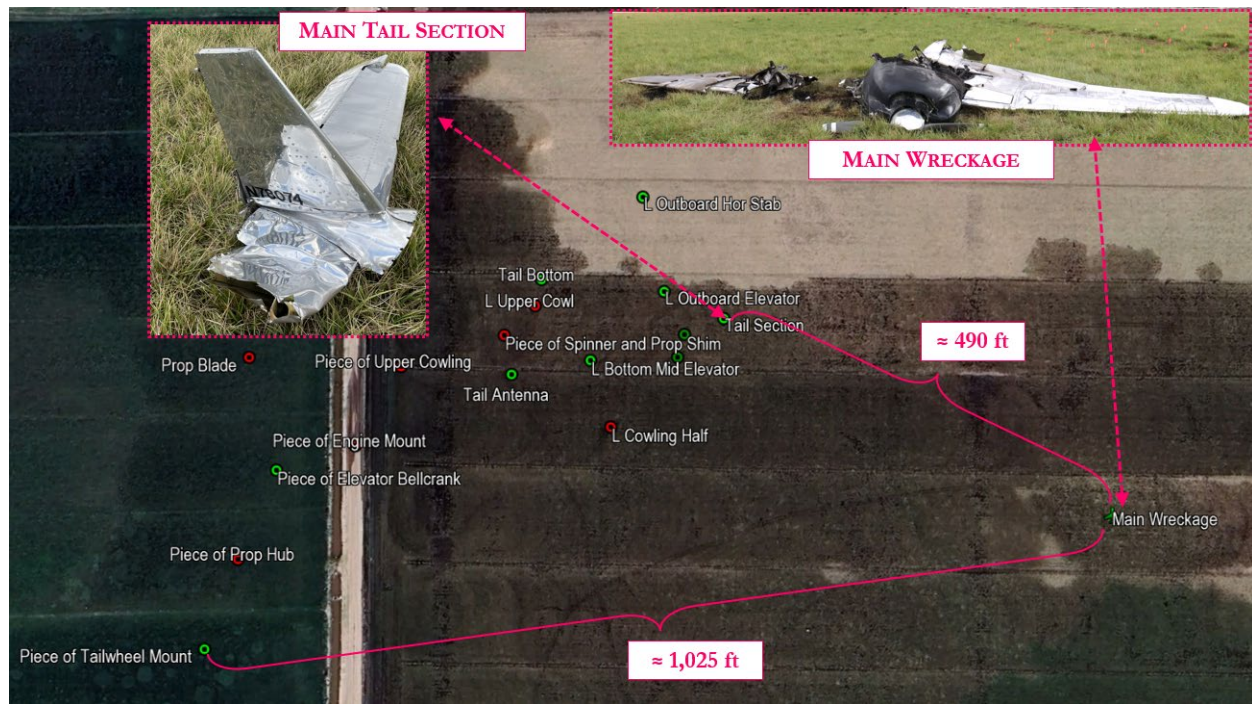
The main wreckage of the Swift was located about 1 nautical mile from the approach end of runway 16. The main wreckage came to rest on a heading of 290°. The wreckage had sustained significant fire damage, primarily to the cockpit and inboard wings where the fuel tanks were located. The Swift main landing gear was found in the retracted position. The remaining wing and fuselage skin did not show evidence of broad impact damage from the collision with the Cessna. The Swift propeller remained attached to the engine and was undamaged.

Figure 9: Debris field

The Swift main tail section was located about 450 ft from the main wreckage. The tail section was missing the bottom tail cone, the outboard right elevator, horizontal stabilizer, and rudder, all of which were found nearby in the debris field. The debris field extended about 1,025 ft and contained intermingled components from both airplanes. Numerous Swift skin fragments were scattered throughout the debris field, with most of those fragments originating from the lower tail section. Several debris items were coated with red hydraulic oil from the Cessna propeller hub.

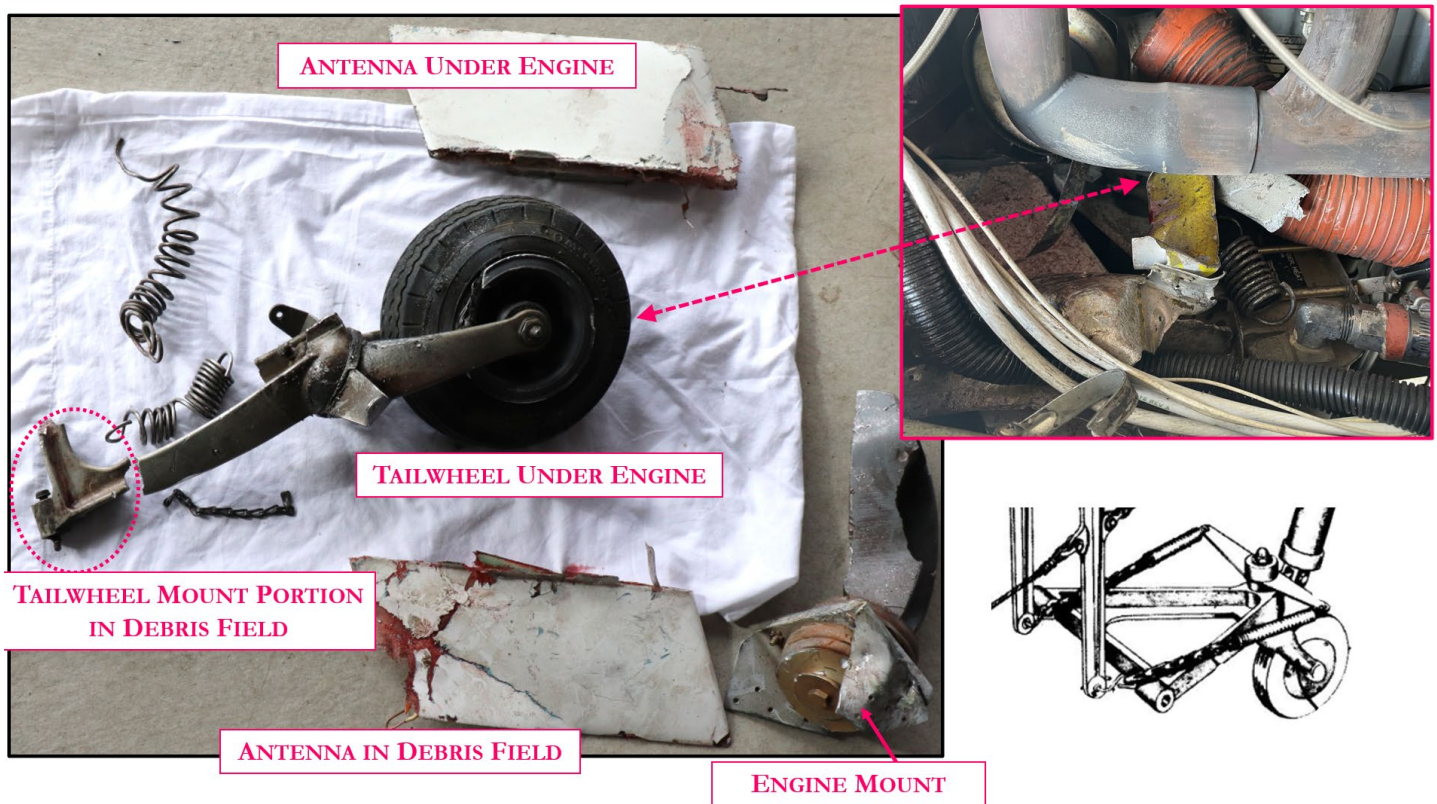
The Cessna sustained damage to the forward engine, propeller, cowling, firewall, and engine mount areas. One Cessna propeller blade separated from the hub. The main portion of the separated propeller blade was found in the debris field, and an 8-inch blade tip section was lodged in the firewall area. The Cessna engine was canted to the right due to fractured mounts. The Swift tailwheel and portions of its mounting structure were lodged entirely underneath the Cessna engine and were not visible until the engine was moved. The Cessna front-right engine mount had separated from the airframe and was found near the Swift tailwheel, having punctured the tunnel.

Figure 10: Impact damage of Swift tailwheel in the Cessna's engine compartment

The physical contact evidence were consistent with the Cessna's forward engine/propeller area contacting the lower aft fuselage and tailwheel area of the Swift. The Swift's aft lower fuselage/tailwheel structure was located beneath the Cessna's engine, and damage to the Cessna propeller, engine mount, firewall area, and cowling was concentrated

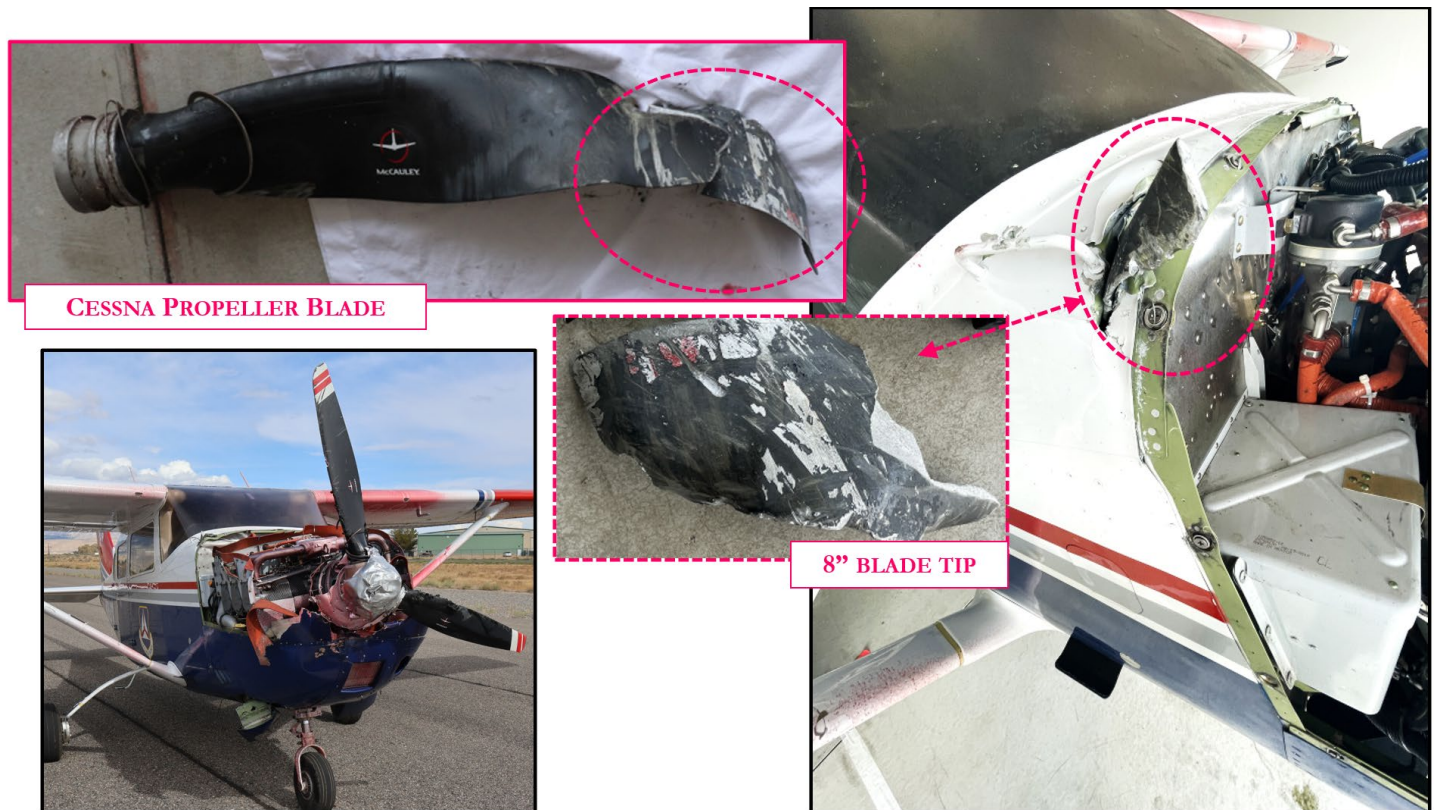
Figure 11: Impact damage showing Cessna propeller

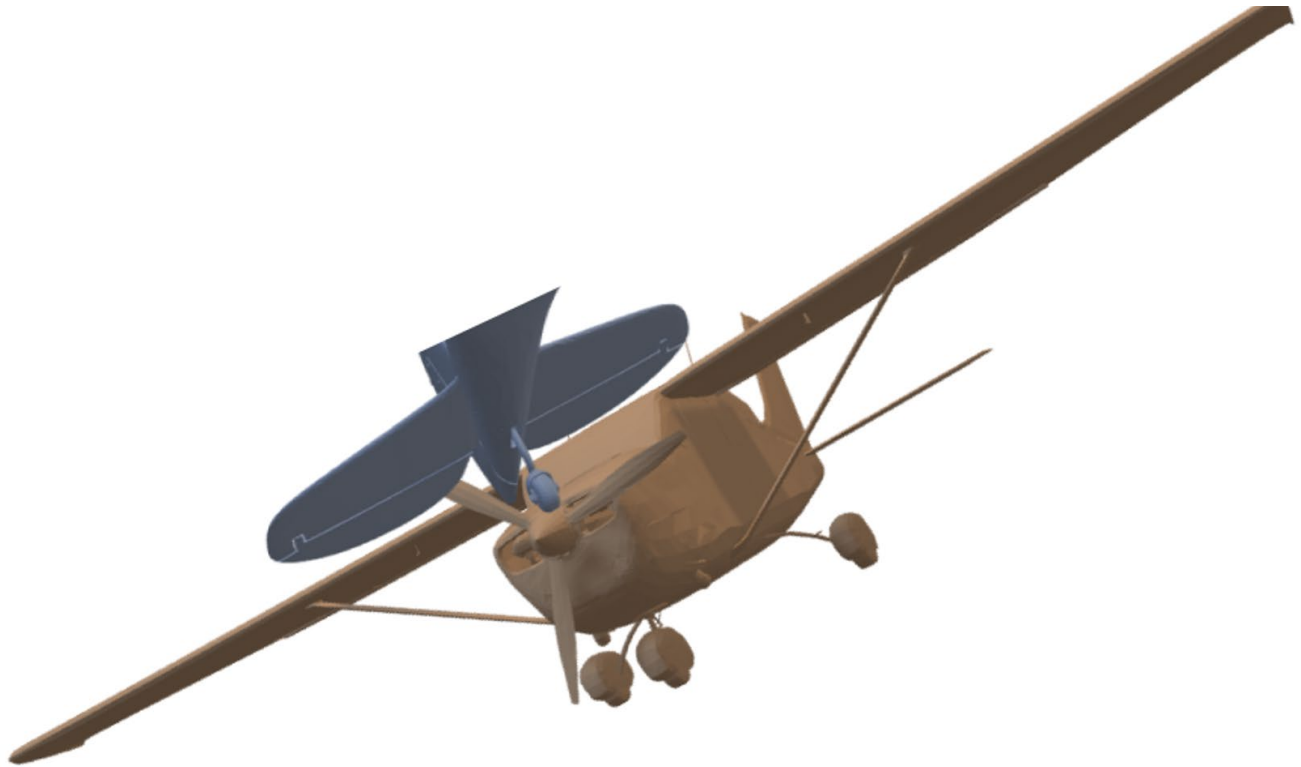
The physical evidence placed the Cessna behind and below the Swift and placed the Swift ahead and slightly above the Cessna. This relative position would have placed the Cessna in or near the Swift pilot's aft blind area. The available evidence did not establish that the Swift pilot had an effective opportunity to visually acquire the Cessna before impact.

Figure 12: 3D models showing probable impact angle

For the Cessna pilots, the Swift would have been ahead and slightly above the airplane during the final seconds. The Cessna was climbing after takeoff, and the Swift likely presented limited relative motion during the closing sequence. The evidence was consistent with neither pilot effectively acquiring the other airplane in time to avoid the collision.
