# National Transportation Safety Board

WPR24FA309

## **WRECKAGE EXAMINATION REPORT**

Location: Lancaster, California  
Date: September 22, 2024  
Time: 1248 Pacific Daylight Time  
Airplane: Nanchang CJ-6A, Registration N313YK; Yakovlev Yak 52 N5287

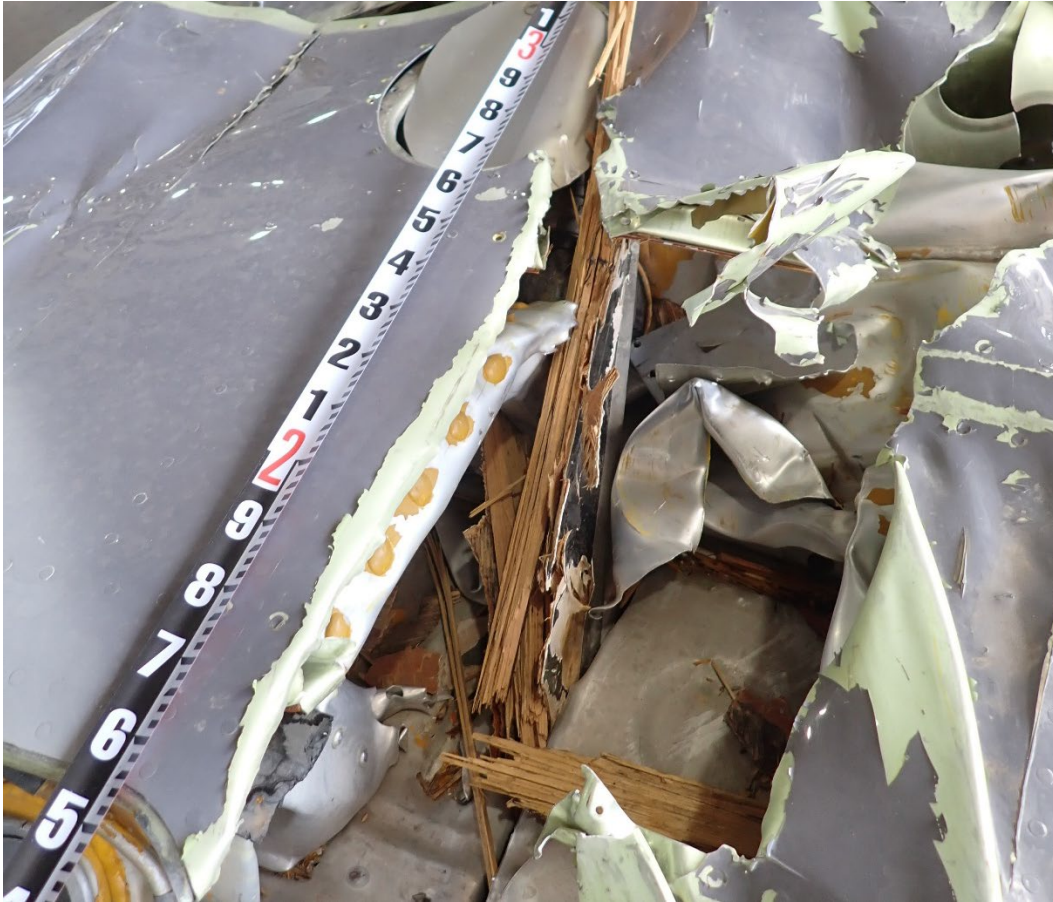
The CJ6 displayed multiple paint transfer signatures, score marks, tears, gouges, and separations. The left wing contained a 3 foot long tear abut midspan with a section of wooden propeller with wood fragmentation inside the wing. Yellow paint transfer marks and light gray or white scuffing was observed aft of the tear. The scuffing was oriented about 25° to the right of the longitudinal axis of the airplane. White/light grey scuffing was also observed on the outboard top skin of the left horizontal stabilizer oriented 47° to the right of the longitudinal axis. The leading edge of the left horizontal stabilizer exhibited a chordwise tear and was deformed from midspan to the stabilizer tip, with an impression and paint deterioration at the leading edge of the horizontal stabilizer tip. Additional light grey striated marks were observed on the top skin of the aft fuselage oriented 25° to the right of the longitudinal axis of the airplane. The lower leading edge of the vertical stabilizer was crushed.

**Figure 1: N313YK left wing with propeller fragments**

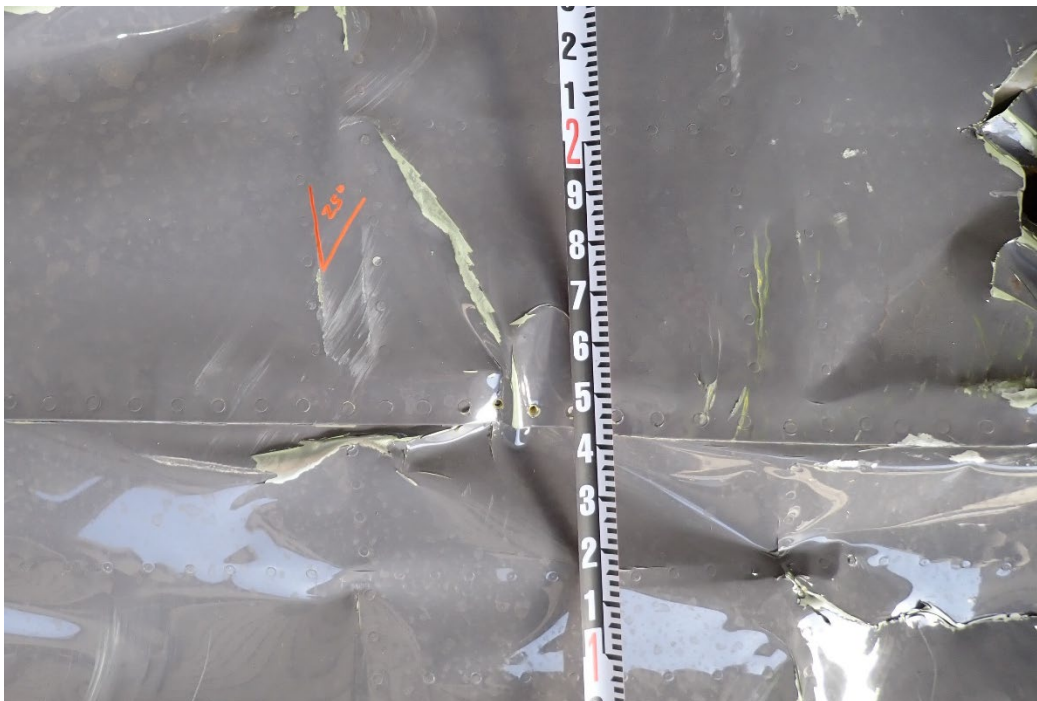
**Figure 2: Yellow paint transfer marks and white/grey scuffing on left wing of N313YK**

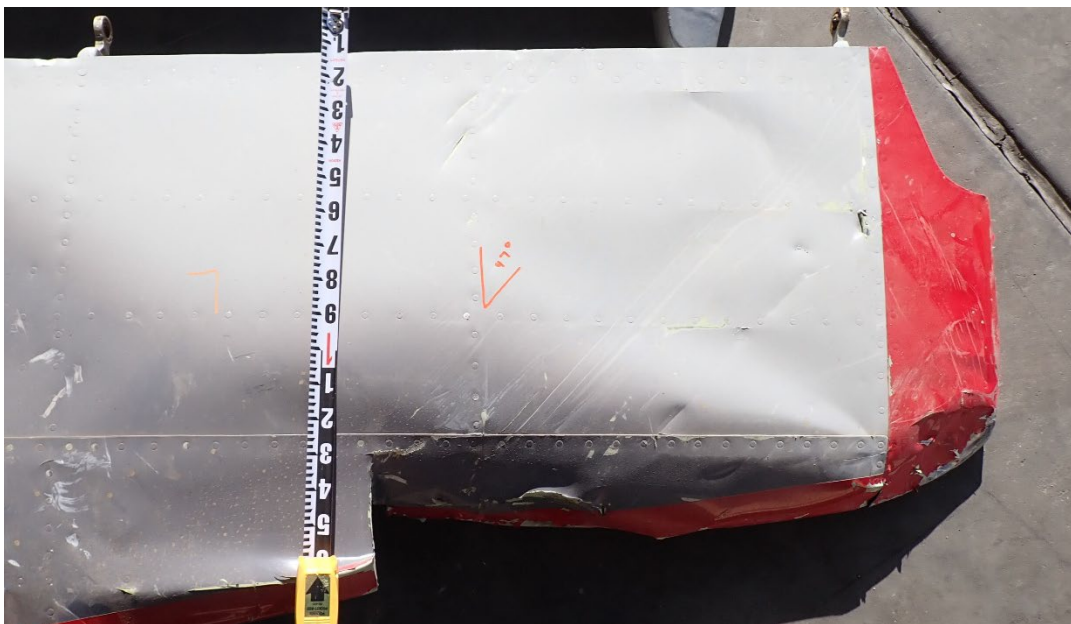
**Figure 3: Left horizontal stabilizer of N313YK**

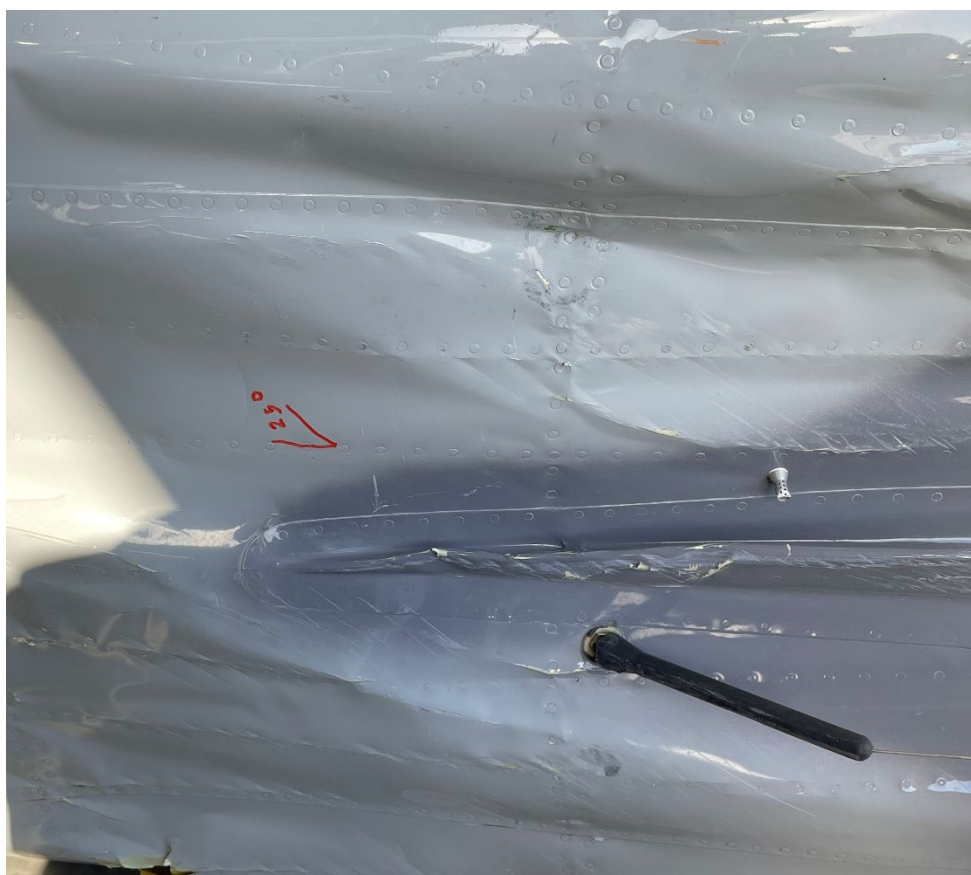
**Figure 4: Top skin of aft fuselage (N313YK)**

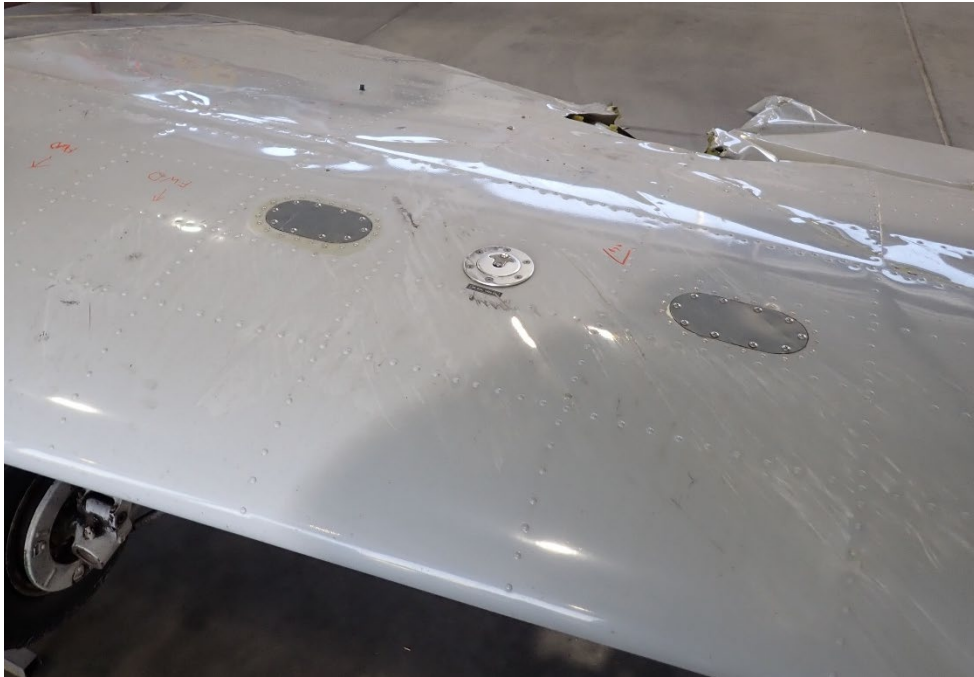
The left wing of the Yak 52 exhibited white/light grey scuffing that was oriented 47° relative to the longitudinal axis of the airplane. An arcing red paint transfer mark that had an approximate diameter of 4 foot 7 inches was observed on the top skin at the inboard left wing. The left side canopy plexiglass at the aft cockpit was broken and a portion of the left side canopy frame was bent. An approximately 1 foot 7 inch long gouge along the chordwise axis of the left wing that terminated with a concaved shaped depression was located about midspan.

**Figure 5: Leading edge top skin left wing of N5287**

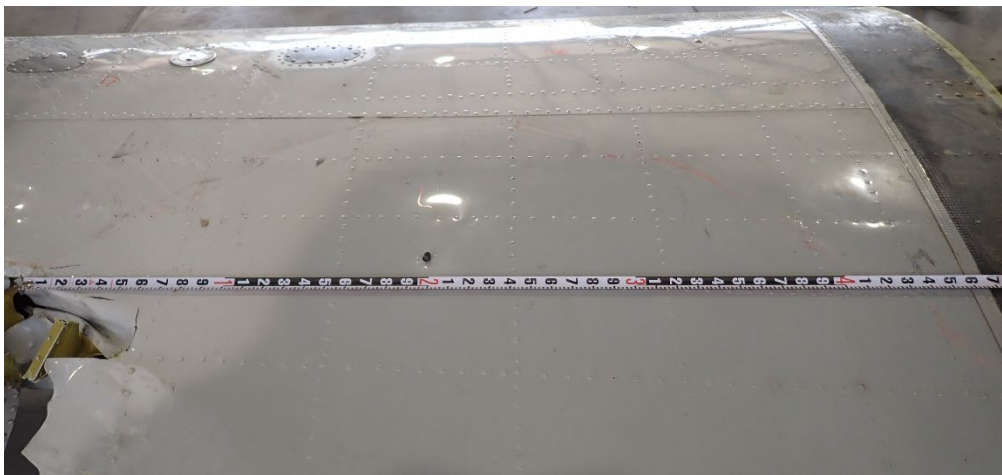
**Figure 6: Inboard top skin of left wing N5287**

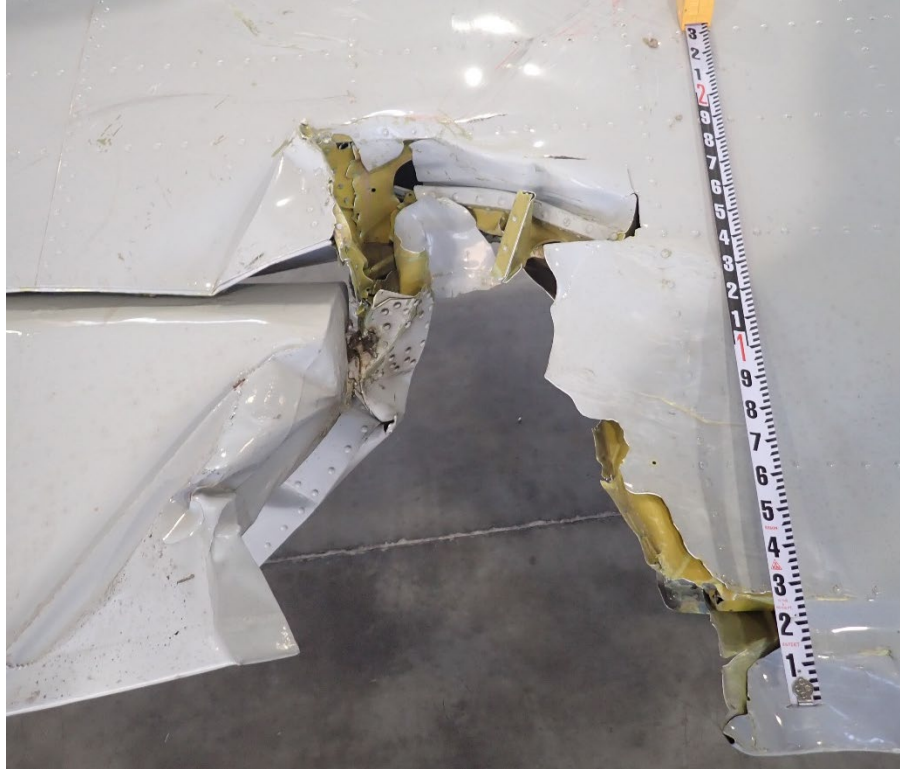
**Figure 7: Left wing midspan trailing edge of N5287**

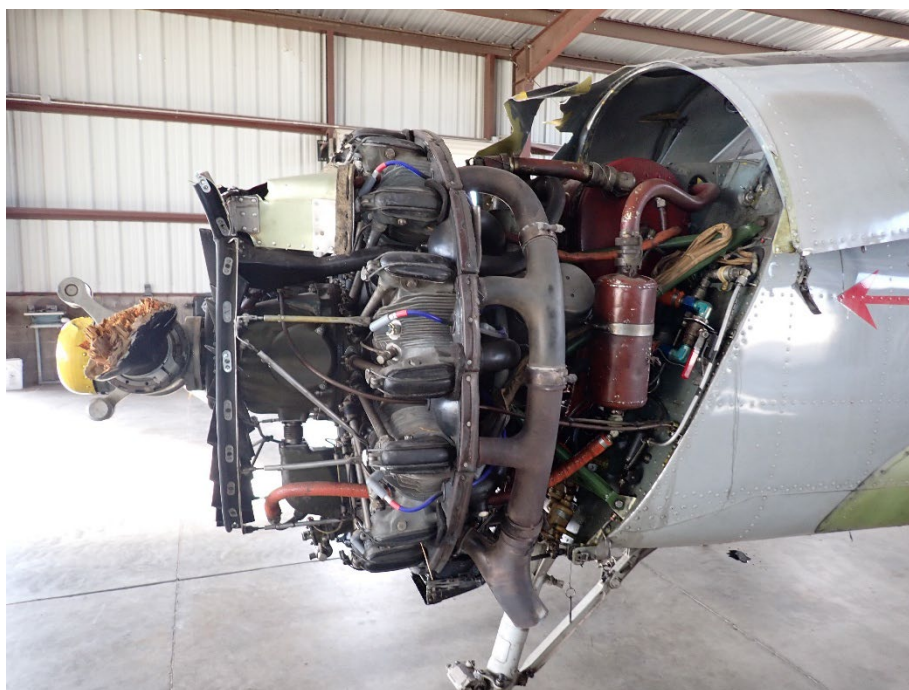
The airplane was equipped with a Vedeneyev, M-14P (s/n K(ya)332064), an air cooled, radial, reciprocating engine. The top cowl louvers were crushed along with the engine cowl above the louvers. The engine accessories were all intact and undamaged.

**Figure 8: M-41P engine installed on Yak-52 prior to examination**

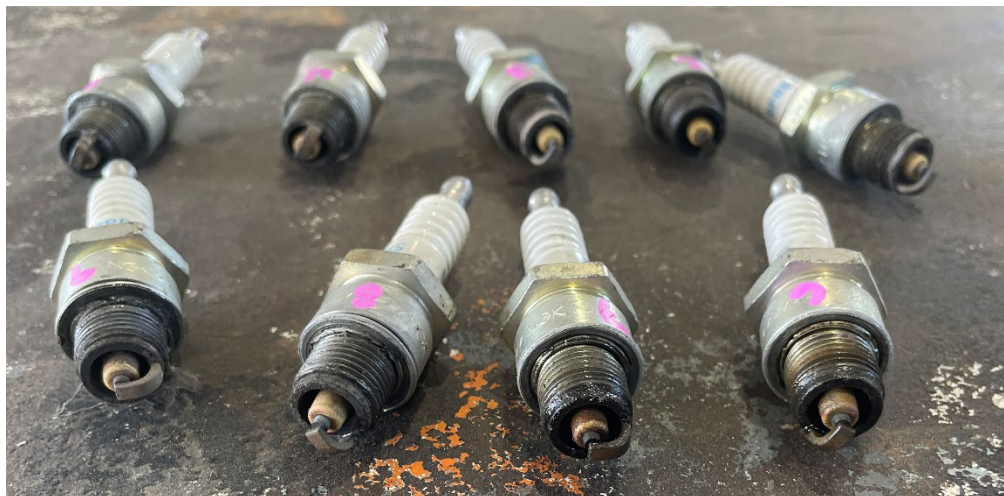
Mechanical continuity of the crankshaft and valvetrain were achieved as the engine was rotated by hand at the propeller. Each of the cylinders displayed normal lift and thumb compression was attained for each of the 9 cylinders as the propeller was rotated. Each of the 9 forward and aft spark plugs remained within their plug ports with their ignition harness leads attached. The forward spark plugs were removed and all exhibited coloration consistent with normal operation. Both the left and right magnetos were secured at their respective mounting pads and both displayed normal spark when rotated using a power drill.

**Figure 9: N5287 forward spark plugs**

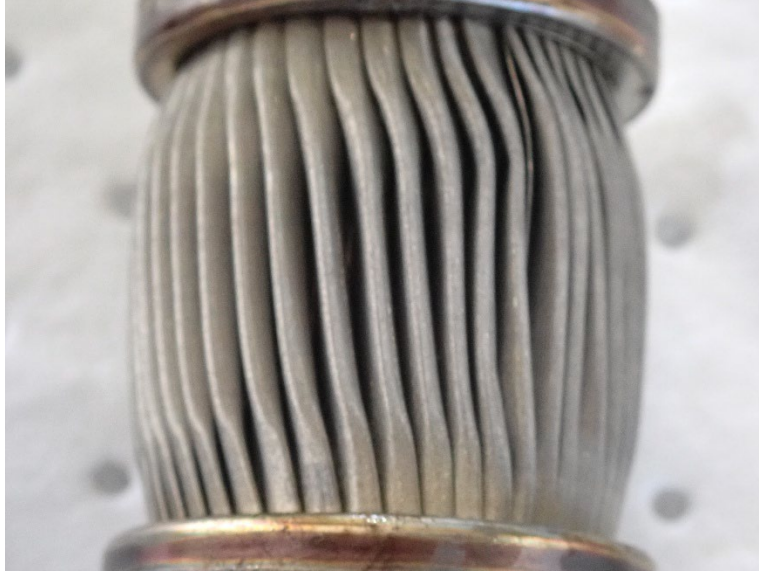
**Figure 10: Metal fine mesh fuel screen from engine (N5287)**

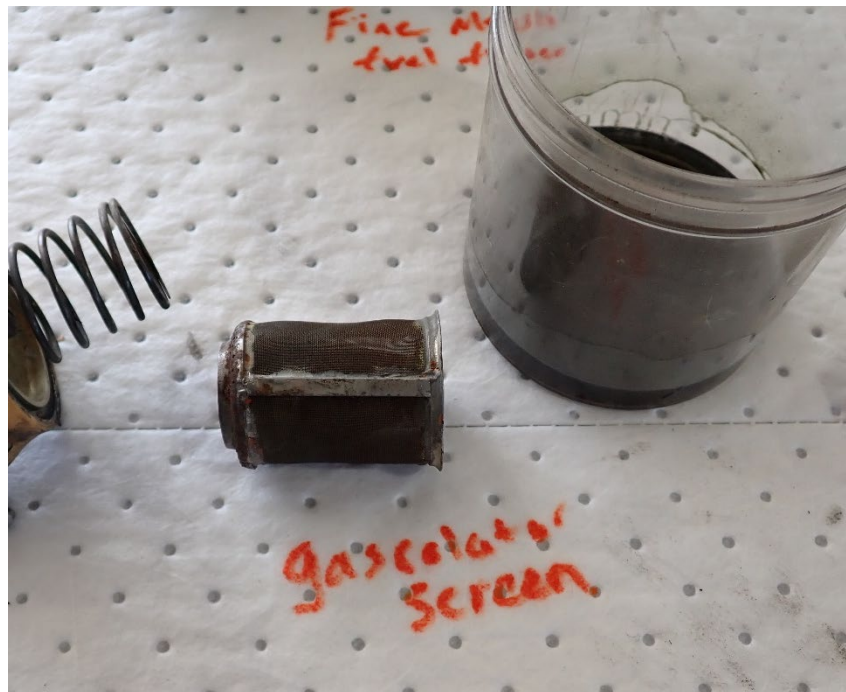
The fuel pump was removed and displayed consistent flow with the inlet line submerged and the drive rotated using a power drill. The carburetor screen was free of debris as was the metal fine fuel screen and the gascolator screen. However, the fuel removed from the gascolator exhibited a dark color and a trace amount of ferrous fragments were observed at the bottom of the sample. The fuel sample exhibited an odor consistent with 100 low lead aviation grade gasoline. The carburetor diaphragm was intact and pliable with no indications of fraying. The butterfly valve articulated freely when the throttle arm was rotated by hand.

**Figure 11: Gascolator screen and fuel sample from engine (N5287)**

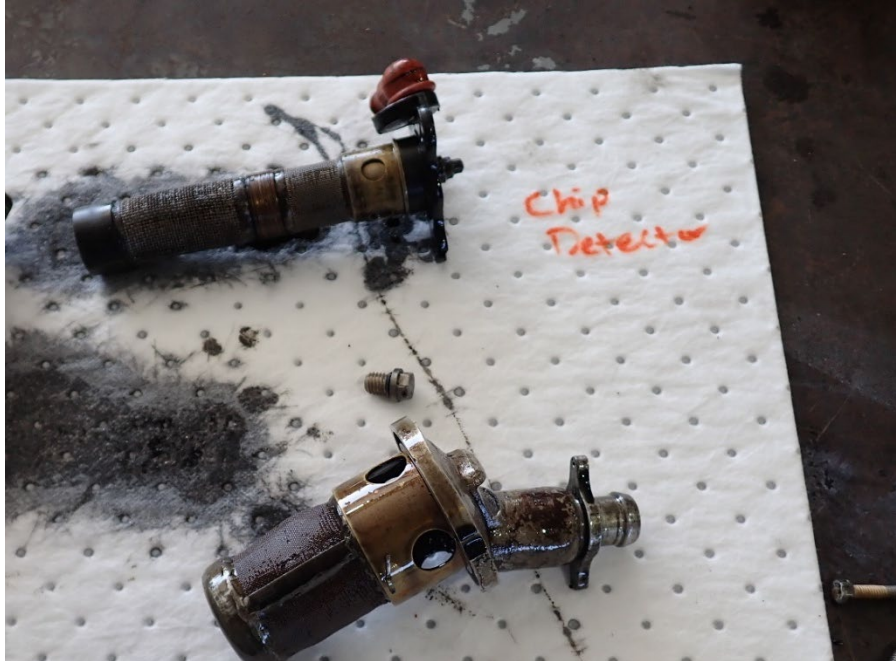
The oil inlet screen and chip detector were free of debris.

**Figure 12: Oil inlet screen and chip detector from engine (N5287)**
