# National Transportation Safety Board

WPR24FA309

## **ONSCENE EXAMINATION REPORT**

Location: Lancaster, California  
Date: September 22, 2024  
Time: 1248 Pacific Daylight Time  
Airplane: Nanchang CJ-6A, Registration N313YK; Yakovlev Yak 52 N5287

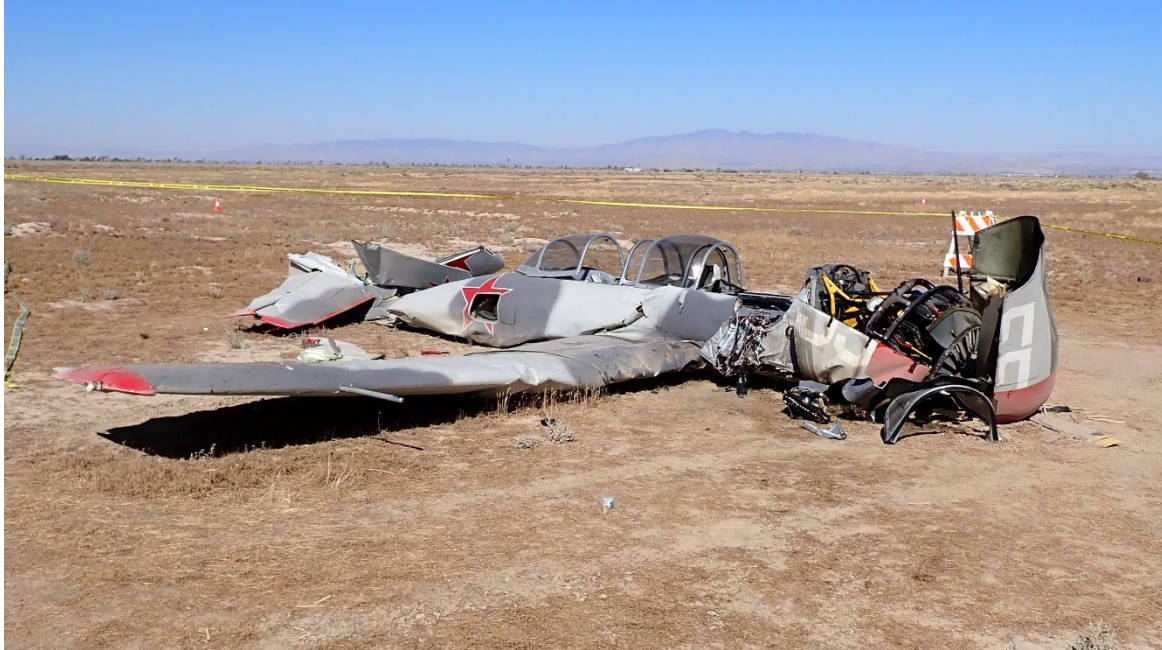
The airplane came to rest upright at a level attitude with the surrounding desert terrain oriented on a northwestern heading at a field elevation of about 2,310 ft mean sea level (msl). Most of the airplane major structures were accounted for at the accident site with exception of the left elevator. The left side antenna from the vertical stabilizer was located about 0.5 nm west of the main wreckage. A ground scar was located beneath the right wing and another ground signature was located under the engine.

**Figure 1: N313YK at accident site**

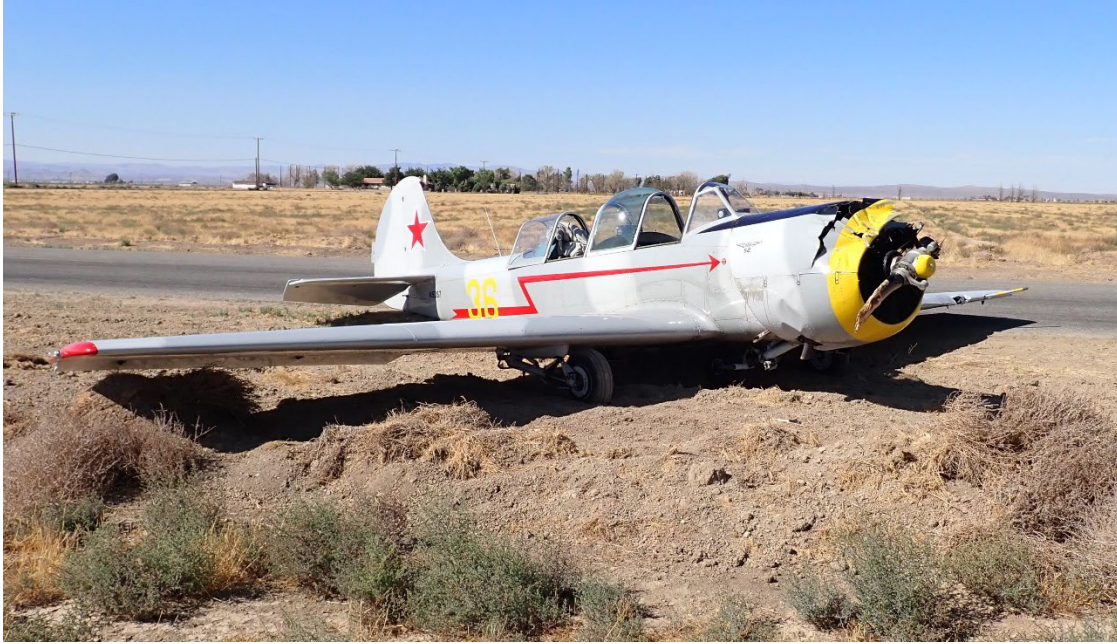
The airplane came to rest upright on the right edge of a road about 1.5 nm southeast of N313YK oriented on a southeast heading at a field elevation of about 2,350 ft msl. All of the major structures were accounted for at the accident site. The airplane was mostly unremarkable with exception to the damage to the trailing edge of the left wing, upper cowling, and both propeller blades which had separated at the blade roots.

**Figure 2: N5287 at accident site**

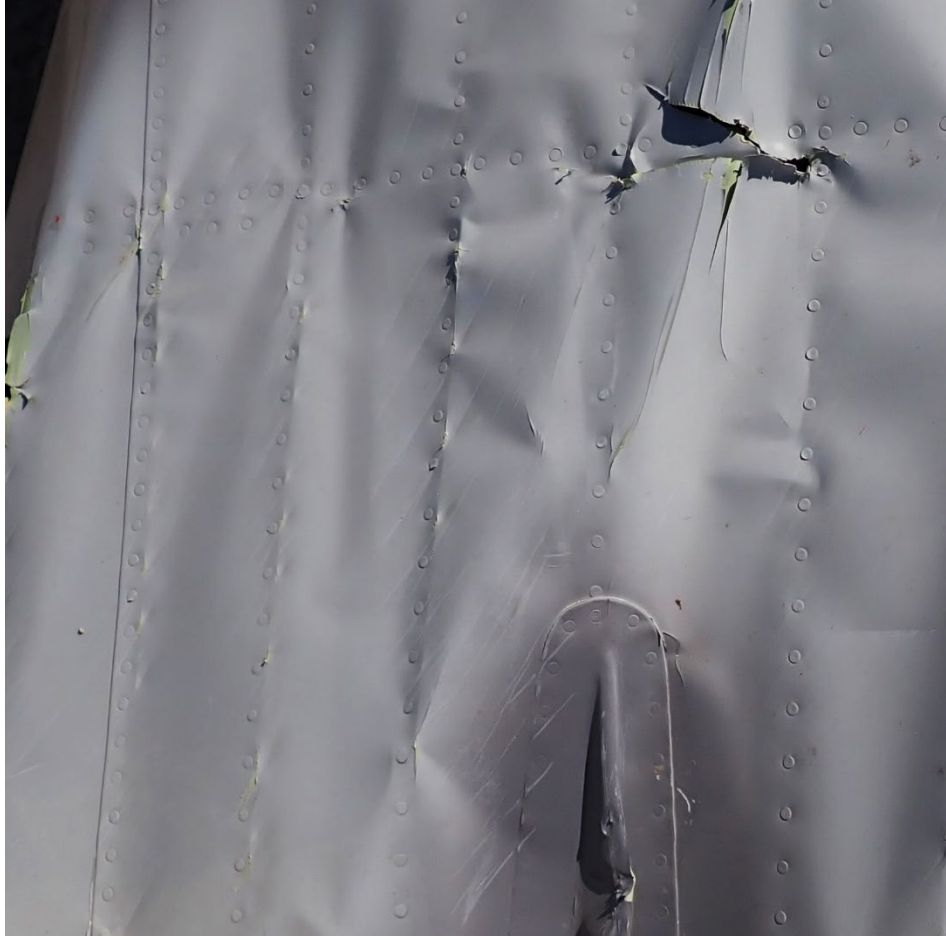
The forward cockpit seat was intact and the instrument panel was mostly damaged by recovery personnel during the occupant extraction process. The rear cockpit was intact and the instrument panel was partially deformed by impact forces. Both canopy windshields were intact with some cracks and broken plexiglass. The forward canopy was seized in the open position. The aft fuselage was crushed downward with numerous light gray striated paint transfer marks that tracked across the top skin from right to left 25° relative to the longitudinal axis of the airplane. An approximately 5 inch long gouge was observed in the top skin of the aft fuselage about midspan and adjacent to the striated marks.

**Figure 3: Light gray striated marks on top skin of aft fuselage (N313YK)**

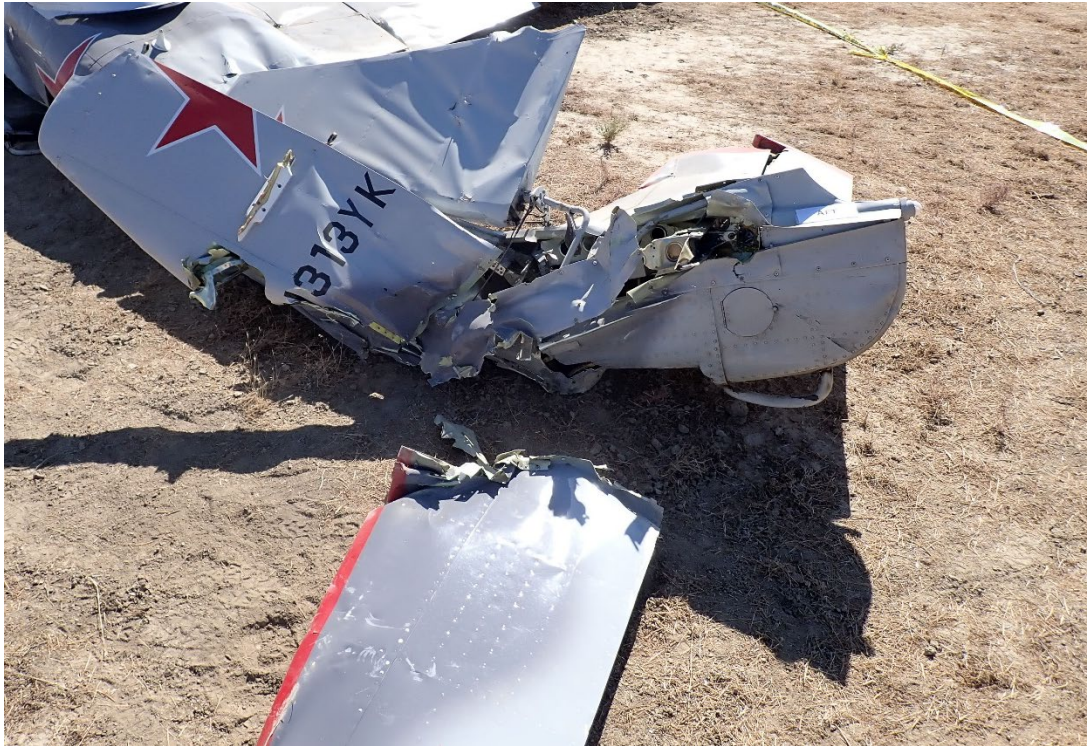
The empennage was mostly separated from the aft fuselage. The rudder separated from the vertical stabilizer, which had separated from its mount on the empennage; however, both control surfaces were still attached at their respective control tubes. The right horizontal elevator remained attached to the right horizontal stabilizer at its inboard and midspan mounts, but separated at the outboard mount. The right elevator trim tab remained attached to the elevator. The left horizontal stabilizer separated from the empennage and the left elevator and trim tab were not found at the accident site or in the surrounding terrain.

**Figure 4: N313YK empennage from left side; note missing left elevator**

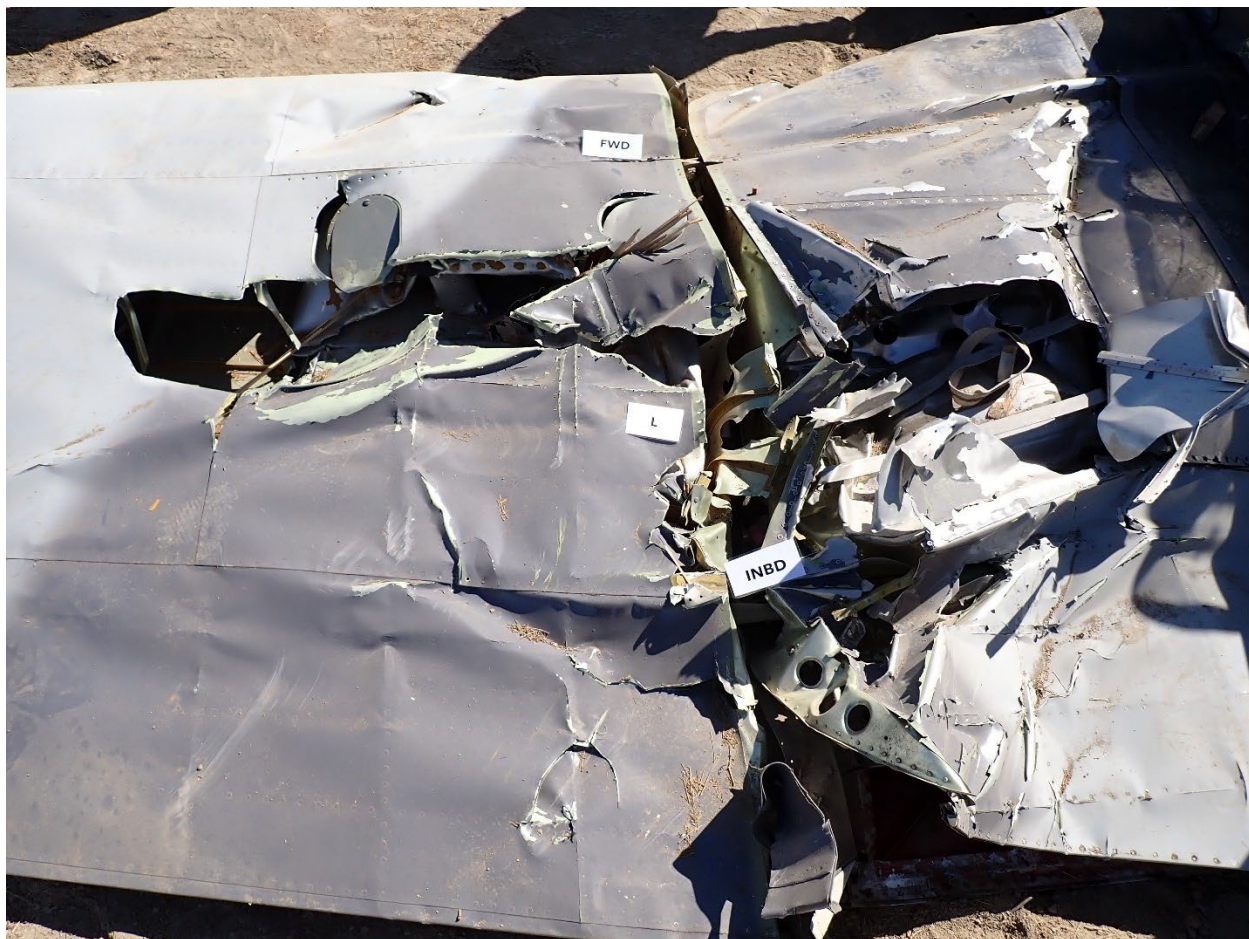
The right wing remained attached to the fuselage, was bent upward and exhibited compression wrinkling and bending at the wing root. Both the right aileron and right flap remained attached to the wing. The pitot tube was attached and intact. The right wing inboard leading edge was buckled and compressed. The left wing also remained attached to the fuselage. Both the left aileron and left flap remained attached although the left flap was partially separated and was displaced downward. The inboard left wing was separated from the leading edge to the trailing edge between two fuel tanks at an inboard wing rib; however, the forward and aft spars remained attached. An approximately 6 foot long lateral tear was located on the top skin of the left wing. A 13 inch long fragment of a wood propeller blade tip was embedded in the wing in the middle of the tear. Several yellow and white paint transfer marks were observed from the inboard beginning of the tear to the trailing edge. The transfer marks were tracked outboard about 30° relative to the longitudinal axis of the airplane.

**Figure 5: Damage to top skin of left wing on N313YK with embedded wooden propeller fragment**

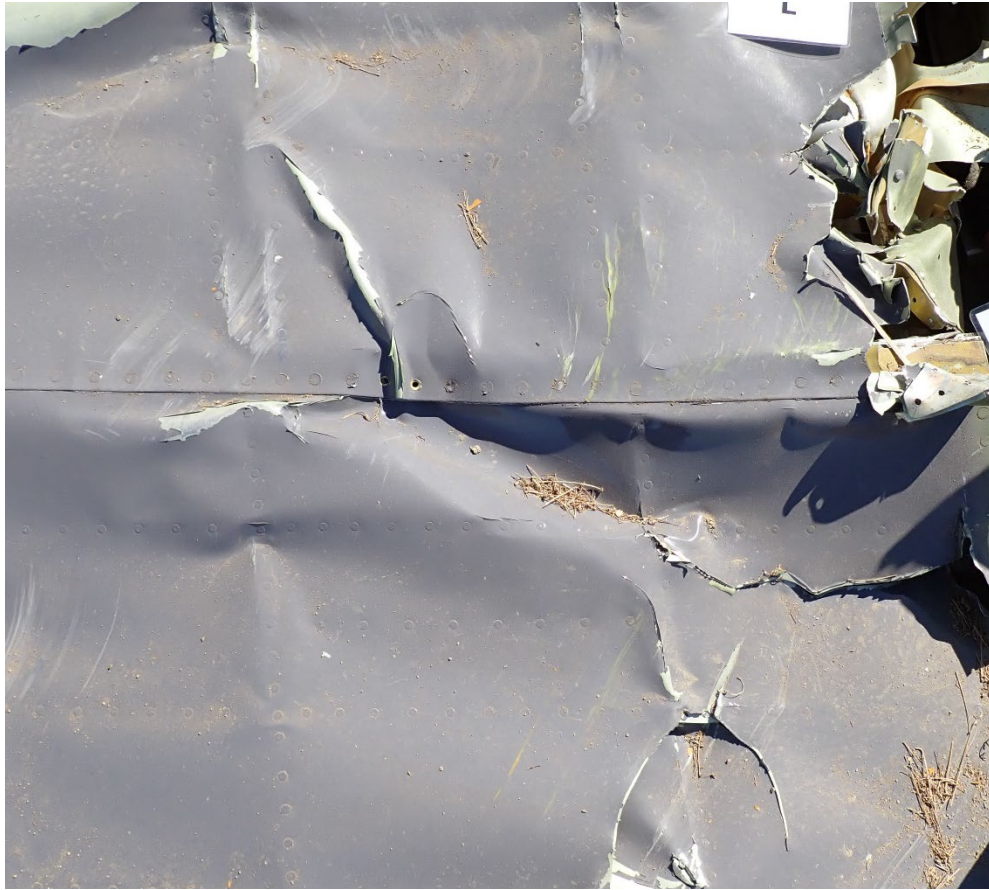
**Figure 6: Yellow paint transfer marks on left wing (N313YK)**

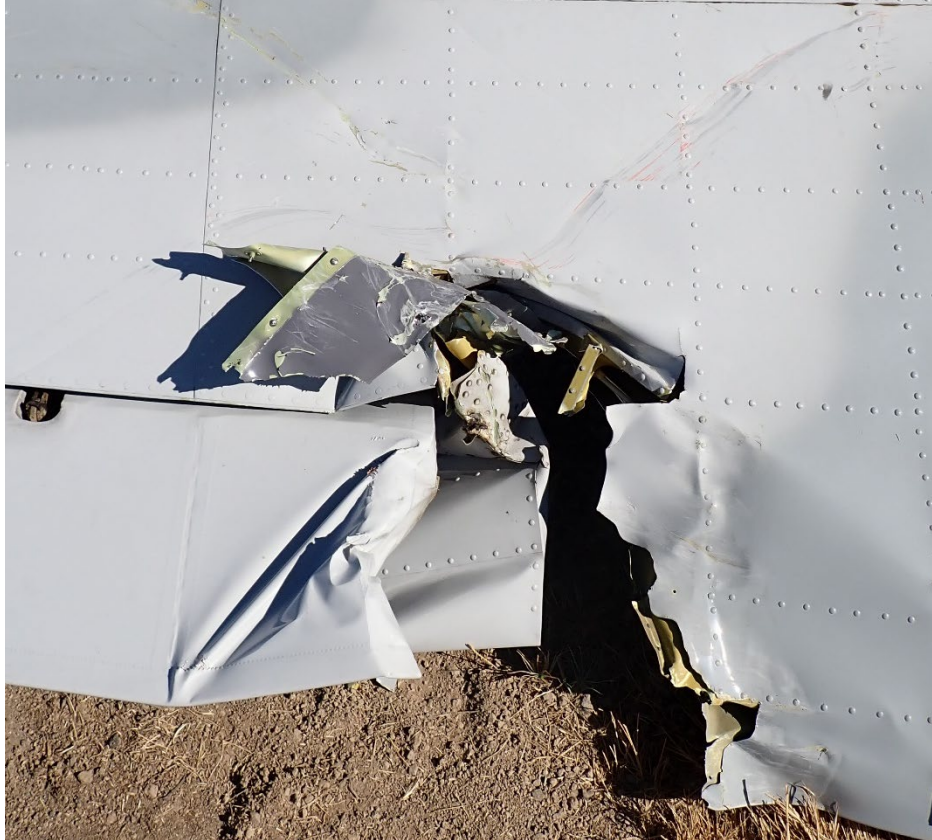
Both wings remained attached to the fuselage. The right wing was unremarkable and the left wing exhibited an approximately 18 inch long chordwise tear about midspan to the trailing edge. Numerous grey paint transfer marks were observed from the leading edge outboard that tracked inboard towards the trailing edge and terminated about midspan. Red and white paint transfer marks formed a large arc inboard on the top of the inboard left wing and a large yellow arc was observed from the midspan depression that tracked outboard.

**Figure 7: Damage to left wing trailing edge of N5287; note yellow and red paint transfer marks**
