WPR24FA309

## INVESTIGATION PHOTOGRAPHS

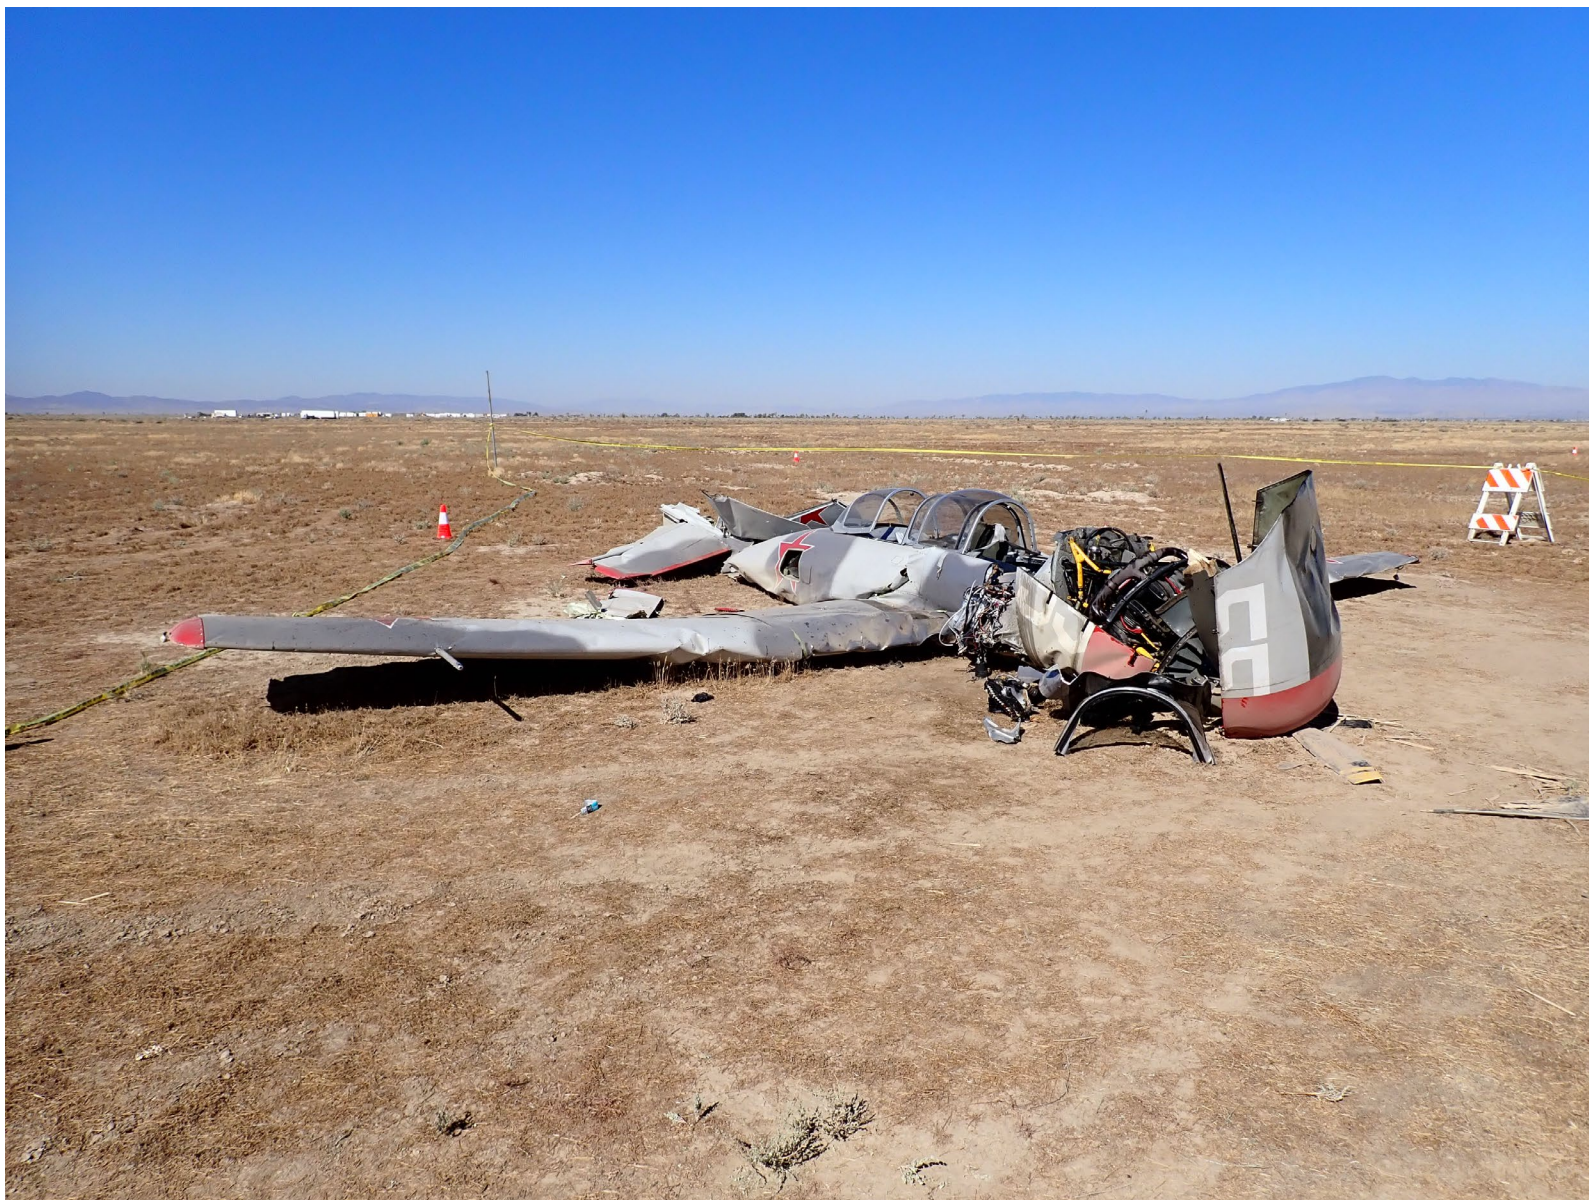
**Photograph 1 - Forward quartering view of N313YK**

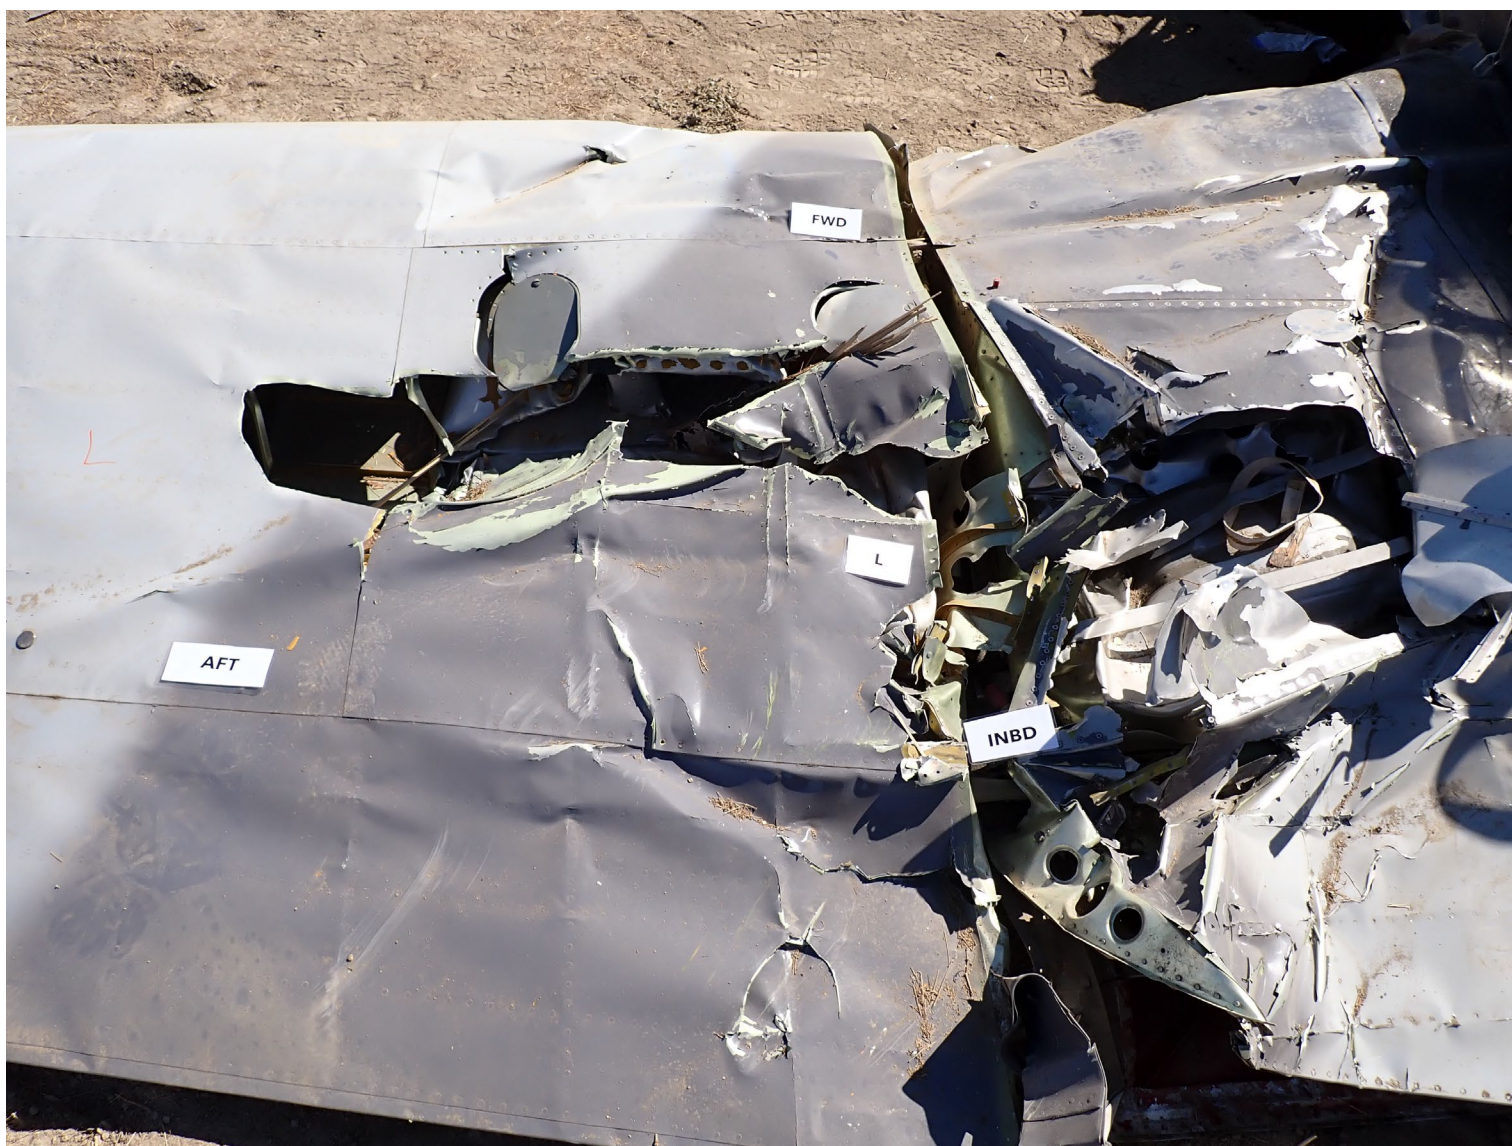
**Photograph 2 - N313YK left wing**

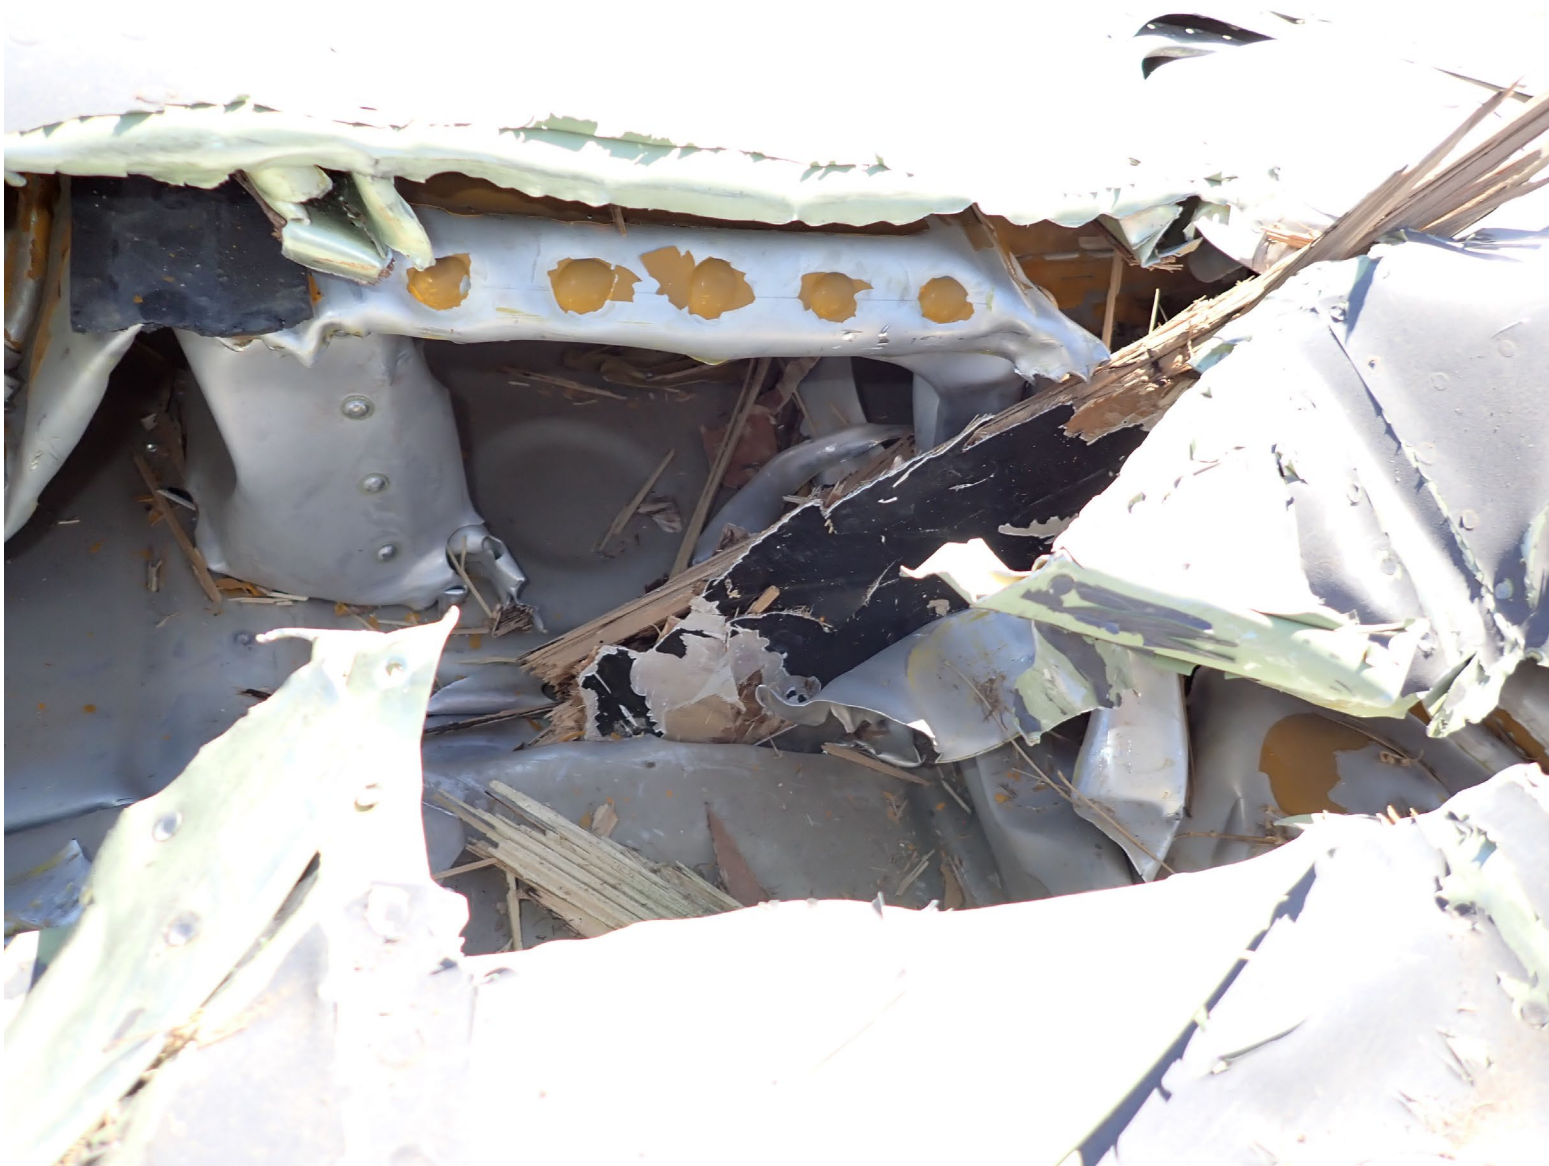
**Photograph 3 - Propeller fragments in left wing of N313YK**

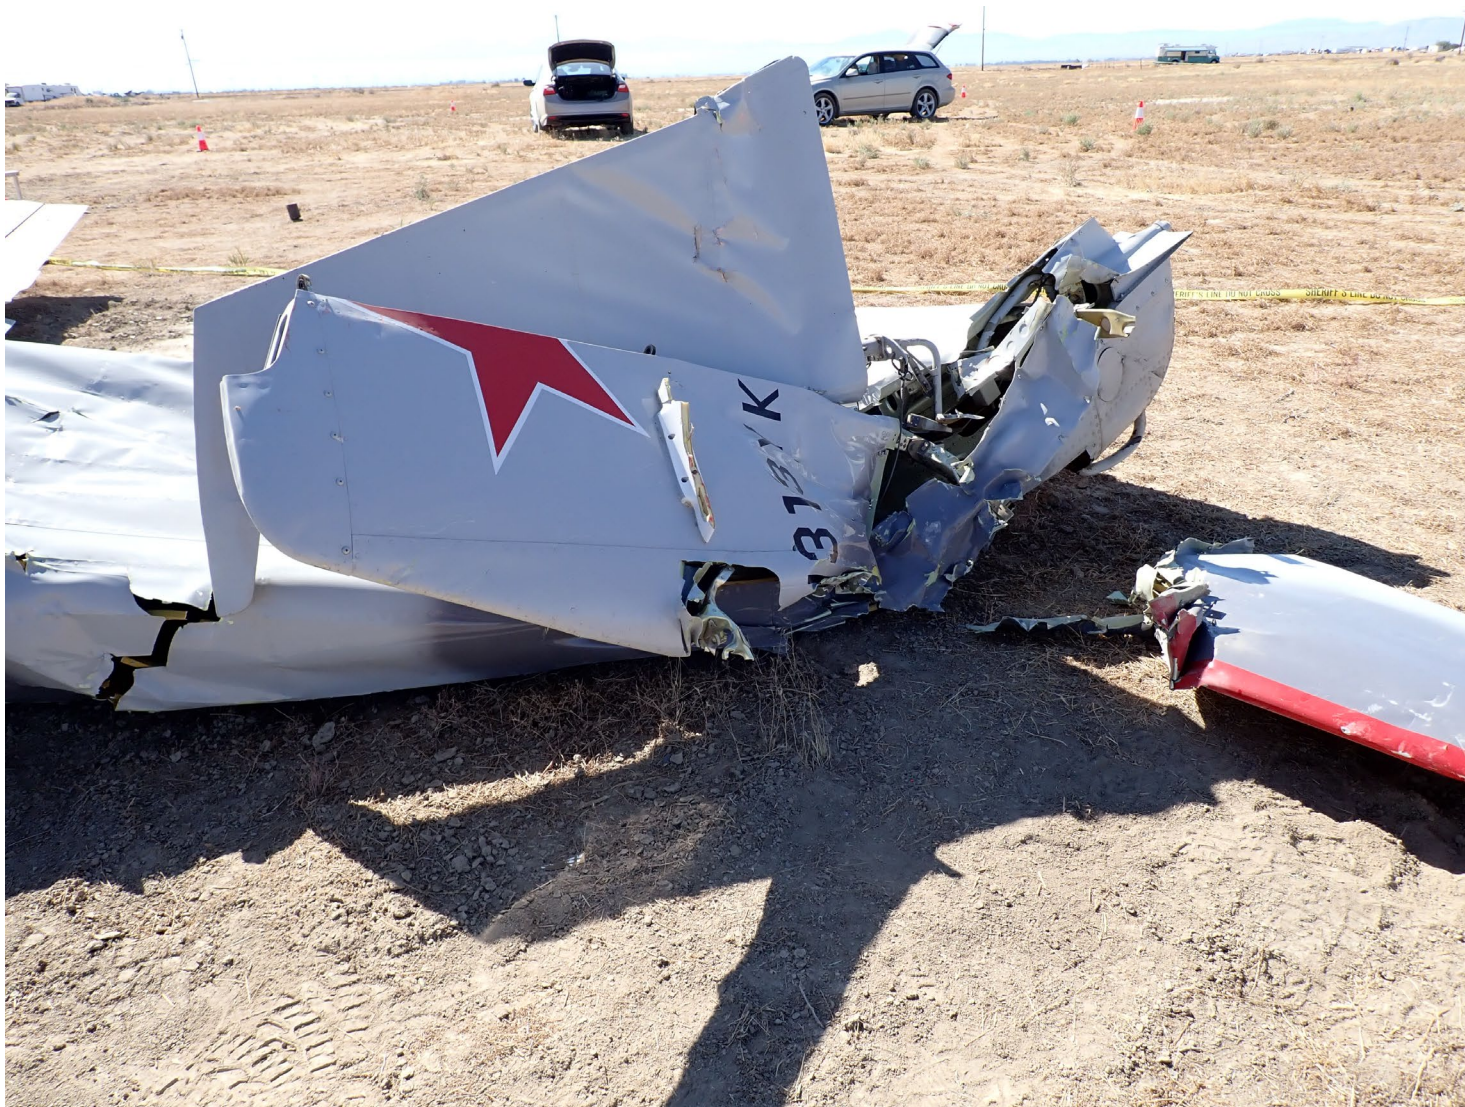
**Photograph 4 - Partially separated vertical stabilizer from N313YK at accident site**

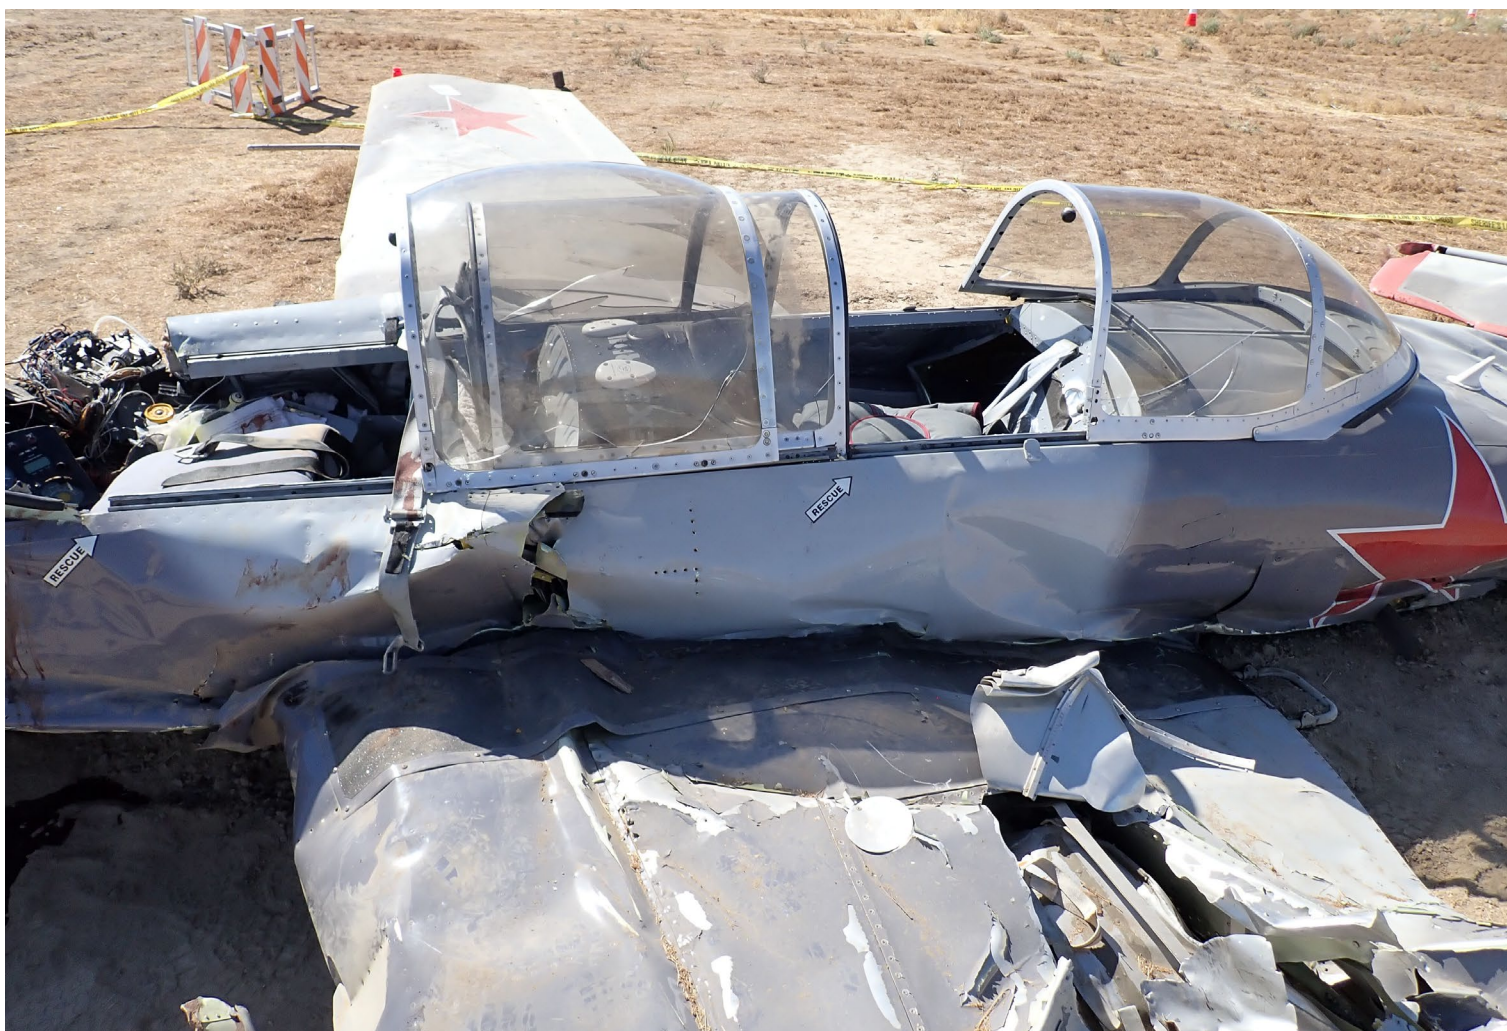
**Photograph 5 - N313YK Cockpit and canopy at accident site**

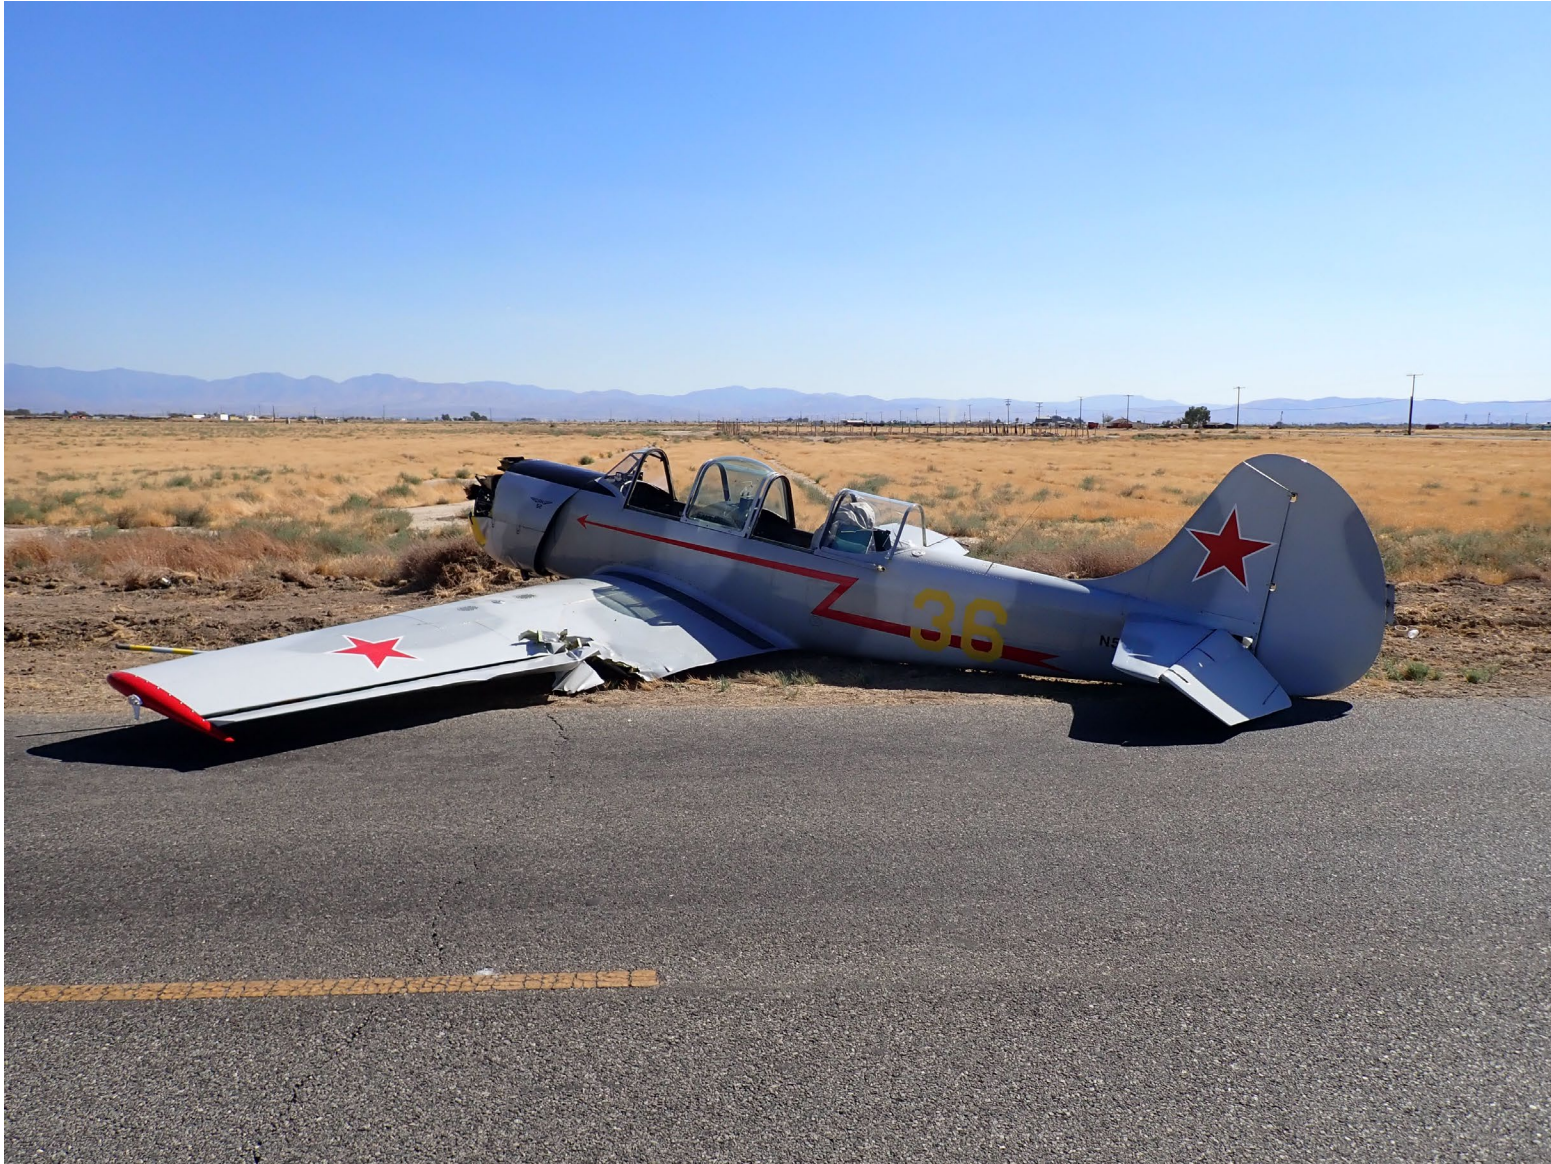
**Photograph 6 - Rear quartering view of N5287 at accident site**

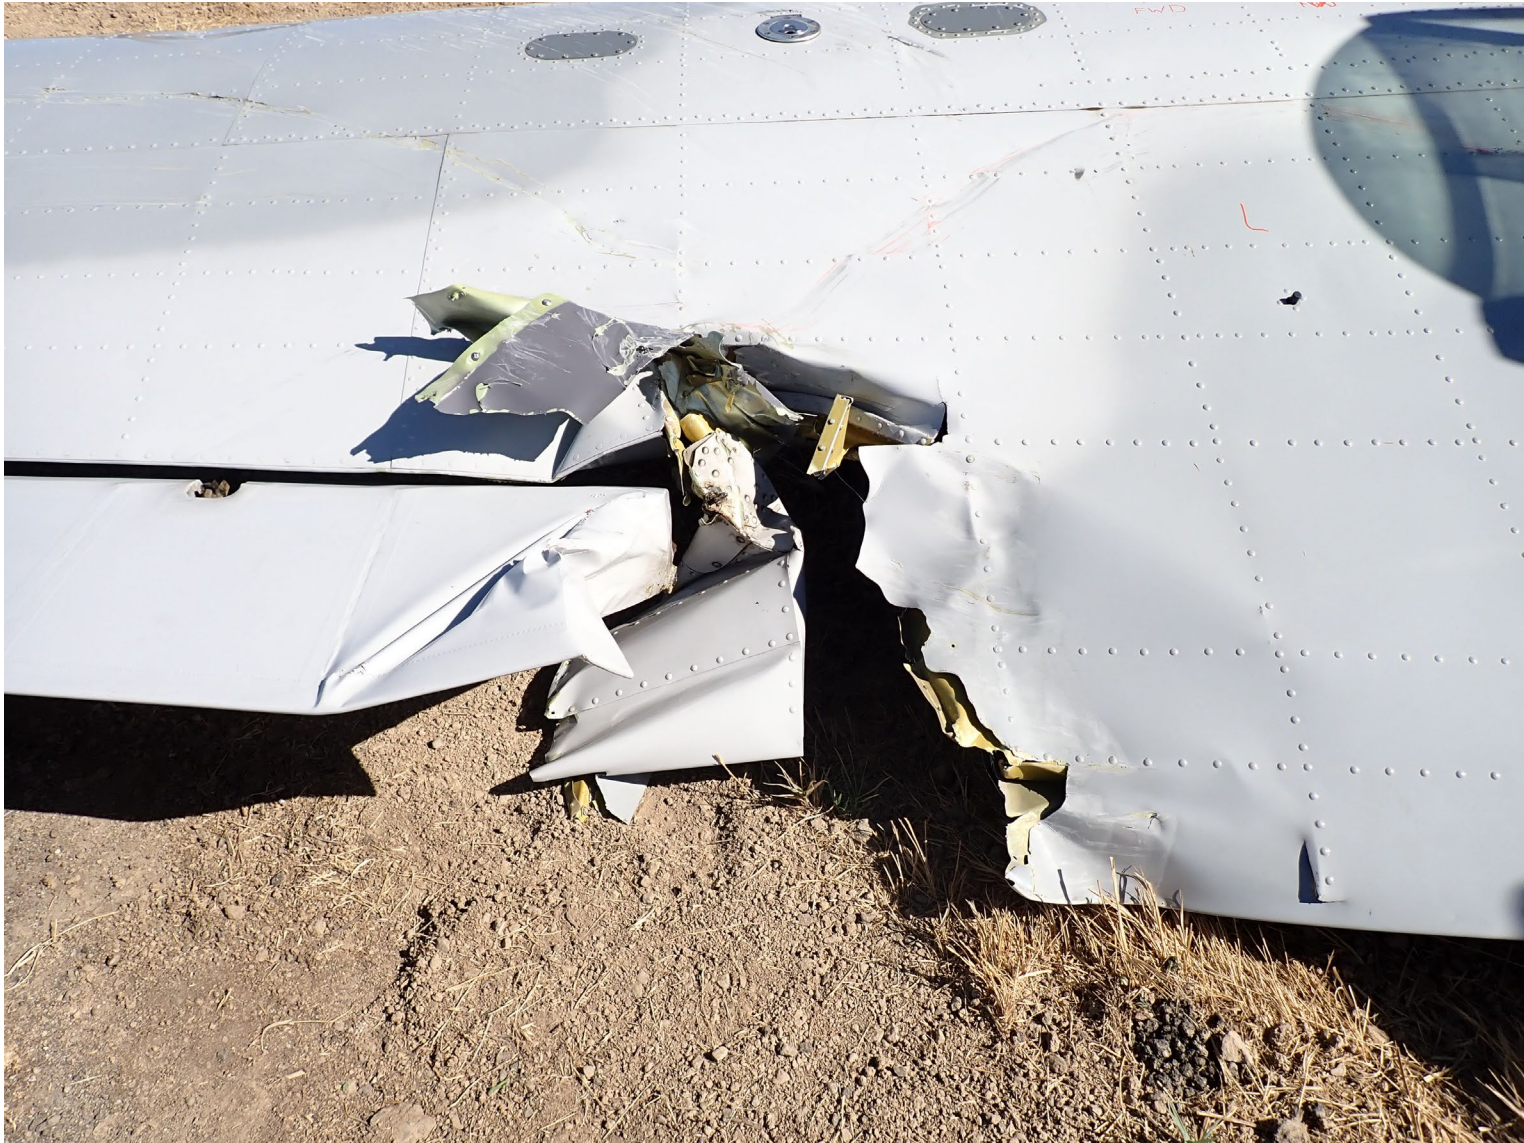
**Photograph 7 - Left wing of N5287 at accident site**

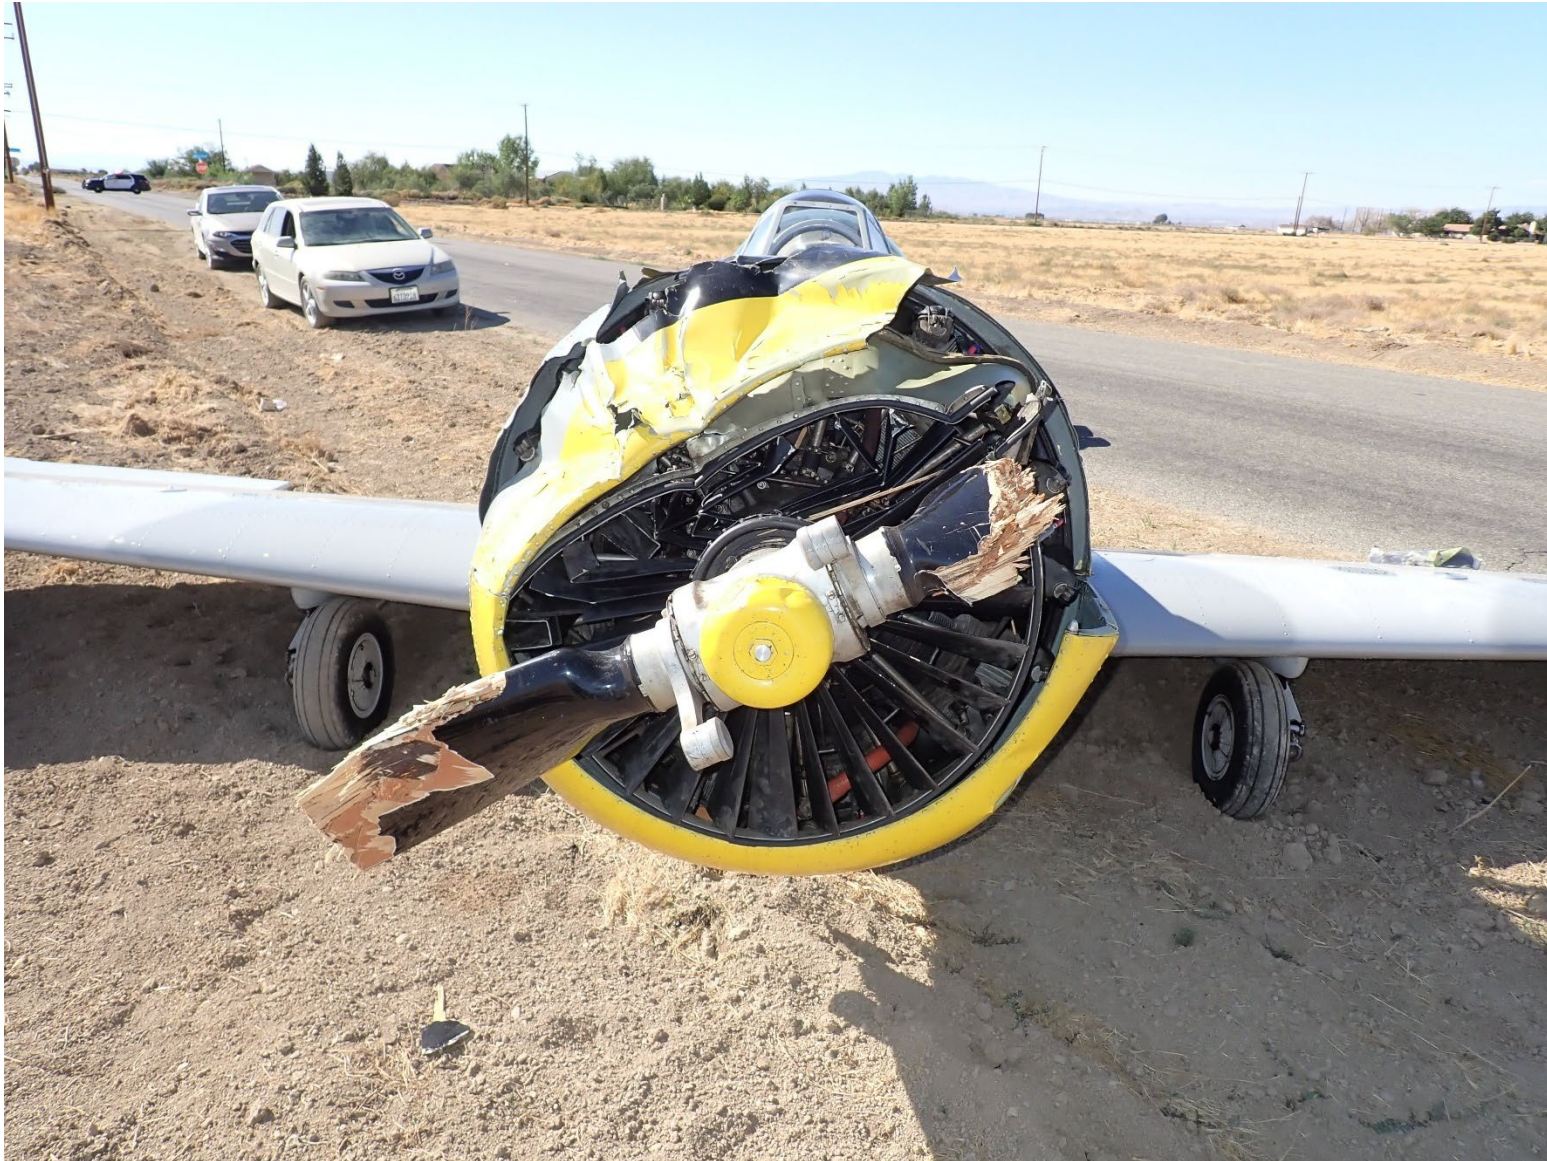
**Photograph 8 - N5287 broken propeller blades at accident site**

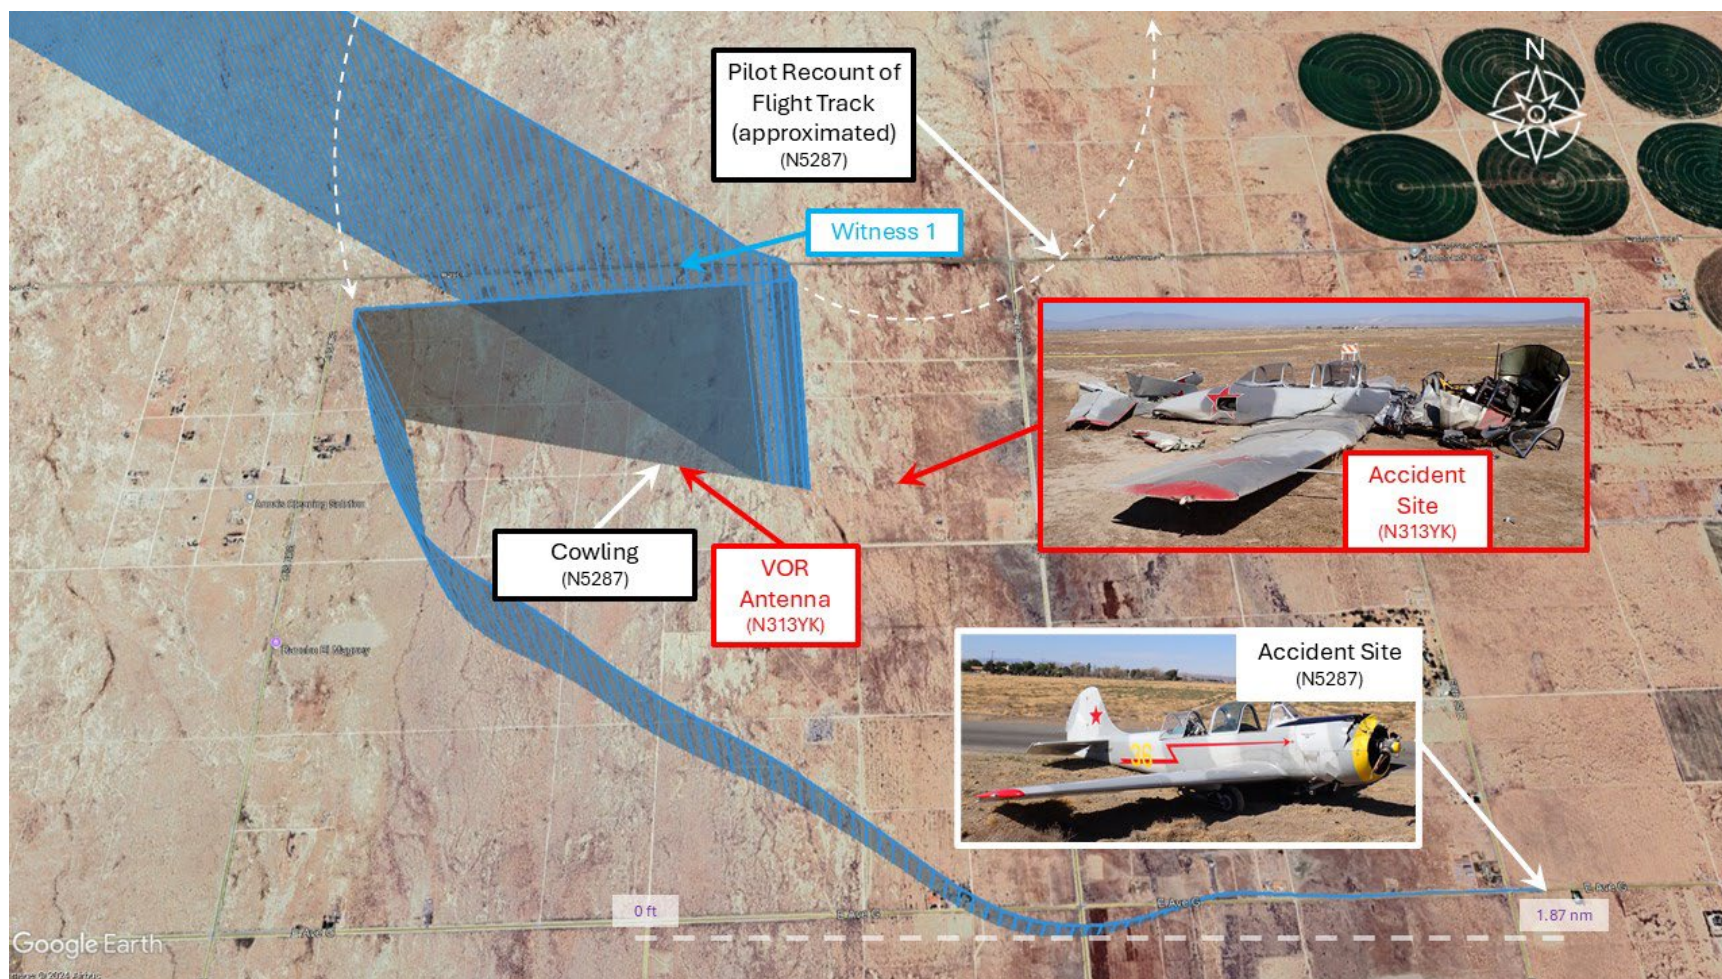
**Photograph 9 - Flight track of Yak52 (N5287) and accident site locations**

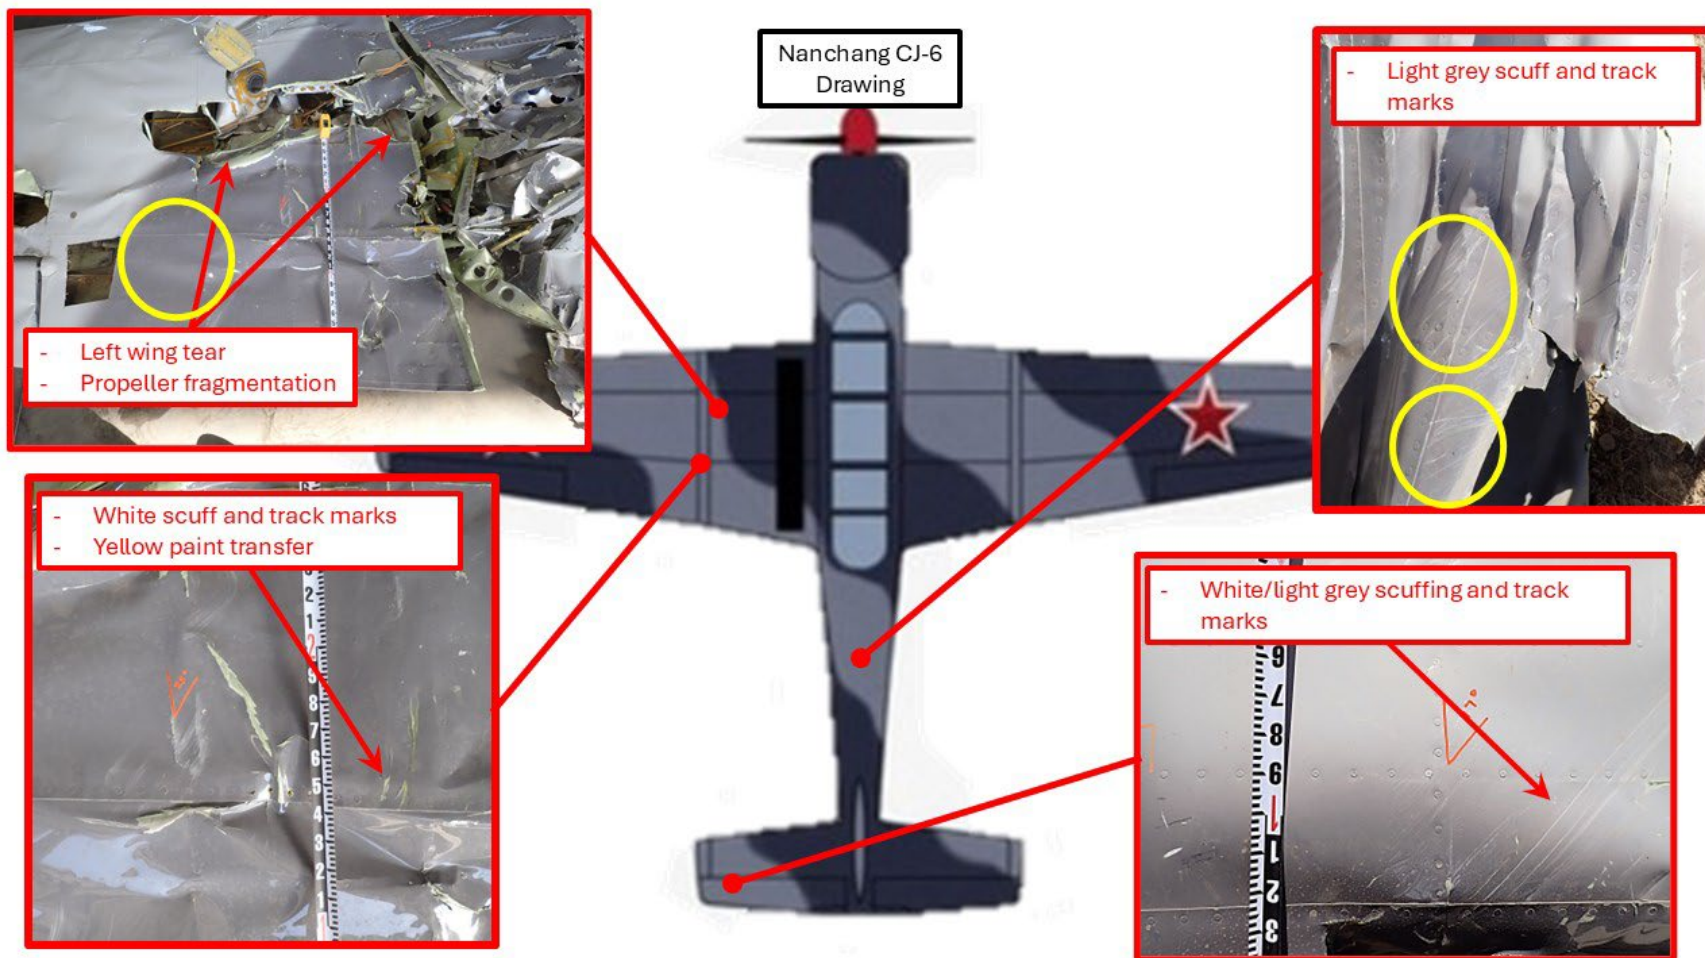
**Photograph 10 - CJ-6A (N313YK) damage figure**

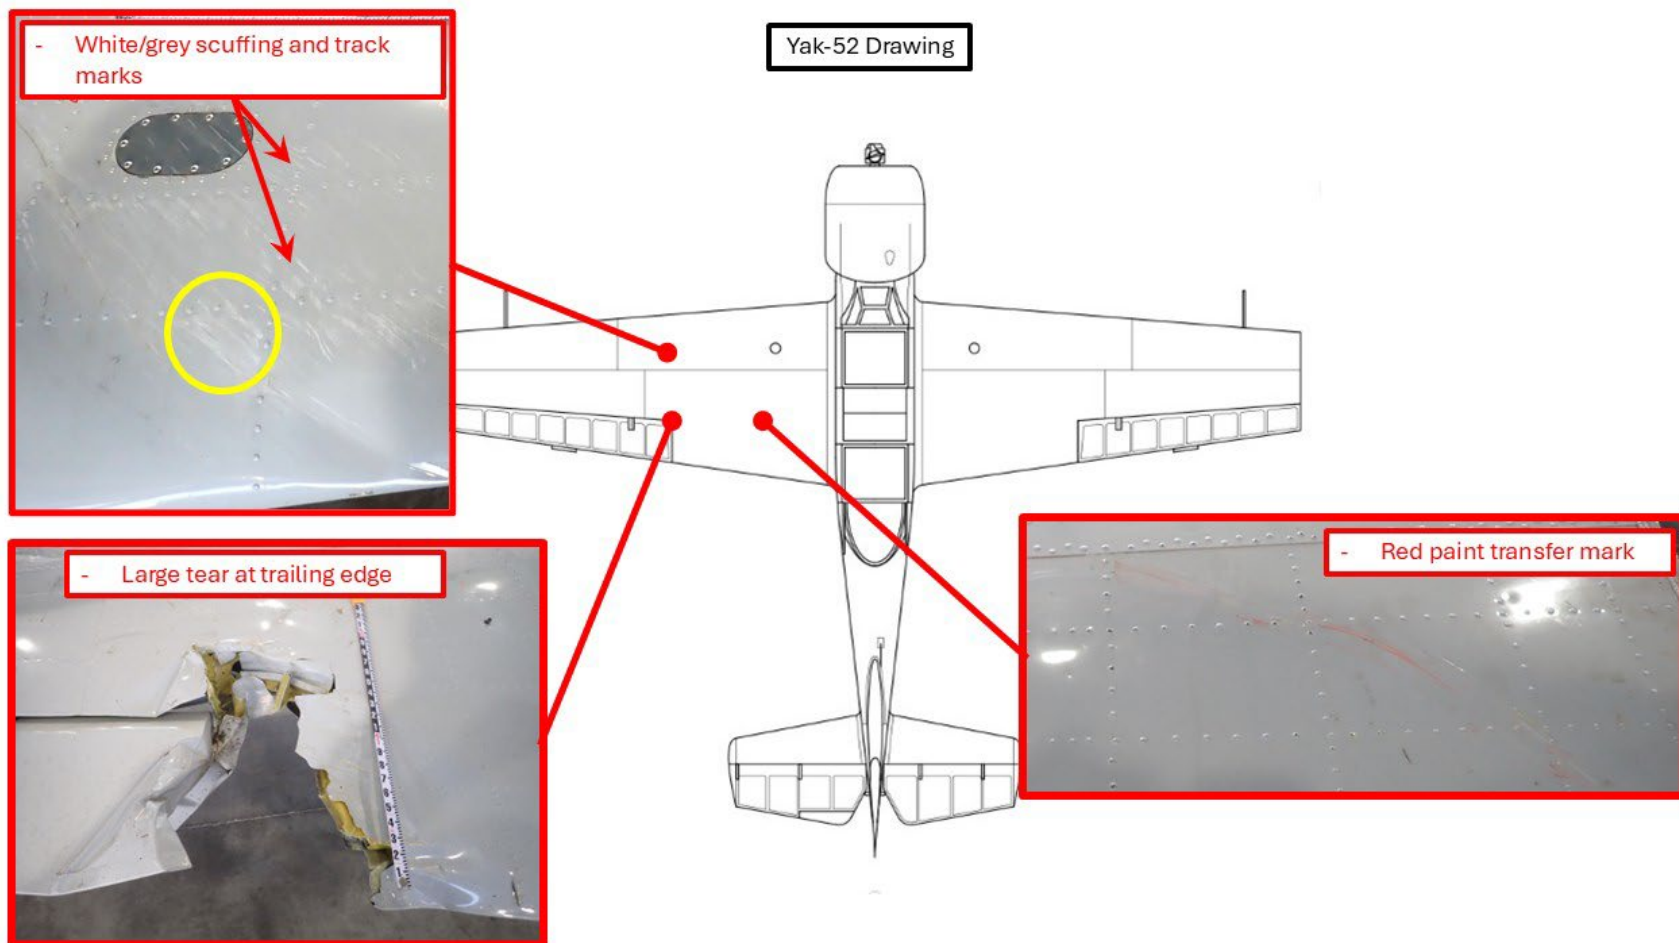
**Photograph 11 - Yak 52 (N5287) damage figure**
