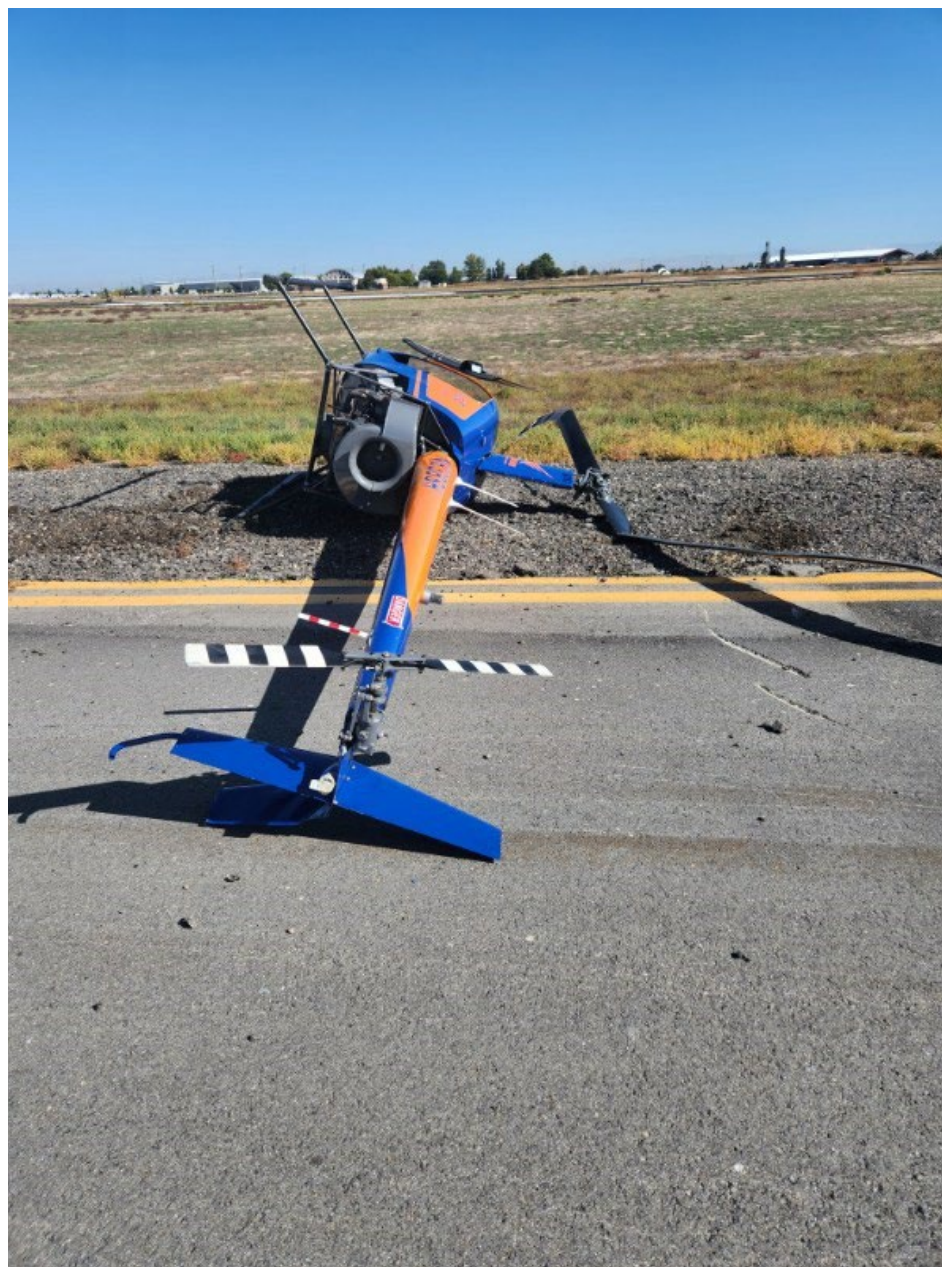
**Photo 1 – View of damage to horizontal stabilizer (courtesy of Operator)**
