WPR23LA023

## INVESTIGATION PHOTOGRAPHS

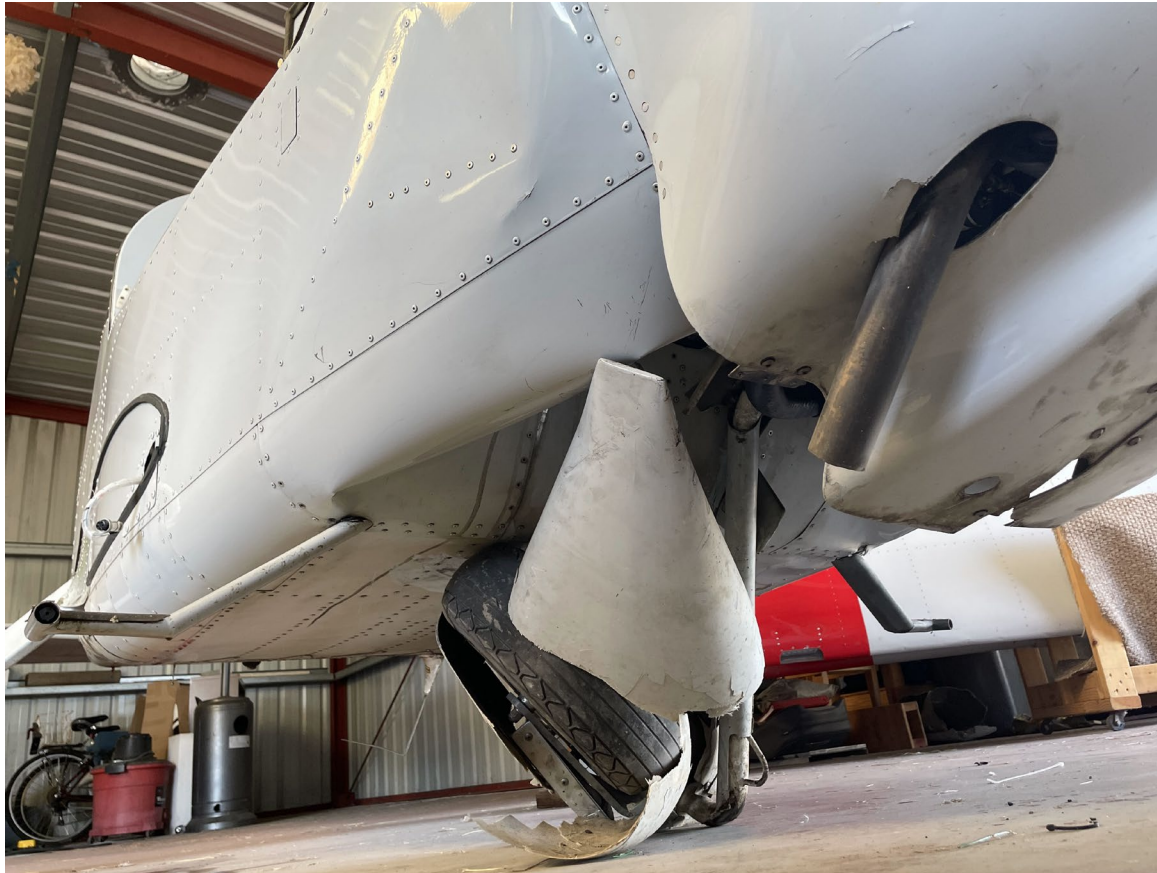
**Photograph 1 - View of recovered fuselage (Courtesy of the FAA).**

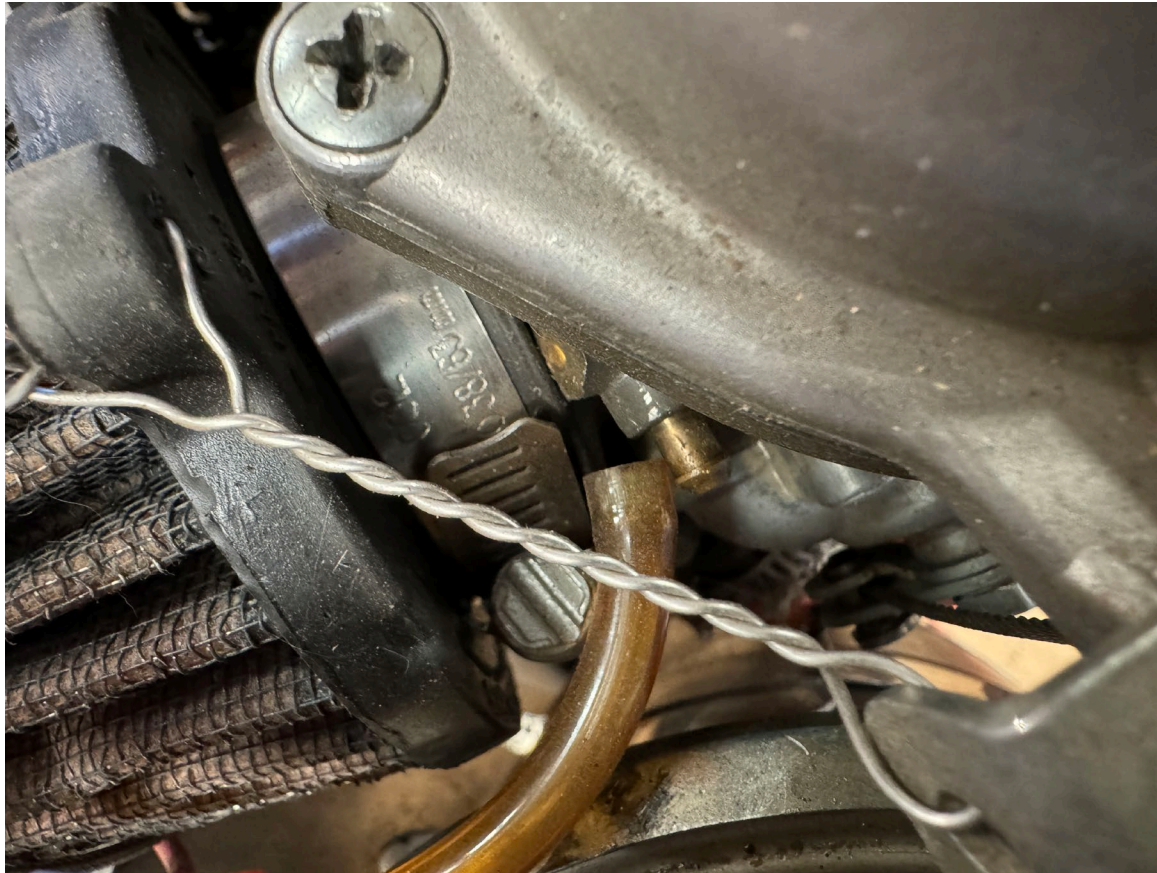
**Photograph 2 - Disconnected carburetor float bowl vent line 1/3 side.**

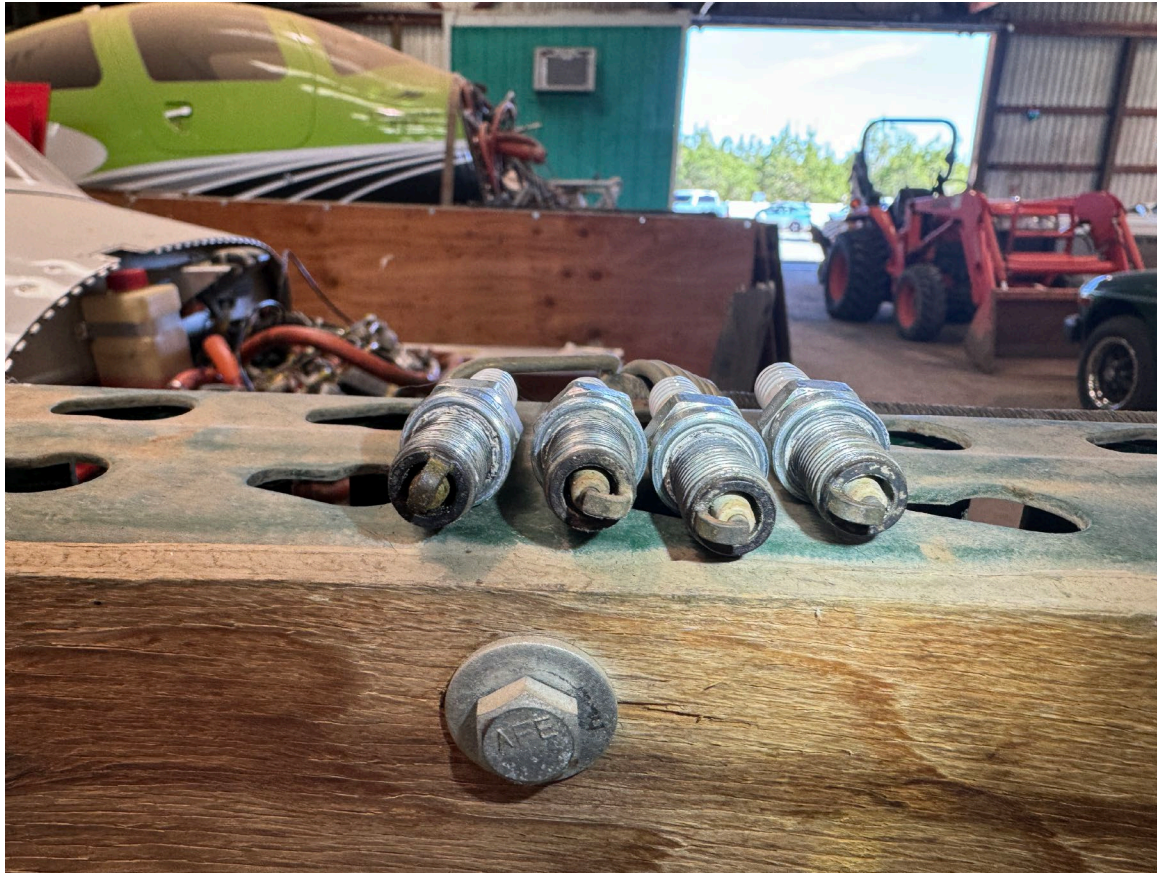
**Photograph 3 - Upper spark plugs.**

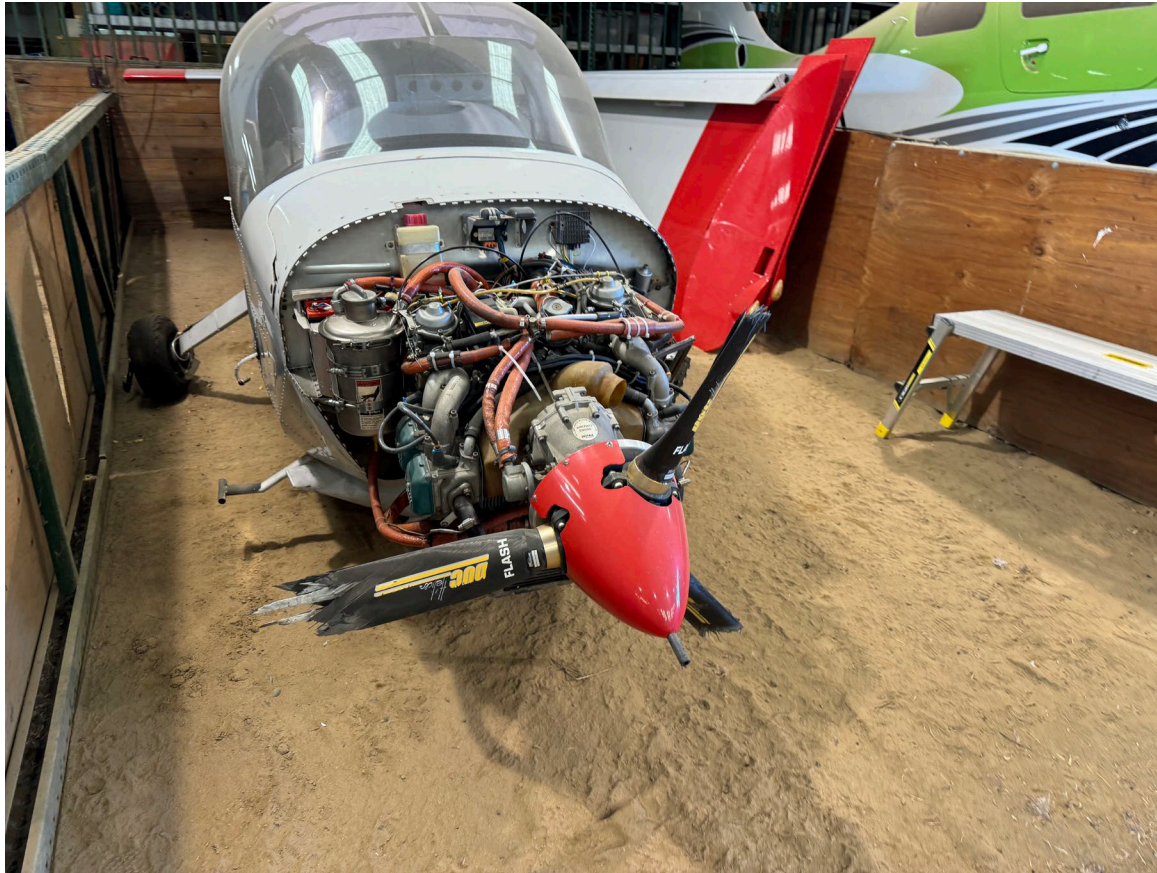
**Photograph 4 - Recovered airframe and engine.**
