# National Transportation Safety Board

WPR24LA030

## EXAMINATION REPORT

Location: Firebaugh, California  
Date: November 4, 2023  
Time: 1200 Pacific daylight time  
Helicopter: Arrow Falcon Exporters UH-1H, N3053Q

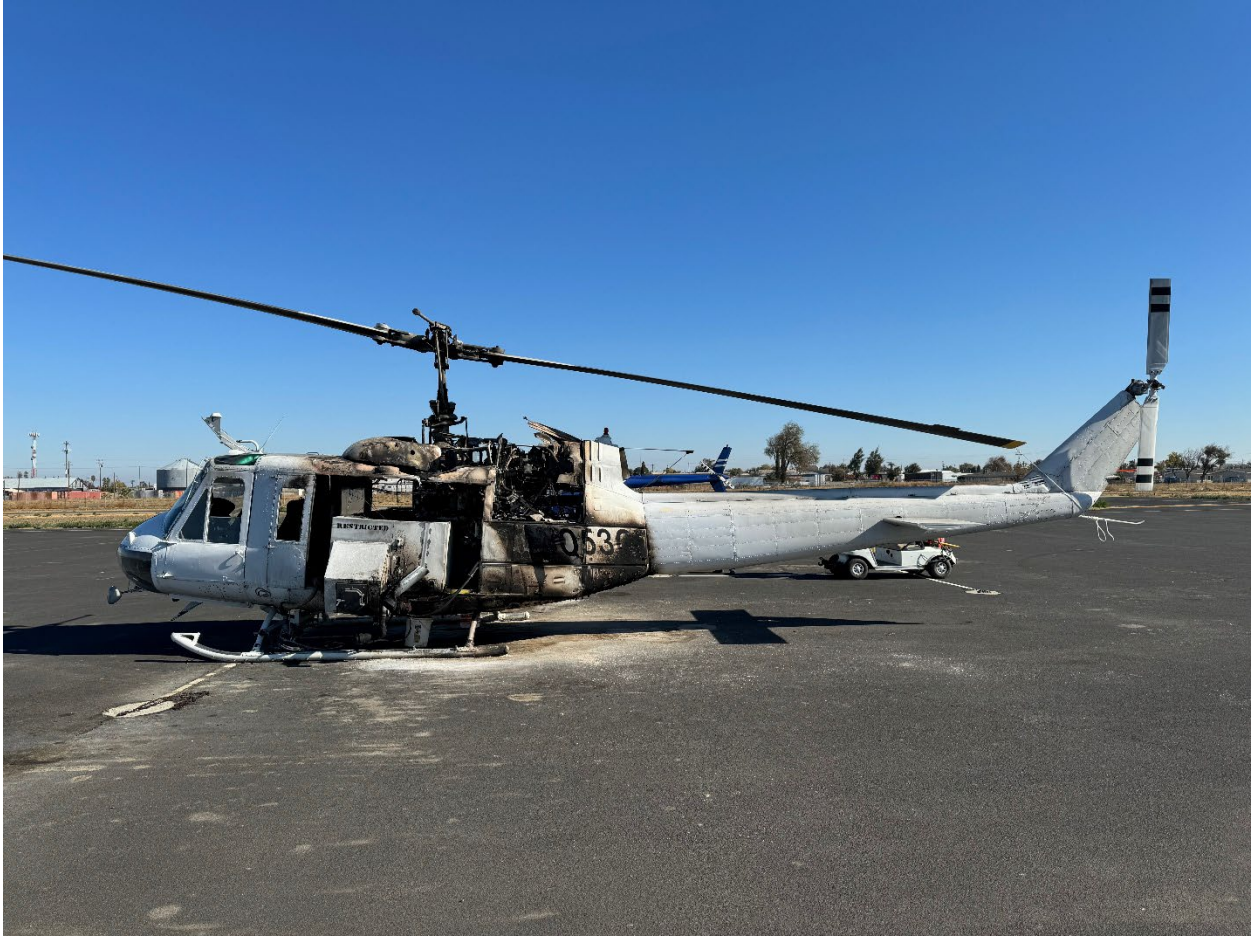
The airframe sustained extensive thermal damage from aft of cockpit (cargo area) to the engine, with the most thermal damage localized on the left side.

Photograph 1: Fire Damaged Left Side of Helicopter (Photo Courtesy of Insurance)

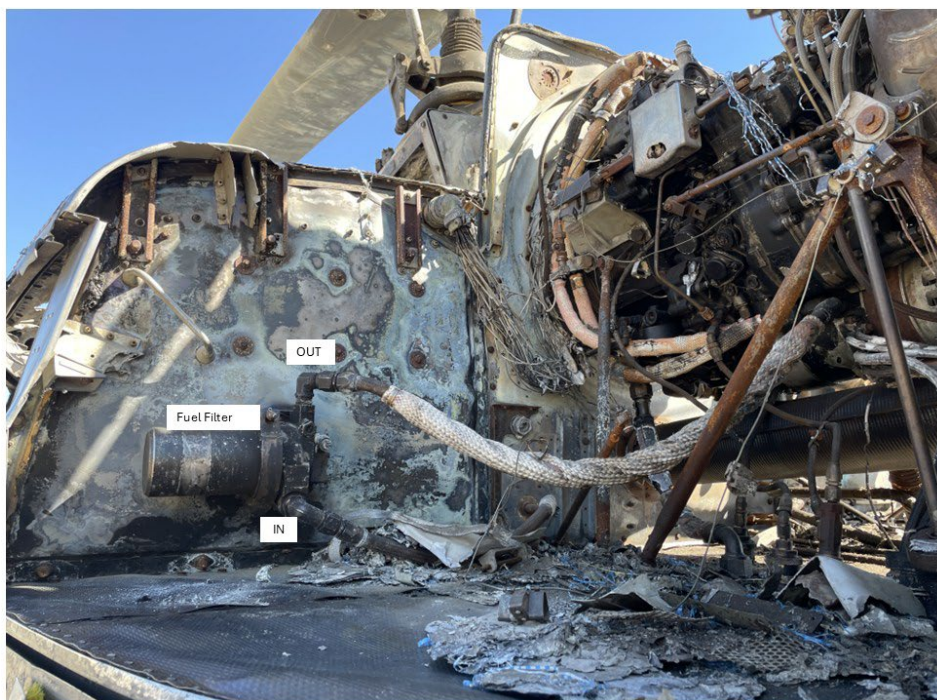
The engine side fuel filter remained attached to the firewall with the fuel lines attached. The fuel shutoff valve located on the airframe had been thermally destroyed and was in the debris in the helicopter in its relative normal position. However, the fuel lines associated with the component had been thermally consumed by the on-ground fire.

Photograph 2. Engine Side Fuel Filter

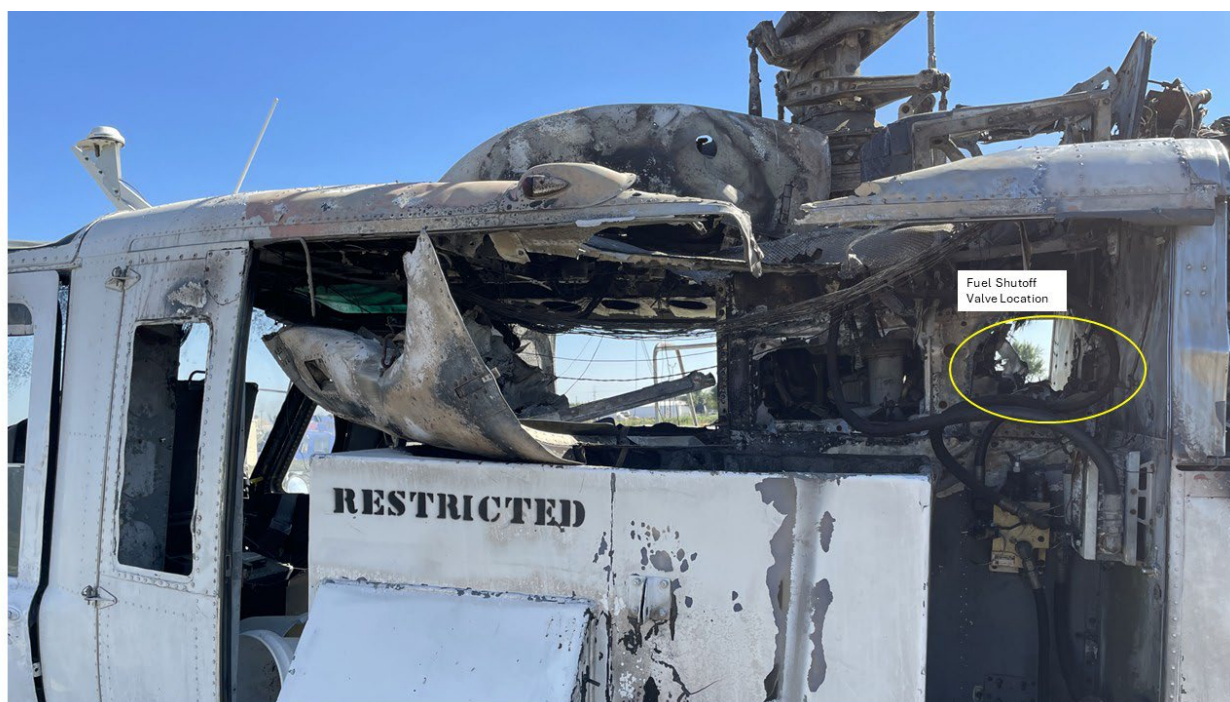
Photograph 3. Airframe Side Fuel Shutoff Valve

The fuel lines on the airframe side located by the fuel shutoff valve are on-condition items to be replaced as needed. At the last annual inspection, the fuel lines on the airframe side were torqued at the fuel valve. There was no logbook entries found that identified that the fuel shutoff valve had been replaced and the operator believed the part to be original equipment manufacturer (OEM). The fuel shutoff valve is an "on-condition" item, which would require replacement only when the component failed to operate.

Due to the fire damage, there was no way to tell if the fuel hoses were OEM or replaced during the 2018 inspection; per maintenance personnel it is likely they were replaced during the 2018 inspection. According to maintenance, the operator utilized the US Army maintenance manual for the UH-1H and noted that the fuel hoses are a replace as needed item. There is also a repair section with approval for

the operator to repair and manufacture the fuel hose. As a result of this accident, the operator has instituted a replacement program for the hoses for every 10 years. Additionally, they checked all the hoses on their other helicopters and replaced the fuel hoses as necessary.
