**Beechcraft**

## Air Safety Investigations Field Investigated Aircraft Incident/Accident Final Report

| Aircraft and Incident/<br>Accident Information | Year: 1960 | Make: Cessna | Model: 310D | | |
| Senior Air Safety Investigator: Casey J. Love | | | Report #: ASI-24-AD | Report date: 06-18-24 | |

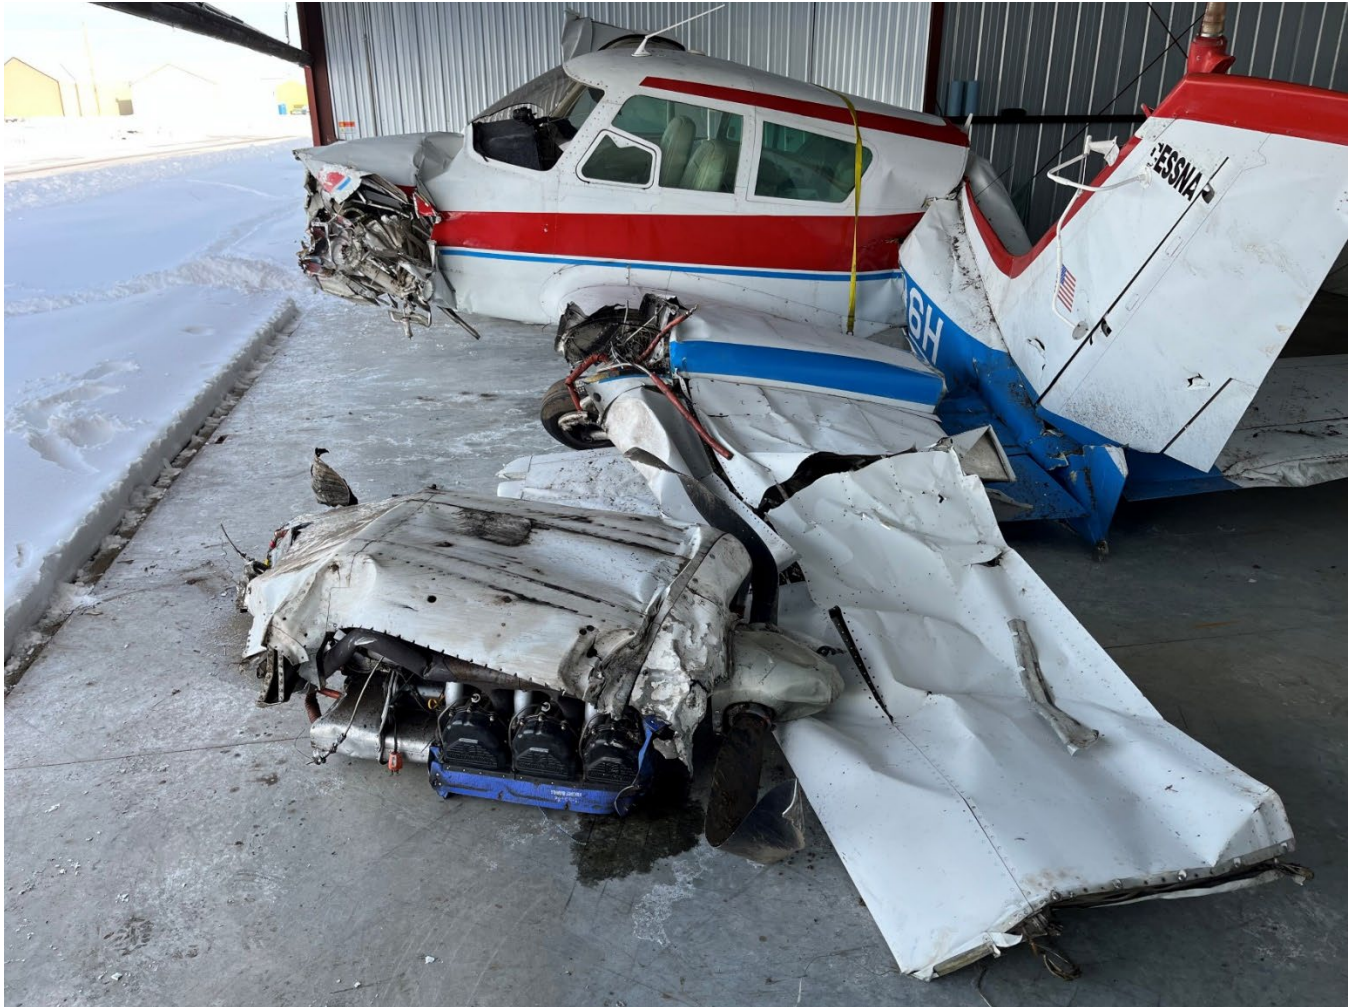
ASI-24-AD-001 (Wreckage overview)

The nose of the aircraft sustained aft crushing damage and was displaced to the left. The nose landing gear was folded aft into the belly skin. The left wing was crushed upward, the wing spars were partially fractured. The upper wing skin exhibited compression wrinkles and skin separation at the rivet joints. The left wing-tip fuel tank was impact separated and ruptured. The right wing was bent upward approximately 15 degrees at the aileron flap intersection. The right wing-tip fuel tank was fracture separated and ruptured. Both wing engine mount structures were fracture separated from the wings. The engines remained attached to the mounts.

The tail was bent toward the left approximately 90 degrees aft of the #3 and #4 seats.

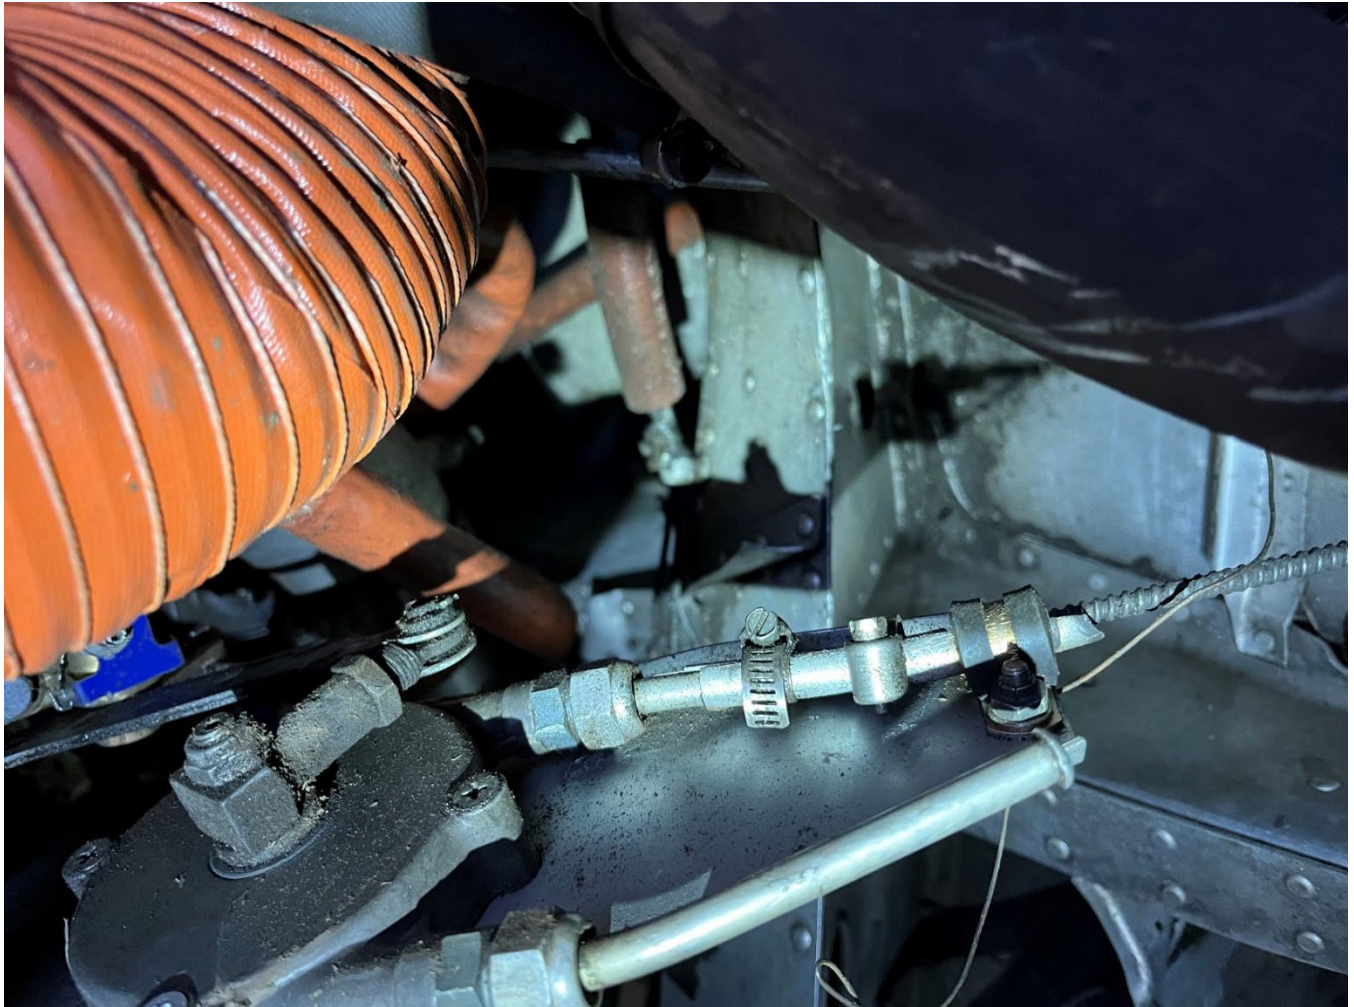
ASI-24-AD-022 (Fabricated cable clamp)

The left engine throttle and mixture control cable attachment to the cable mount bracket had been modified to incorporate a sectioned piece of aluminum fluid line and a rubber padded Adel clamp. The mixture arm from the mixture cable gear drive to the mixture valve was fractured. The throttle control cable mount near the throttle valve was bent. The throttle linkage from the throttle valve to the throttle cable gear drive was in contact with the throttle valve.
