# National Transportation Safety Board

## **MATERIALS LABORATORY**

Factual Report 24-005

Location: Yuma, Arizona  
Date: November 17, 2023  
Vehicle: Beech 95, N2024C  
Investigator: Eric Gutierrez, AS-WPR

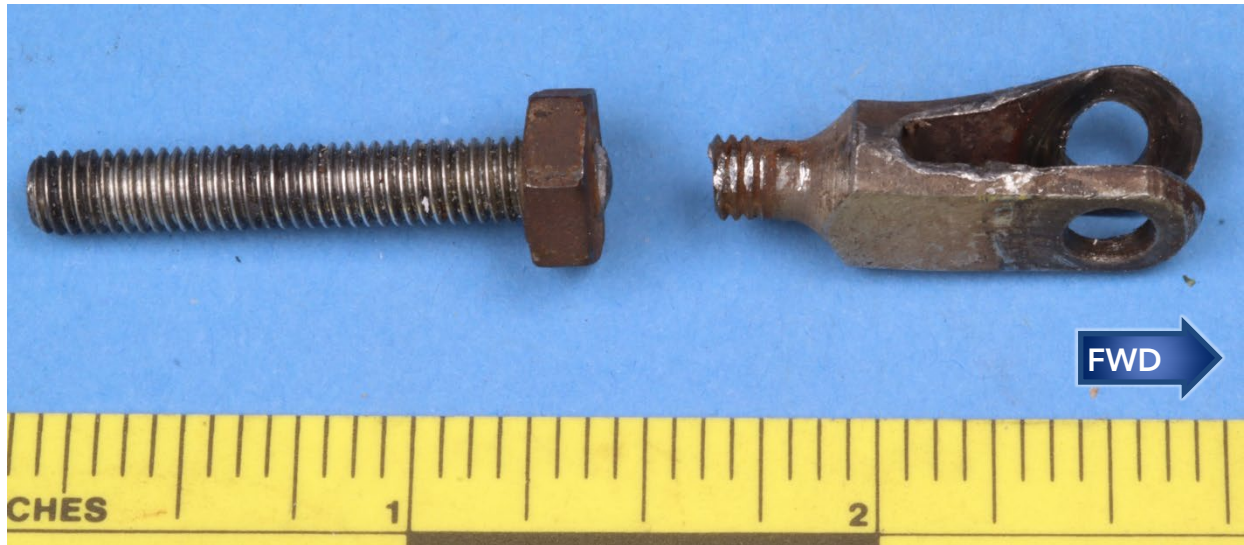
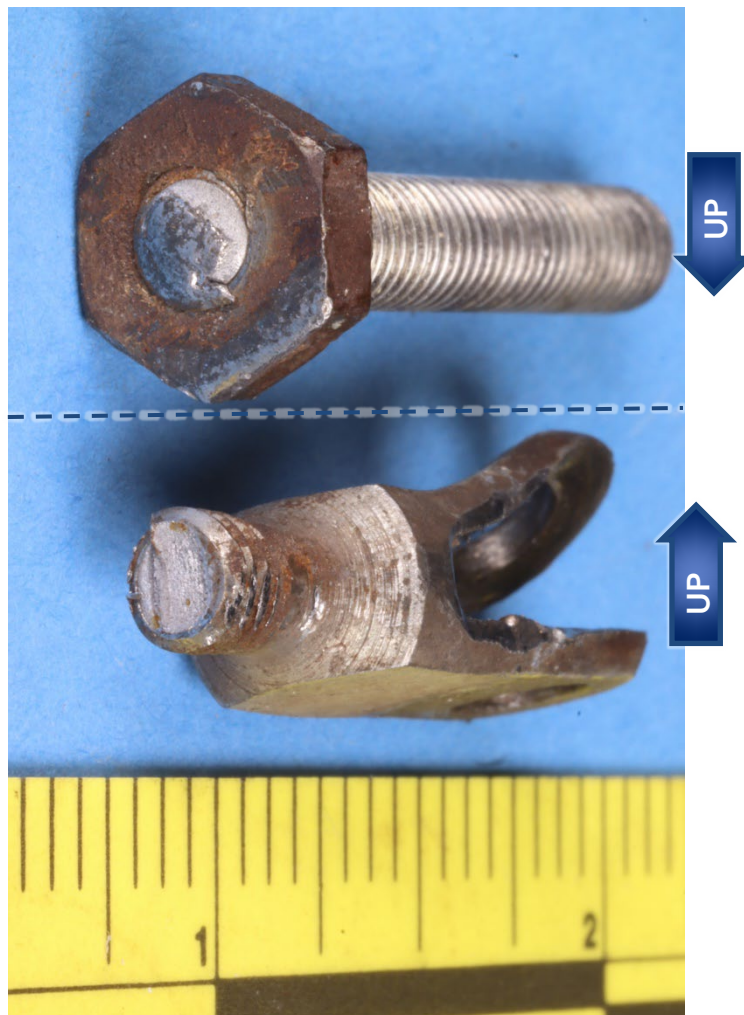
An overall view of the submitted rudder trim control rod end with attached jam nut is shown in figure 1. The rod end was fractured through the threads approximately 3 to 4 threads away from the clevis end. The upper ear of the clevis was bent and twisted as shown in figure 1, and heavy contact damage was noted on the left side of the clevis and on threads between the clevis and the fracture surface. The clevis end was reportedly damaged during the process of disassembling it from the aft end of the trim control actuator rod end. A view of the rod end on the airplane before disassembly is shown in figure 2, where the attachment bolt is inserted through the apparently undeformed rod end clevis.

**Figure 1.** Overall views of the submitted rudder trim control rod end as received.

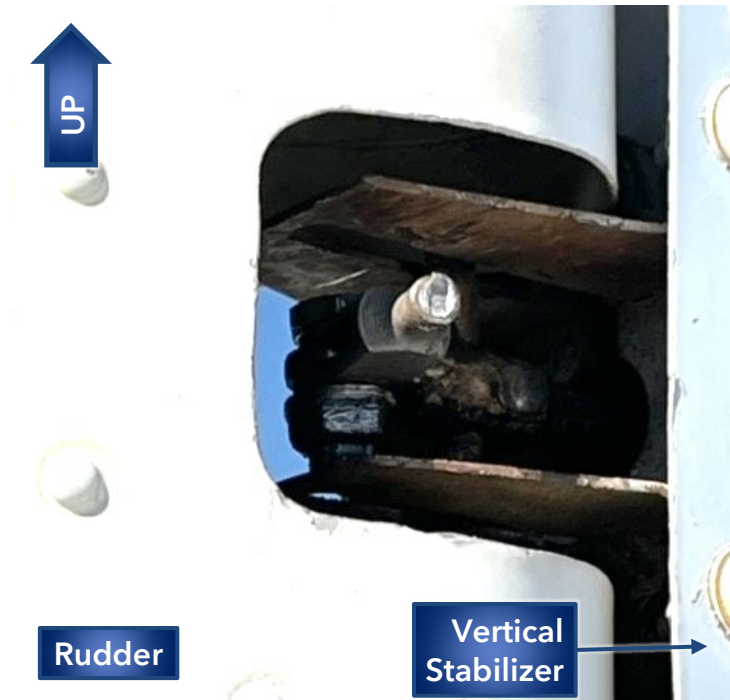
**Figure 2.** View of the right side of the rudder at the rudder leading edge showing the fractured rudder trim control rod end attached to the control actuator rod end before disassembly from the aircraft. (Image source: Federal Aviation Administration)

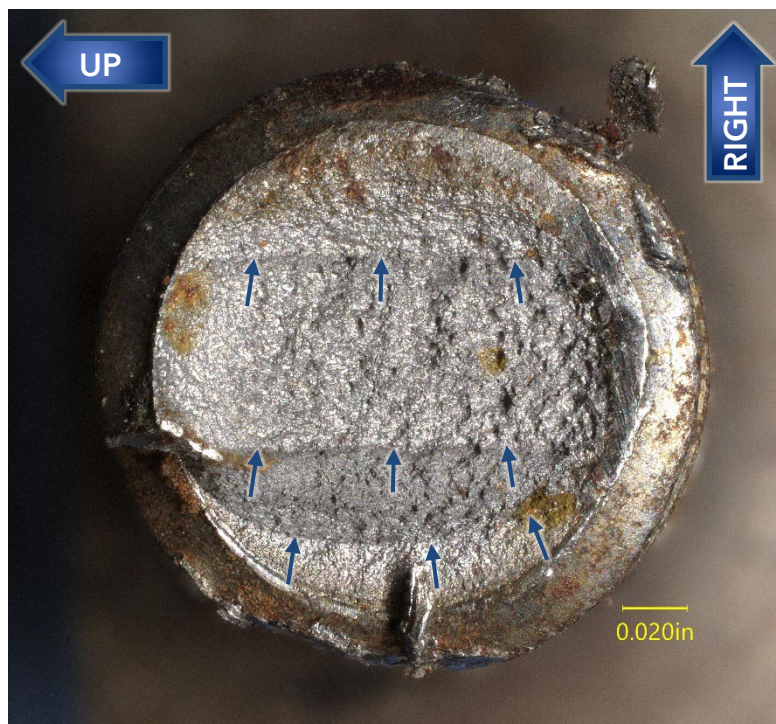
The aft side of the fracture was mostly obliterated by post-fracture damage, so additional examination focused on the forward (clevis) side of the fracture. An overall view of the clevis side of the fracture is shown in figure 3. A portion of the fracture surface on the left side had a more reflective appearance with a curving arrest line, features consistent with fatigue. The fracture features and curvature of the crack arrest lines were consistent with a broad origin area located at the left side of the fracture. Unlabeled arrows point to several crack arrest lines as the crack progressed through the cross-section. The first arrest line indicates the boundary of the relatively reflective region associated with fatigue. The middle portion of the fracture had rough, matte gray features consistent with ductile overstress fracture, and the second crack arrest line indicates a location where the upper side of the crack transitioned to the adjacent thread on the upper side of the fracture. A third arrest line was observed near the right side of the fracture as indicated with additional unlabeled arrows in figure 3. The remainder of the fracture on the right side had rough features with a more reflective appearance, and the outer edges of the fracture were deformed and smeared.

The middle portion of the fracture surface showed dimple features consistent with ductile overstress fracture up to the third crack arrest line indicated at the right side of the fracture in figure 3. To the right of the third crack arrest line, the fracture surface showed smeared dimple features shown in the overall SEM image of the right side of the fracture shown in figure 5. Closer to the right side, the smeared dimple features transitioned to flatter fracture features with coarse striations consistent with additional high-stress low-cycle fatigue crack propagation as shown by the lower image in figure 5. Smearing and deformation consistent with compressive contact damage was observed at the outer edge on the right and lower sides, contact damage that was not observed on the right side at the fatigue origin area.

**Figure 3.** Optical image of the clevis side of the fracture. Unlabeled arrows indicate fracture progression marks.

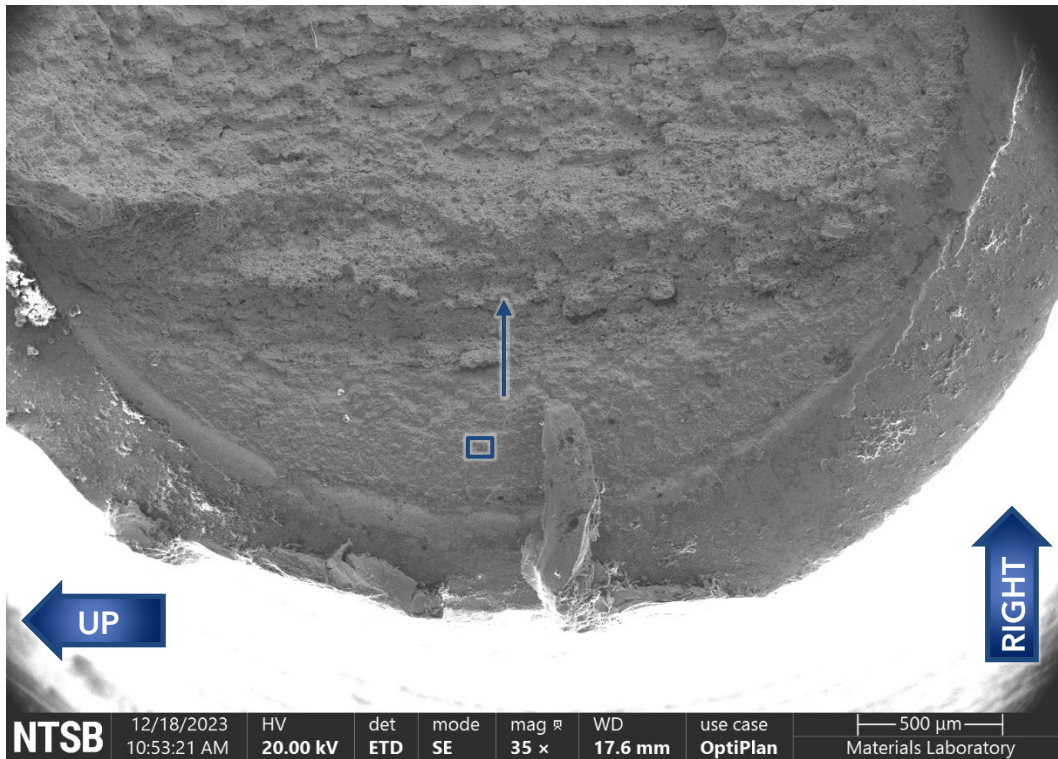
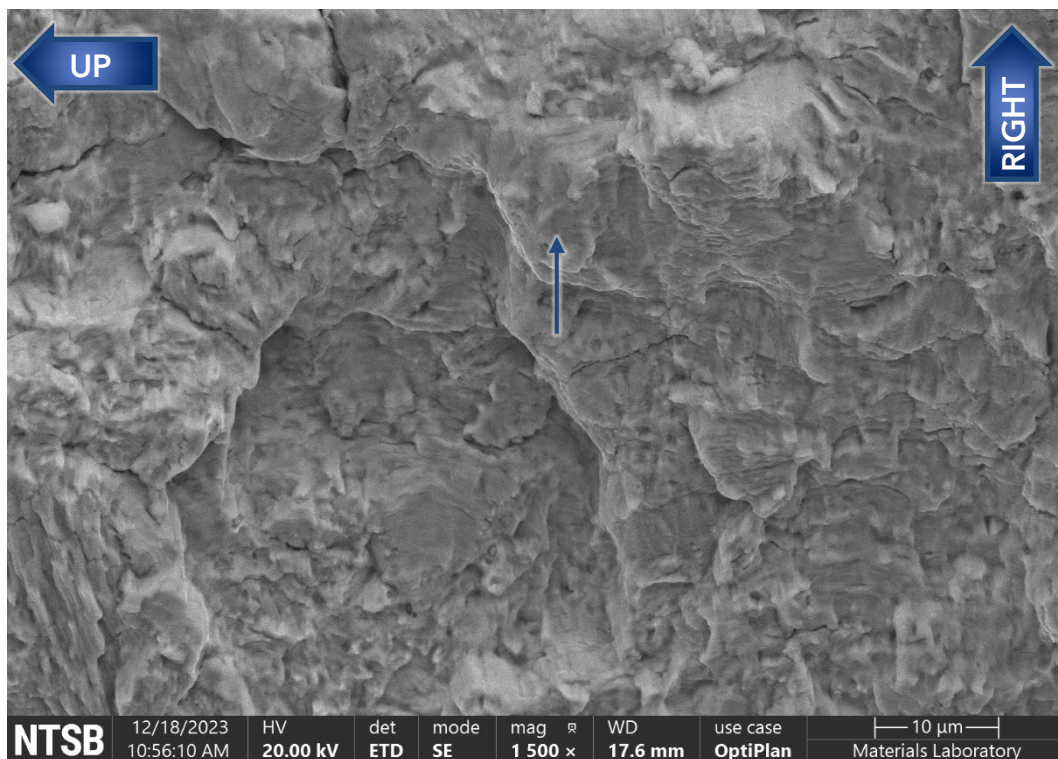
The fracture surface was further examined using a scanning electron microscope (SEM). SEM images of the fatigue region on the left side of the fracture are shown in figure 4. The fatigue features emanated from a broad origin area at the root of the thread and propagated preferentially along the thread root. Course striations and secondary cracking was observed at higher magnifications shown in the lower image in figure 4, features consistent with a relatively high-stress low-cycle fatigue fracture mechanism extending to the first crack arrest line shown in figure 3.

**Figure 4.** SEM image of the left side of the fracture (upper image) with a closer view of progressive fracture features near the origin area (lower image). The lower image shows features in the rectangular area marked on the upper image. Unlabeled arrows indicate the general fracture propagation direction.

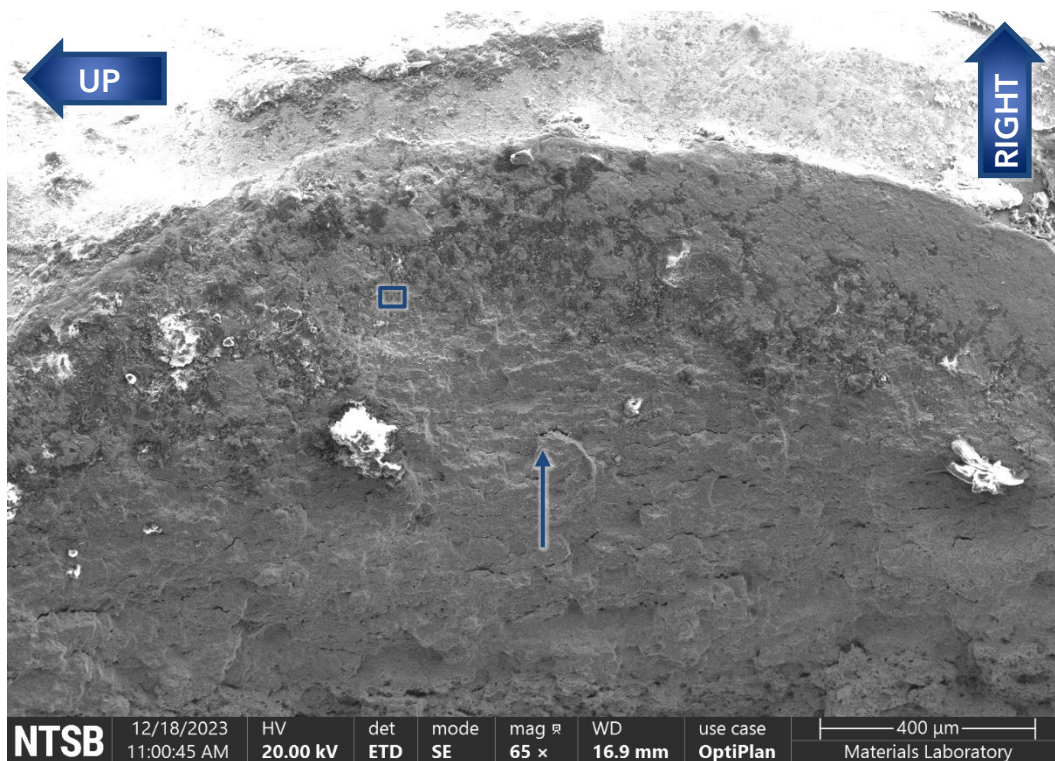
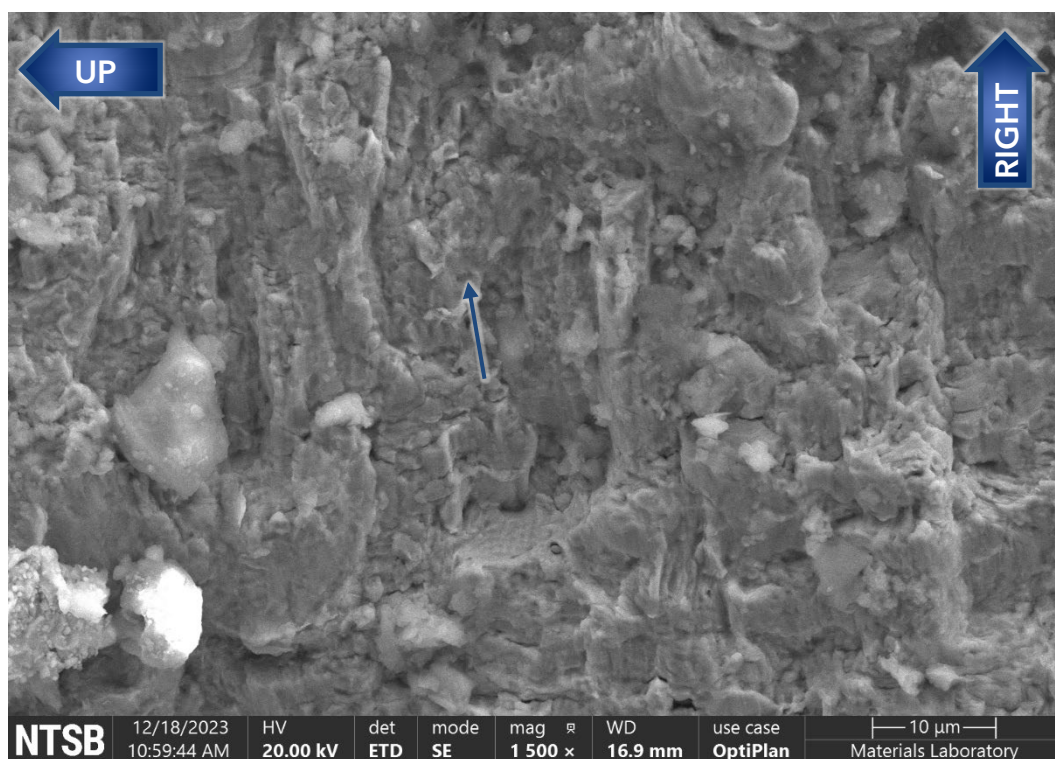
**Figure 5.** SEM image of the right side of the fracture (upper image) with a closer view of progressive fracture features near the right side of the fracture (lower image) in the rectangular area marked on the upper image. Unlabeled arrows indicate the general fracture propagation direction.
