WPR24LA038

## INVESTIGATION PHOTOGRAPHS

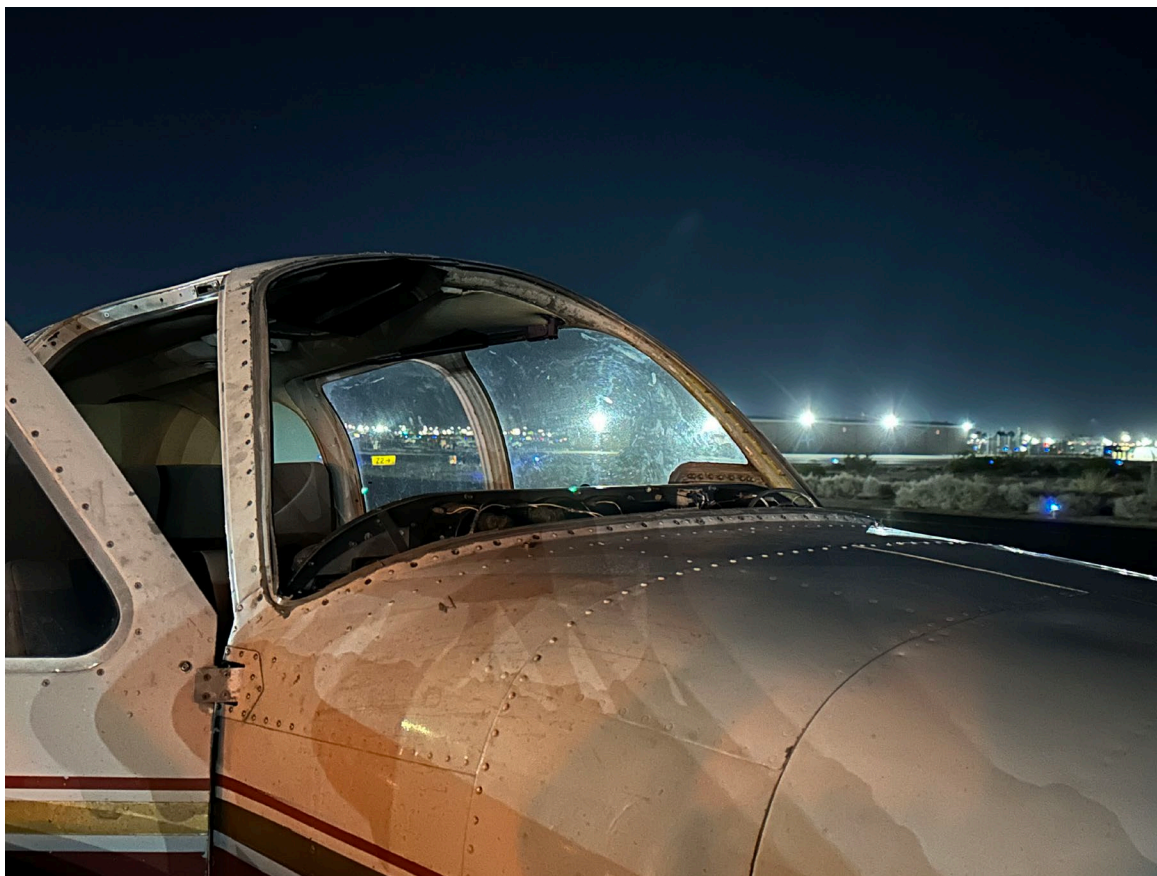
**Photograph 1 - Front view of accident airplane with missing windshield (Courtesy of FAA)**

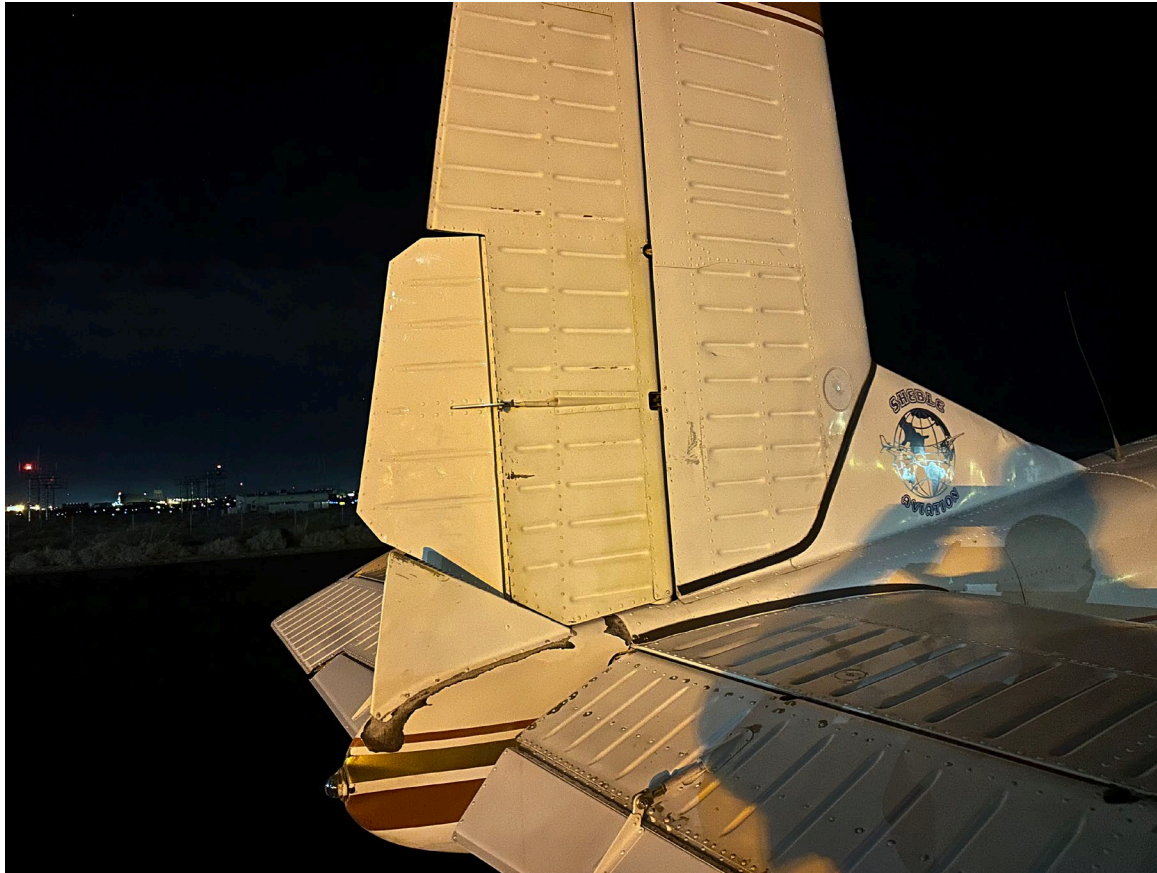
**Photograph 2 - View of accident airplane empennage (Courtesy of FAA)**

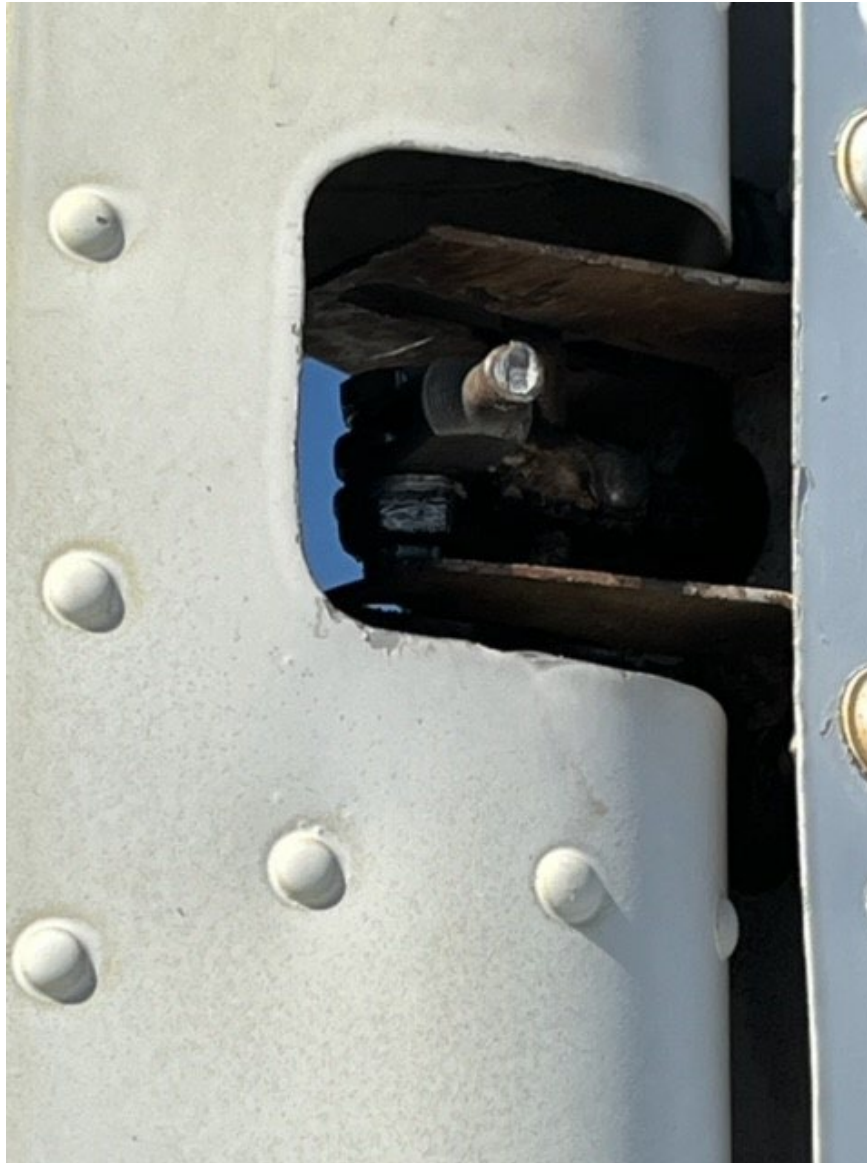
**Photograph 3 - View of broken rudder trim tab rod end (Courtesy of FAA)**
