# National Transportation Safety Board

WPR24LA039

## **AIRFRAME & ENGINE EXAMINATION SUMMARY**

Location: Woodland, Washington  
Date: 11/18/2023  
Time: 1522 Pacific standard time  
Airplane: N6266K Cessna 150M

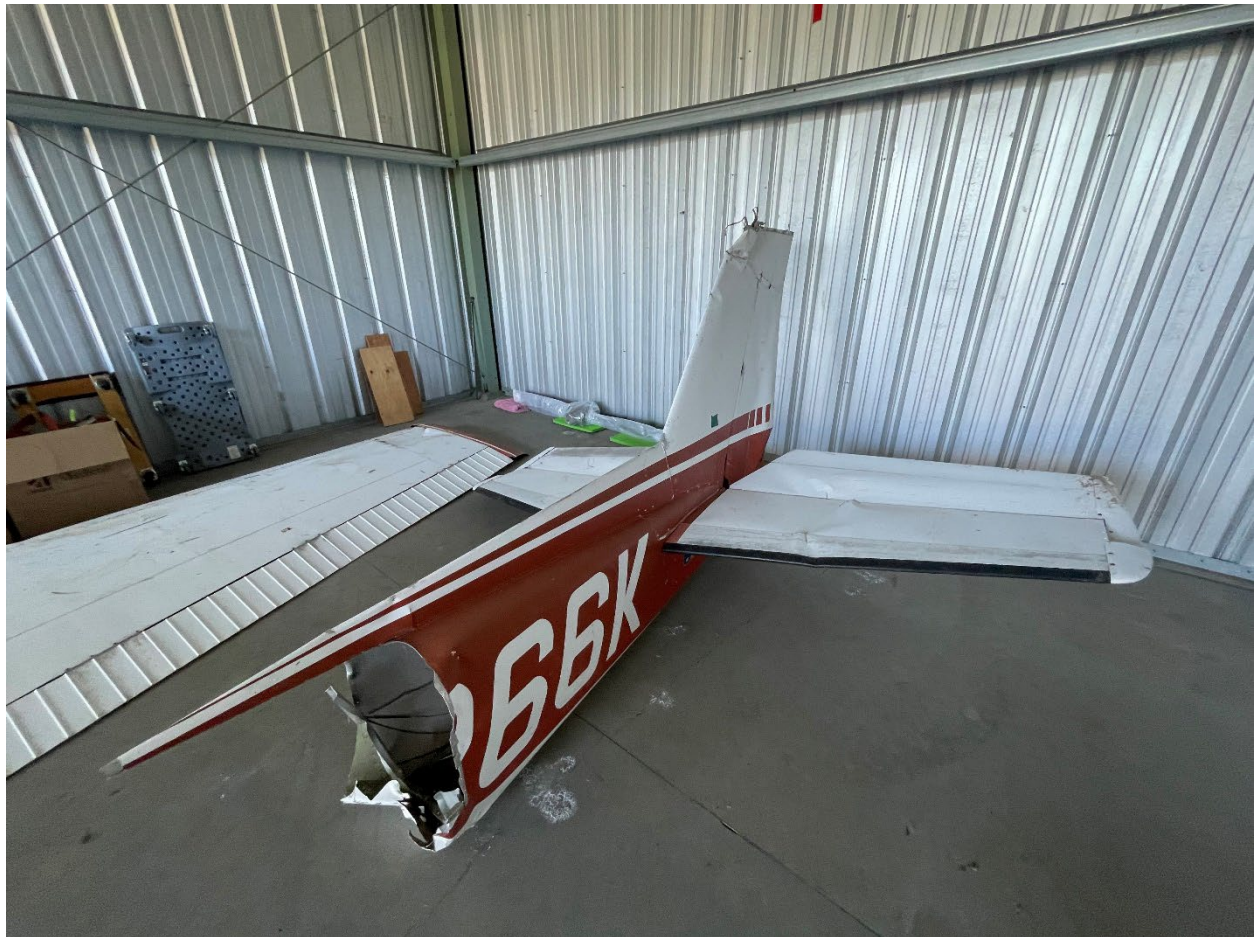
Both left and right horizontal stabilizers and elevators remained secured to its mounting point. The rudder remained attached with compression damage to its upper section, consistent with a nose-over. The control cables were cut during the recovery. Control continuity was confirmed from the flight control surfaces to the cockpit controls.

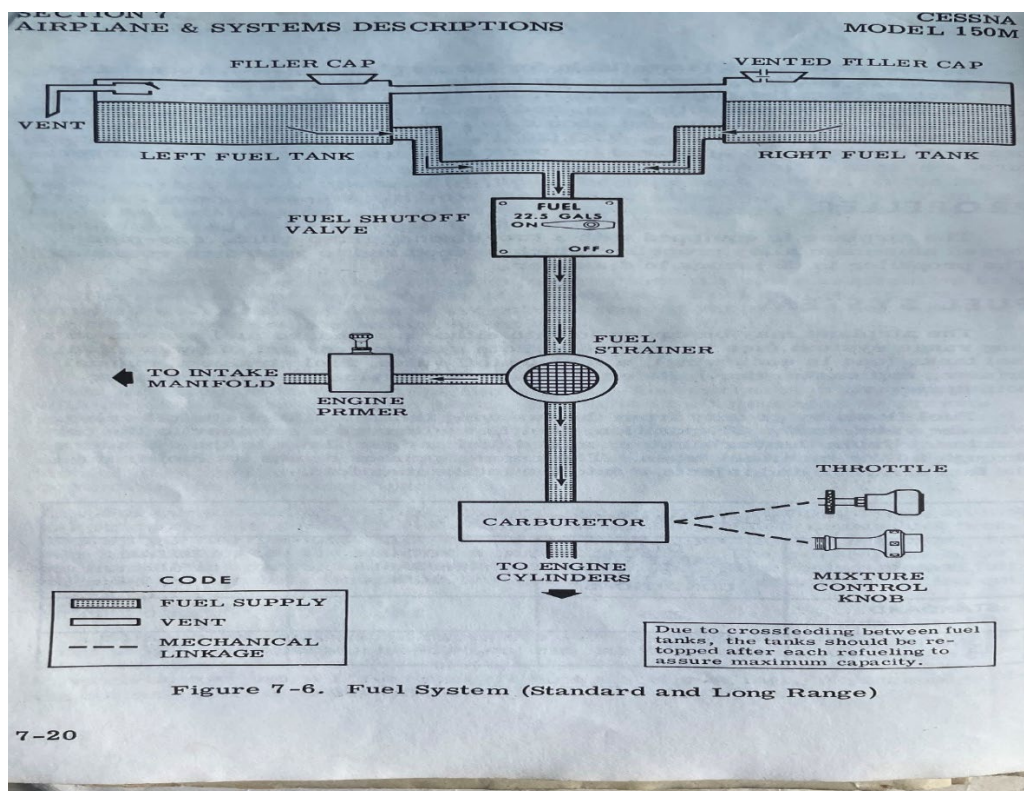
The airplane was equipped with two vented fuel tanks, a fuel shut off valve, fuel strained, manual primer, and carburetor. Fuel flow continuity was confirmed from each wing tank to the engine using compressed air. The fuel shutoff valve in the cockpit was found in the open position. The fuel filter bowl remained secured to its mount. Its removal revealed that the bowl had about 2 oz of fuel consistent with 100LL avgas; the filter was free of debris. The manual primer remained secured. The recovery company reported that they did not recover any fuel from the airplane.
