# National Transportation Safety Board

WPR24LA046

## **PROPELLER EXAMINATION SUMMARY REPORT**

Location: Big Bear City, California  
Date: December 2, 2023  
Time: 1400 Pacific Standard Time  
Airplane: Cessna P-210N

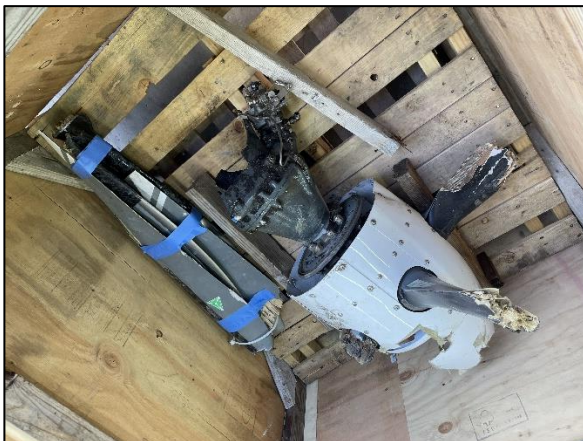
The undamaged shipping container was opened, and the propeller components were secured to the bottom side of the container. The forward end of the beta rod was bent to one side and cut from the forward end of the propeller hub. The beta rod was driven through the propeller with a hammer and punch to facilitate the removal of the gear box section from the propeller hub.

**Figure 1-Shipping container contents.**

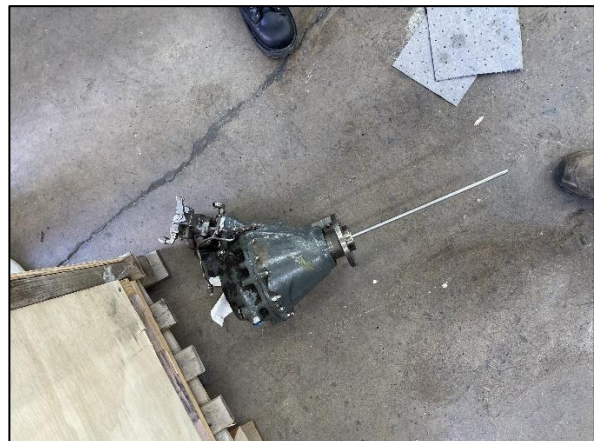
**Figure 2-Gearbox and beta rod sections.**

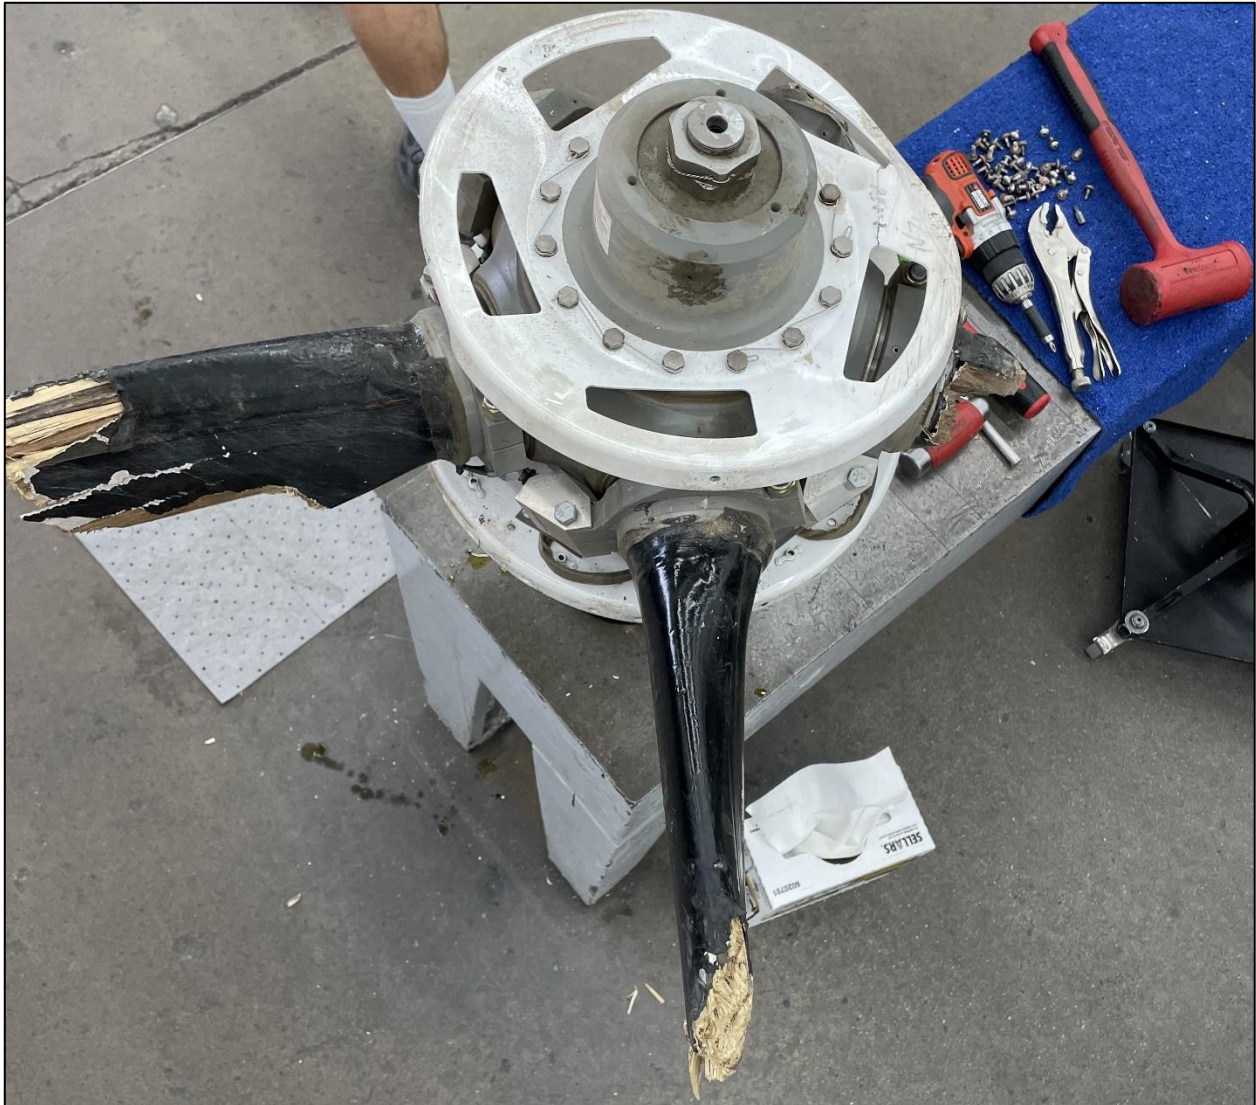
The propeller spinner had impact damage and was removed from the hub. The propeller hub was attached to a test bench and the beta rod forward port was plugged. The No. 1 blade had about 12 inches of blade material remaining. The No. 2 blade had about 10 inches of blade material remaining. The Nos. 3, 4 and 5 blades all had about 1 inch of blade material remaining. The No. 5 blade snap ring and spacer were damaged.

**Figure 3-Propeller assembly attached to a test bench.**

About 150 psi of air pressure was added to the propeller hub from the test bench and the blades rotated slowly in unison to near the reverse position. The spinner forward plate was damaged and was making contact with a blade counterweight.

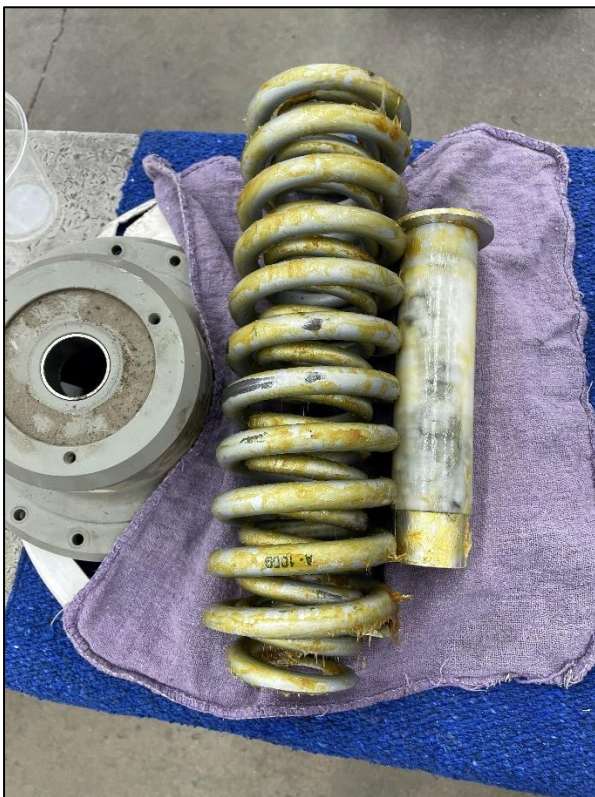
**Figure 4-Propeller hub springs.**

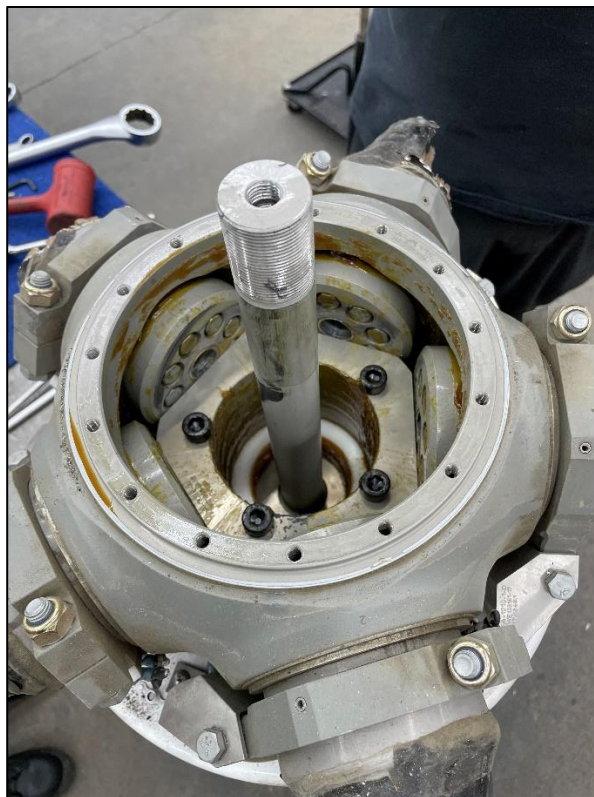
The top cover was removed from the hub and all internal components were covered in yellow colored grease. Normal rubbing of internal parts was noted. The piston extension and pitch change blocks and spacers were removed and undamaged. The propeller blades were removed normally from the hub and the ball bearings and bearing races were covered heavily in bearing grease. The ball bearings and races showed normal operation and no spalling signatures were noted.

**Figure 5-Propeller hub and internal components.**
