# National Transportation Safety Board

WPR24LA046

## **WRECKAGE EXAMINATION SUMMARY REPORT**

Location: Big Bear City, California  
Date: December 2, 2023  
Time: 1400 Pacific Standard Time  
Airplane: Cessna P-210N

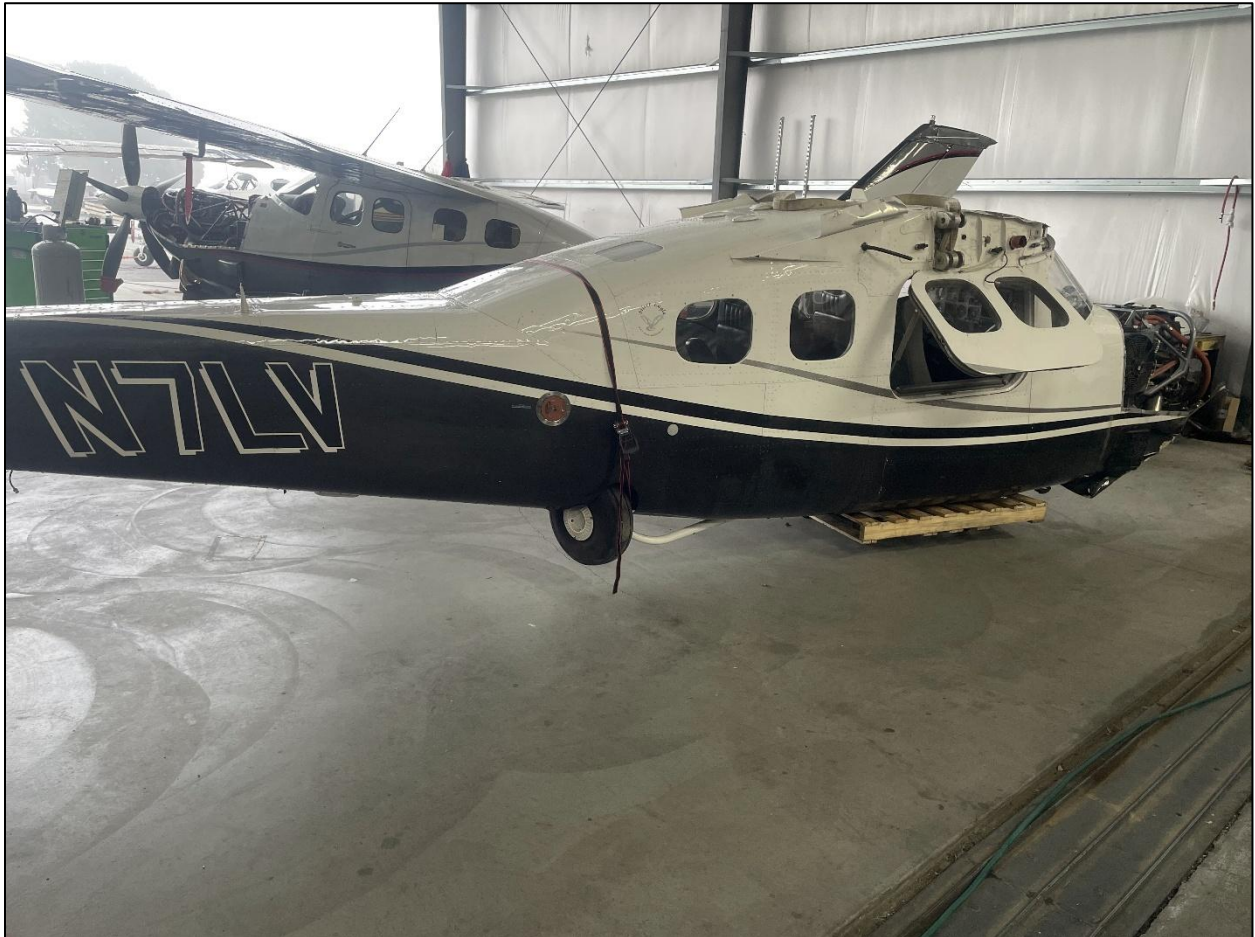
The airplane was located in a hangar for the examination. The wings, vertical and horizontal stabs, rudder, elevators and flaps were removed and displayed on the ground for the examination. The landing gear was found in the retracted position and the selector handle was positioned in the retracted position. The fuselage and engine were positioned on a rolling pallet. The upper cowling was removed and there was impact damage to the lower cowling and fuselage. The nose landing gear separated, and a section of the oleo and linkage remained attached. The main landing gear was in the retracted position. The left wheel assembly separated from the axel attachment point. The propeller gear box and the propeller assembly separated from the engine. Three of the propeller blades separated near the hub. The two other propeller blades separated about 10 inches from the hub. The two blades appeared to be in a feathered blade position. Four of the blade sections were found with the wreckage.

Two of the blades showing leading edge damage were broken at the root. It was later known that the pilot had retained one of the separated propeller blade sections from the accident site.

**Figure 1-Follow-up examination, main wreckage.**

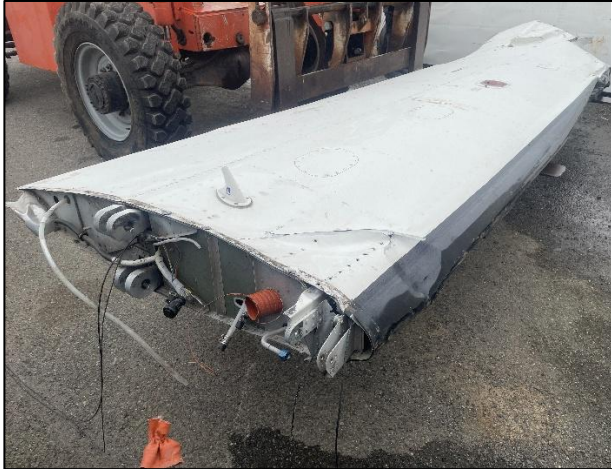
The left tip tank separated from the wing. The left tip tank vent line separated from the tank and was unobstructed. The right tip tank was intact and the vent was unobstructed. The wing main fuel tanks vents were unobstructed. The vented fuel tank caps (4) were examined and were unremarkable. The fuselage aux tank unvented cap and was unremarkable. The cap gaskets were unremarkable.

Aileron flight control continuity was established on both wings. Flap cable continuity was established and the flap push rods were intact. The flap actuator was found near zero degrees. Elevator trim was undetermined. Elevator and rudder cable continuity was established.

**Figure 2-Left wing.**

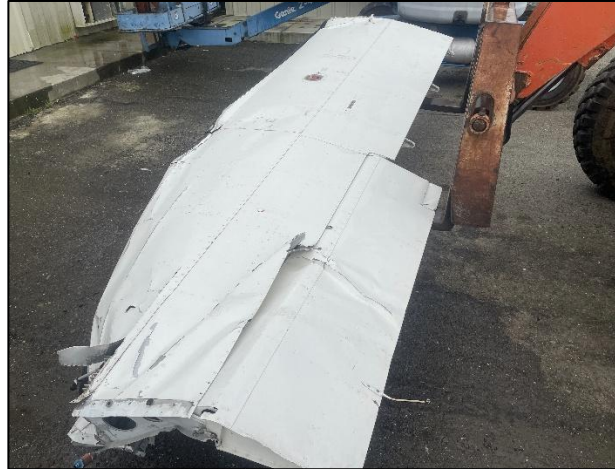
**Figure 3-Right wing.**

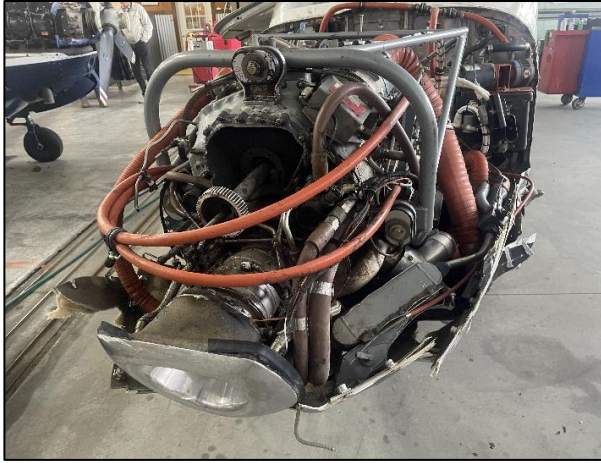
The engine remained attached to the airframe and the propeller and gear box separated. The engine and cradle assembly was bent downward. The right exhaust pipe was crushed upwards. The left exhaust assembly was crushed upwards. The rear side of the outer combustion case was crushed by the engine mount cross bar.

**Figure 4-Engine assembly and forward fuselage.**

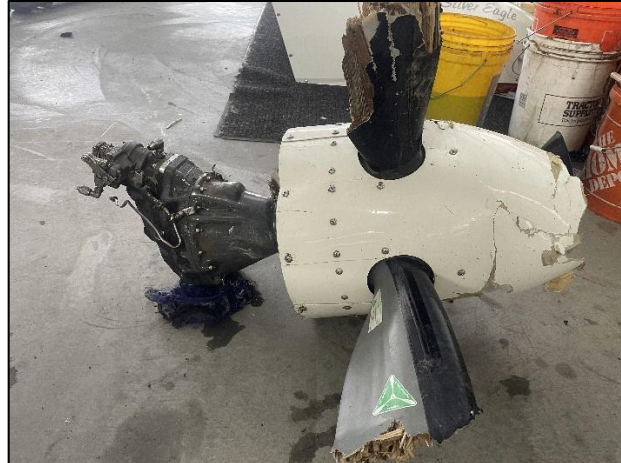
The propeller housing was fractured exposing the planetary gear set and internal surfaces. The interior surfaces were covered with oil and dirt.

**Figure 5-Propeller and gearbox assemblies.**
