**National Transportation Safety Board**

WPR24LA046

**EXAMINATION SUMMARY**

Woodward 8210-140 (s/n 15226599)

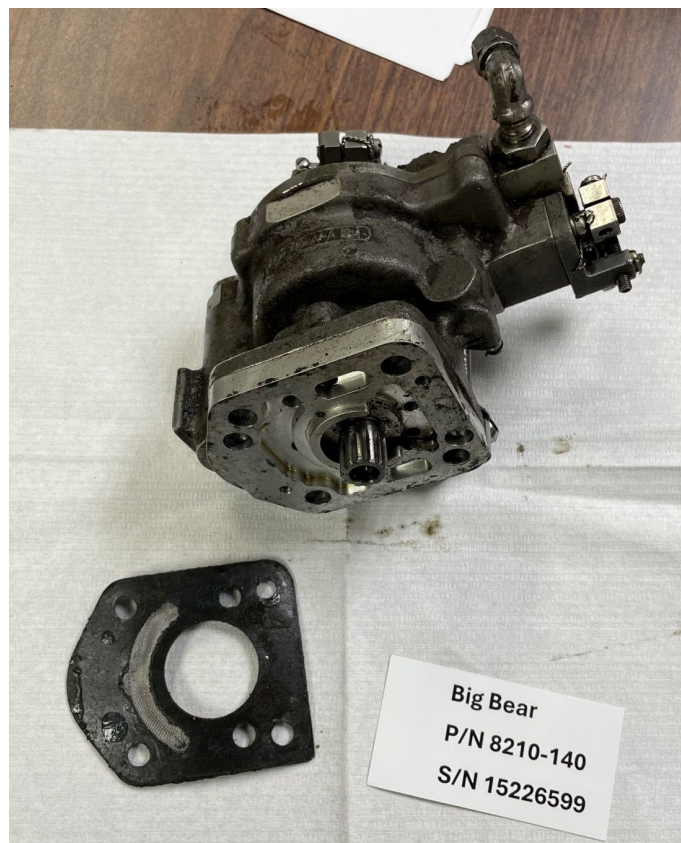
The propeller governor was received in a sealed carton. The unit exhibited impact related damage such as localized gouges on the housing, bent fittings, and a

broken off max speed lever.<sup>1</sup> The driveshaft and air bleed lever appeared undamaged and rotated freely using hand pressure. The brass relief valve seal is damaged. Installed lockwire, lockwire seals, and torque sealant were not from the manufacturer. The customer-installed Py inlet fitting was secure but was damaged and bent.<sup>2</sup> A third-party linkage remained attached to the bleed air lever.

Figure 2 - Propeller Governor (As Received)

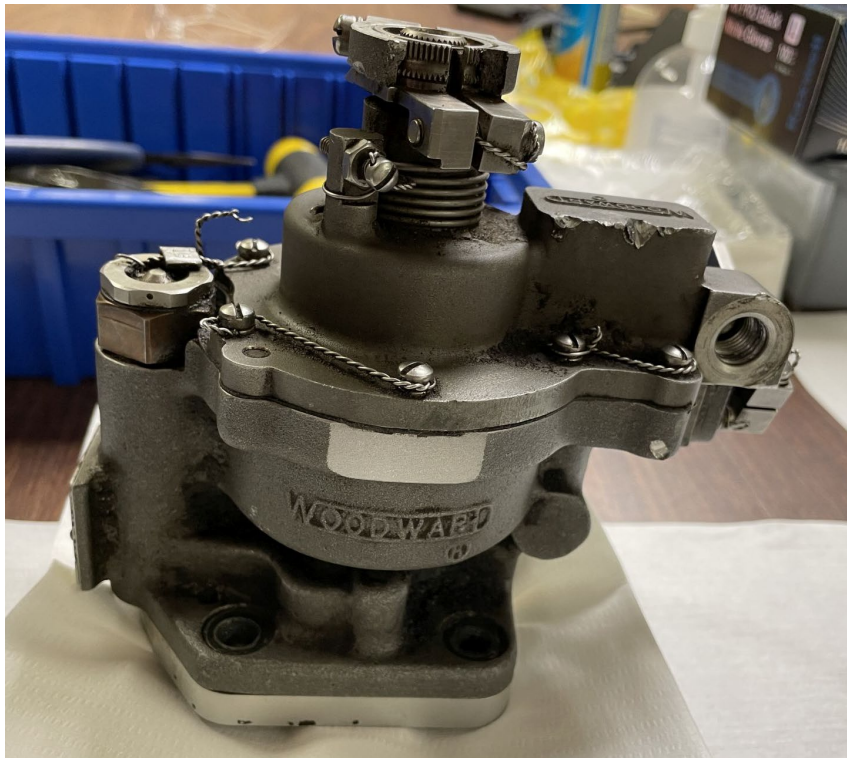
*Figure 3 -- Propeller Governor (As Received)*

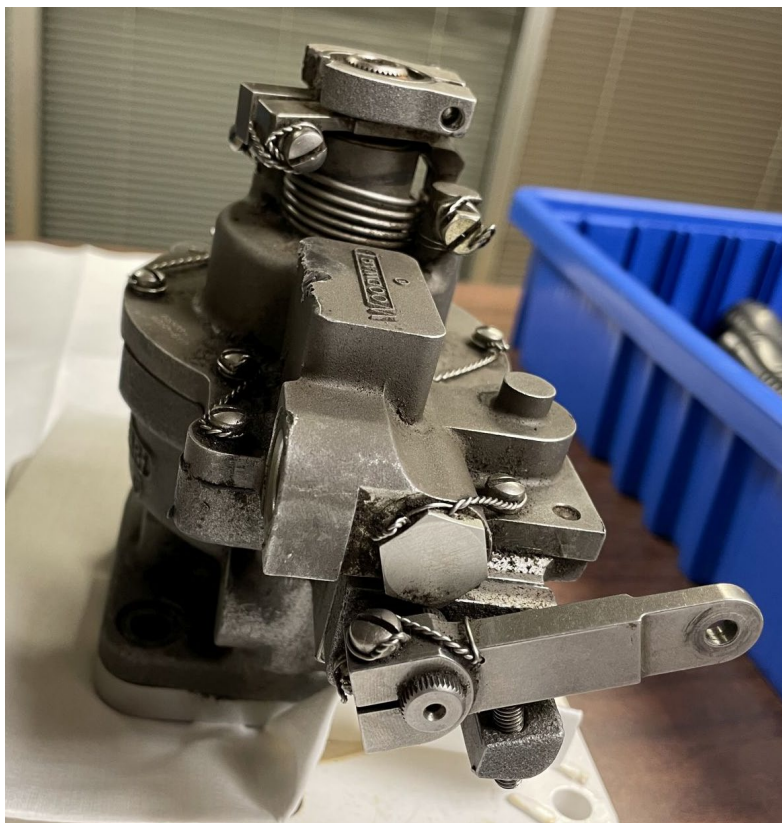
*Figure 4 -- Propeller Governor (As Received)*

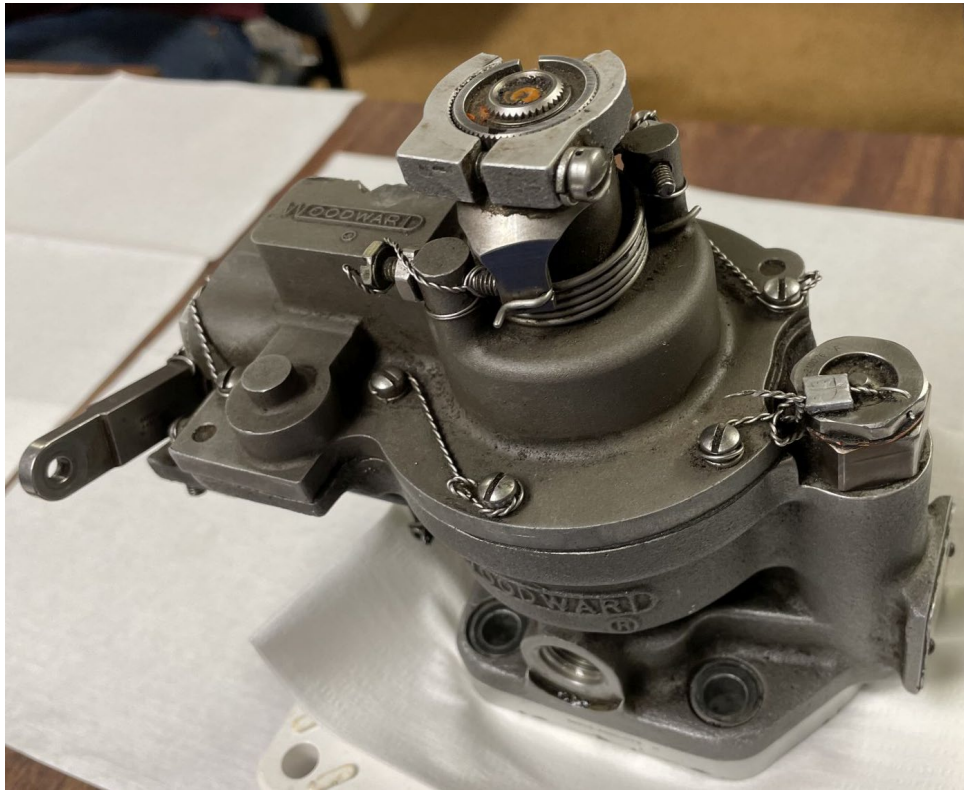
Figure 5 -- Propeller Governor (As Received)

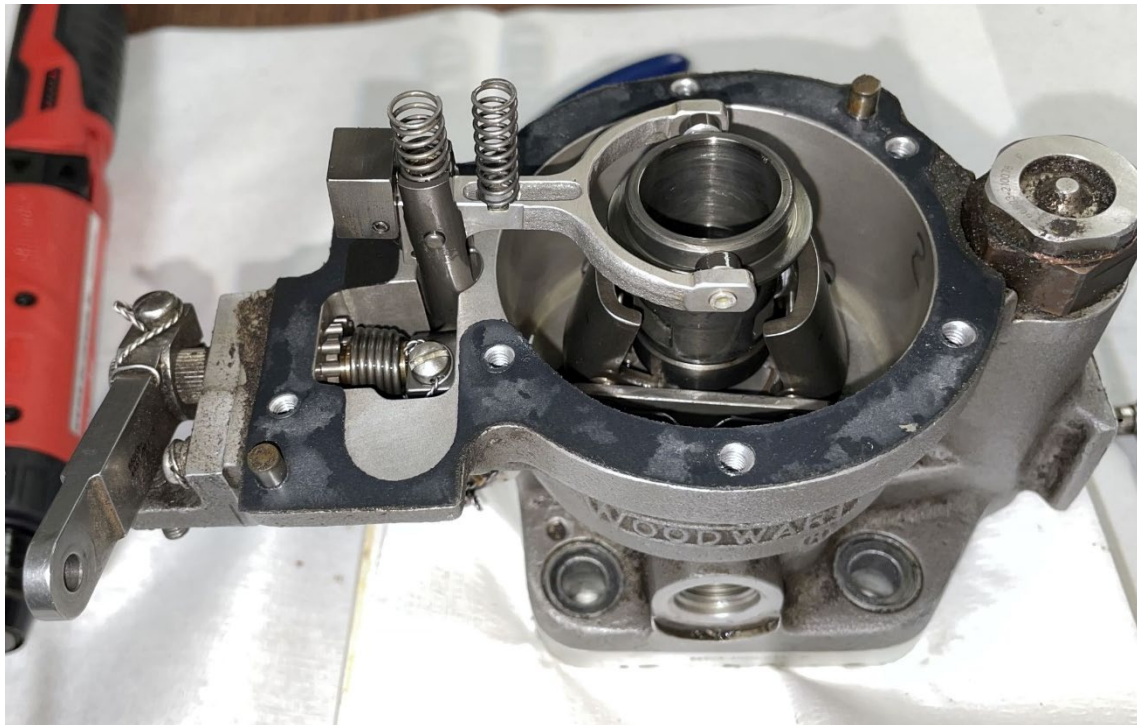
The unit was disassembled; however, no anomalies were identified. The unit was free of debris or sediment. All internal detail parts appeared undamaged.

Figure 6 -- Propeller Governor (With Cover Removed)

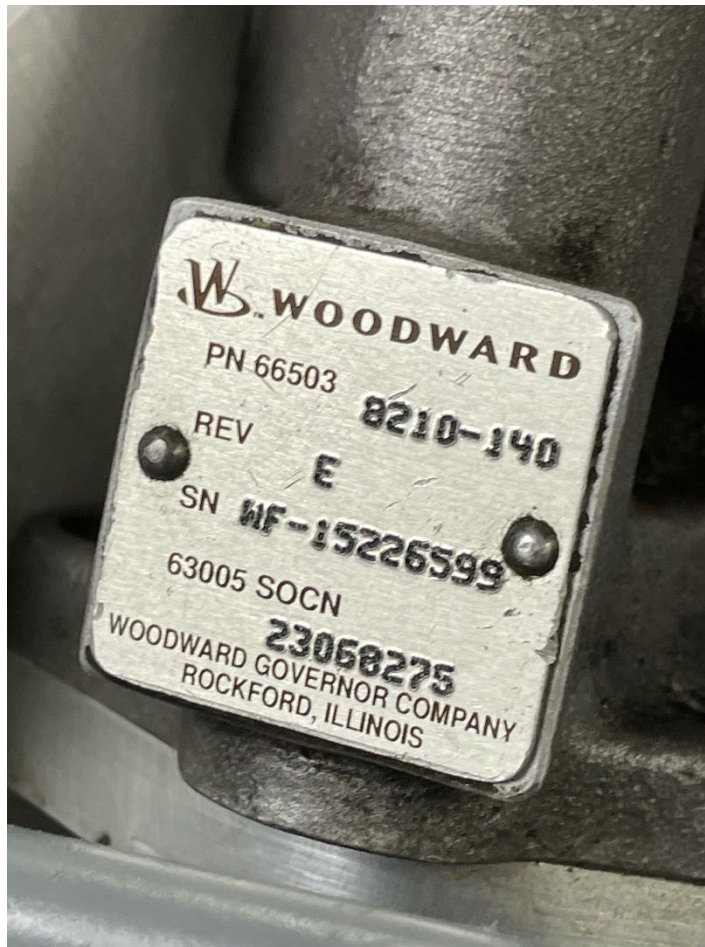
Figure 7 -- Data Plate

The data plate was secure and denoted as Woodward which included the part and serial numbers, and revision "E".
