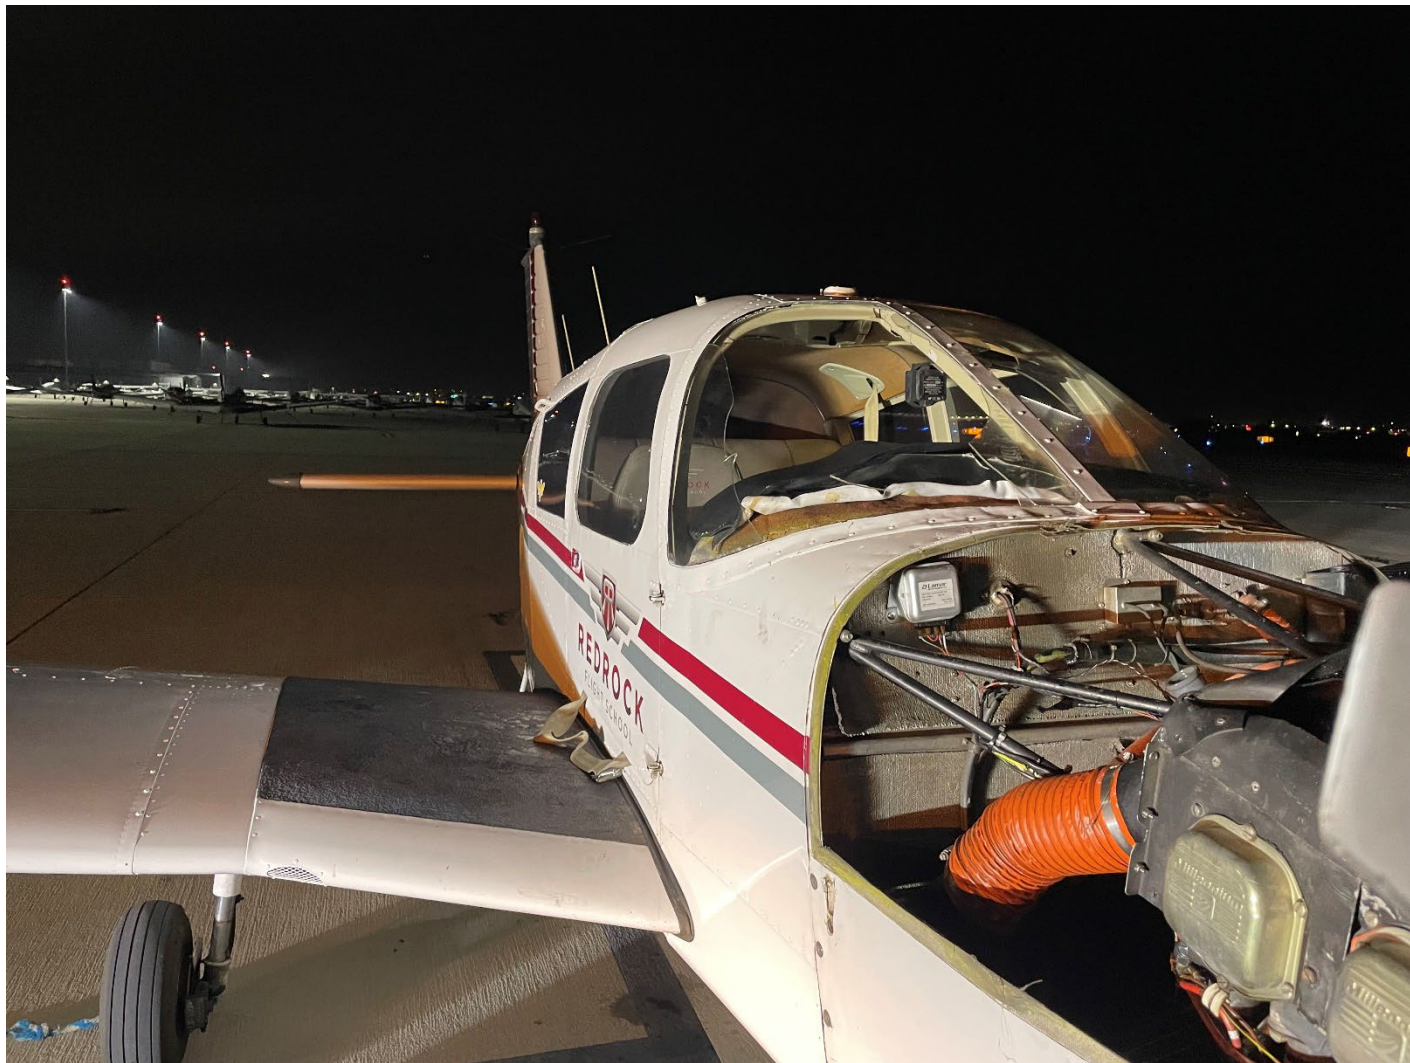
**Photo 1 – View of damage to windscreen (Courtesy of FAA)**

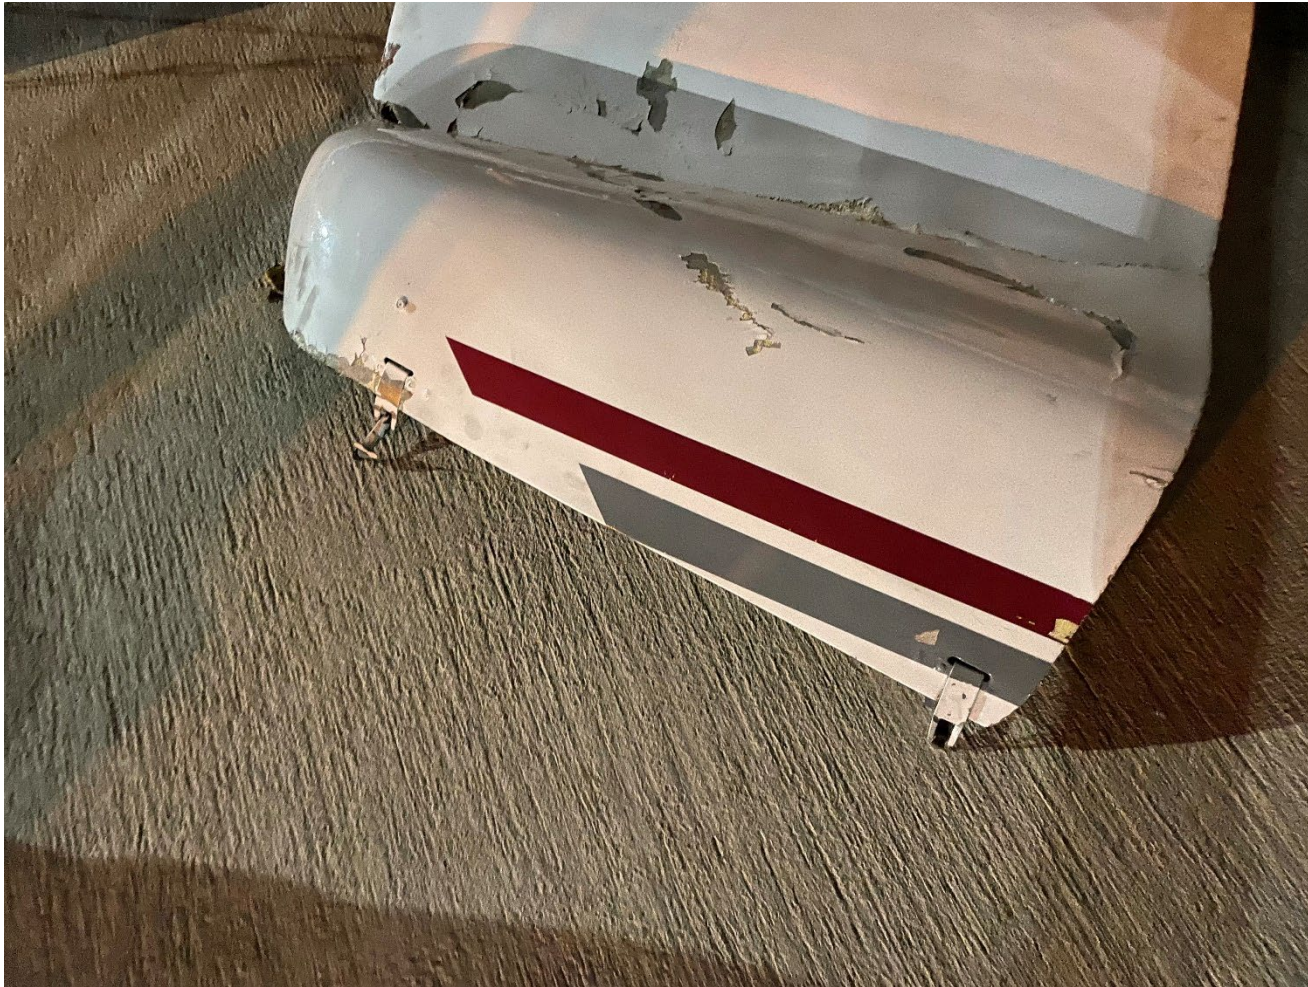
**Photo 2 – View of left side engine cowling (Courtesy of IIC)**

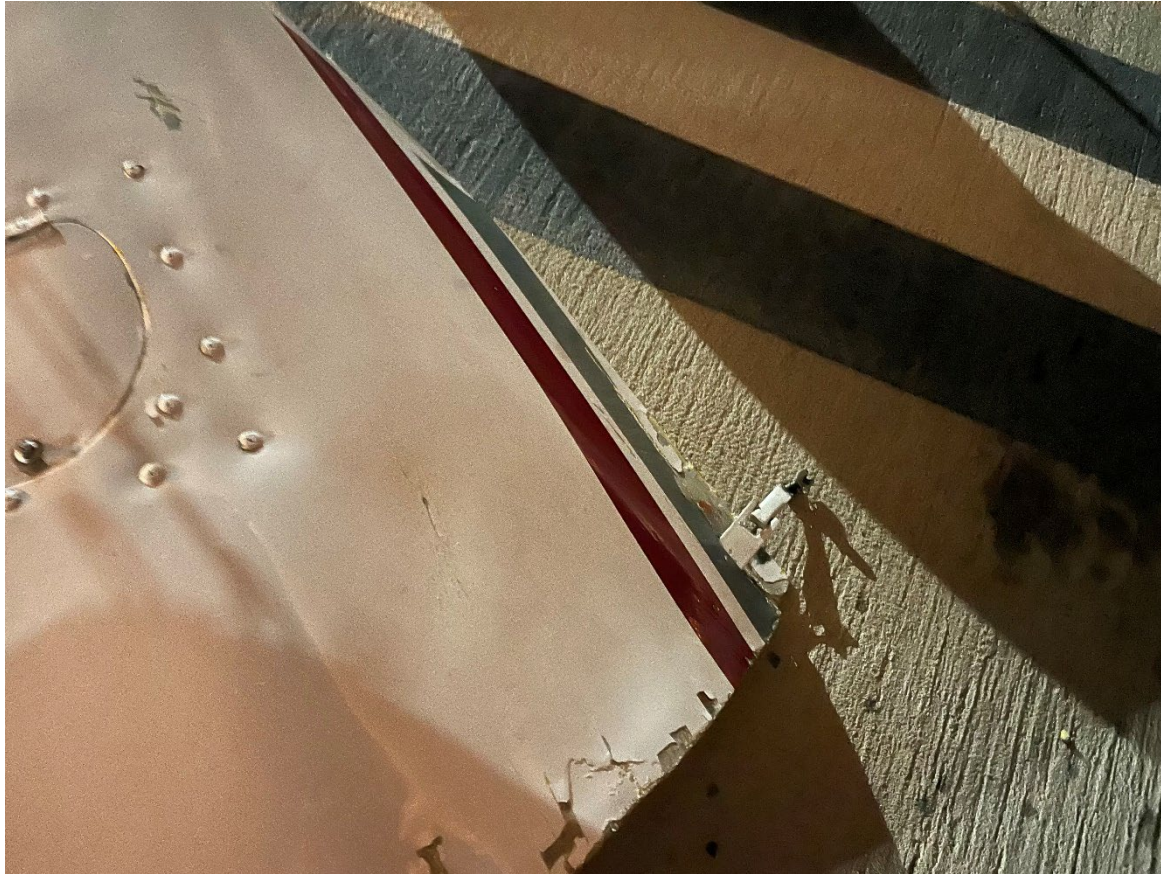
**Photo 3 – View of right side cowling pin failure (Courtesy of FAA)**

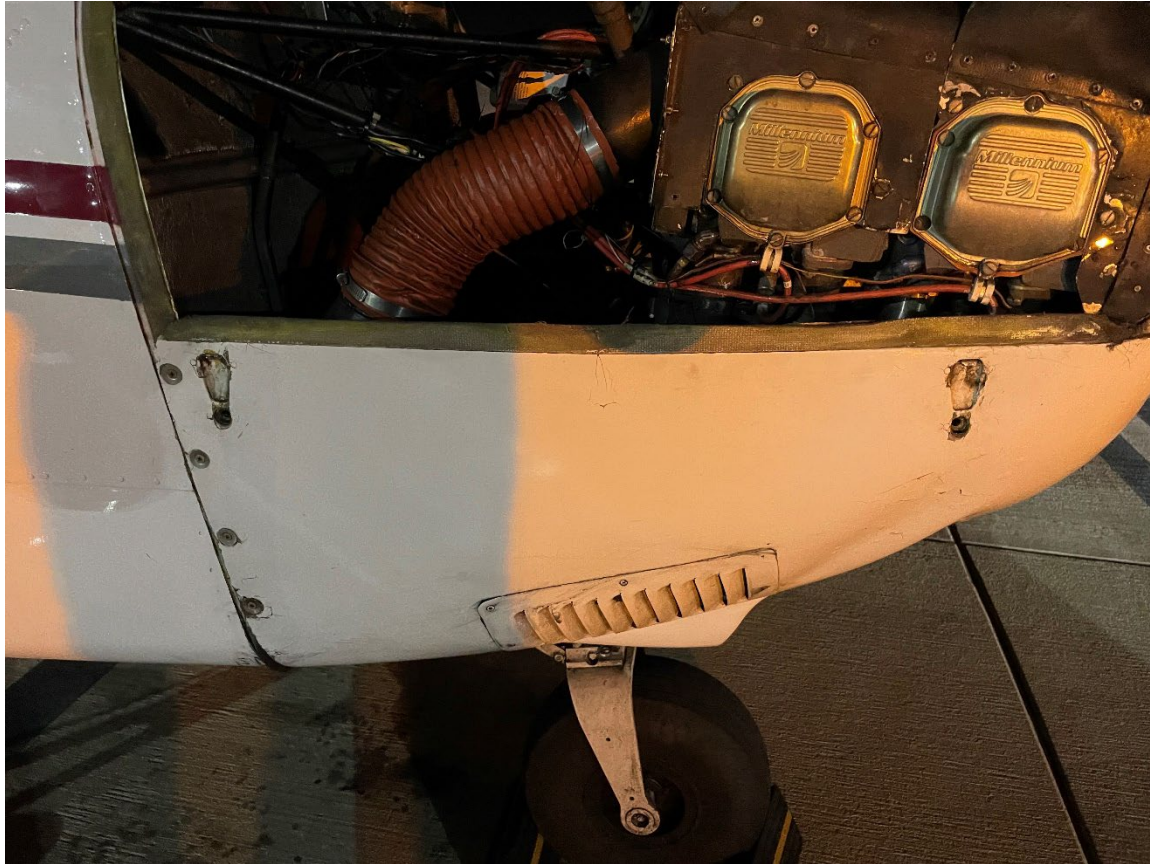
**Photo 4 – View of right side cowling attachment composite failure (Courtesy of FAA)**
