# National Transportation Safety Board

WPR24LA060/193573

## **EXAMINATION SUMMARY**

Location: Carlin, Nevada  
Date: December 21, 2023  
Time: 1210pst  
2010utc  
Airplane: MOONEY - M20J - N2073K

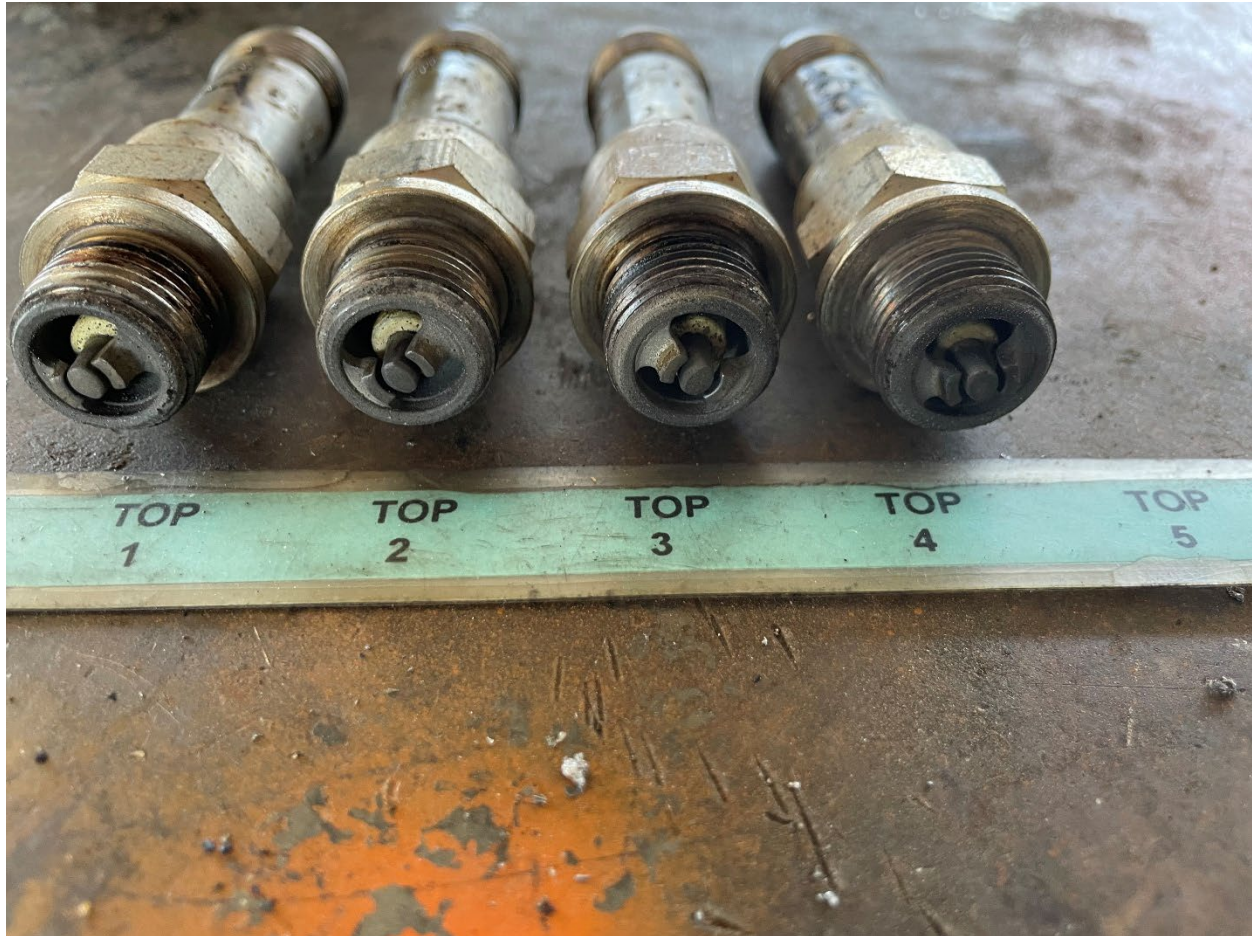
**Figure 1:** Forward to aft view of top spark plugs

The spark plugs were secure at each position with their respective spark plug lead attached. The top spark plugs were removed, examined and revealed equal wear with no visible abnormalities. The spark plug electrodes remained mechanically undamaged, and according to the Champion Spark Plugs Check-A-Plug Chart AV-27, the spark plug electrodes displayed coloration consistent with normal operation. The magneto impulse coupling could be heard via audible clicking. The ignition harness was attached at the magneto cap and each spark plug.

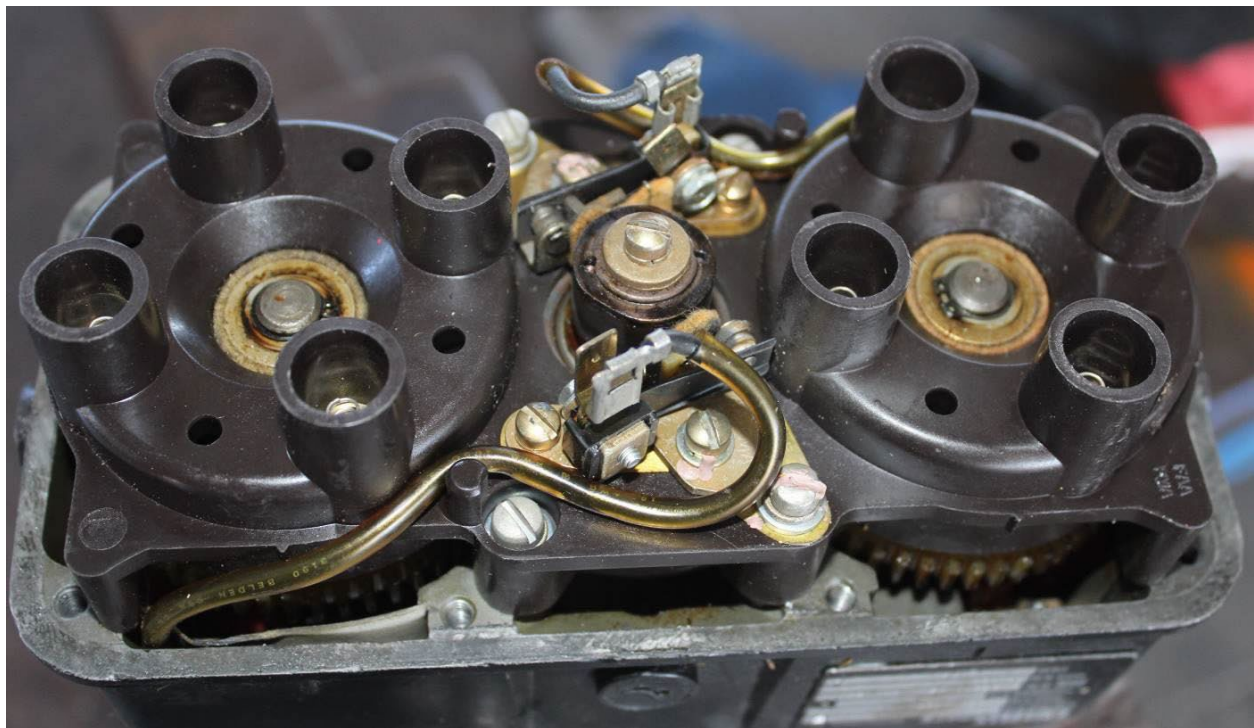
The single drive dual magneto was found securely clamped at the mounting pad. The impulse coupling was heard clicking near top dead center (TDC) during rotation of the crankshaft. The magneto to engine timing was checked utilizing a timing synchronizer box, by advancing the No. 1 cylinder piston to 20° before TDC. However, the timing synchronizer box would not produce an audible tone to indicate that either of the contact assemblies were open. The single drive dual magneto did not produce spark at any of the ignition leads and was removed for further examination. The magneto distributor housing was removed; the cam drive was rotated by hand and found that neither of the contact assemblies was functioning. The contacts did not appear burnt and the plastic cam follower foot was intact and showed no evidence of heat distress. There was no evidence of internal mechanical malfunction of the internal gears. The wiring within the magneto appeared normal. The magneto cap internal surfaces and wires remained free of oil residue or evidence of arcing. A definitive magneto service history could not be determined from available maintenance records.

**Figure 2:** Top view of single drive dual magneto

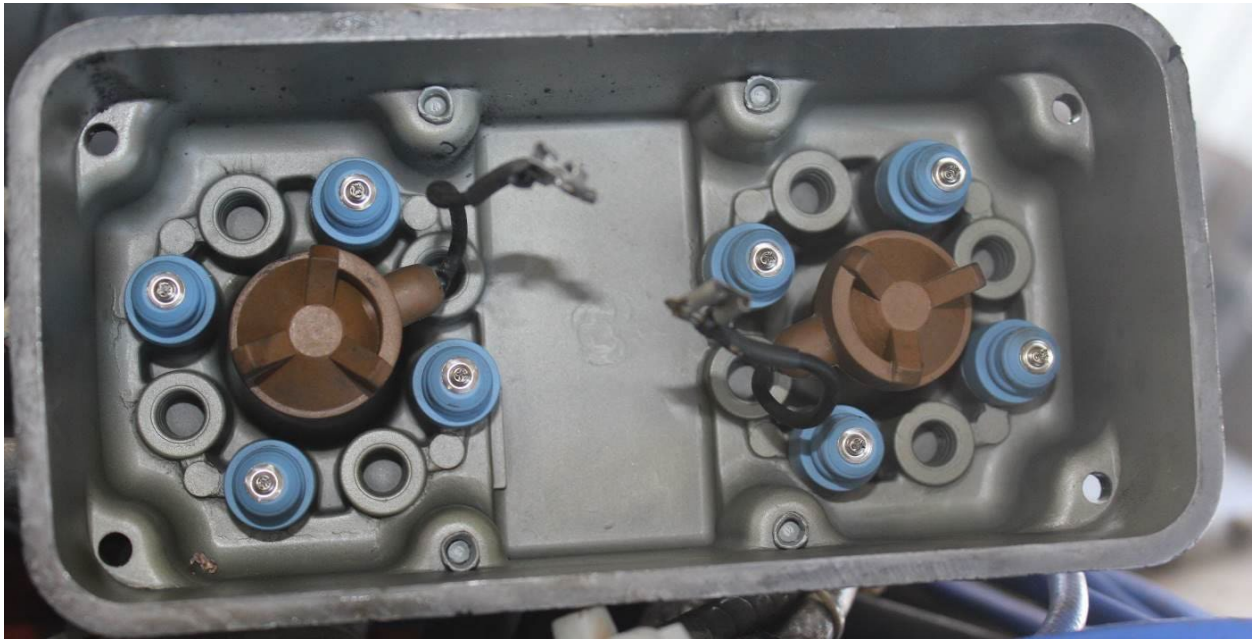
The magneto was shipped to the manufacturer, and a bench test was completed. The bench test revealed that the right magneto produced a spark to each of the four ignition leads. The left magneto did not produce a spark to any of the four ignition leads. The magneto distributor housing was removed for further examination and revealed that the right magneto cam follower was engaging the cam, thus allowing the contact assembly breaker points to open when the cam lobe lifted the cam follower, contact assembly frame bracket and breaker point. However, the left magneto cam follower was not engaging the cam.

**Figure 3:** Inside view of the single drive dual magneto distributor housing

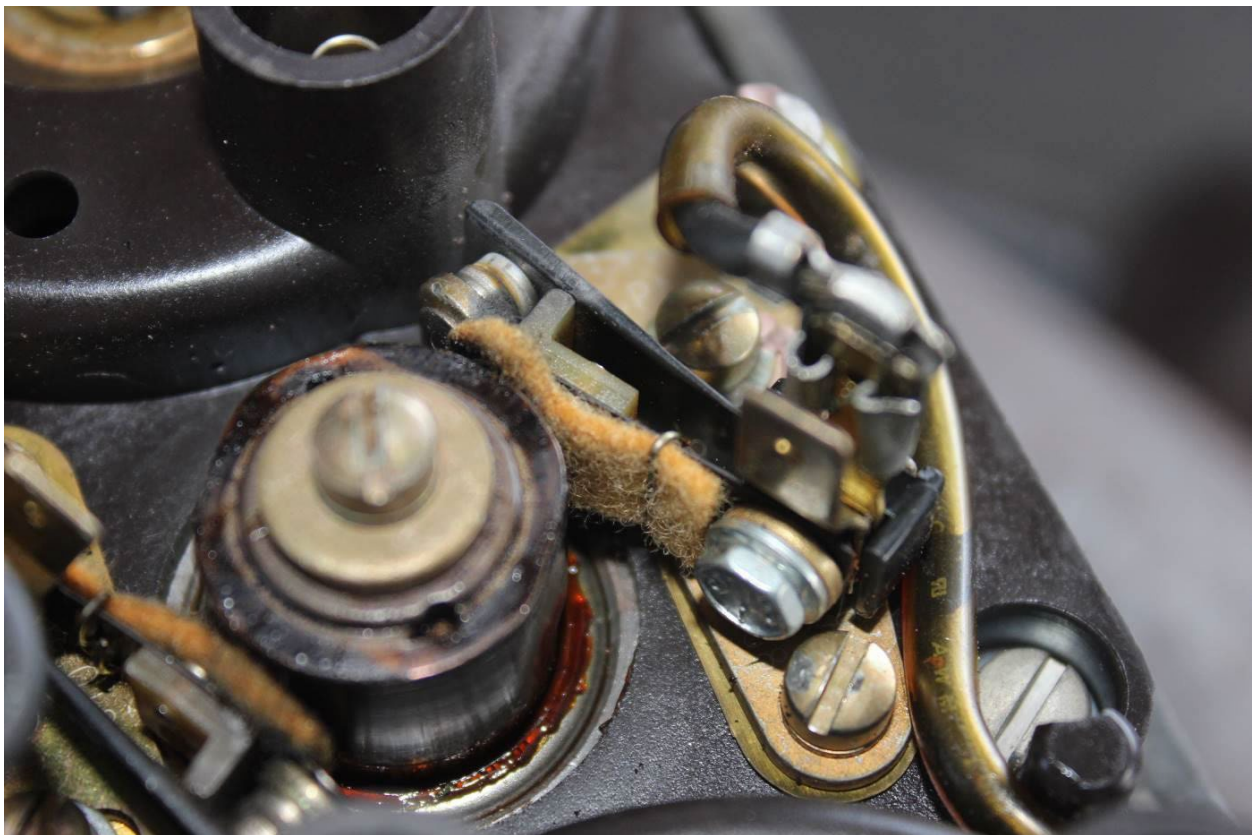
With the timing synchronizer box positive wire attached to the right magneto capacitor spade terminal and with a proper ground connection assured, the single drive was rotated by hand, and the cam was observed in rotation. However, the cam follower would not engage the main breaker point frame bracket, thus allowing the breaker points to open or close. Subsequently, the contact assembly breaker points were manually separated using a screwdriver to lift the main breaker point frame bracket, separating the main breaker point from the retard breaker point, which produced a corresponding audible tone from the synchronizer box and the green light was not illuminated.

**Figure 4:** View of the right magneto breaker points contact assembly

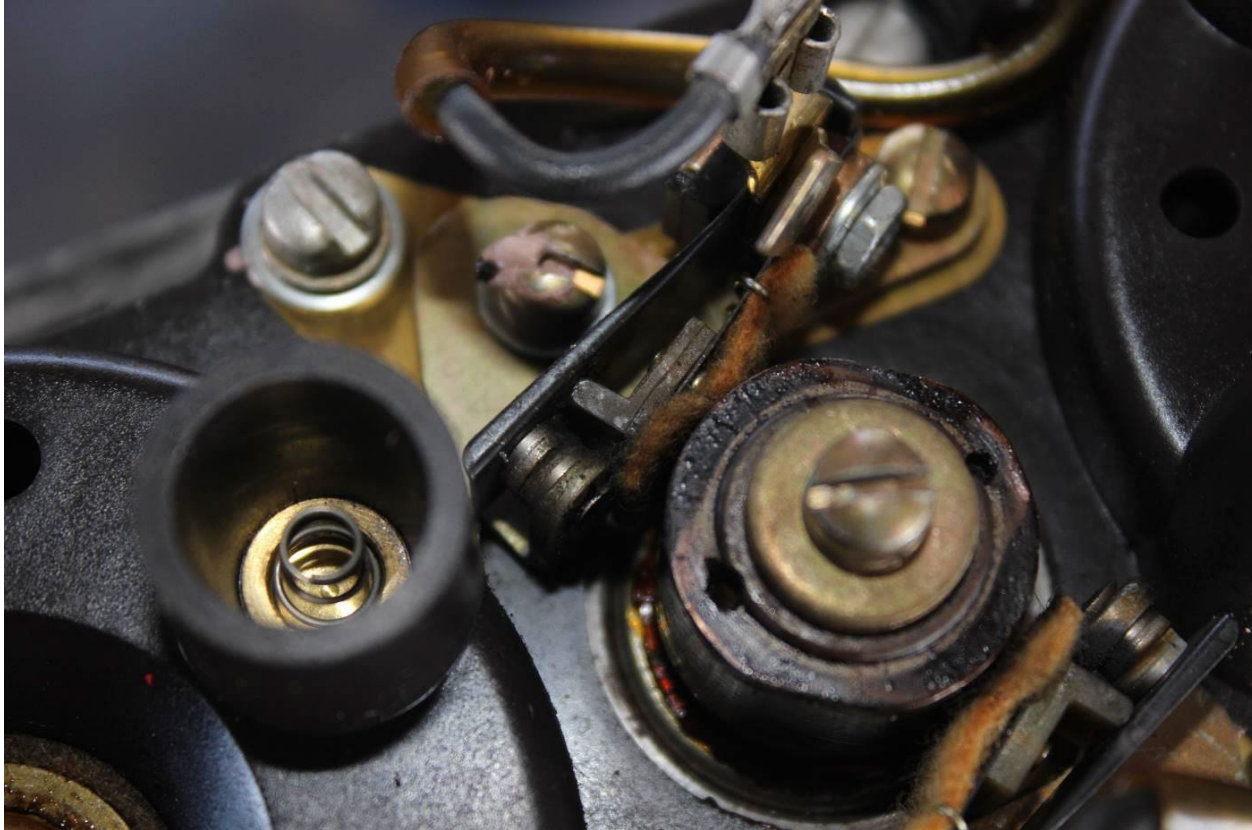
With the timing synchronizer box positive wire attached to the left magneto capacitor spade terminal and with a proper ground connection assured, the single drive was rotated by hand, and the cam was observed in rotation. However, the cam follower would not engage the main breaker point frame bracket. Subsequently, the contact assembly breaker points were manually separated by using a screwdriver to lift the main breaker point frame bracket, separating the main breaker point from the retard breaker point, which did not produce an audible tone, and the green light illuminated.

The manufacturer's High Tension Magneto Service Support Manual (page 9-15) provided instructions to adjust the assembly frame bracket for breaker points clearance. Step No. 8 of the Contact Assembly Installation stated that the cam should be rotated so the high lobe(s) is (are) under the cam followers of the contact assemblies. Adjust the left main contact to obtain  $0.016 \pm 0.002$  inch opening. Check the retard contacts for  $0.016 \pm 0.004$  inch clearance.

**Figure 5:** View of left magneto breaker points contact assembly

The contact assembly frame bracket was adjusted to increase the breaker points opening clearance and subsequently, the magneto drive housing and the distributor housing were reassembled. A second bench test was conducted, and both the left and right magnetos produced a shower of sparks to each of the designated ignition leads. The left main contact was not measured before or after the bench test.

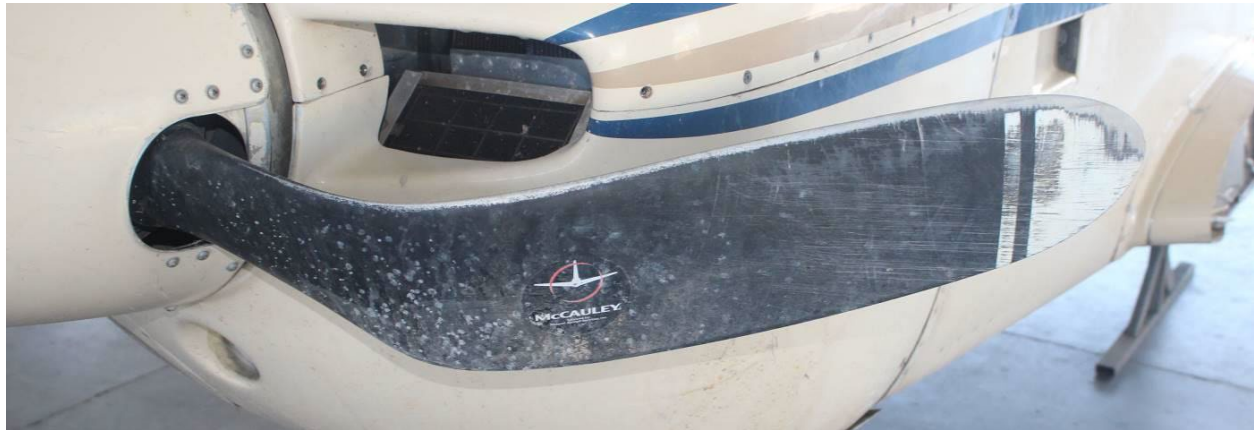
The two bladed constant speed propeller remained attached at the crankshaft flange. The spinner was attached to the propeller. The propeller blades remained attached to the propeller hub. One blade was bent aft approximately 45° and the opposing blade remained showed slight aft bending. The propeller blades displayed leading edge burnishing and chordwise striations across the cambered surface. The

signatures were consistent with the absorption of rotational forces applied at the crankshaft at the time of impact.

**Figure 6:** View of impact damage to propeller blade with about 45° aft bending, chordwise polishing and spanwise scratches

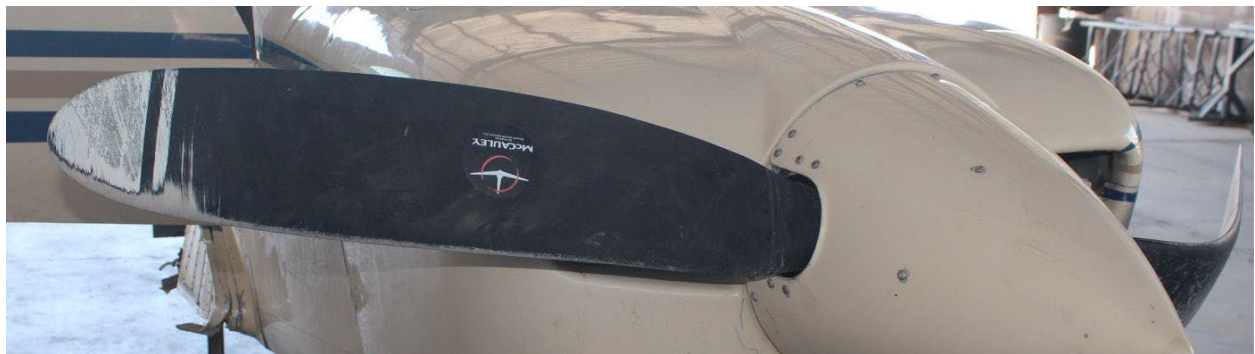
**Figure 7:** View of impact damage with slight aft bending to propeller blade chordwise polishing

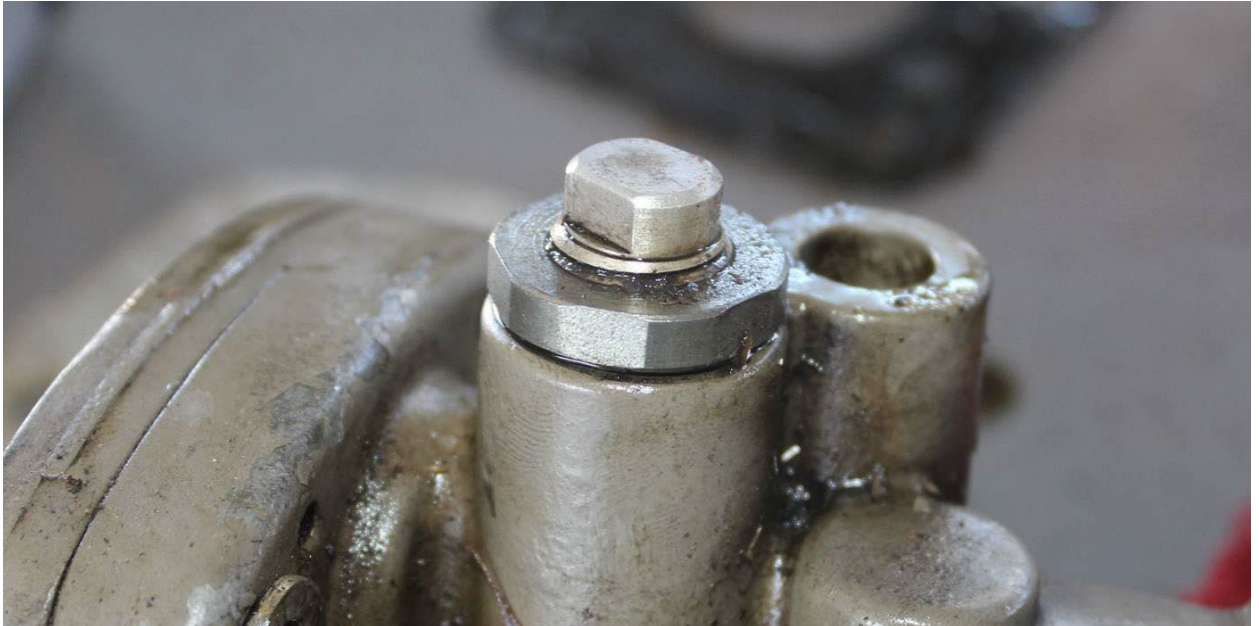
of visible contamination. The jam nut on the pressure relief valve was finger tight and exhibited evidence of an oil leak (figure 8).

**Figure 8:** View of propeller governor mounting gasket stack with oil residue

The proper governor mounting gasket stack as depicted in the applicable Illustrated Parts Catalog (IPC) and Lycoming Service Instruction 1438A was present and appeared free of visible oil leaks.
