# National Transportation Safety Board

WPR24LA061

## **TAILWHEEL ASSEMBLY EXAM**

Location: Prescott, AZ  
Date: December 26, 2023  
Airplane: Glasair SH2, N29TT

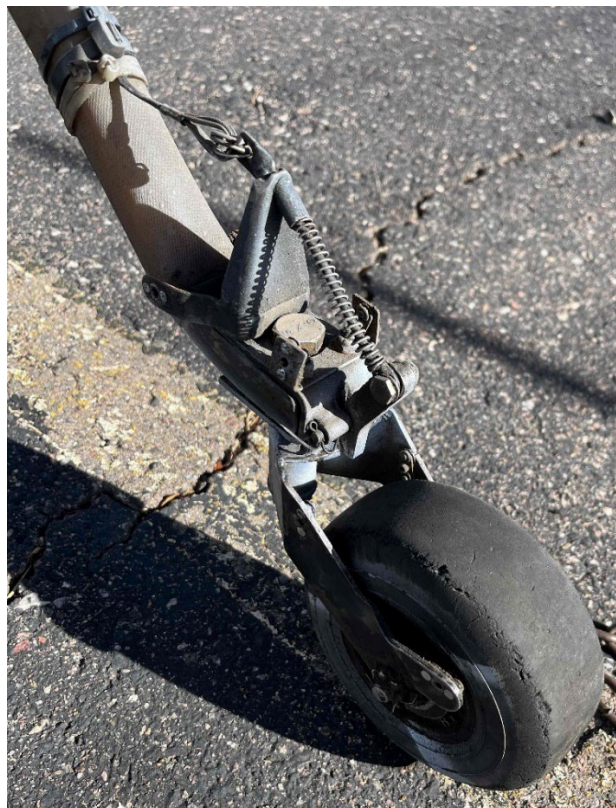
The airplane was equipped with a free-castering tailwheel, designed to be locked in the straight position during takeoff and landing (figure 1). It was controlled by a lever in the cabin that was connected via a cable to a spring-loaded locking arm in the tailwheel assembly. The locking arm, when activated, dropped down into a slot cut into the upper plate of the tailwheel forks. The plate was a steel segment of about 90° radius (referred to in the construction manual as a "half-moon") and welded to the tailwheel fork. The pilot reported that in accordance with the airplanes operating instructions, he locked the tailwheel straight during takeoff, and confirmed it was locked before landing.

**Figure 1 - Tailwheel assembly in locked position - note cable ties used to secure release cable.**

The construction plans specified that the control cable should be routed directly from the locking arm to a phenolic guide in the vertical fin shear web (attachment 1). However, the cable was routed from the locking arm down to a set of four cable ties mounted to the tailwheel strut. (figure 1)

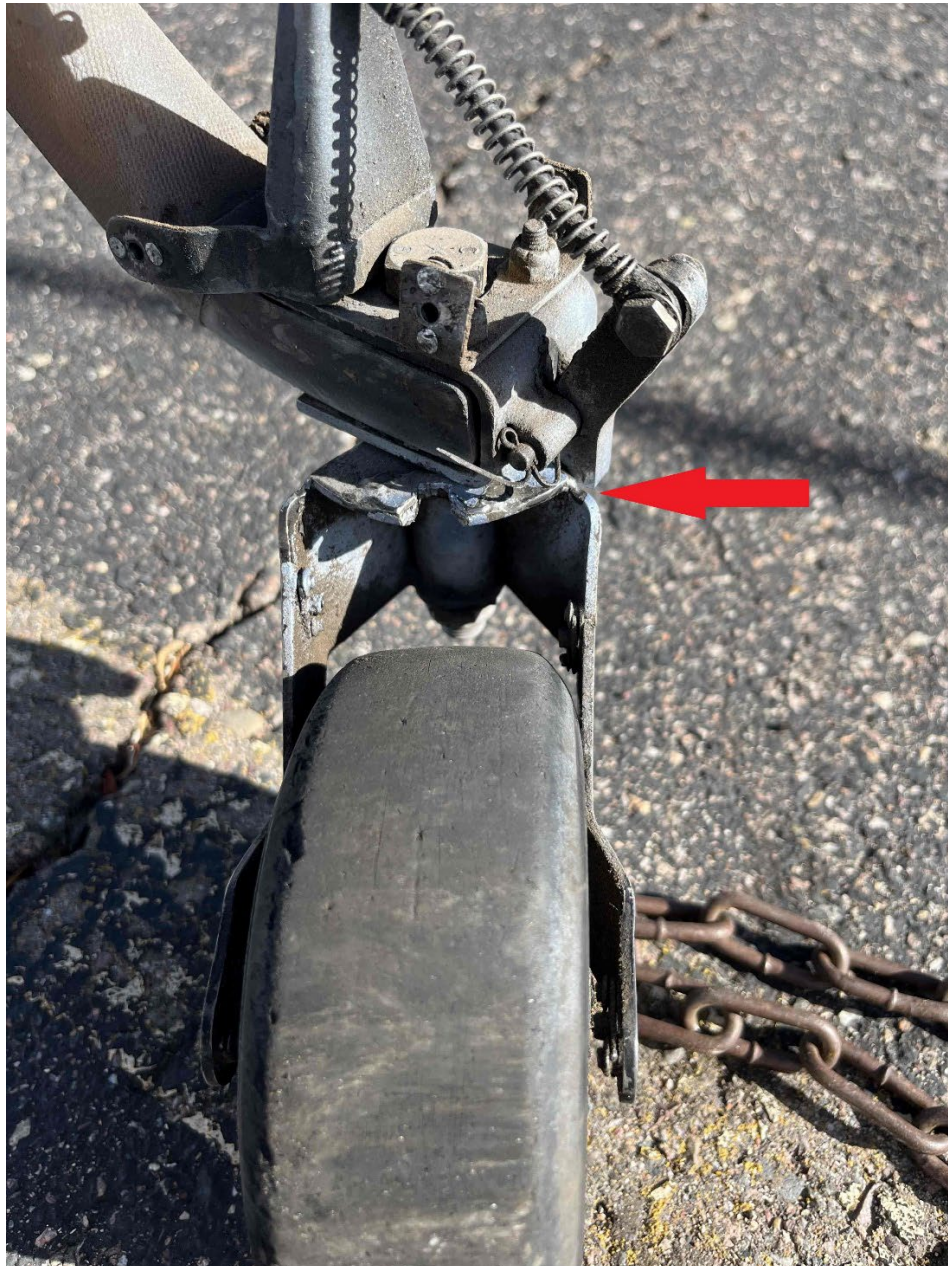
Post-accident examination via video conference with the pilot revealed that both the cabin control and locking arm were in the locked position, but the tailwheel was jammed about the 45 ° to the left, rather than straight (figure 2). Further examination revealed that the locking arm and associated plate slot were worn (figure 3, 4), and the locking spring had limited tension, such that with light force the tailwheel could be moved out of the straight position and jammed over-center as the locking arm dropped down against the outer edges of the locking plate (figure 2).

**Figure 2 - Tailwheel about the 45 ° over center, with locking arm stuck past and against the pivot plate.**

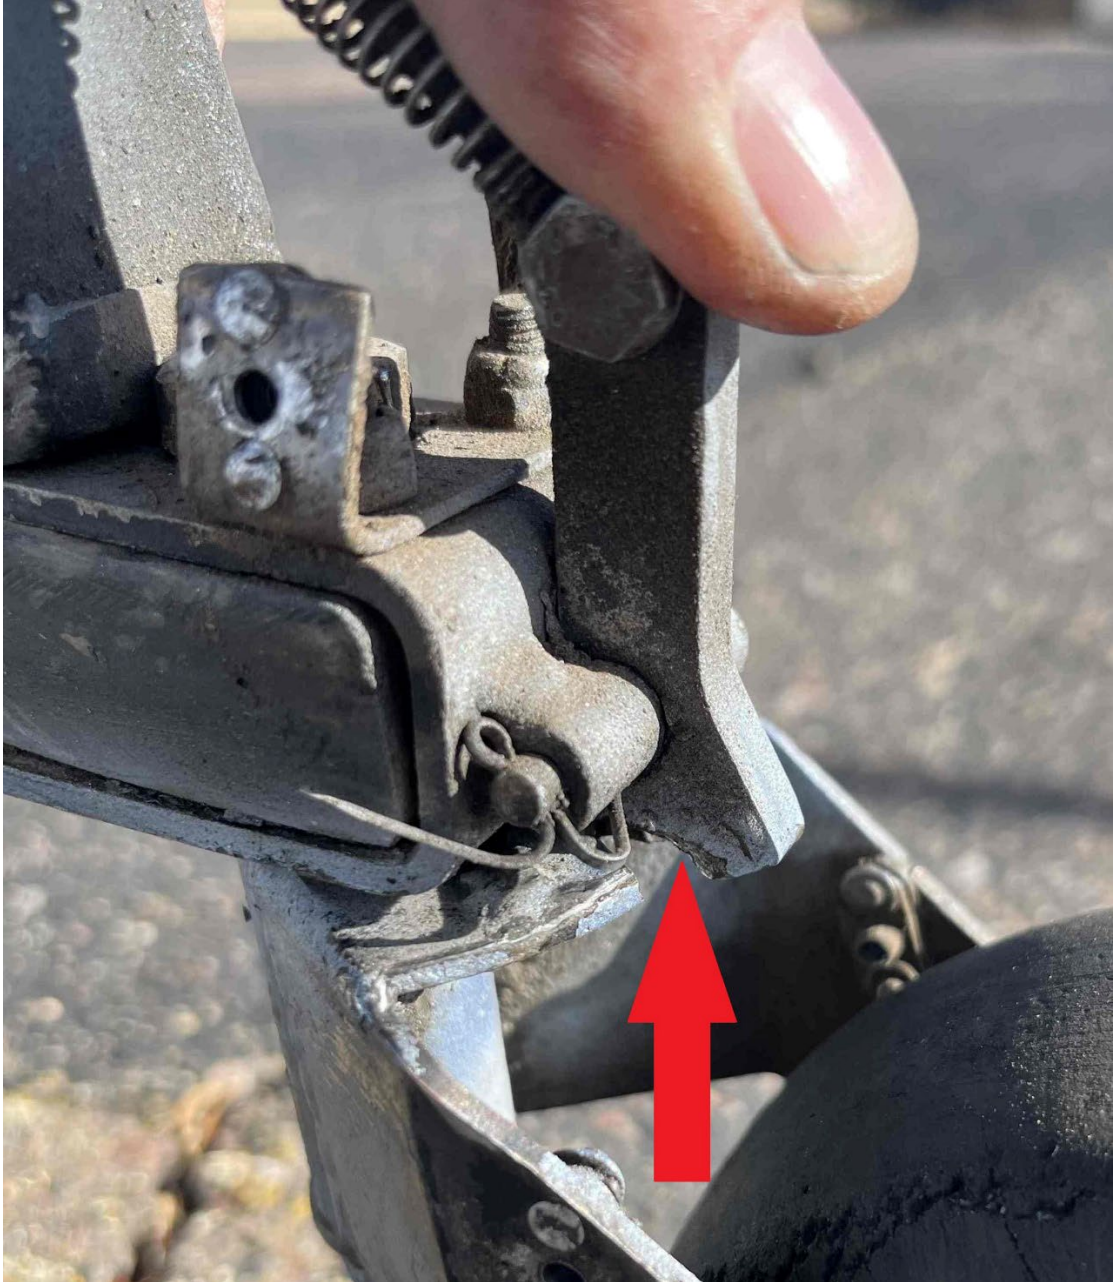
**Figure 3 - Worn locking arm.**

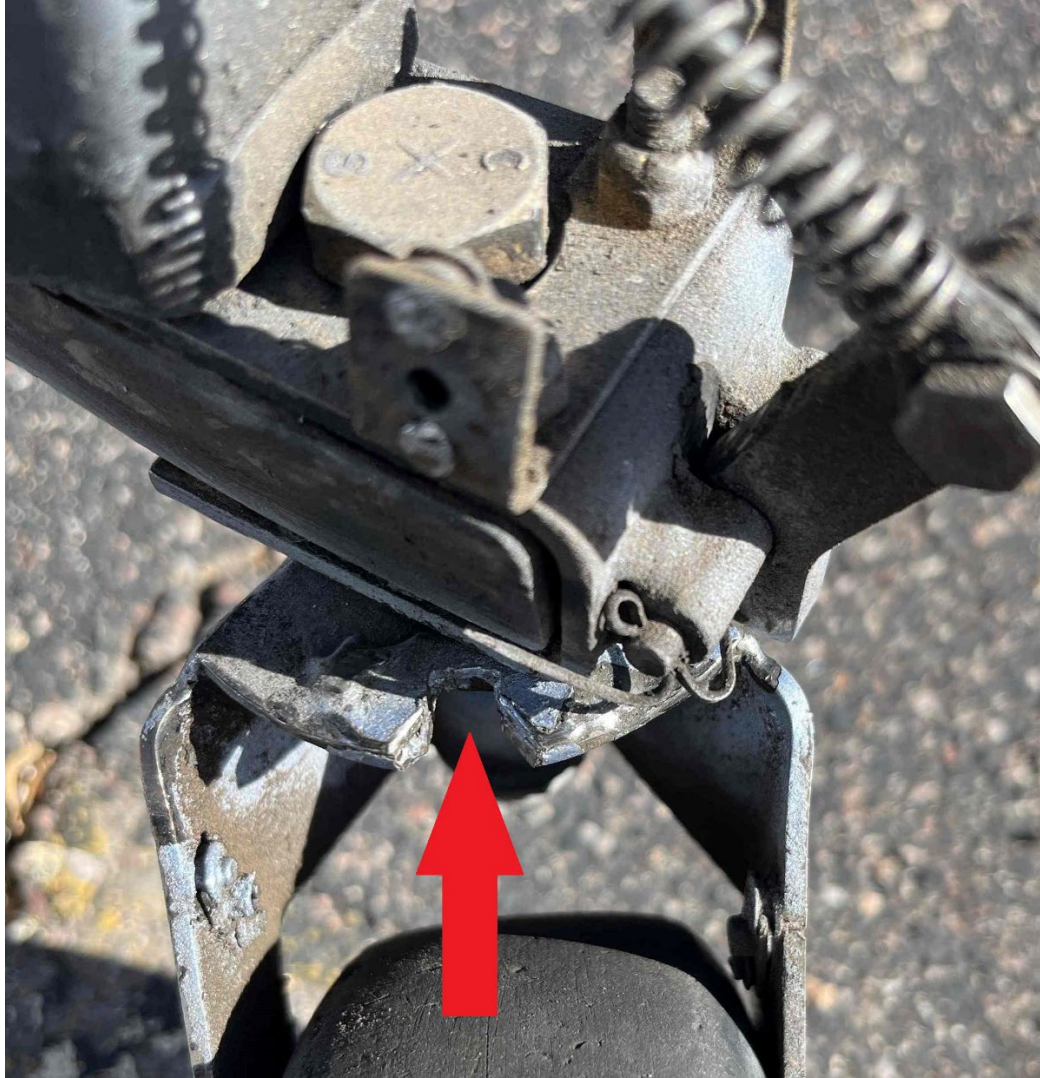
**Figure 4 - Worn pivot plate locking slot.**

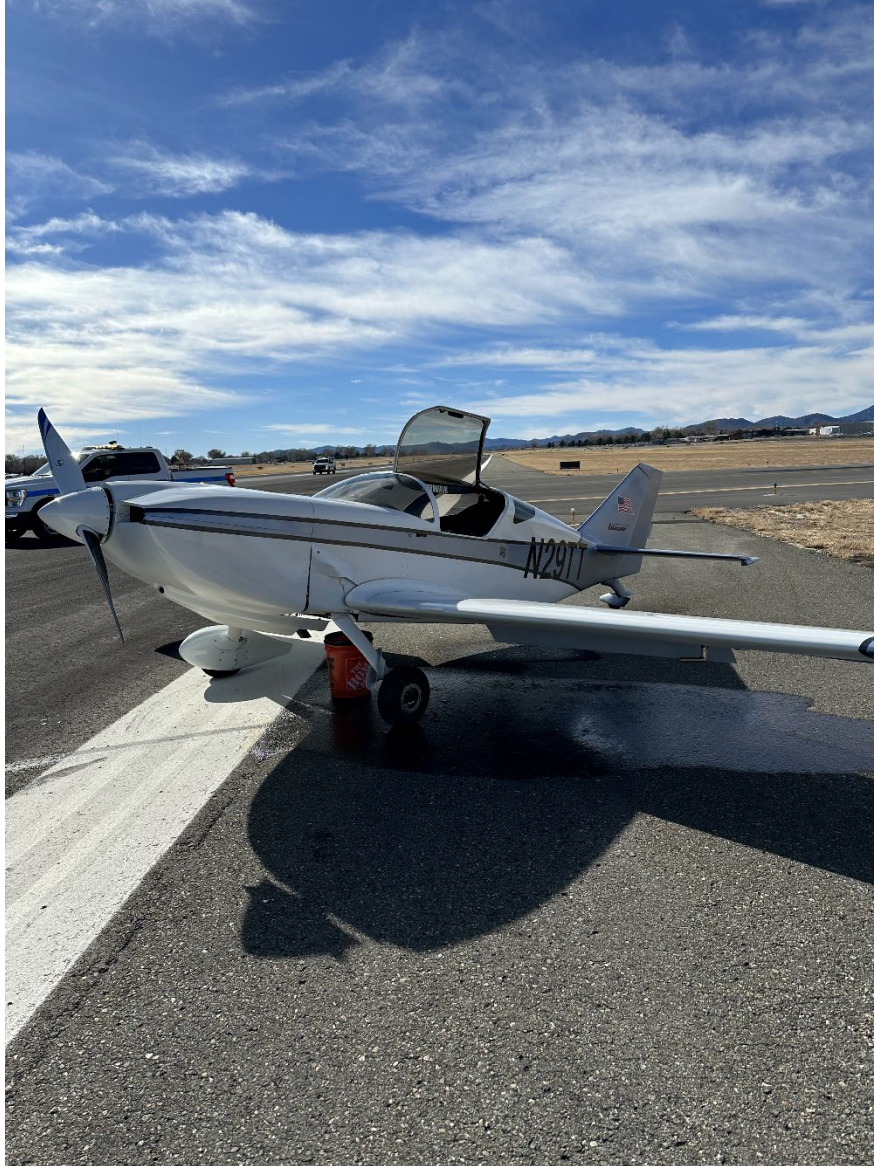
**Figure 5 - Airplane at the accident site, with damage to fuselage. Photo courtesy of KPRC Airport Operations.**
