# National Transportation Safety Board

## **MATERIALS LABORATORY**

Factual Report 24-047

Location: El Centro, California  
Date: December 23, 2023  
Vehicle: Bell 206B, N111PM  
Investigator: Kristyn Blocher, AS-WPR

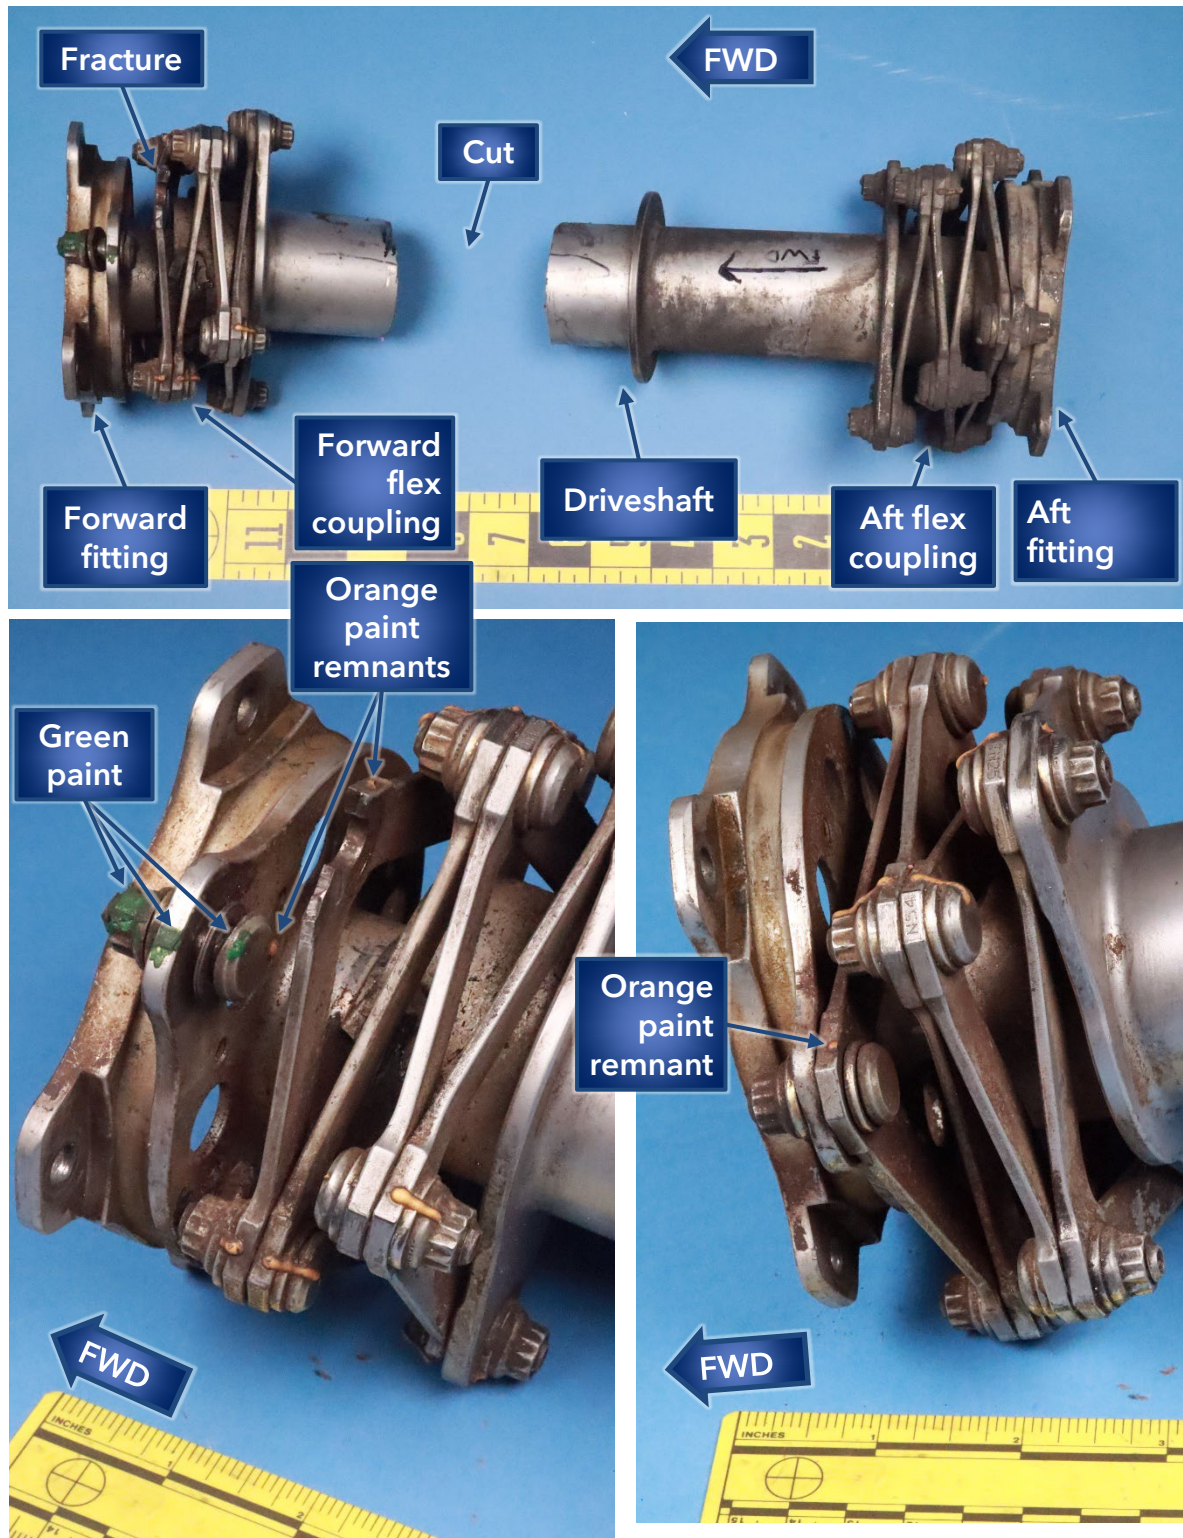
An overall view of the submitted KAflex driveshaft assembly is shown as received in figure 1. The flex plate at the forward end of the forward flex coupling was fractured where it had been attached to the forward driveshaft fitting as indicated in figure 1. The driveshaft had been cut after the accident as indicated to facilitate removal from the aircraft.

On the forward coupling, torque paint was missing, broken, or incomplete on half the bolt heads and 6 of the 10 nuts including the heads and nuts at the forward flex plate. In 4 of the joints where torque paint was missing from one or both sides of the joint, the outer surface of the flex plate showed evidence of circumferential rubbing contact with another object.

Closer views of the forward flex coupling are shown in the lower images in figure 1. At the joint associated with the fracture location, remnants of yellowish orange colored torque paint were observed on the head of the bolt and on the side of the forward flex plate as indicated in the lower left image in figure 1. Additionally,

green torque paint was observed on the nut and adjacent washer, the side of the forward fitting lug, and the edge of the bolt head, also indicated in the lower left image in figure 1. With the green paint on the bolt head aligned with the green paint on the forward fitting lug, the yellowish orange paint remnants on the bolt head and adjacent flex plate would not be aligned if the flex plate was placed in its original installed position. On the opposite side of the coupling, a remnant of yellowish orange paint was observed on the side of the forward flex plate as indicated in the lower right image in figure 1, and paint was absent from the remainder of the joint.

The joint between the forward driveshaft fitting and the forward flex plate was loose, and visible gaps opened as the joint was flexed by hand. Attempts to remove the nut for the loose joint by holding the bolt in place with a hex wrench inserted in the threaded end of the shank while turning the nut were unsuccessful in overcoming the breaking torque on the nut without risk of breaking the hex wrench. Subsequently, the nut was cut using a handheld abrasive cutting tool to facilitate its removal, thereby separating the forward flex plate from the forward driveshaft fitting. The bolts attaching the forward flex plate to the adjacent flex plate were also removed to separate the forward flex plate from the rest of the assembly.

**Figure 1.** Overall view of the submitted driveshaft assembly (upper image) with closer views of the forward end of the assembly showing the flex plate fracture location (lower left) and the side of the flex coupling opposite from the fracture (lower right).

According to Kamatics Service Instruction Number SIN2348 Rev. K, *Installation, Maintenance, and Repair of the KAflex Driveshaft for the Bell 206A and 206B Helicopter*, the driveshaft assembly should be inspected for loose or missing hardware (bolts, nuts, washers), daily (before the first flight of the day). The inspection should include a check of the torque stripes for evidence of slippage. If evidence of loose or missing hardware is found, the driveshaft is to be returned to Kamatics Corporation. The procedures include a warning to not disturb or tighten the flex frame nuts or bolts, and that evidence of turning fasteners by wrench or other means is cause for rejection.

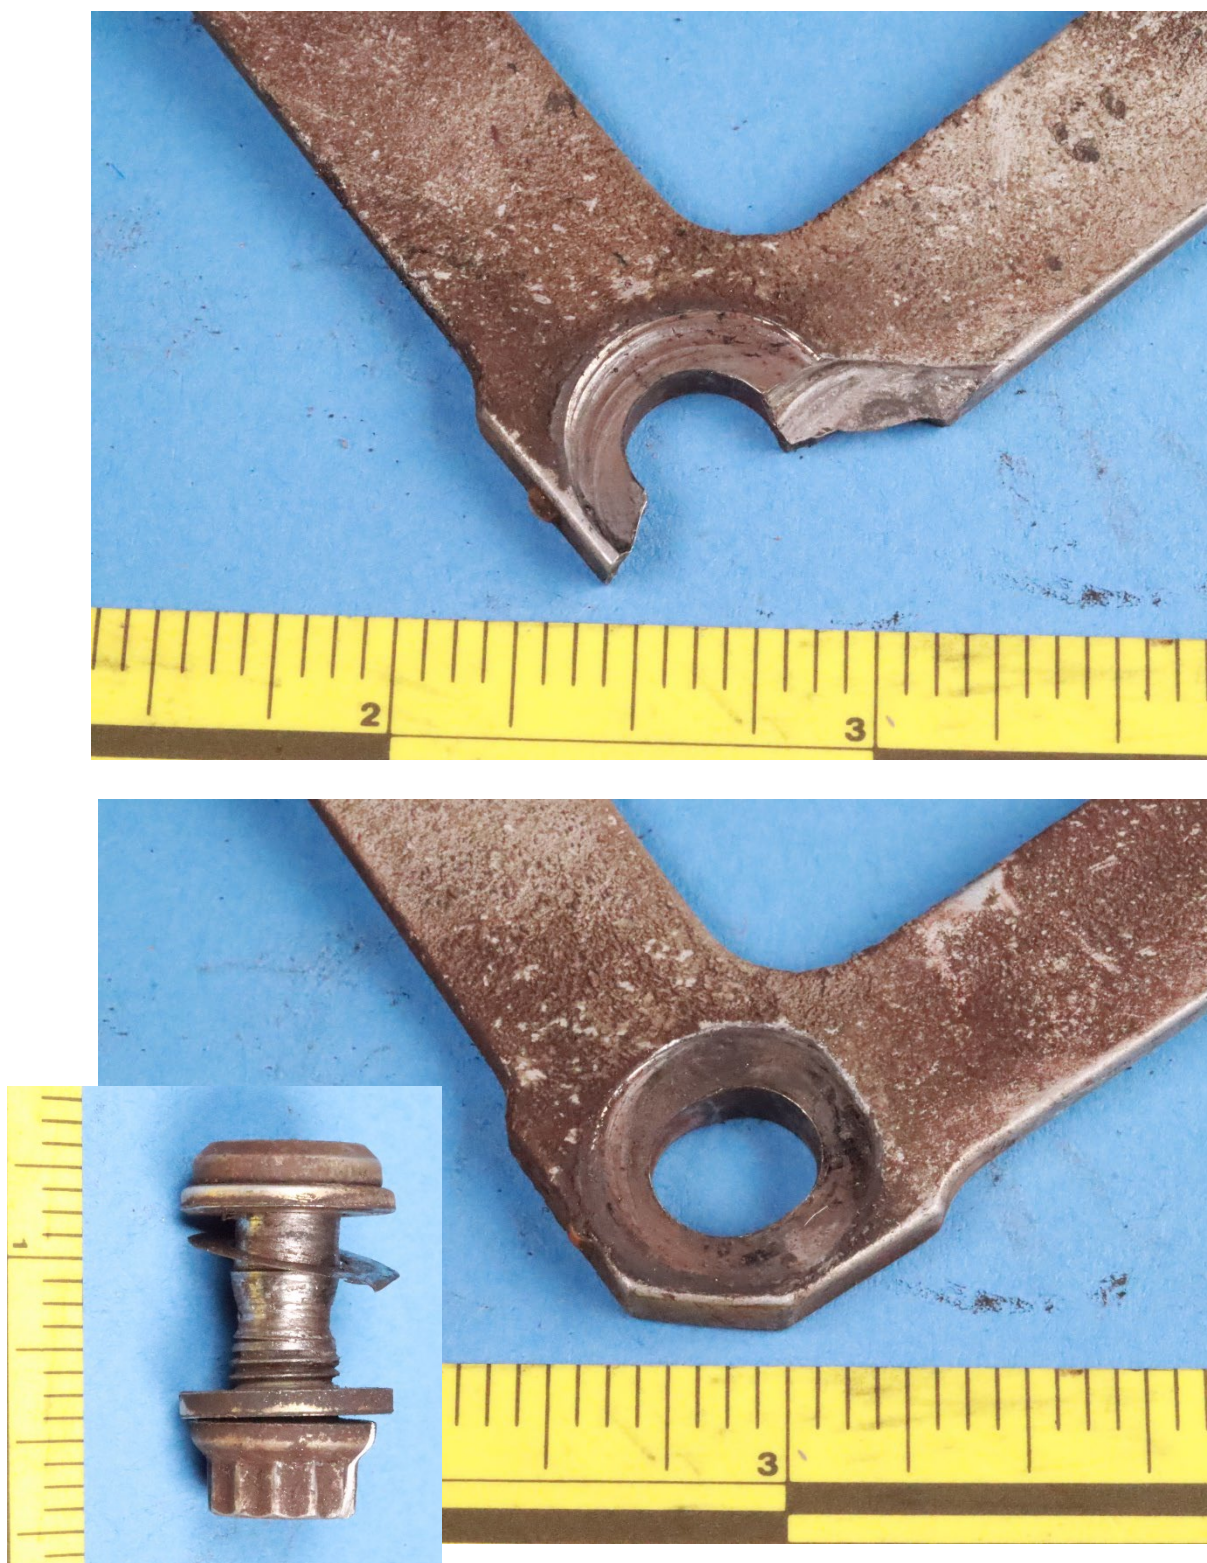
Views of the aft face of the forward flex plate at the fracture location and at the hole opposite the fracture location are shown in figure 2. Both holes were elongated, and surfaces around the hole were dished with thinning through the thickness consistent with wear contact from relative motion between the flex plate and associated bolts and washers. The bolt shanks at both locations were also thinned consistent with contact wear from relative motion between the bolt and the attachment holes. The bolt that was removed from the intact side is shown in the lower left image in figure 2.

**Figure 2.** Aft face of the fractured flex plate after disassembly showing the fracture location (upper image) and the attachment hole on the opposite side of the plate (lower image). The hardware associated with the hole in the lower image is shown at the lower left side of the figure.

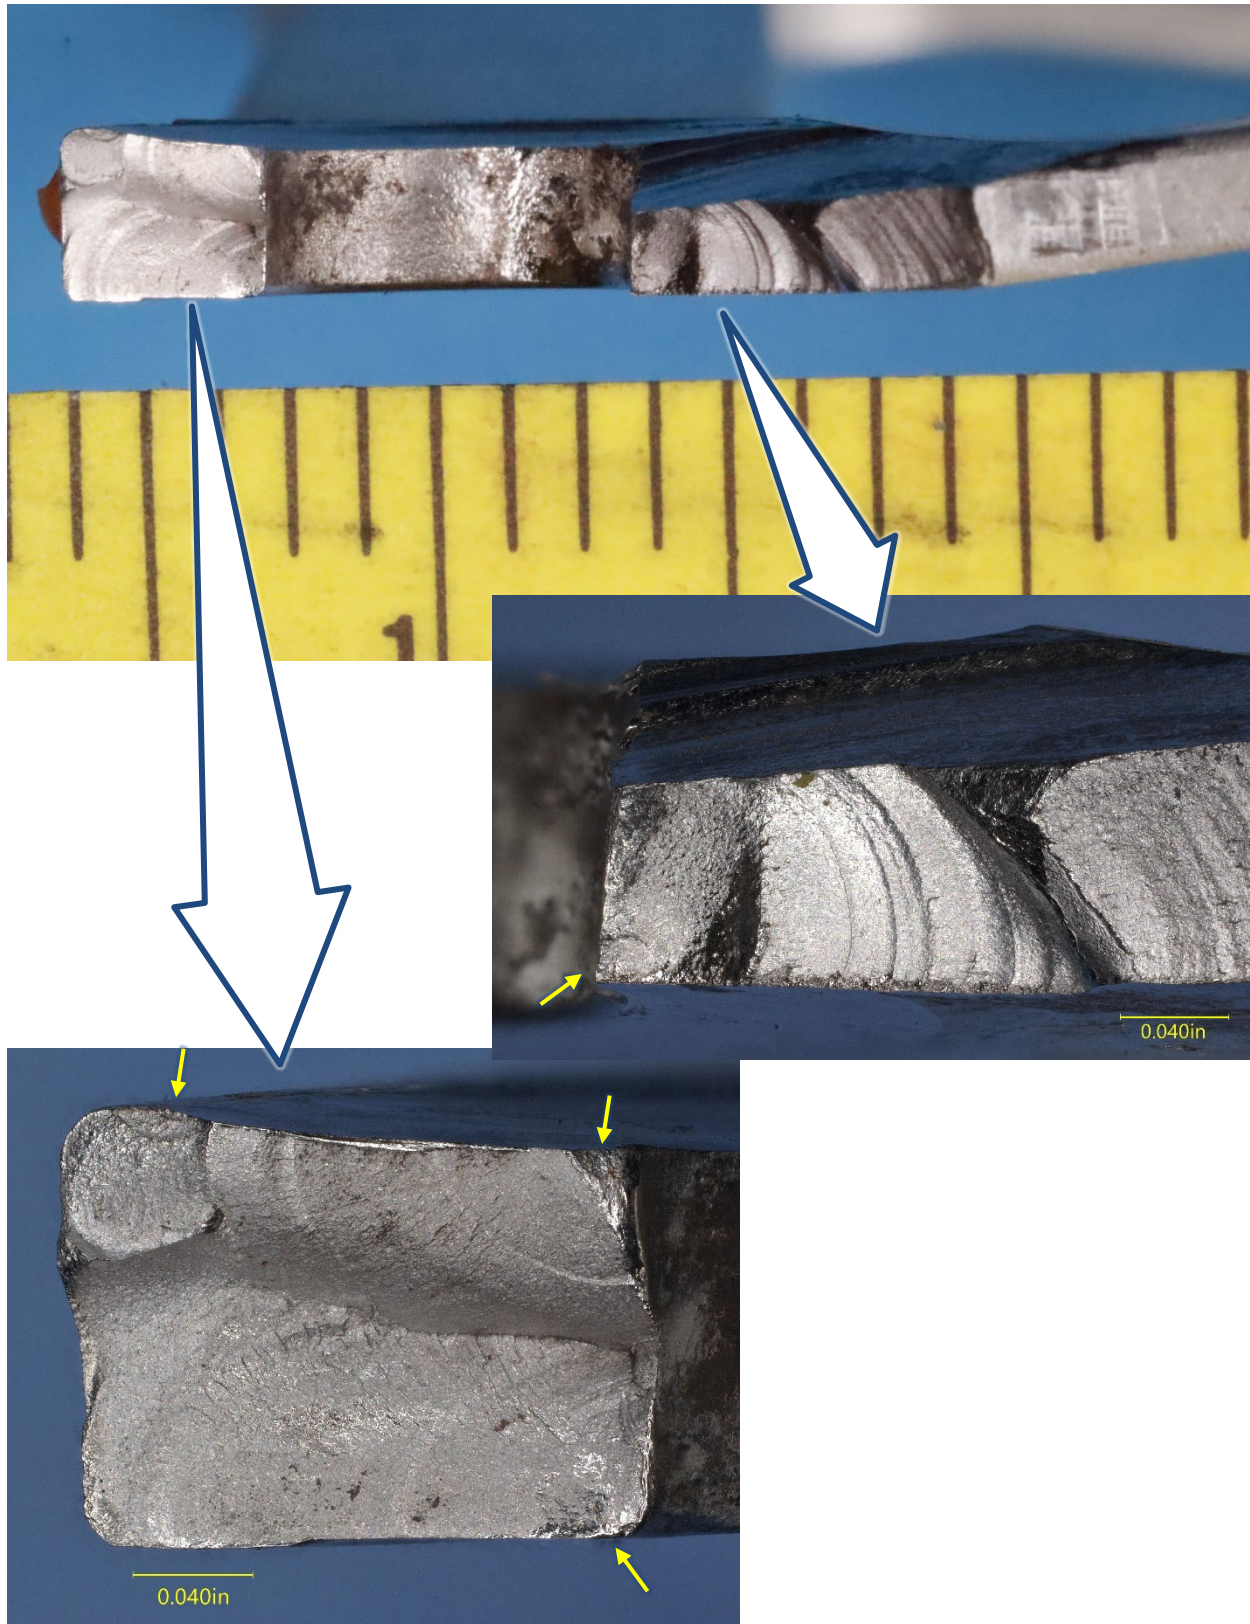
Views of the fracture surfaces in the forward flex plate are shown in figure 3. Flat fracture features with curving crack arrest lines were observed, features consistent with fatigue fracture. Fatigue features emanated primarily from origin areas located near the hole bore at the upper and lower surfaces as shown with unlabeled arrows in the middle and lower images in figure 3. Fatigue features emanated across most of the fracture surface on both sides of the hole consistent with high cycle fatigue with relatively low nominal stress levels.

**Figure 3.** Views of fatigue fracture features on the flex plate fracture surfaces. Unlabeled arrows in the middle and lower images indicate fatigue origin areas.
