# National Transportation Safety Board

WPR24LA067

## **AIRFRAME AND ENGINE EXAM SUMMARY REPORT**

Location: El Centro, California  
Date: December 23, 2023  
Time: 22:30 Pacific standard time  
Airplane: N111PM, Bell 206B

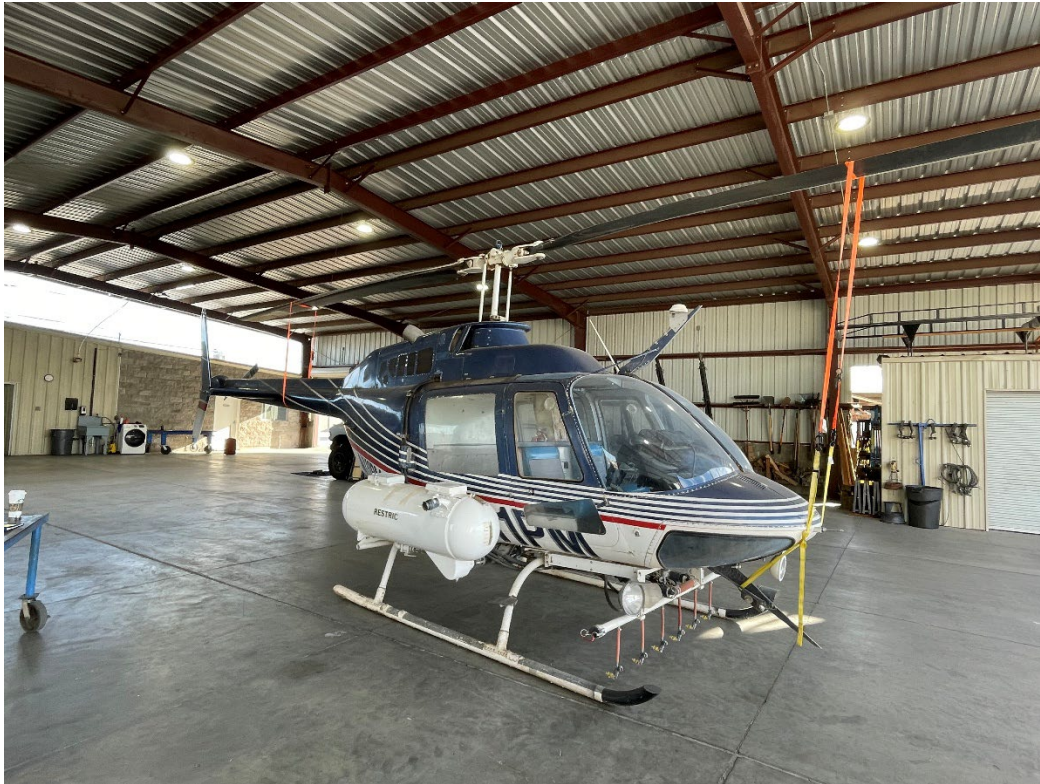
The fuselage, windscreen, cabin doors, cabin seat frames, upper and lower wire strike protection systems (WSPS), and tailboom assembly were undamaged (Figure 1).

Figure 1. View of right side of helicopter.

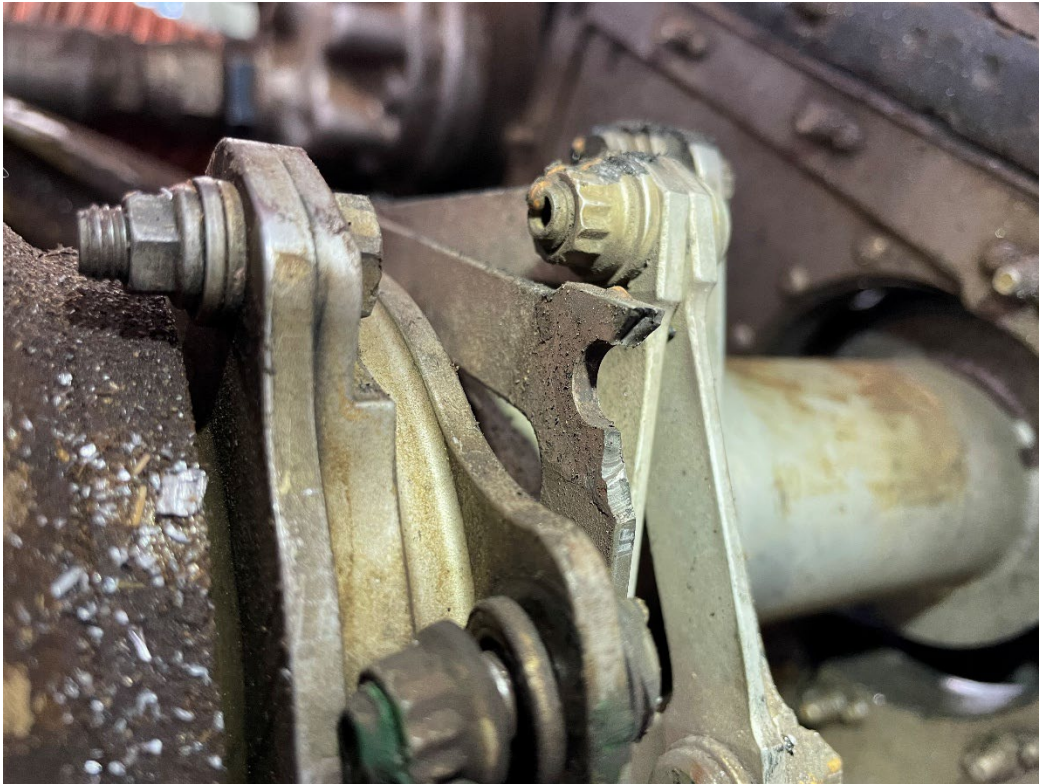
Main rotor continuity was observed when the mast was rotated by hand, through the transmission to the main rotor drive shaft. The KAflex coupling exhibited a fractured flex plate (Figure 2). The associated bolt and hardware assembly remained attached

to the flex plate. Multiple flex plates exhibited striations and witness marks consistent with contact with the isolation mount. The isolation mount exhibited gouging and witness marks, consistent with contact from the main rotor drive shaft and KAflex coupling assembly (Figure 3). The remainder of the upper deck surface was undamaged.

Figure 2. View of fractured KAflex plate.

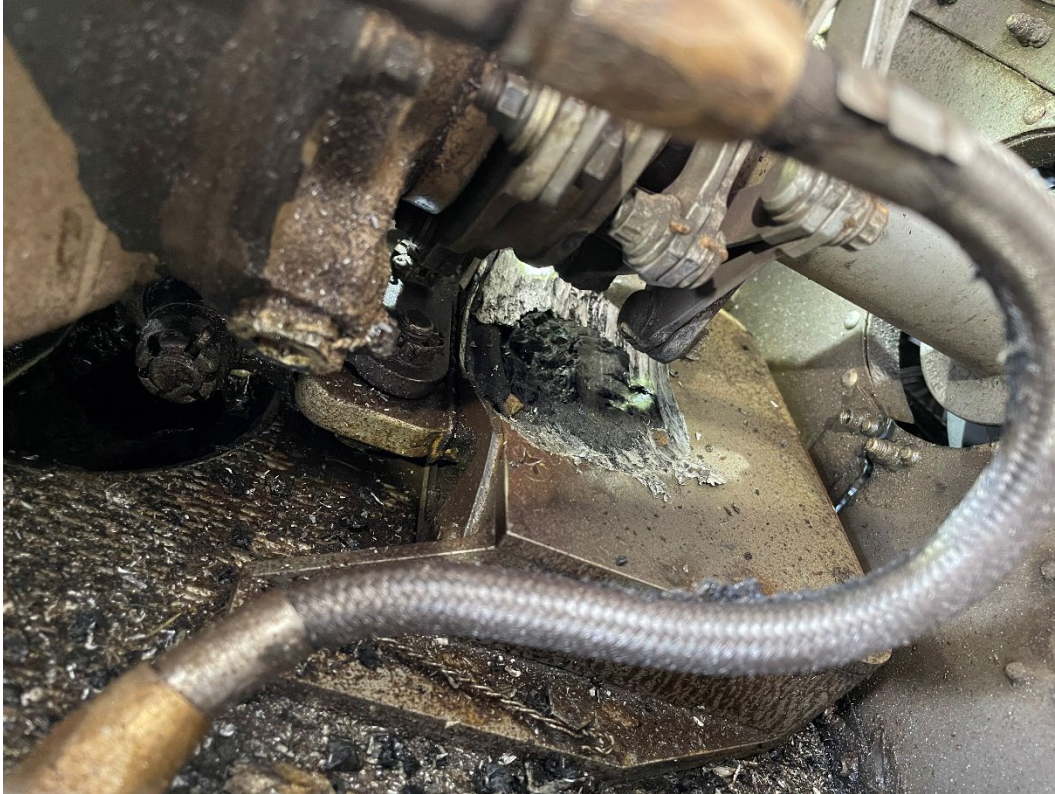
Figure 3. View of isolation mount.

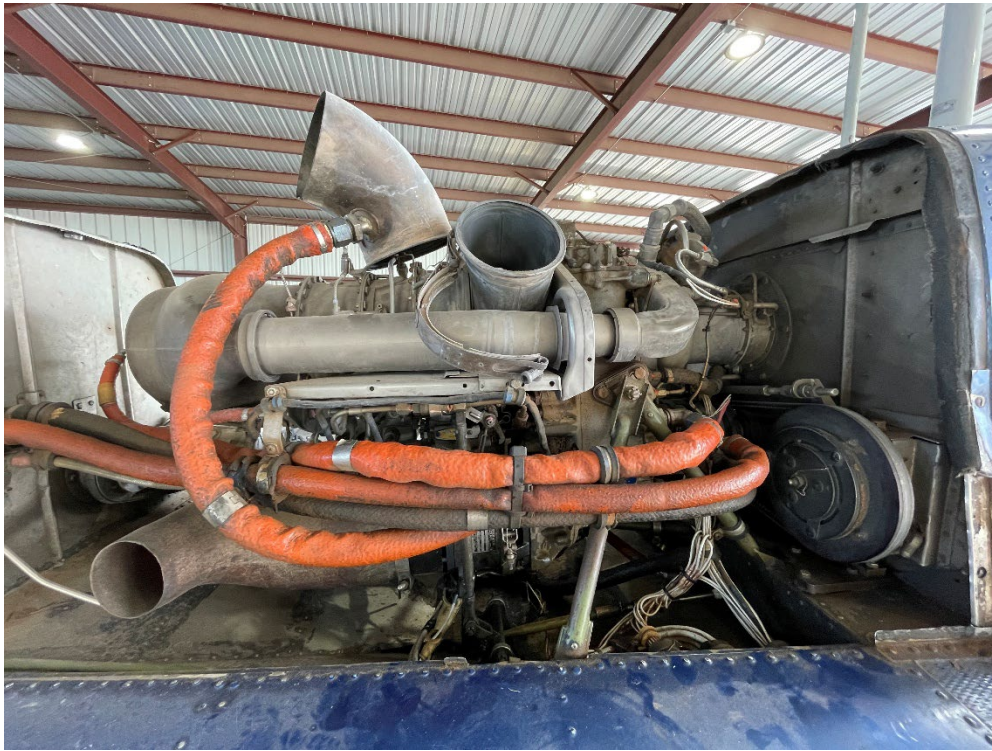
All engine mounts were intact, and the engine was undamaged. Linkages from the cockpit controls to both the Power Turbine Governor (PTG) and the Fuel Control Unit (FCU) were checked with no anomalies noted. The bleed valve was open, and all external air, fuel, and oil line connections were tight. A pneumatic leak check was conducted of the fuel control system using shop air, with no leaks detected. The aircraft was equipped with an engine inlet barrier filter, which was intact and unobstructed. (Figure 4)

Figure 4. View of right side of engine.
