WPR24LA070

## INVESTIGATION PHOTOGRAPHS

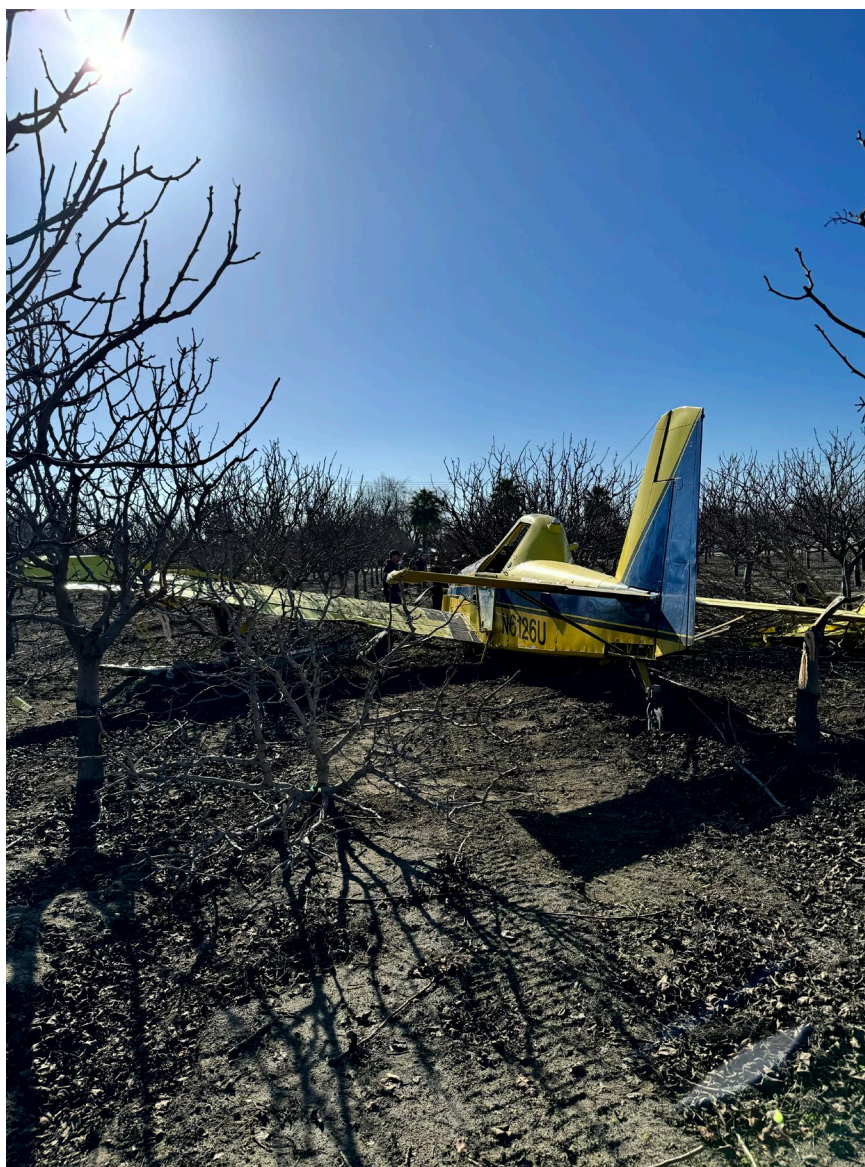
**Photograph 1 - Tail view at accident site (Courtesy of FAA)**

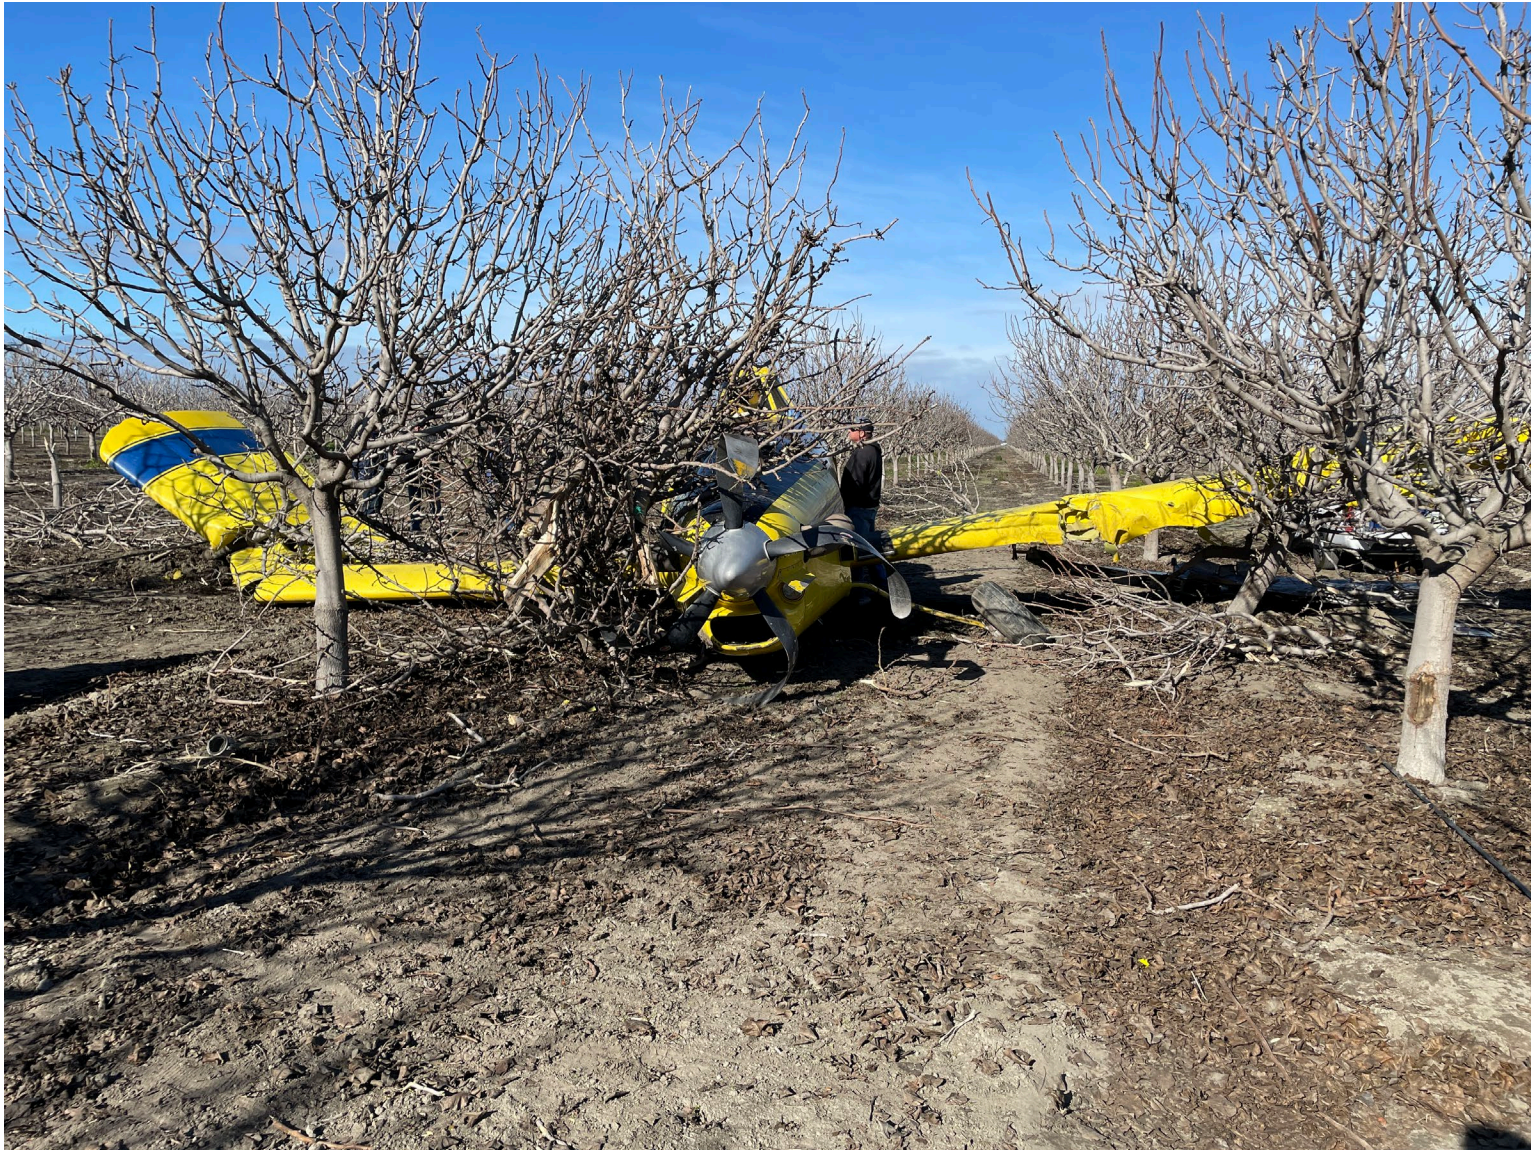
**Photograph 2 - Forward view of accident site (Courtesy of FAA)**

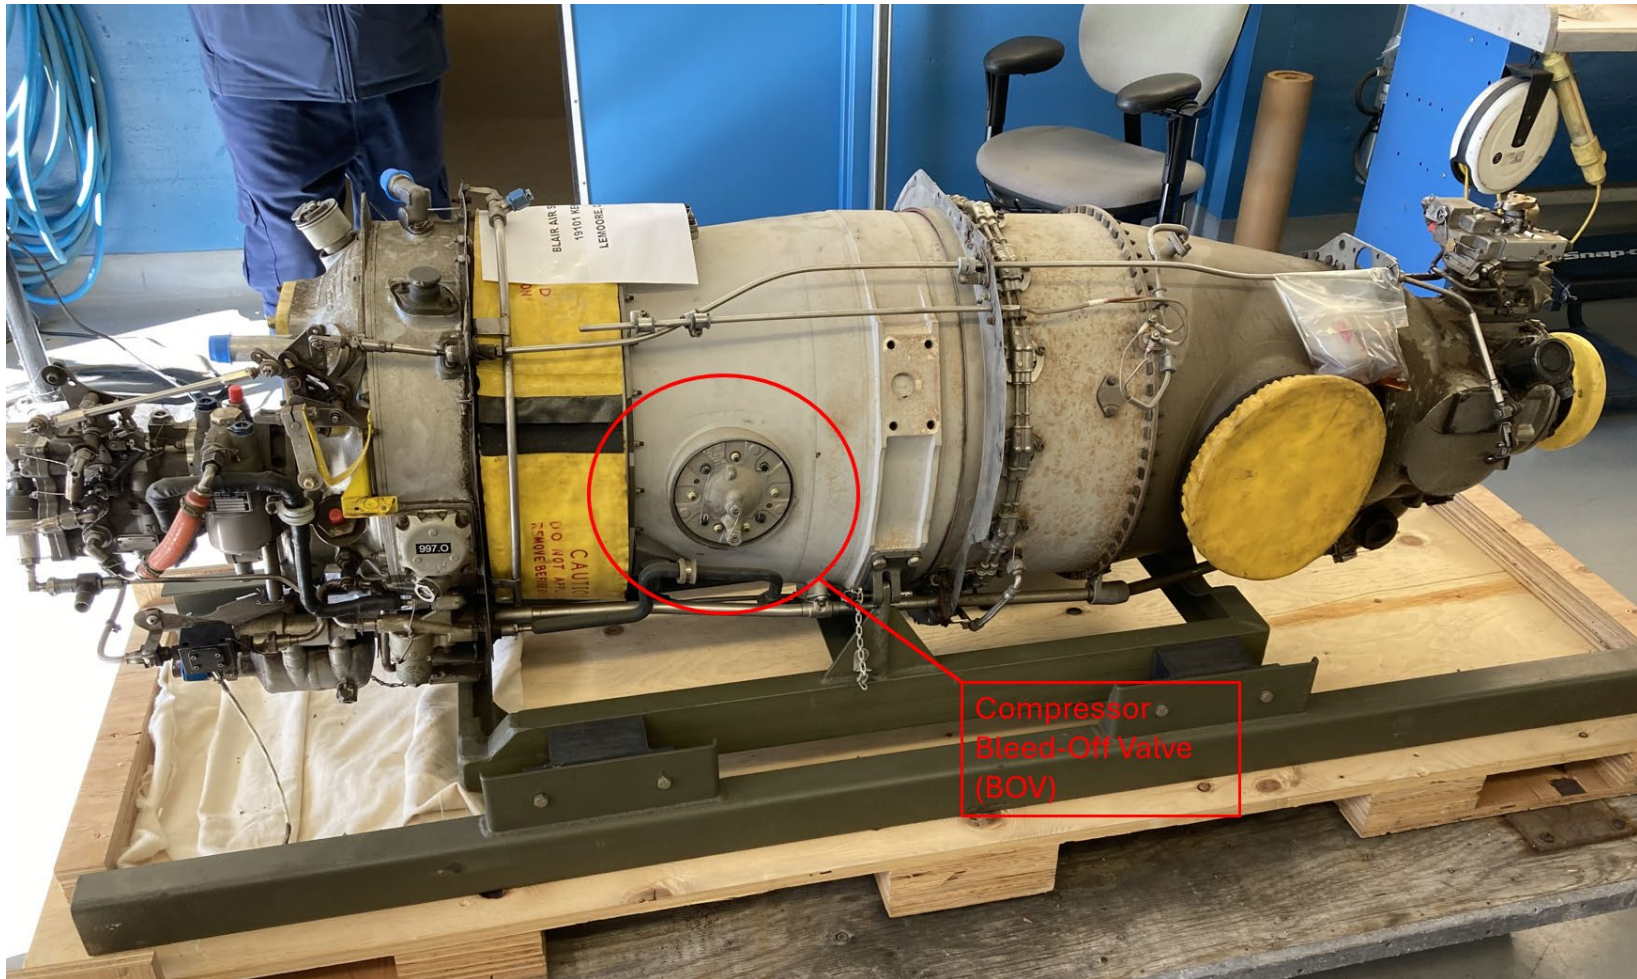
**Photograph 3 - Engine received with compressor bleed-off valve (BOV) center at PWC.**

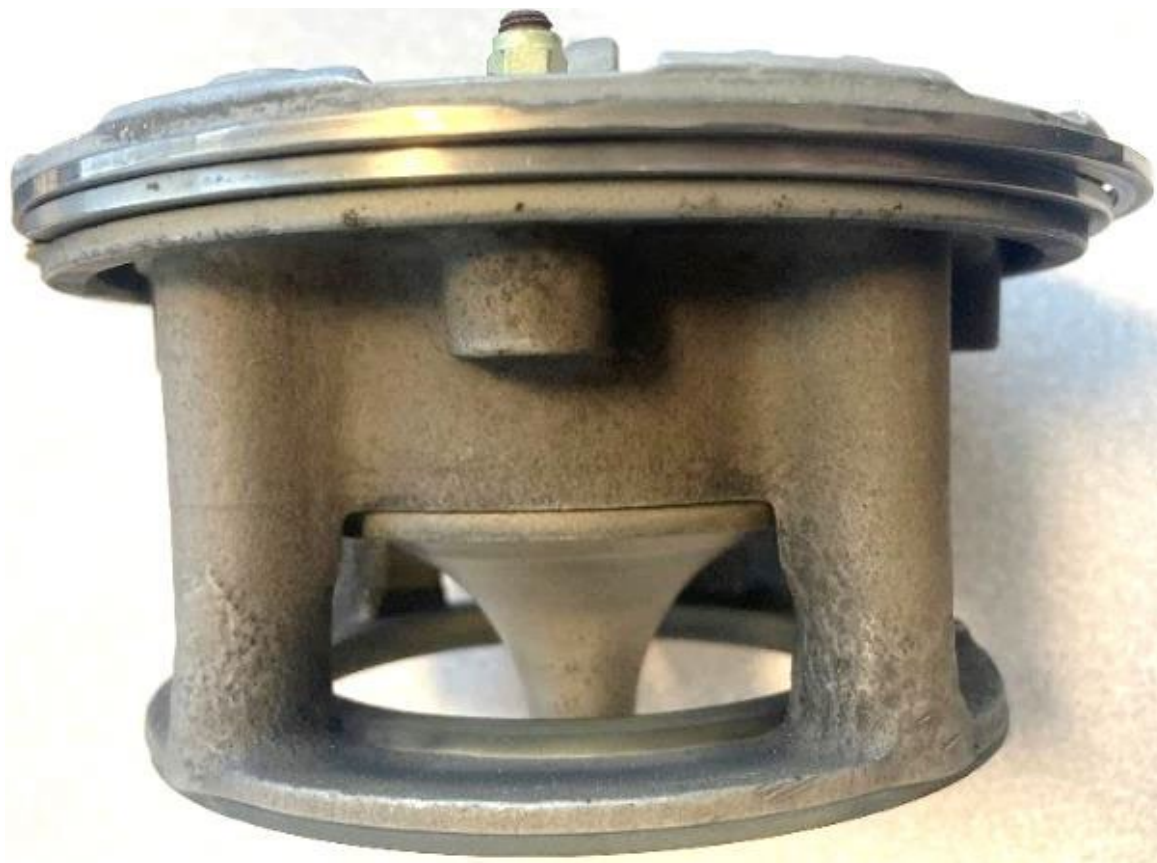
**Photograph 4 - Compressor bleed-off valve removed. (Courtesy of PWC)**

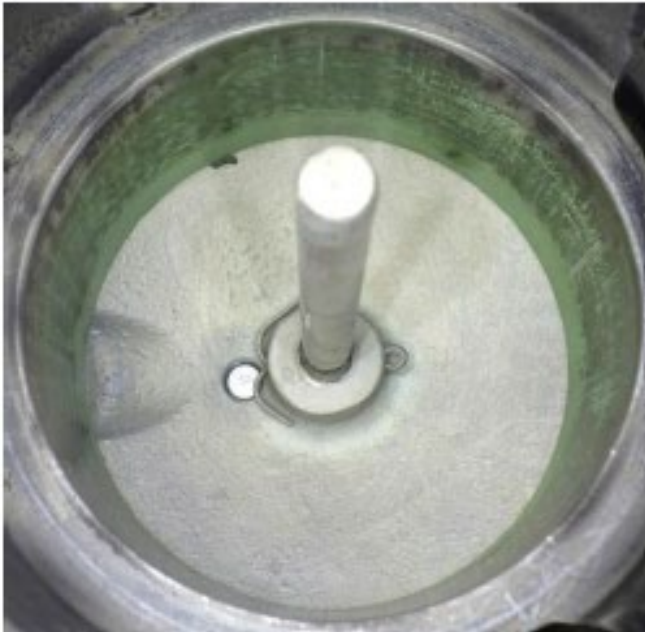
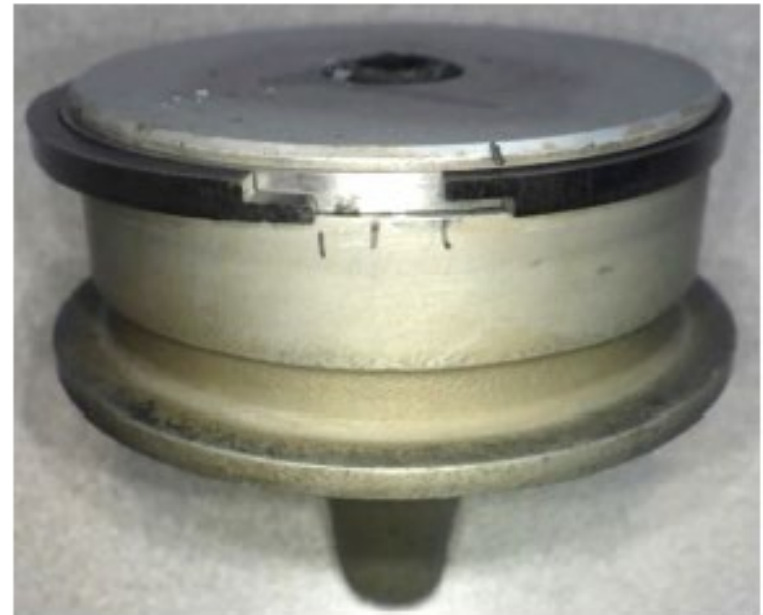
**Photograph 6 - BOV piston removed from housing. (Courtesy of PWC)**
