# National Transportation Safety Board

WPR24LA070

## ENGINE EXAM SUMMARY

Location: Stratford, CA  
Date: January 10, 2024  
Time: 10:10 local  
17:10 UTC  
Airplane: AIR TRACTOR INC AT-502A

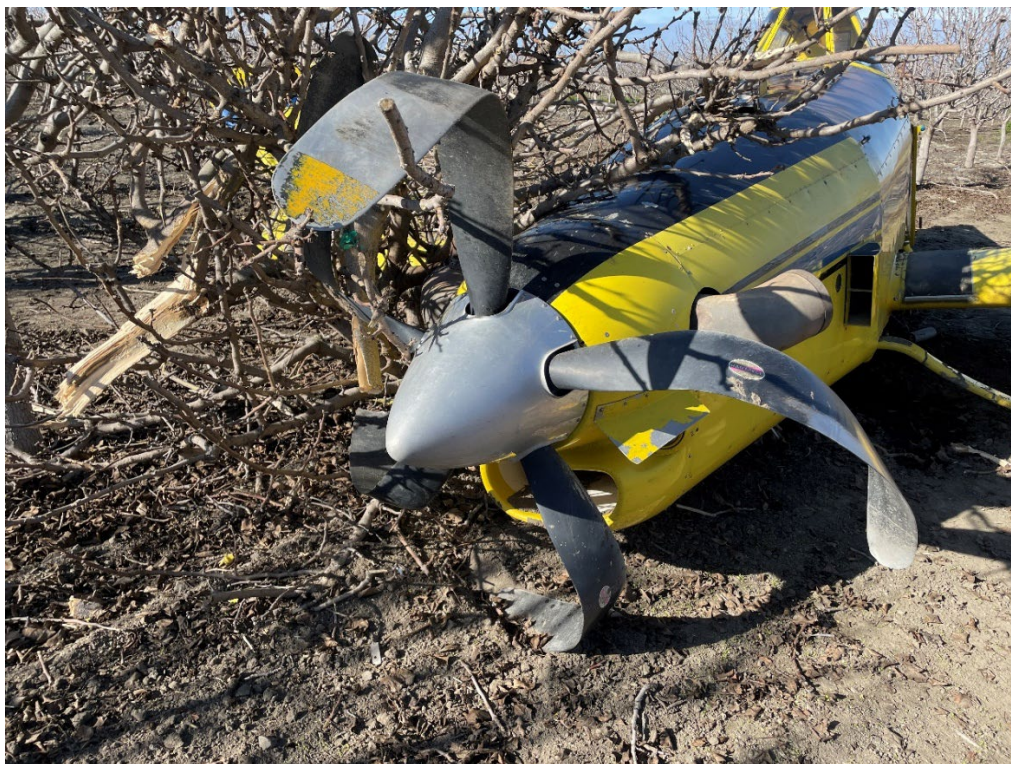
The pilot reported that during takeoff the airplane failed to develop full power. At about 200 ft above ground level (agl), the engine rolled back to near idle. The pilot's attempt to vary power lever inputs did not affect engine power output. The pilot maneuvered the airplane between two houses onto a grove of small trees. During the landing roll, the airplane impacted several trees, resulting in substantial damage to the wings and fuselage.

*Figure 1. Front view of accident airplane at the crash site.*

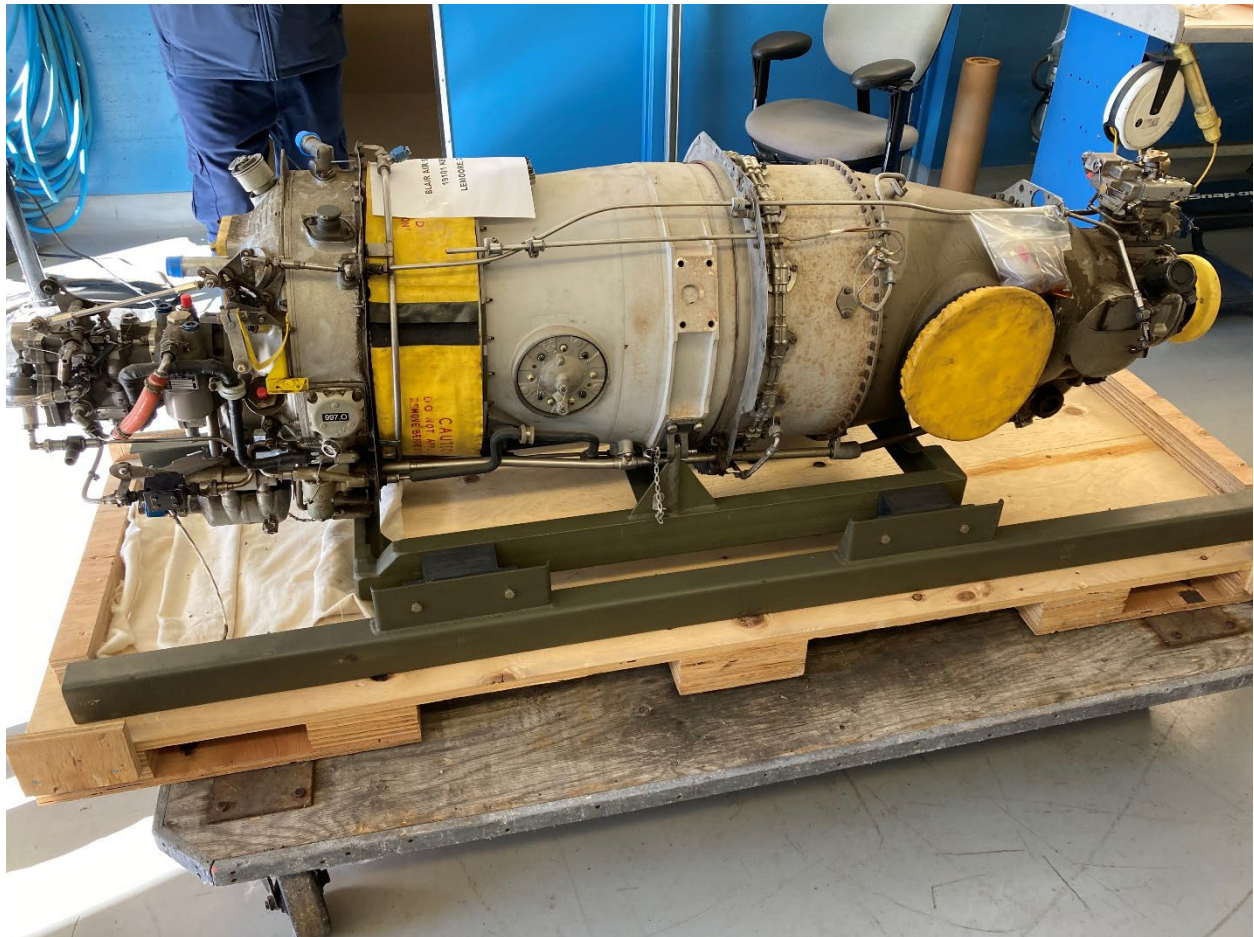
Examination of the recovered wreckage revealed that the airplane was equipped with a Pratt & Whitney Canada (PWC) PT6A-65R engine. The engine produces a takeoff power of 1,376 shaft horsepower. The PT6A engine is a 2-spool turbo-prop engine. The power section module consists of two stage power turbines (PT), which drive the propeller through a 2-stage planetary reduction gearbox (RGB). The gas generator (GG) module consists of a compressor section, which has 4 axial, and 1 centrifugal stages driven by a single-stage compressor turbine. The combustion chamber is a reverse-flow annular type. The constant-speed, variable pitch propeller is a single-acting type and is hydraulically controlled. The engine power management system consists of a hydro-mechanical fuel control unit (FCU), which governs the GG speed by delivering fuel flow to the engine in response to the power lever angle, compressor discharge pressure and GG speed. The propeller governor and

The 5-bladed Hartzell propeller on the engine was part number (P/N) HC-B5MP-3C, serial number (S/N) EVA2206.

*Figure 2. Side view of accident engine on engine box.*

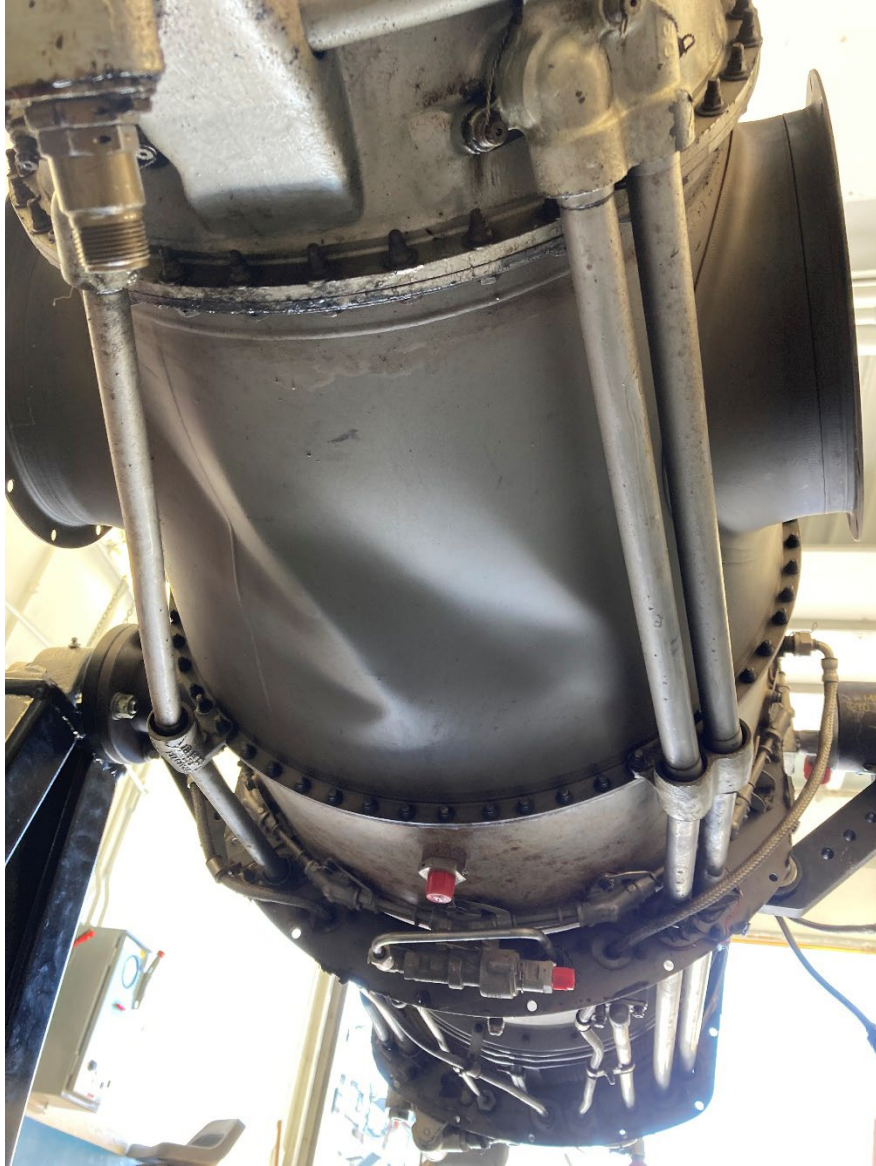
After shipment to Canada removing engine from crate, it was noted that the exhaust case had torsional buckling on the top and bottom surfaces. The power turbine was visually examined, and deformation was identified that precluded running the engine on the test cell in the as received condition. A spare power section module, provided by the manufacturer, was installed for testing.

*Figure 3. View of the bottom of engine with exhaust casing torsional buckling*

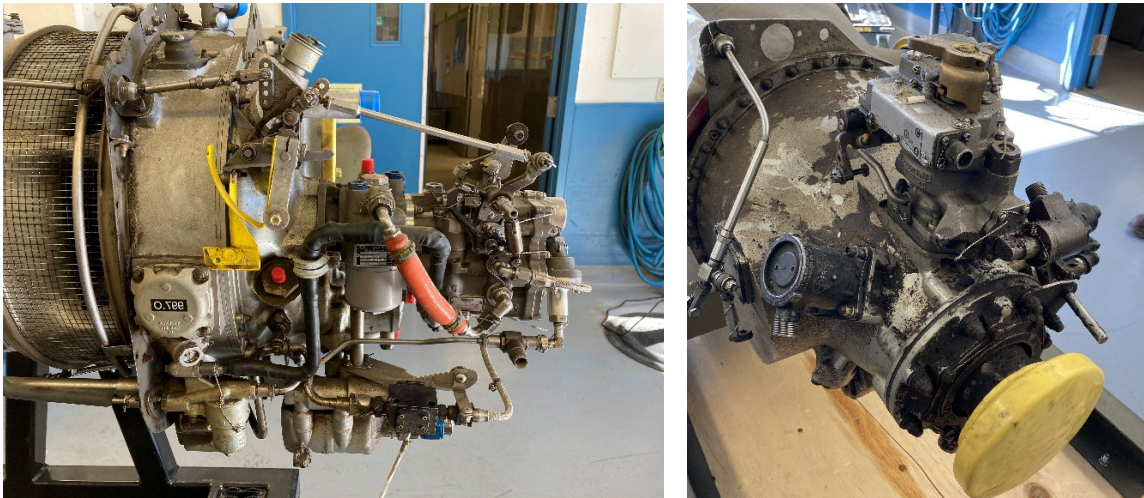
The FCU and fuel pump were removed and taken to their respective test benches and tested to the manufacturers component maintenance manual (CMM). The results of the tests found both FCU and fuel pump operated within the respective manufactures' standards.

The Propellor governor was disassembled, and the magnetic coil connector was observed soiled and appeared burnt. Electrical testing will be accomplished to ascertain the condition of the connector. No other anomalies were noted with the propellor governor.

*Figure 4. View of Fuel Control Unit, Fuel pump and prop governor.*

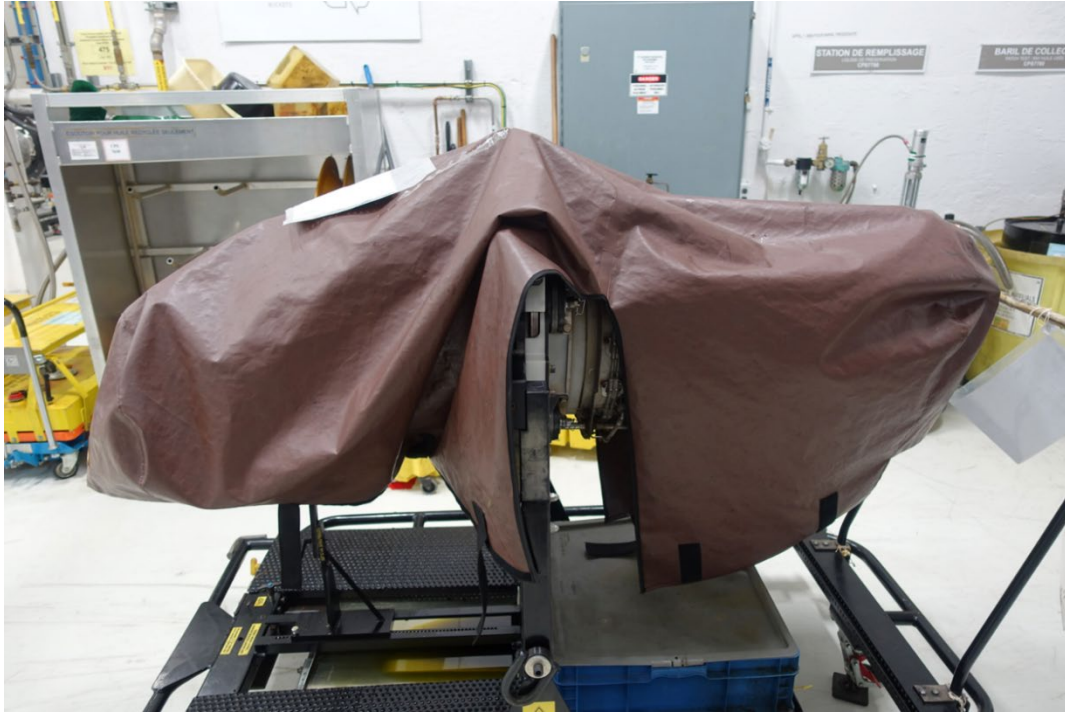
*Figure 5- ESN PCE-97015, as Received at the PWC Test Cell Area*

Due to the damage to the engine power section, a substitute PT6-65B power section was utilized, serial number: PS 32133, and the accessory controls were reinstalled and rigged in accordance with the engine maintenance manual (EMM). The substitute power section included a spare propeller governor/constant speed unit. The engine was then staged in the PWC Plant 1 test cell area in Longueuil, Québec, Canada.

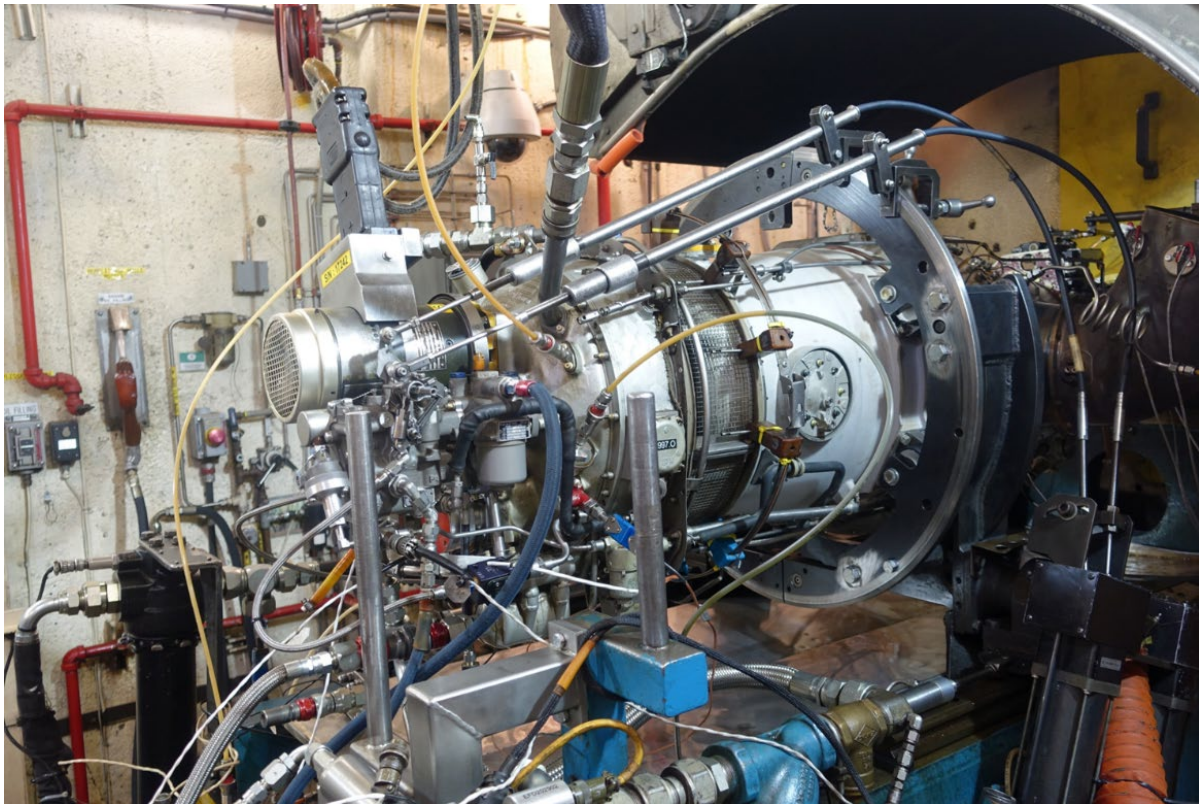
The engine was installed in the test cell and started normally. Following a short dwell period at ground idle speed to raise the oil temperature, the engine slowly accelerated to approximately 35,000 RPM (95% Ng). The test cell plenum pressure change confirmed that the compressor bleed valve (BOV), closed normally during

engine acceleration. Later data review showed the BOV was slow to close. The test cell T5 temperature (inter turbine temperature) readings began to fluctuate, and the engine was shut down for troubleshooting. Continuity checks of the test cell wiring and the engine T5 harness isolated the issue to the T5 harness that was installed with the spare power section. No additional testing could be completed due to the inaccurate T5 signal and risk of overtemperature.

*Figure 7- ESN PCE-97015, Installed in Test Cell*
