# National Transportation Safety Board

WPR24LA074

## **ENGINE EXAMINATION**

Airplane: Sonex N920MB

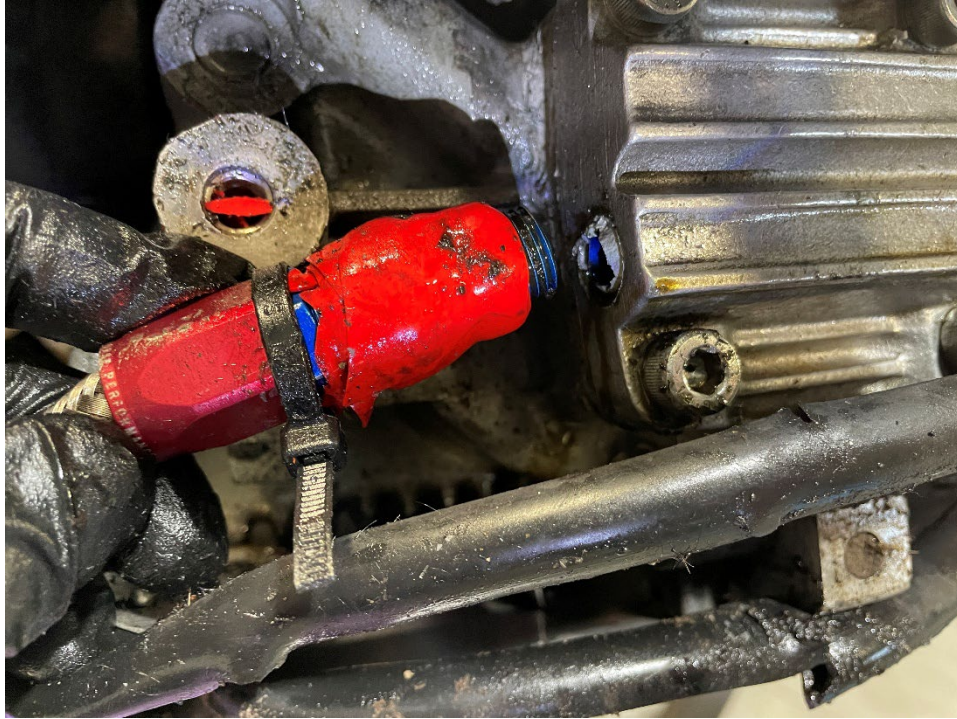
The oil pump housing had sustained impact damage and contacted the forward section of the engine mount. No oil cooler had been installed, and a bypass line was installed in its place. The line had fractured on the right side of the oil pump housing (figure 1).

**Figure 1 - Oil pump housing and broken cooler bypass fitting**

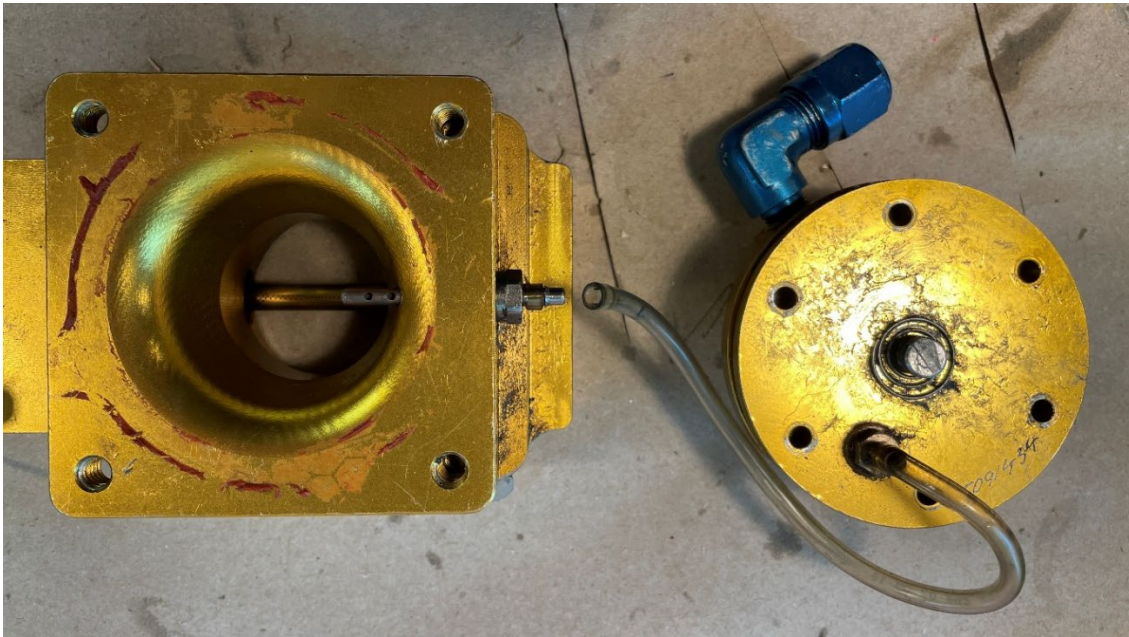
The TBI incorporated a separate “on demand metering” fuel regulator, which included a fuel priming feature. The regulator uses air pressure tapped from within the throttle body bore for reference. A plastic line was used to connect throttle body reference nipple to the air side of the regulator’s diaphragm. Examination of the plastic line revealed that it had detached from the body, and was almost completely full of a liquid which when tested with water detecting paste, appeared to be water (figure 2, 3, 4). The regulator was disassembled, and the air side of the diaphragm was covered in water (figure 5).

**Figure 2 - TBI throttle body and regulator**

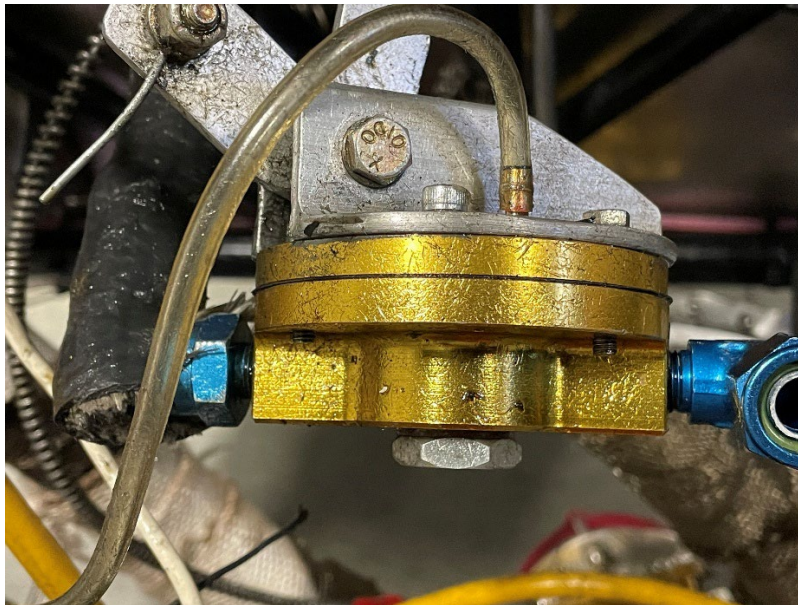
**Figure 3 - Throttle body-to-regulator line containing water**

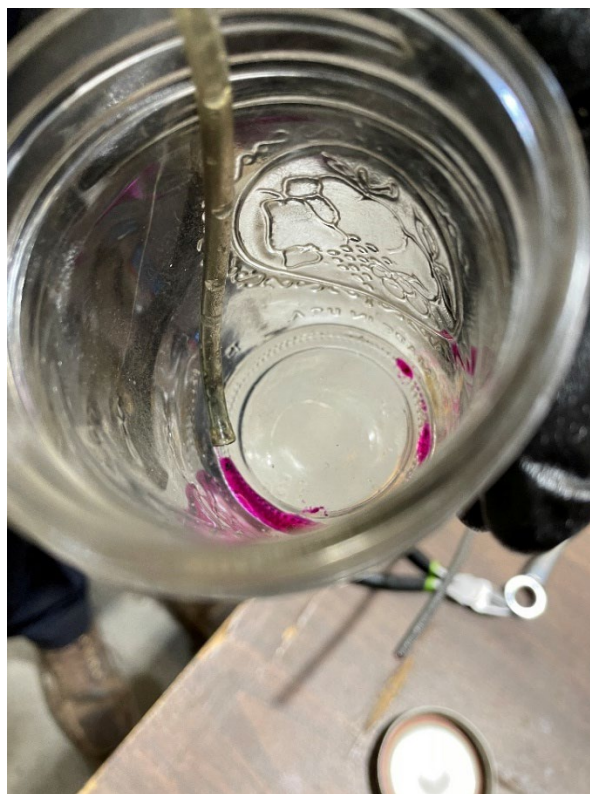
**Figure 4 - Water in line (red indicates water)**

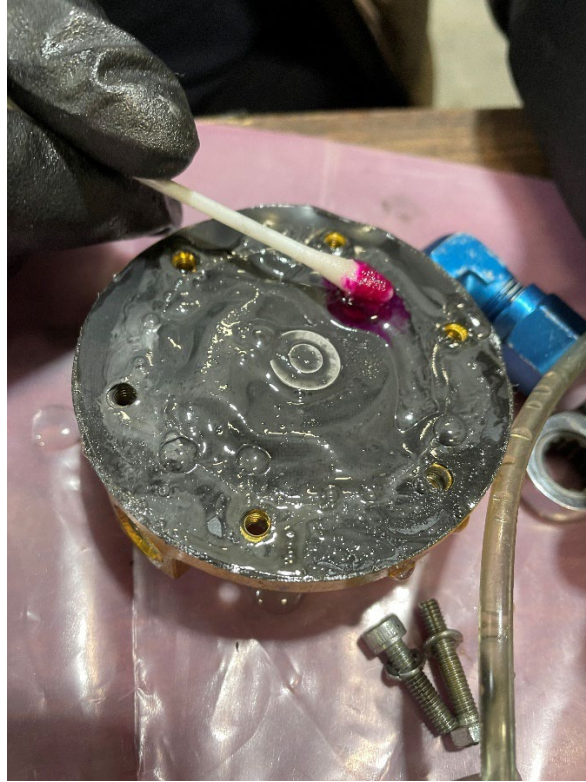
Examination of the engine revealed moisture contamination on the air side of the regulator that supplies fuel to the throttle body injector. It is not known how the moisture penetrated the unit. Although there was evidence of a significant oil leak, the engine exhibited no evidence of oil starvation, seizure, or catastrophic failure.

**Figure 5 - Water on air side of regulator diaphragm (red indicates water)**

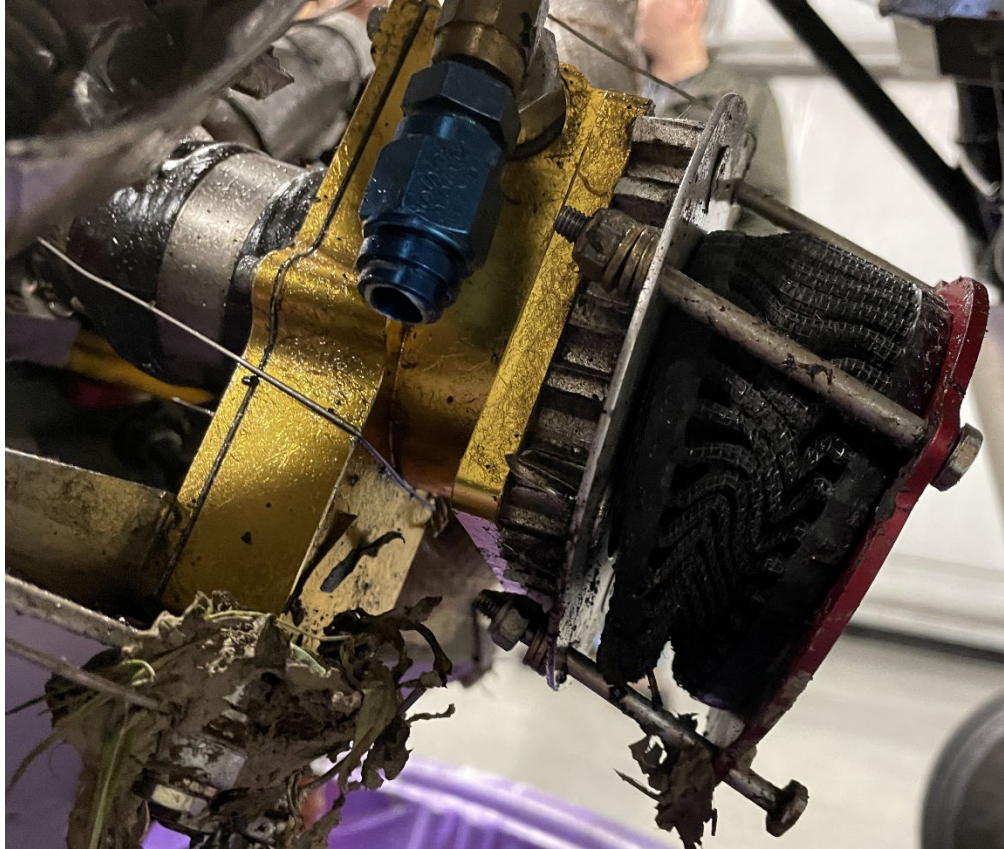
The fuel inlet strainer was free of debris, and the air inlet filter was clear. A 1-inch-thick honeycomb spacer had been installed between the filter and the TBI air inlet (figure 6).

**Figure 6 - Air filter and honeycomb spacer**
