# Aviation Investigation Final Report

| <b>Location:</b> | Mesquite, Nevada | <b>Accident Number:</b> | WPR24LA075 |
| <b>Date &amp; Time:</b> | January 12, 2024 15:15 Local | <b>Registration:</b> | N630L |
| <b>Aircraft:</b> | Harmon Rocket II | <b>Aircraft Damage:</b> | Substantial |

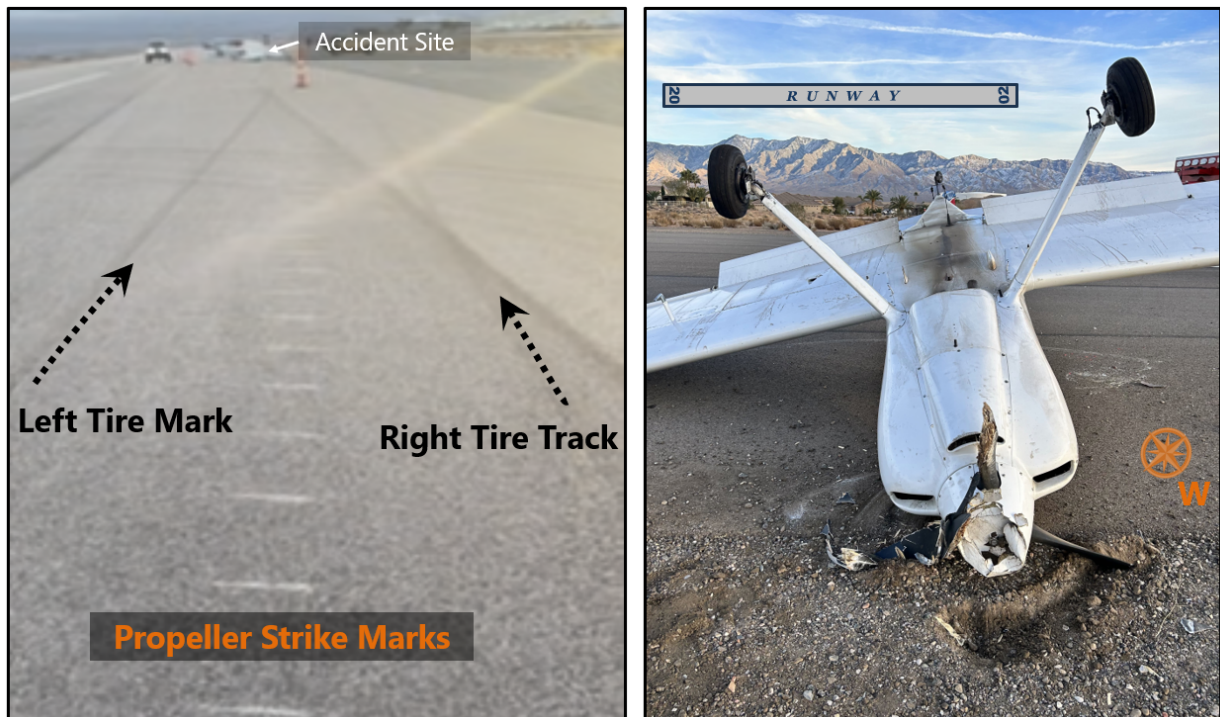
According to a witness, the first identified point of contact with the runway occurred about 1,200 ft from the approach end of runway 20, where tire marks were observed near the runway centerline. The tire marks subsequently veered right, and multiple propeller strike marks extended approximately 30 ft down the runway. Pieces of the

wooden propeller were located in this area. Tire marks continued to the right of the runway, and propeller strike marks resumed approximately 150 ft beyond the initial strike marks. The witness reported that runway markings indicated the airplane pitched forward and slid on the propeller hub and fuselage until it reached the right edge of the runway and entered the adjacent deep gravel. Depressions in the gravel were consistent with the airplane flipping over and coming to rest inverted along its longitudinal axis (see figures 1 and 2). The pilot's mechanic stated that from the tire marks, it appeared the pilot was applying brakes at the same time the engine was producing power.

Figures 1 and 2: The tire marks showing the propeller strike marks and the main wreckage showing orientation to the runway.
