WPR24LA079

## INVESTIGATION PHOTOGRAPHS

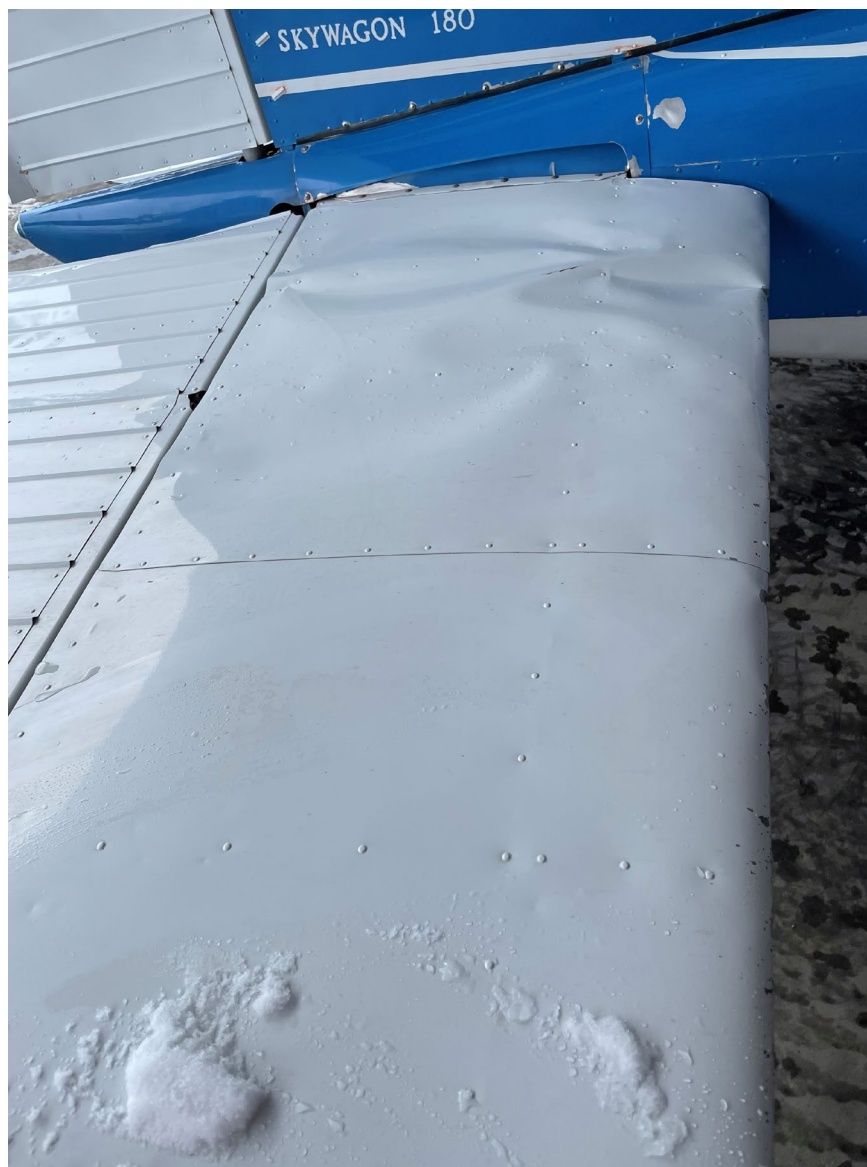
**Photograph 1 - View of right horizontal stabilizer damage (Courtesy of Pilot)**
