# National Transportation Safety Board

WPR24LA081

## **AIRFRAME AND ENGINE EXAM REPORT**

Location: Camarillo, California  
Date: January 30, 2024  
Time: 13:17 Pacific standard time  
Airplane: N906CR, Raptor Junior 540

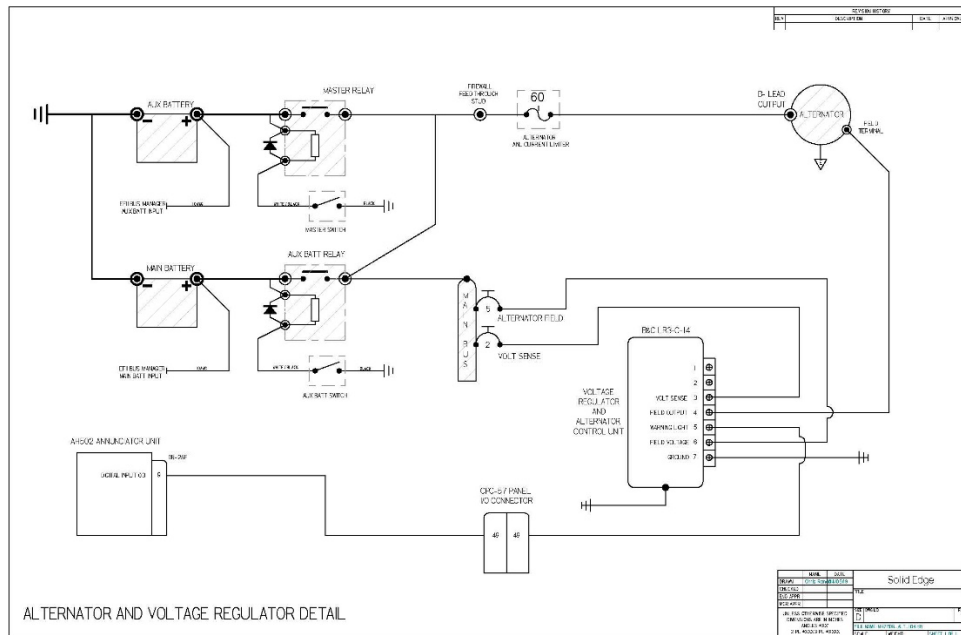
Electrical system redundancy is accomplished by use of both a main and auxiliary battery system, connected to the main bus. (Fig. 1 and 2)

**Figure 1.** Diagram of main electrical bus and essential electrical bus, powered by an alternator and dual batteries.

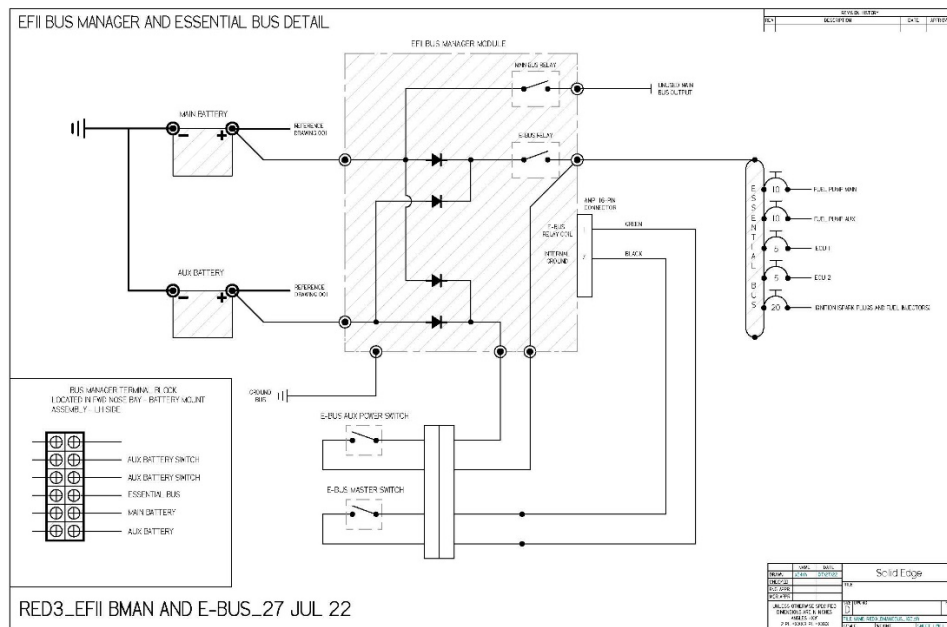
The airplane was designed with a main electrical bus and essential electrical bus, powered by a conventional alternator, and dual batteries. The EFII system is powered through an essential bus by an EFII bus manager module.

**Figure 2.** Diagram of EFII bus manager and essential bus.

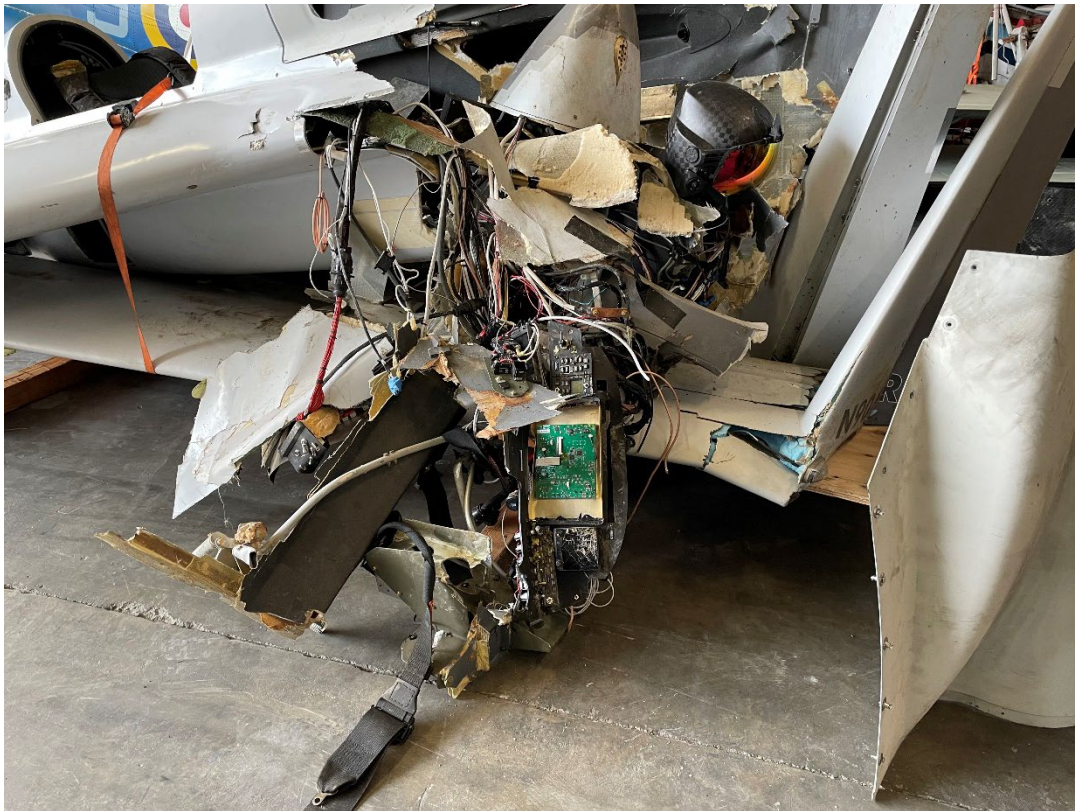
The forward fuselage and cabin area were impact damaged. The nose cone was separated from the forward fuselage. Impact and crush damage prevented an accurate assessment of cockpit circuit breakers and switches. All instruments and avionics systems were impact damaged.

**Figure 3.** Forward fuselage area.

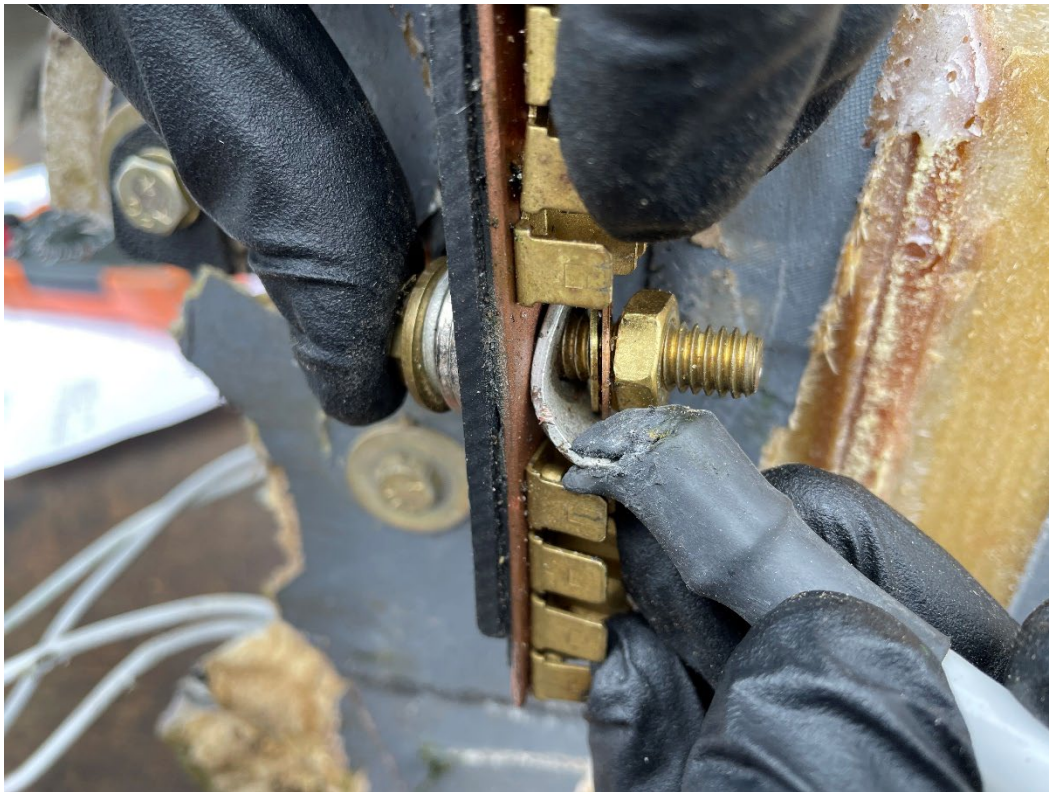
Within the nose cone, the negative terminals of both batteries remained connected via their common ground line, however, the common ground feed through stud was loosely connected to the ground bus on the nose cone bulkhead.

**Figure 4.** Common ground feed through stud loosely connected to the ground bus.

Examination revealed that the feed through nut was 3.5 turns loose, which corresponded to approximately 3.5 threads of the feed through stud. Disassembly of the feed through stud assembly revealed that a single tooth lock washer had been used, rather than both a tooth lock washer and spring lock washer as had been found with all other primary electrical connections.

Additionally, the EFII ground bus had an ABS plastic backing of 1/8 inch thick (as seen in Figure 4), and the stud was not equipped with a secondary locking nut, as had been consistent throughout the entire electrical system. All electrical ground spade connectors had pulled away from the ground bus.

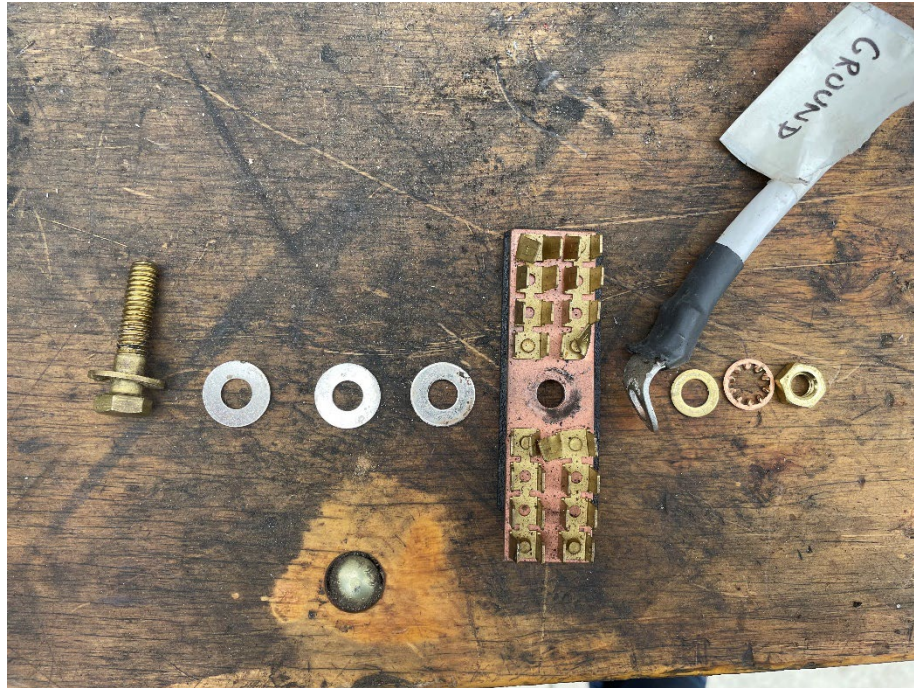
**Figure 5.** Disassembled feed through stud assembly.
