# National Transportation Safety Board

WPR24LA082

## **NTSB WRECKAGE EXAMINATION REPORT**

Location: Eden, Oregon  
Date: January 26, 2024  
Time: 1329 Pacific standard time  
1800 UTC  
Airplane: Piper PA-18A-150 Supercub

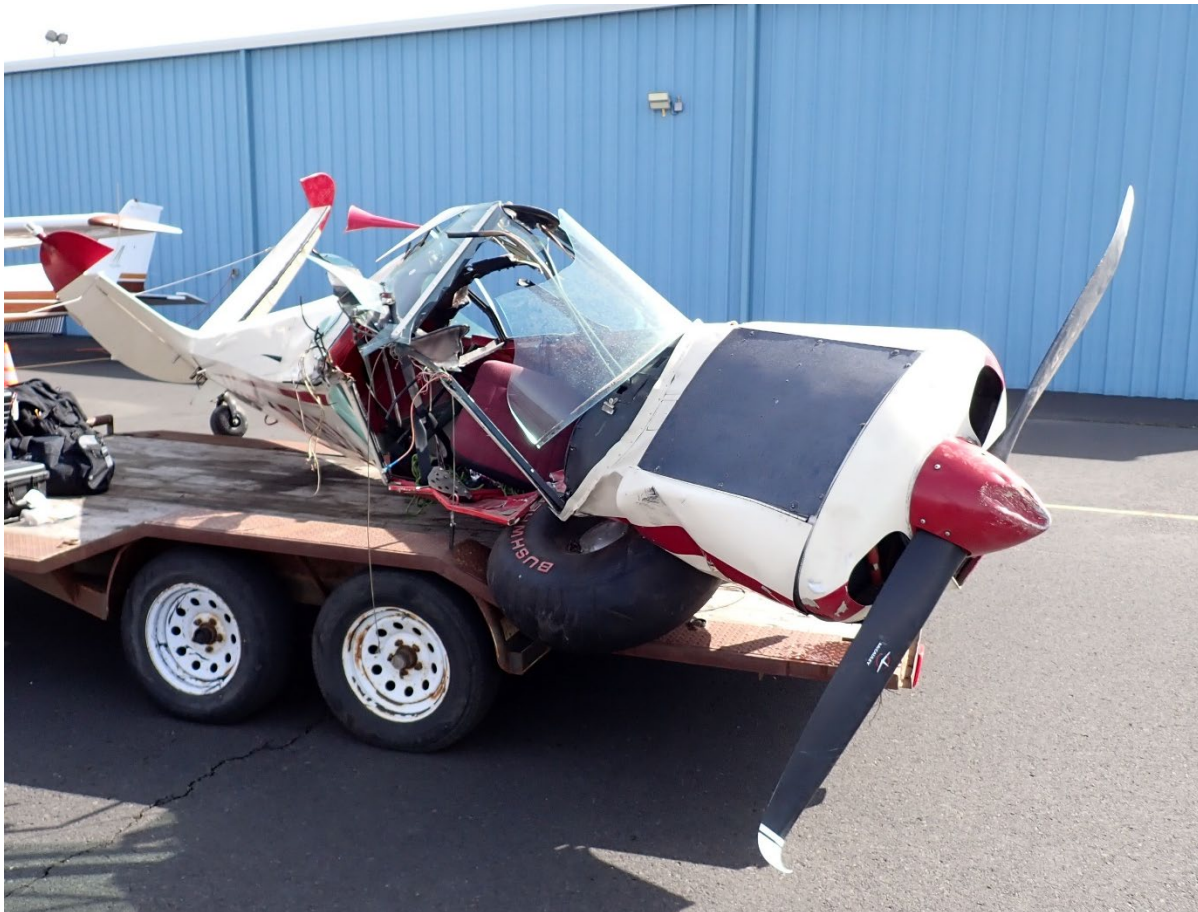
The fuselage remained mostly intact with some bent structural tubes at the top of the cabin. The forward seat foot well was crushed upward and the right rudder pedal was displaced. The instrument panel was unremarkable.

**Figure 1: Airplane prior to wreckage examination**

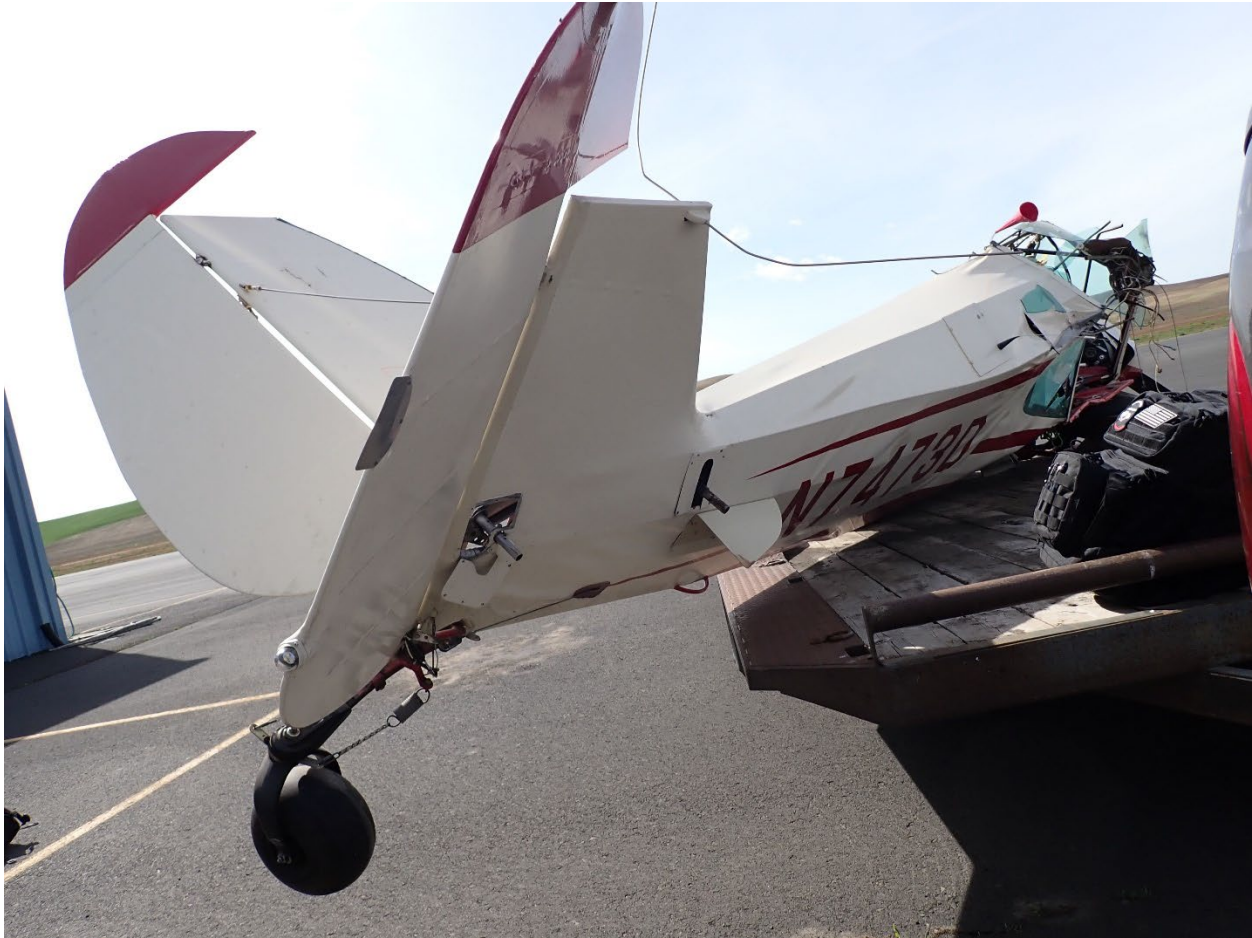
The empennage was intact and undamaged. The right horizontal stabilizer and elevator were also undamaged, but had been disassembled by recovery personnel. The elevator control cables were continuous from the flight control stick to the empennage. The rudder remained attached to the empennage and rudder control continuity was confirmed from the rudder pedals at the cockpit to the flight control surface.

**Figure 2: Empennage**

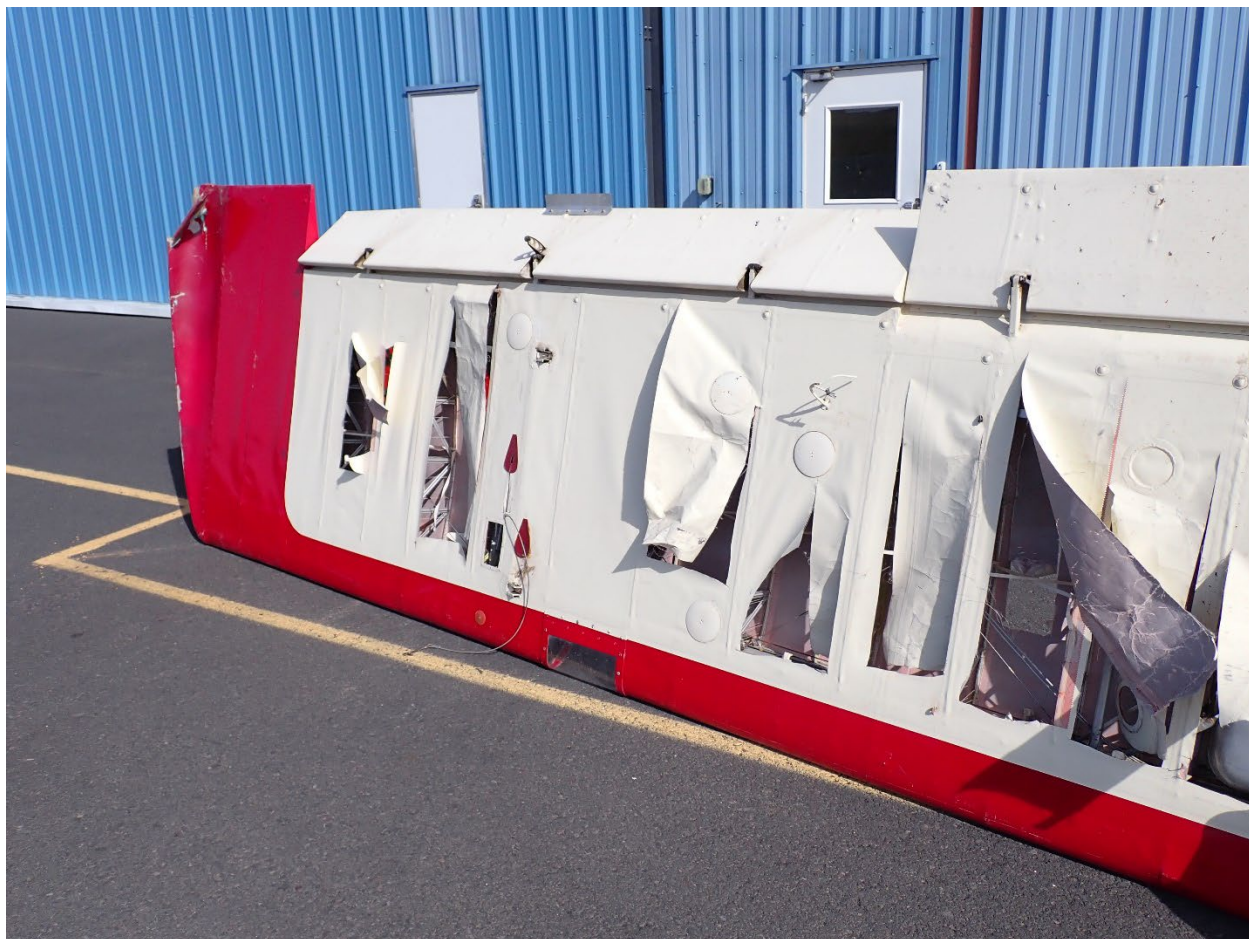
Both wings were removed by recovery personnel. The right wing was separated inboard; however, the aileron and flap remained attached. Both the right and left wing struts were damaged. The left wing remained intact and the left aileron and flap remained secured at their respective attachment points. The left and right aileron cables were continuous from their flight control surfaces to the wing roots.

**Figure 3: Left wing**

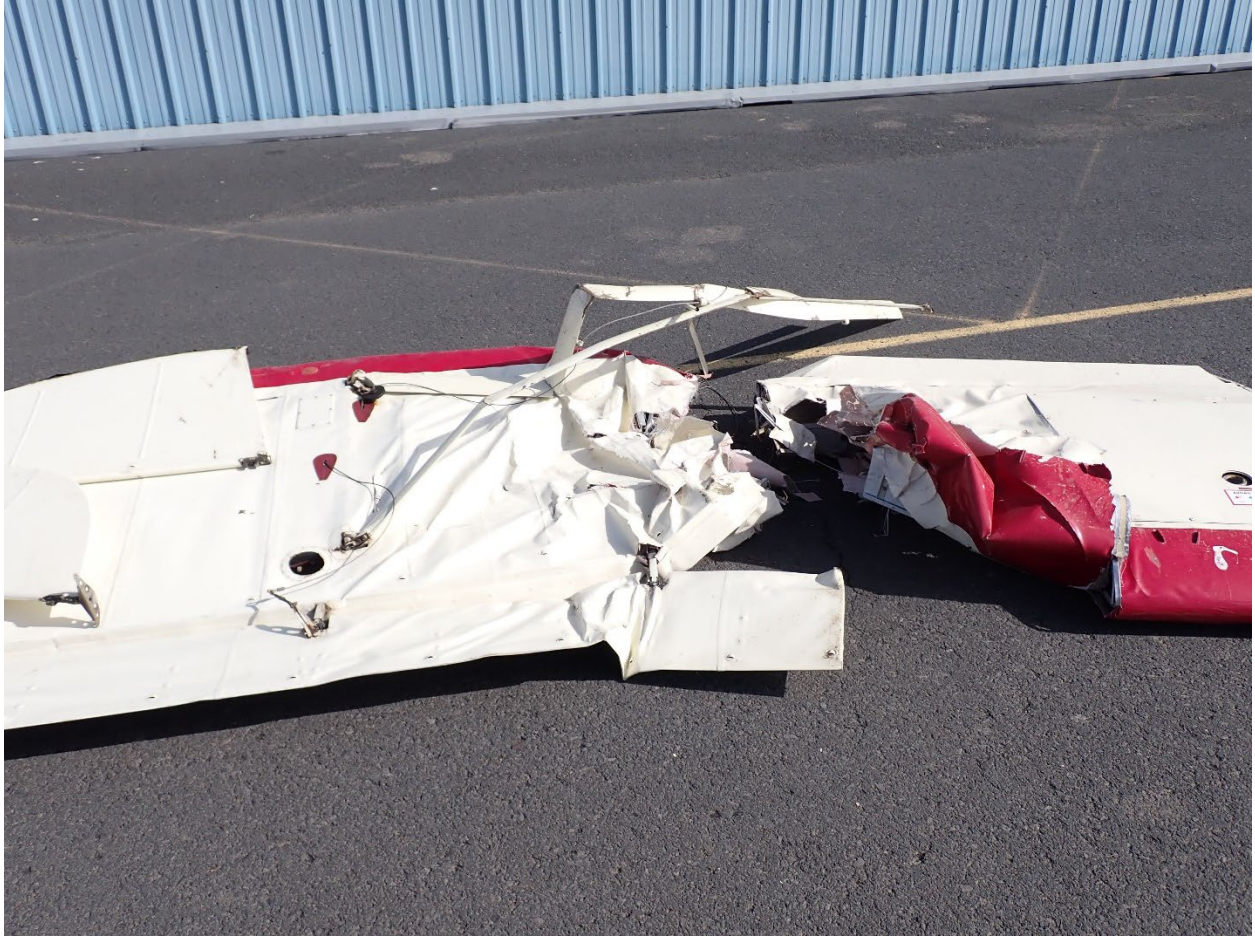
**Figure 4: Right wing**

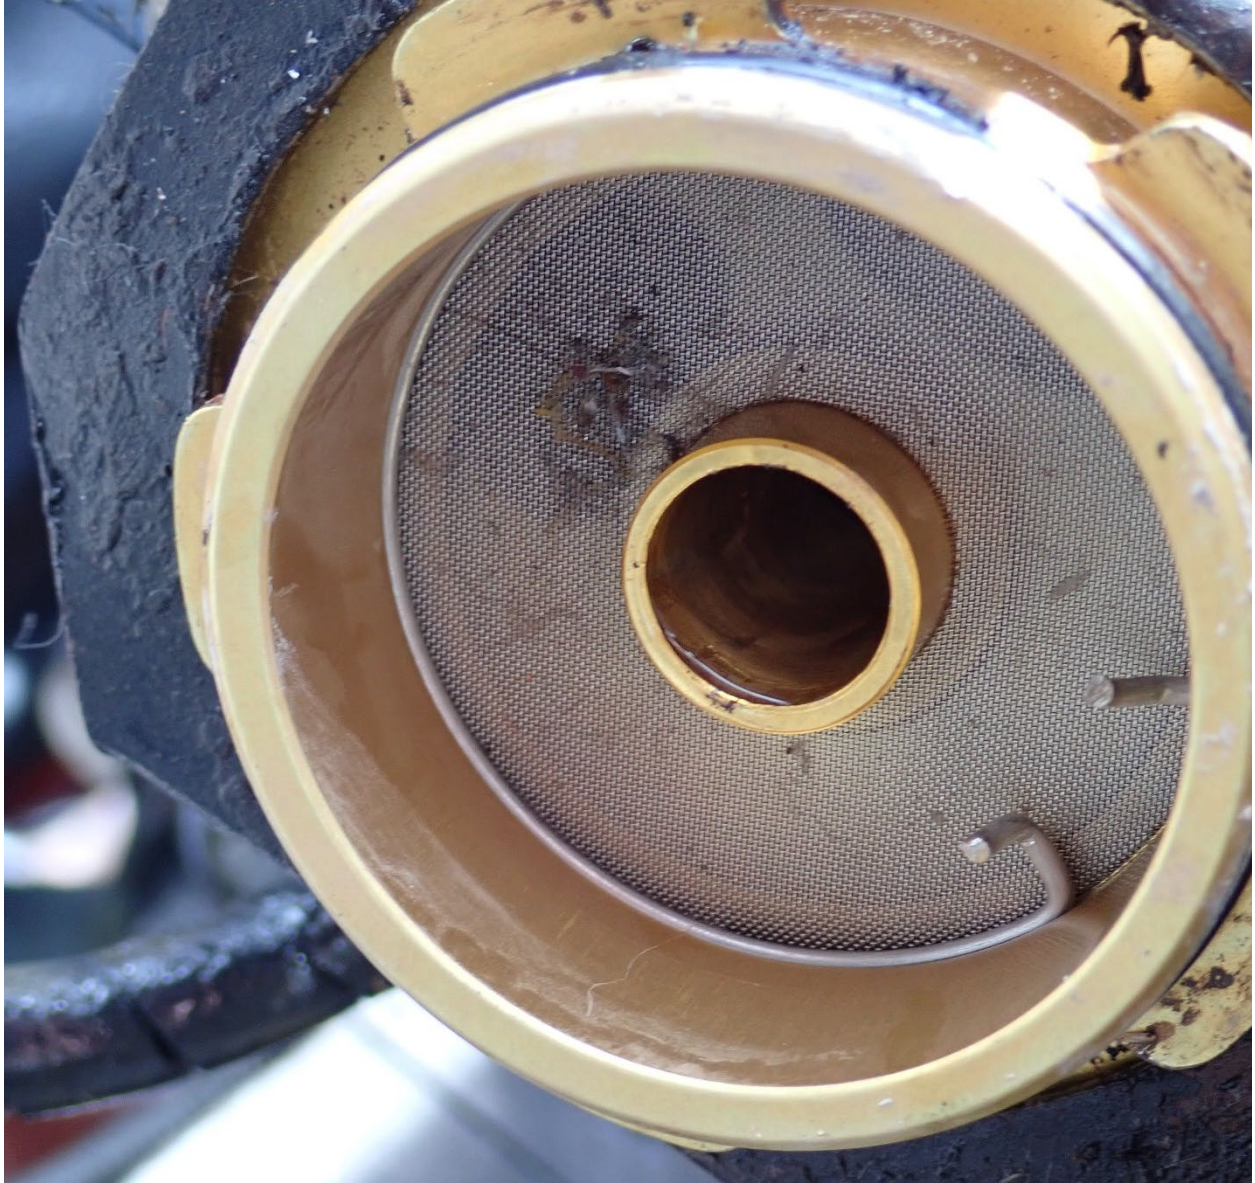
The airplane was equipped with two metal fuel tanks that were installed at the wing root of the right and left wings. Both fuel tanks were filled with about 5 gallons of water. The water in both wings was expelled from the lower fuel port, which revealed that neither tank was compromised. The fuel lines were continuous from their disconnection at the wing roots to the engine at the carburetor. The fuel strainer bowl was free of contamination and the strainer filter a trace amount of debris.

**Figure 5: Fuel strainer filter**

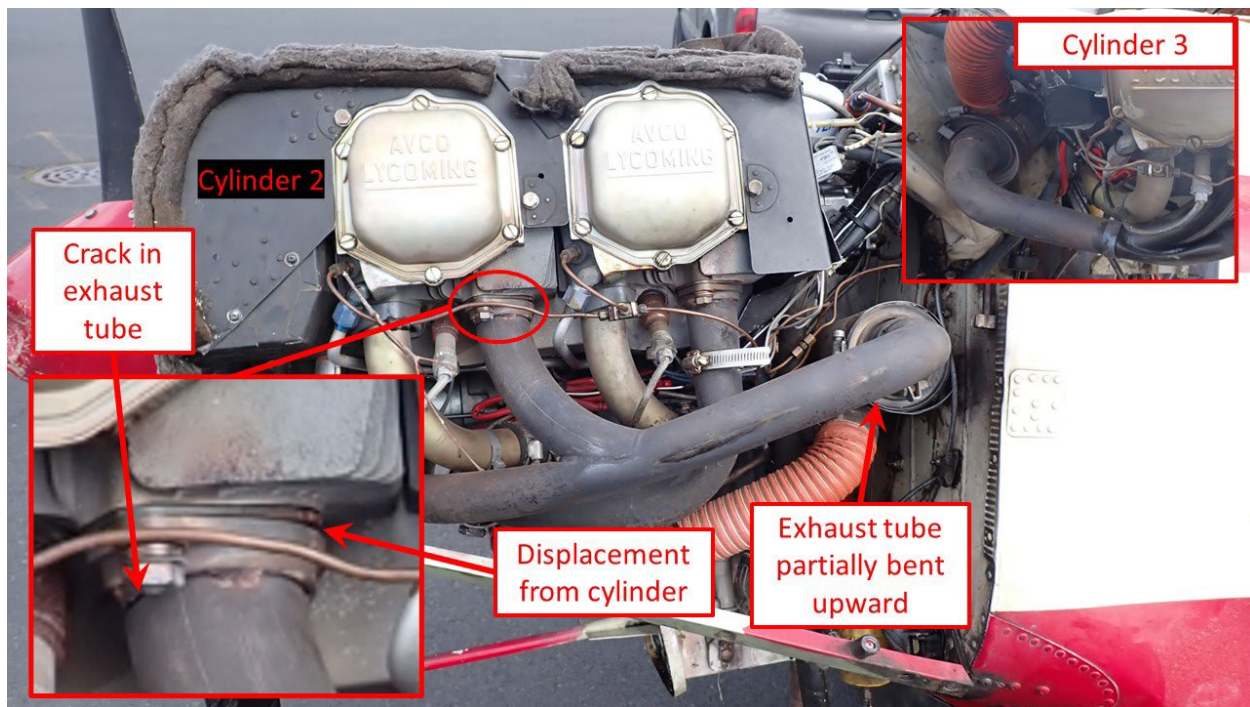
The airplane was equipped with a Lycoming Engines O-320-A2B, a 180 hp, horizontally opposed, air cooled, normally aspirated, reciprocating engine. The engine remained intact and mostly undamaged with exception of the engine air filter, which was partially crushed upward. The cylinder 2 exhaust tube was bent upwards near the engine fire wall and the tube was cracked and partially displaced at the cylinder when compared to the exhaust tube for cylinder 1 and 3. The airplane had no evidence of oil staining on the fuselage or in the cowling. There was a trace amount of oil staining below the nut of the cylinder 4 oil return line, but no evidence of a leak.

**Figure 6: Cylinder 2 crack and displacement**

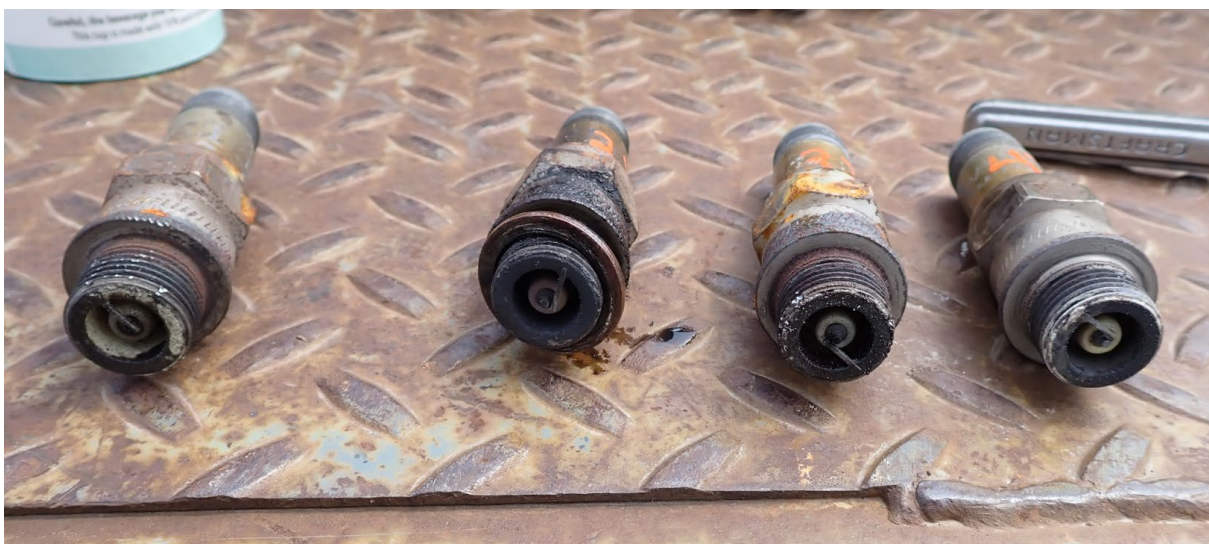
All eight of the ignition harness wires remained attached at the magnetos and corresponding spark plugs. The top spark plugs were Champion REM 38S fine wire plugs and were free of mechanical damage. Each of the top plugs displayed coloration consistent with normal wear with some evidence of rust and corrosion. The electrodes were undamaged.

**Figure 7: Top spark plugs**

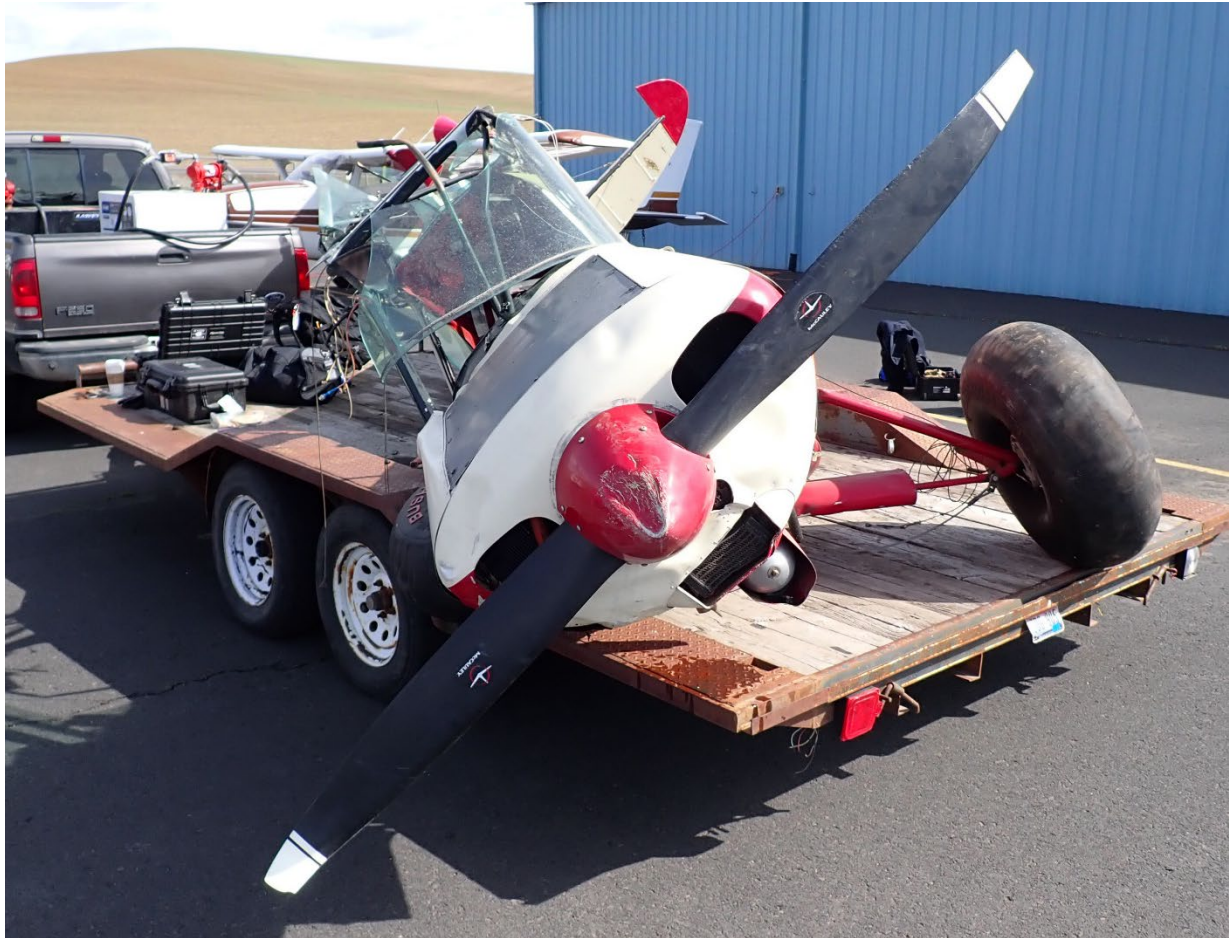
The McCauley 2 bladed fixed blade propeller remained attached to the propeller hub. One propeller blade exhibited tip curling and the other blade was slightly bent aft. The camber and face sides were both unremarkable.

**Figure 8: View of propeller blades from front of airplane**
