## Air Safety Investigations Aircraft Incident/Accident Technical Report

| Aircraft Incident/<br>Accident Information | Year: 1980 | Make: Cessna | Model: 172P |
| | Serial number: 17274520 | | Registration: N52436 |
| Senior Air Safety Investigator: Jennifer D. Barclay | | Report #: ASI-24-AN-T | Report date: 07-16-24 |

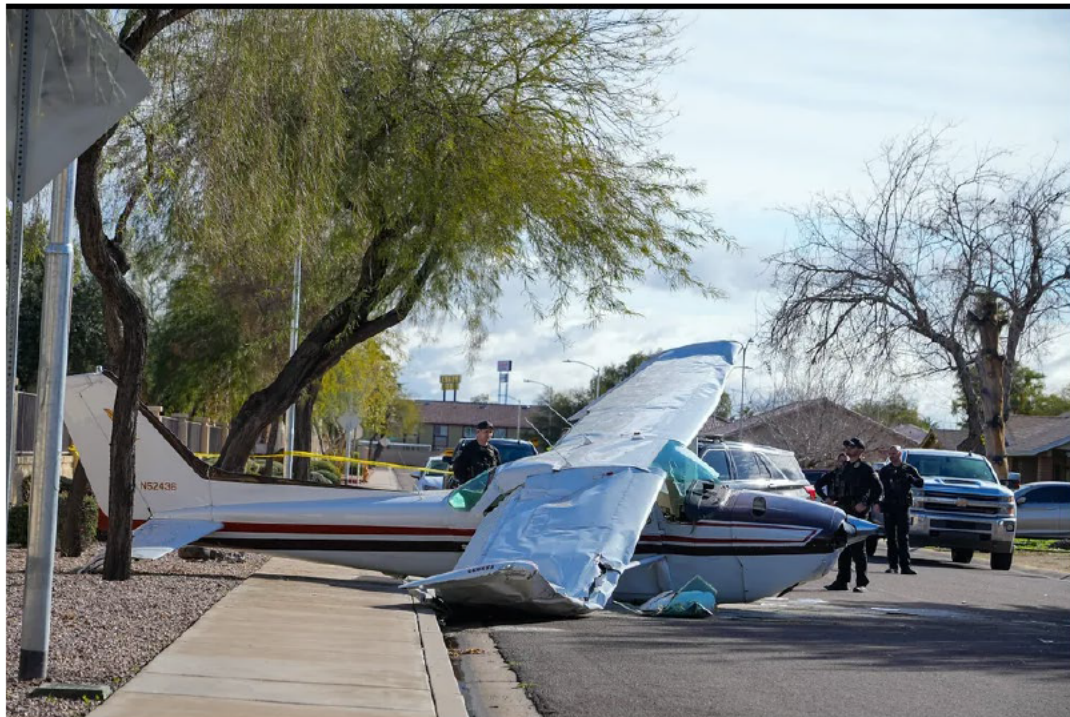
There was no evidence of fire. The wings and struts were removed by recovery personnel to facilitate transport to the storage facility. Slight buckling was observed on the right side of the fuselage forward of the cabin door and aft near the baggage area. The right main landing gear was inverted which prevented opening of the right cabin door. The left wing exhibited leading edge damage from midspan to the wingtip and downward buckling to the outer 1/3 of the wing. The right wingtip was forced upward, and the wing exhibited downward buckling from midspan to the wingtip. The leading edge exhibited tearing midspan.

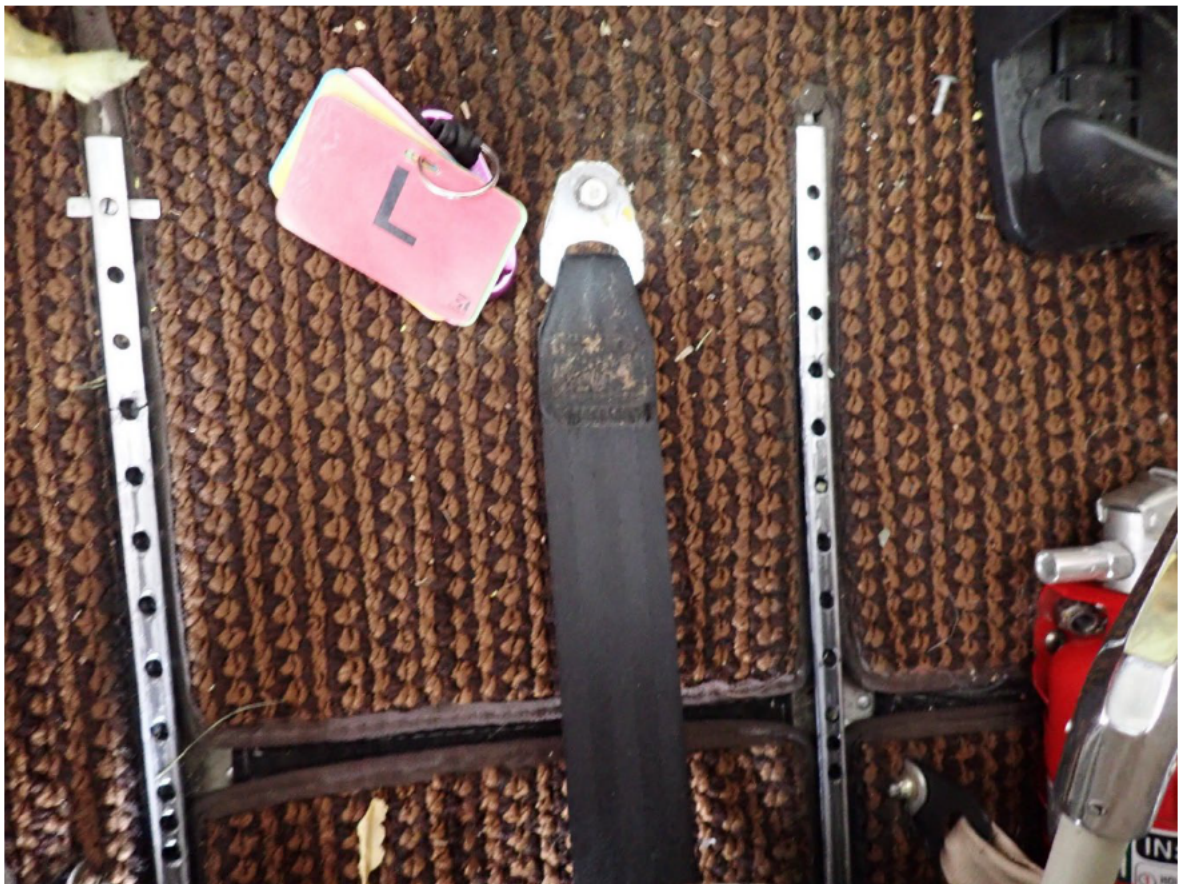
Both occupants were utilizing the lap-belt portion only of the available three-point restraints. All four seat rails exceeded the seat rail hole dimensions listed in AD 2011-10-09.

Pilot seat rails, ASI-24-AN-023

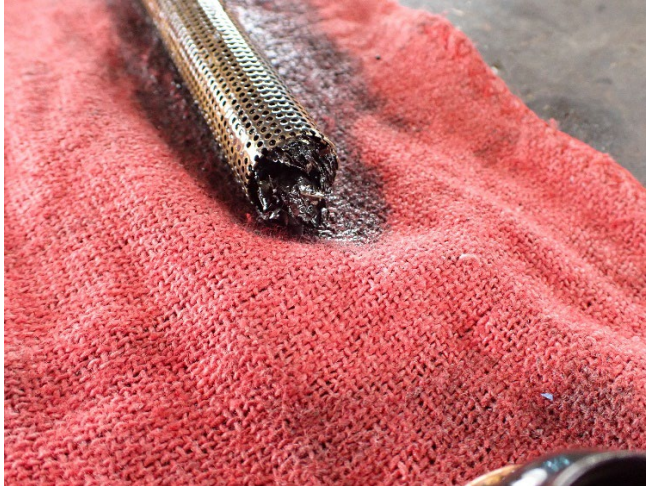
The engine could only be partially rotated with the propeller due to an internal engine malfunction. Thumb compression/suction could not be obtained. The oil dipstick indicated approximately four quarts of oil in the sump. The oil filter was cut open, and metal contamination consistent with bearing material was observed in the pleats. The oil suction screen was about half full of metal consistent with bearing material.

Oil suction screen, ASI-24-AN-050

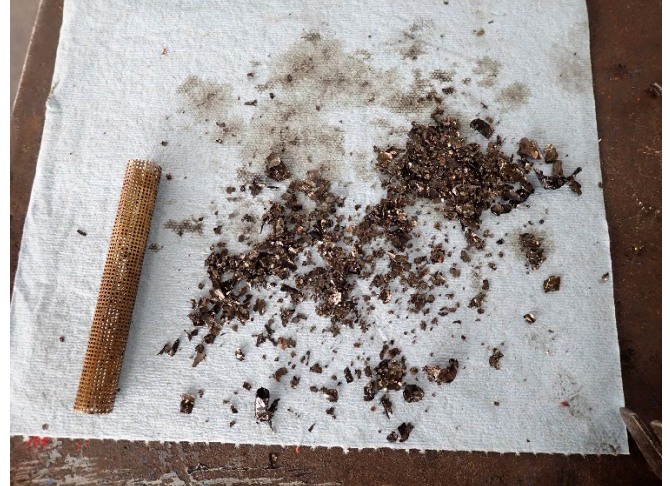
Metal removed from suction screen, ASI-24-AN-052

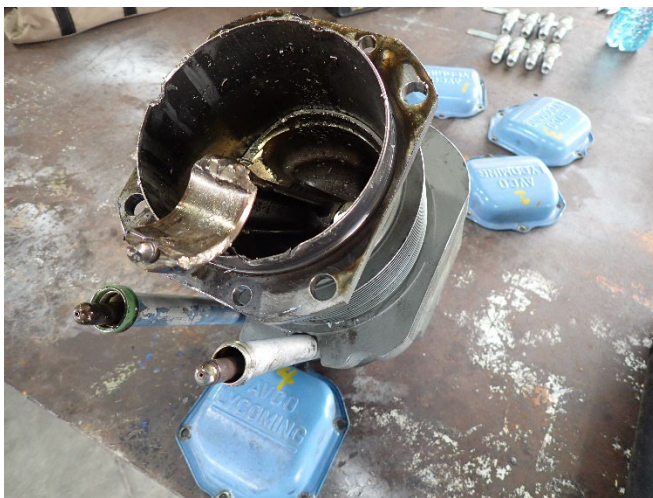
Cylinders #1, #2 and #4 were removed to facilitate examination; cylinder #3 could not be removed due to a damaged cylinder barrel. The #4 connecting rod separated from the crankshaft and had mechanical damage to the yoke end. The lower yoke portion separated from the connecting rod. The #4 connecting rod journal surface showed normal operating signatures. The #3 connecting rod separated from the journal and had mechanical damage to the yoke end. Both yoke end portions separated from the connecting rod. The #3 journal surface exhibited thermal distress. The separated connecting rod parts were found in the lower area of cylinders #3 and #4. The #4 bearing was found with deformation and no thermal distress. Four connecting rod cap bolt ends separated about mid-length and all 4 nuts remained attached. The #2 connecting rod was loose on the crankshaft. The connecting rod exhibited thermal distress at the yoke and cap end. Most of the bearing separated from the connecting rod. The #2 connecting rod journal exhibited thermal distress. The #1 connecting rod journal exhibited normal operating signatures. The connecting rod nuts were found tightly secured on the #1 & #2 rod caps prior to removal. The oil sump was removed from the crankcase and contained metal contamination and mechanically damaged parts.

Cylinder #4, ASI-24-AN-057

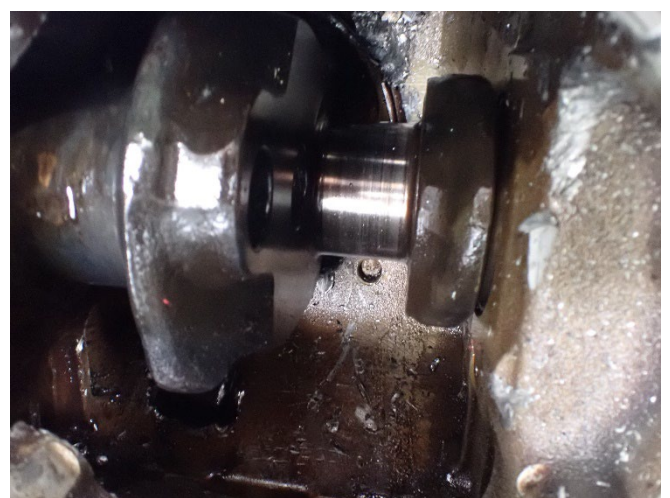
#4 journal surface, ASI-24-AN-060

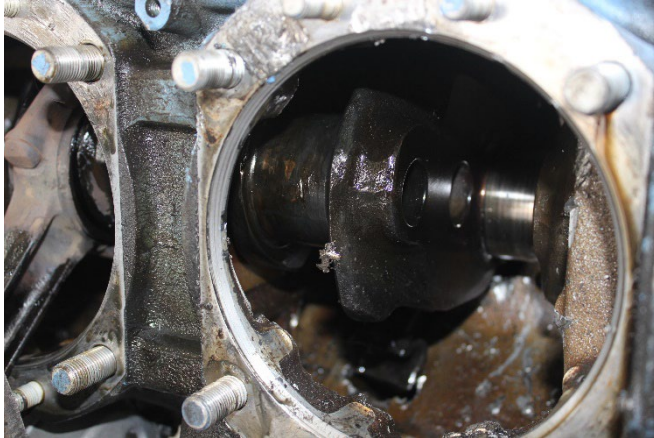
#3 journal surface, Lycoming photograph

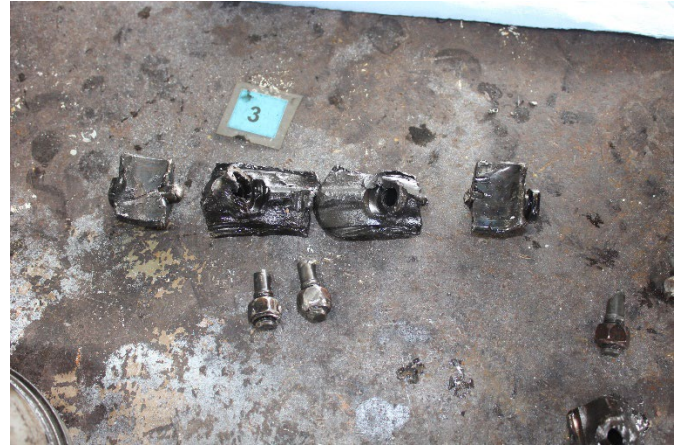
#3 yoke end, Lycoming photograph

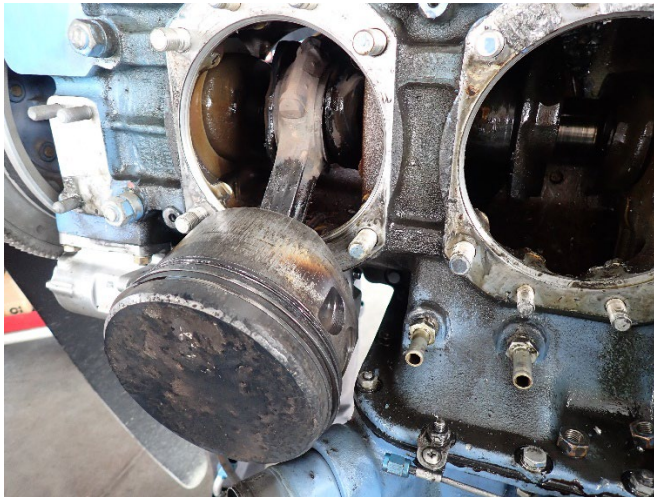
#2 connecting rod, ASI-24-AN- 067

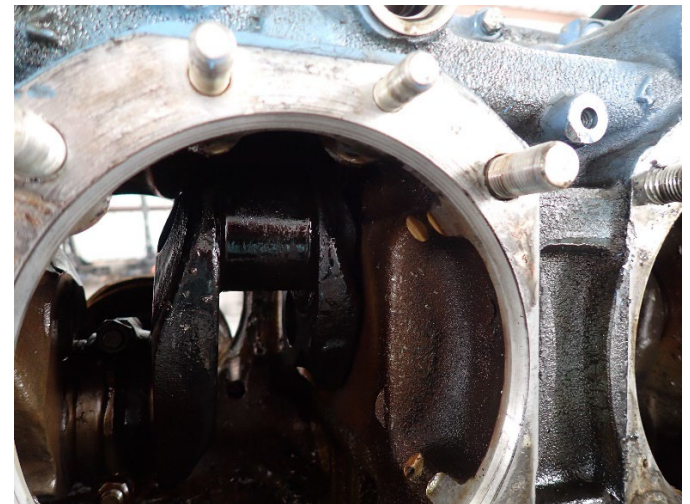
#2 journal surface, ASI-24-AN-075

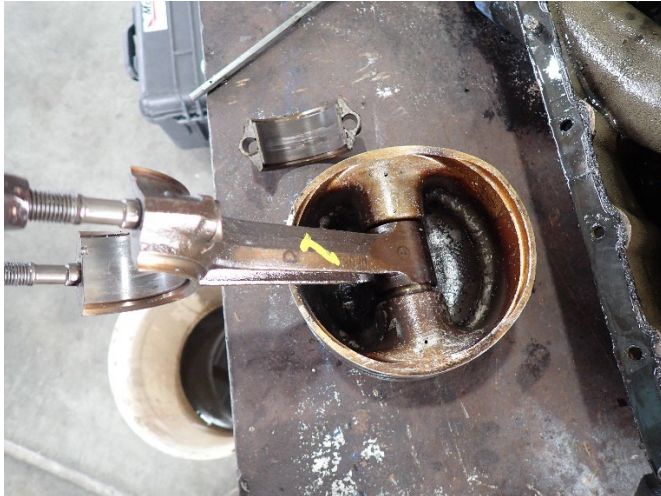
#1 connecting rod, ASI-24-AN-079

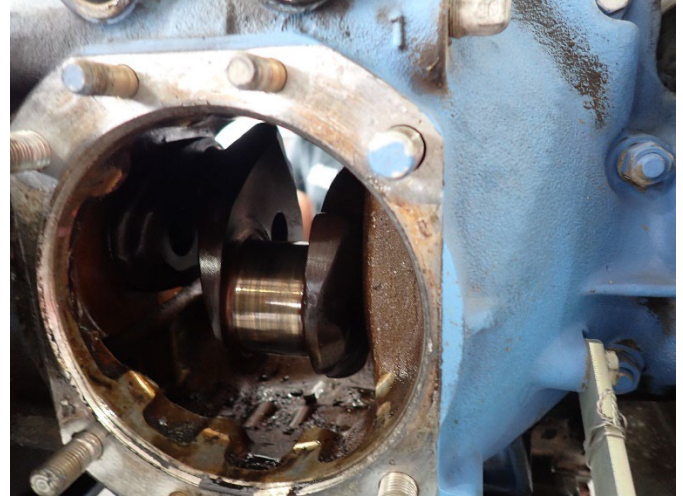
#1 journal surface, ASI-24-AN-078
