# National Transportation Safety Board

WPR24LA084

## **WRECKAGE EXAMINATION SUMMARY REPORT**

Location: Goodyear, Arizona  
Date: 2/10/2024  
Time: 0745 local  
Airplane: Cessna 172P

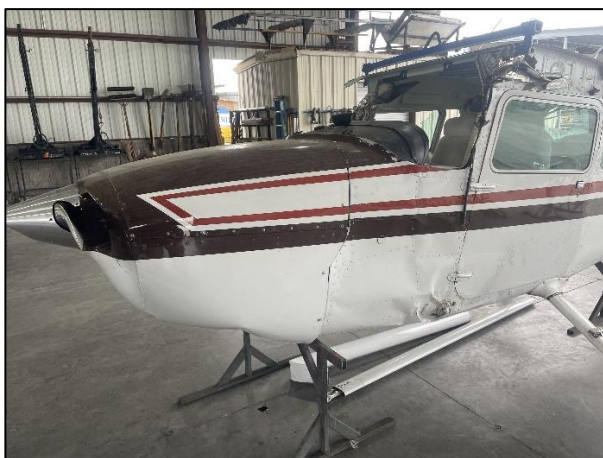
Figure 1-Follow-up examination, main wreckage.

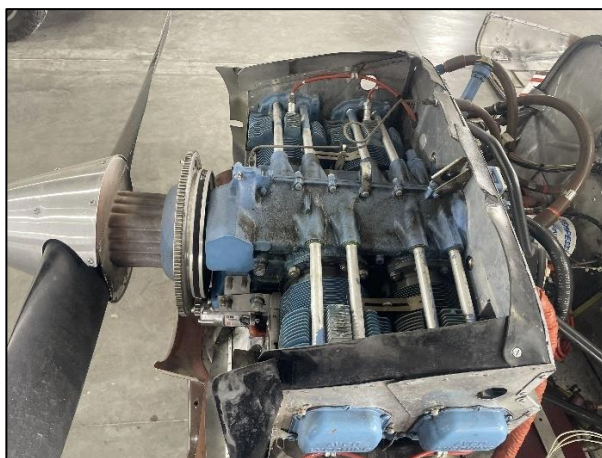
Figure 2-Engine decowled.

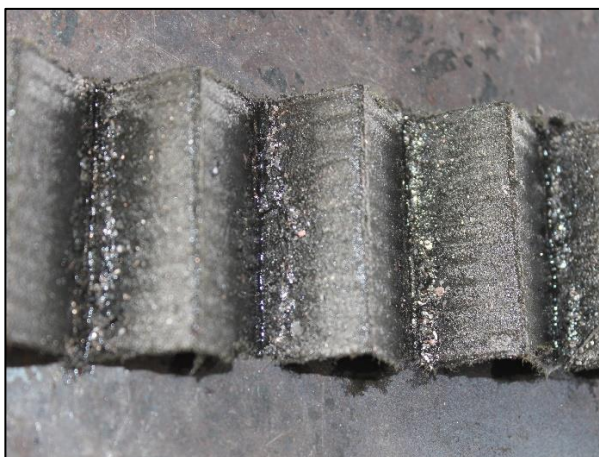
The oil filter was removed from the engine and disassembled. Metal contamination consistent with bearing material, was noted in the pleats of the filter. The oil suction screen was removed and contained metal contamination. The screen was about half full of metal consistent with bearing material. The oil sump was removed and contained bearing material fragments.

Figure 3-Oil filter pleats and contamination.

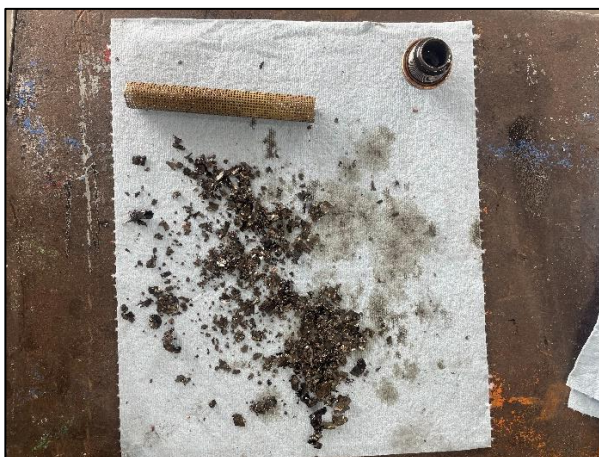
Figure 4-Oil suction screen and contaminants.

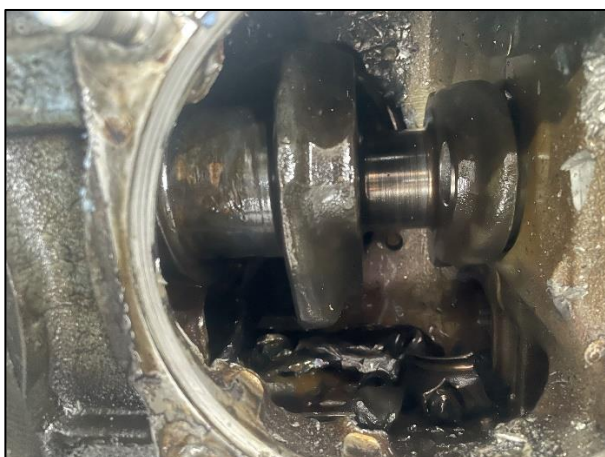
The No. 4 cylinder was removed and the No. 4 connecting rod separated from the crankshaft and had mechanical damage to the yoke end. The lower yoke portion separated from the connecting rod. The No. 4 connecting rod journal surface showed normal operating signatures. The No. 3 connecting rod separated from the journal and had mechanical damage to the yoke end. Both yoke end portions separated from the connecting rod. The No. 3 connecting rod journal surface showed thermal distress and mechanical damage. The separated connecting rod parts were found in the bay area between cylinders No. 3 and 4. The No. 4 bearing was found with deformation and no thermal distress. Four connecting rod cap bolt ends separated about mid-length and all 4 nuts remained attached.

Figure 5-No. 4 cylinder bay area.

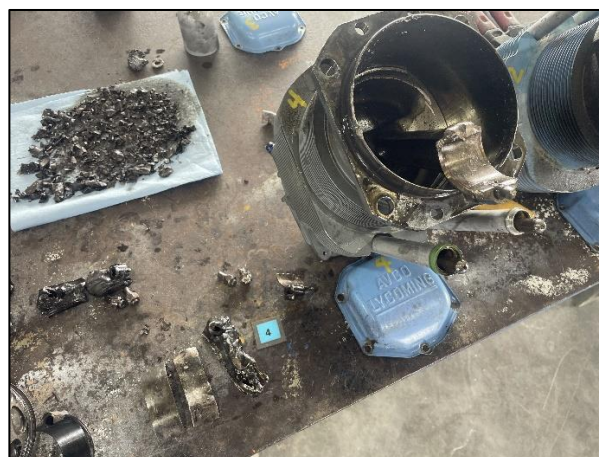
Figure 6-No. 4 cylinder removed.

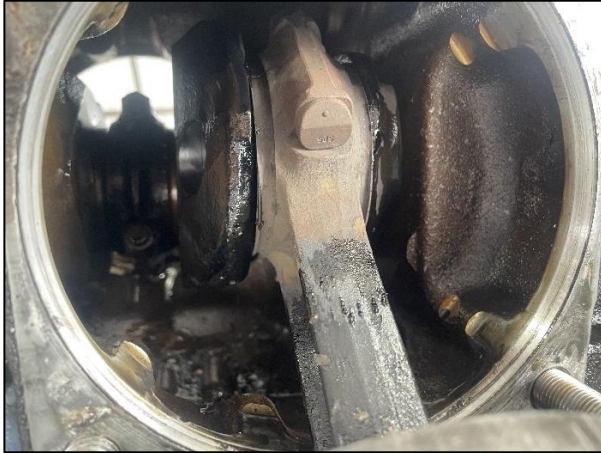
The No. 2 cylinder was removed, and the connecting rod was loose on the crankshaft. The connecting rod showed thermal distress at the yoke and cap end. The majority of the bearing separated from the connecting rod. The No. 2 connecting rod journal showed thermal distress. The No. 1 cylinder and connecting rod was removed and the connecting rod journal showed normal operating signatures. The connecting rod nuts were found tightly secured on the No.1 and 2 rod caps before removal.

Figure 7-No. 2 cylinder bay area and connecting rod.

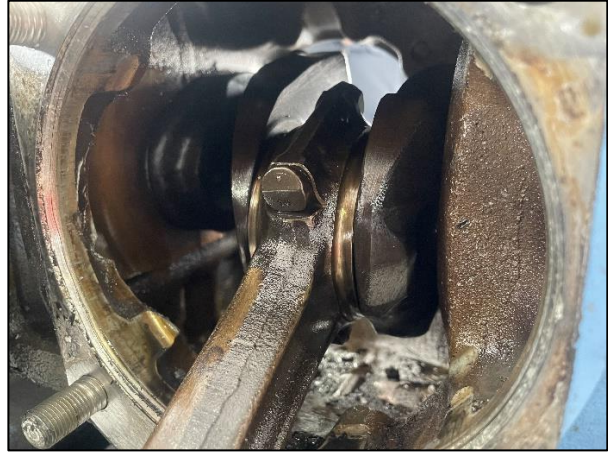
Figure 8-No. 1 cylinder bay area and connecting rod.

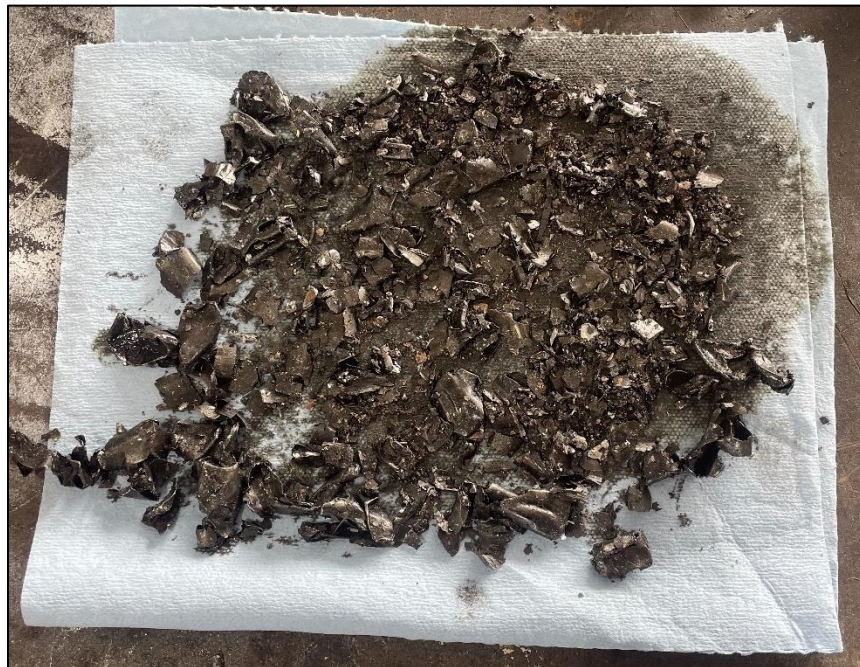
The oil sump was removed from the crankcase and the sump contained metal contamination and mechanically damaged parts.

Figure 9-Oil sump contaminates.

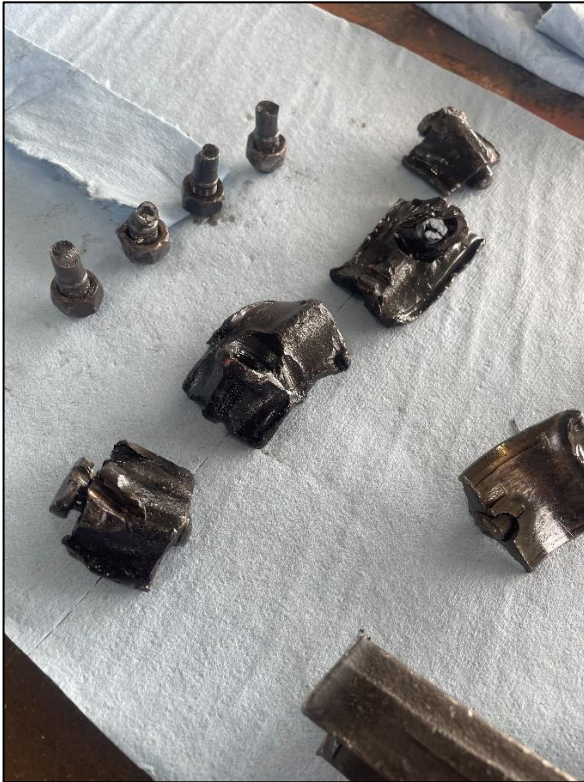
Figure 10-No. 3 connecting rod parts.

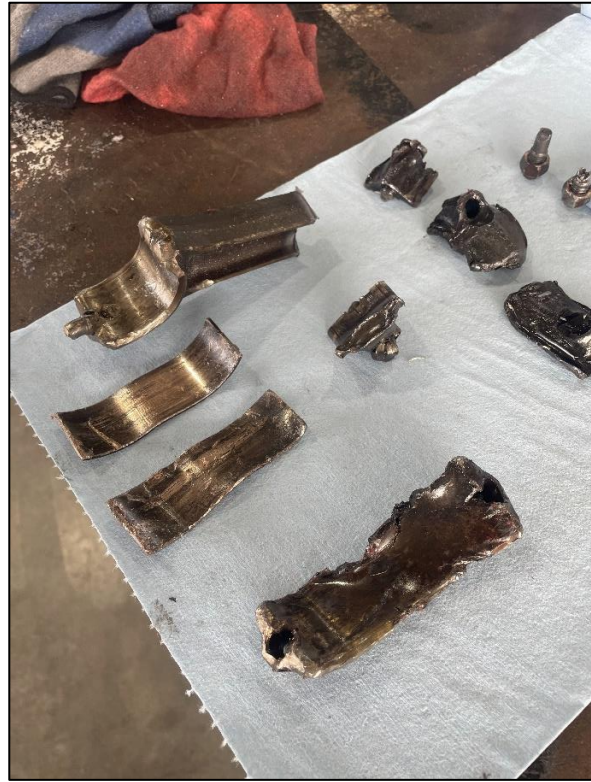
Figure 11-No. 4 connecting rod parts.
