WPR24LA085

## INVESTIGATION PHOTOGRAPHS

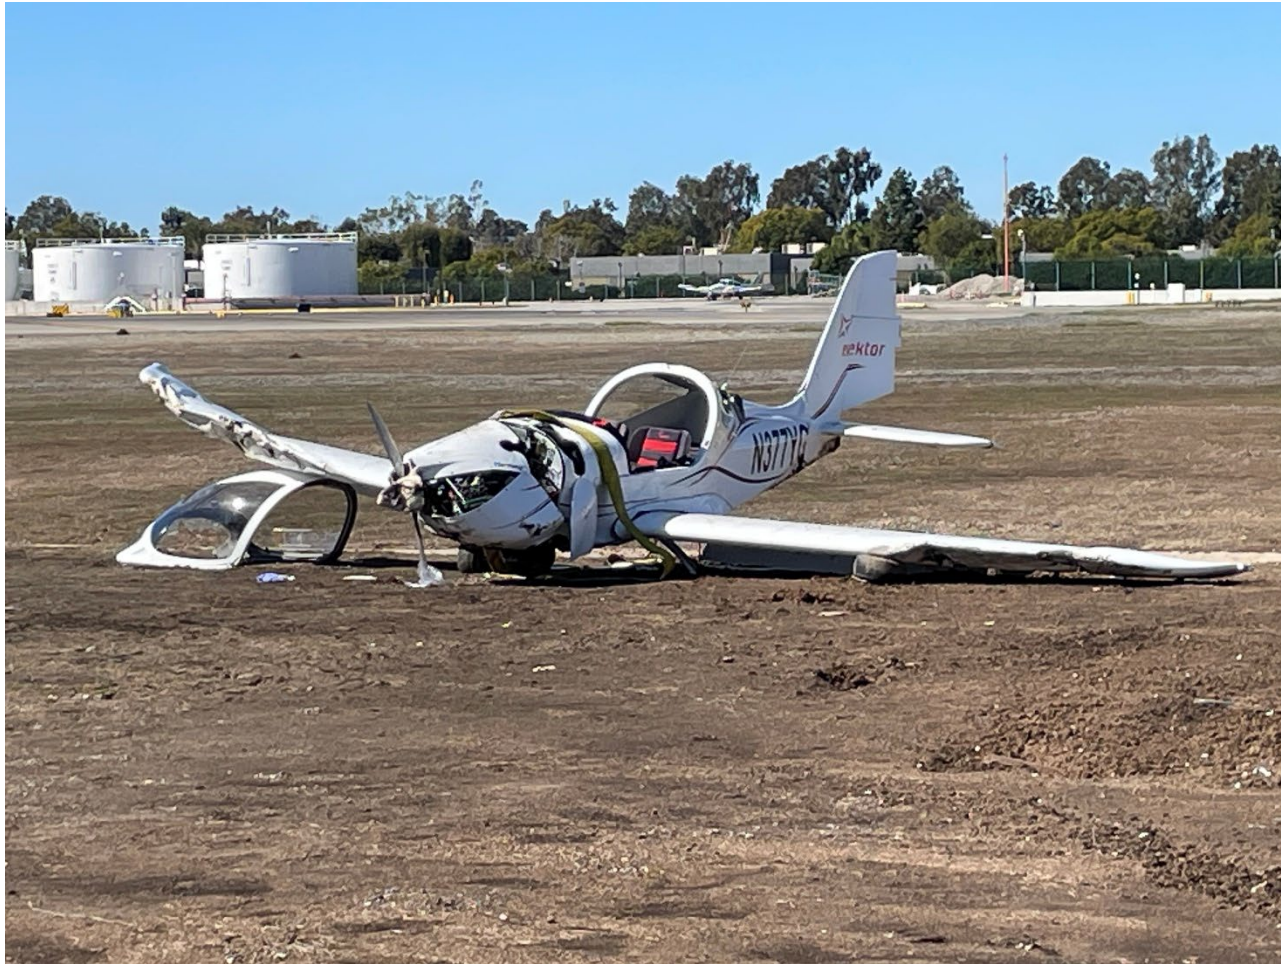
**Photograph 1 - Forward to aft view of the accident airplane (Courtesy of Airport Operations)**

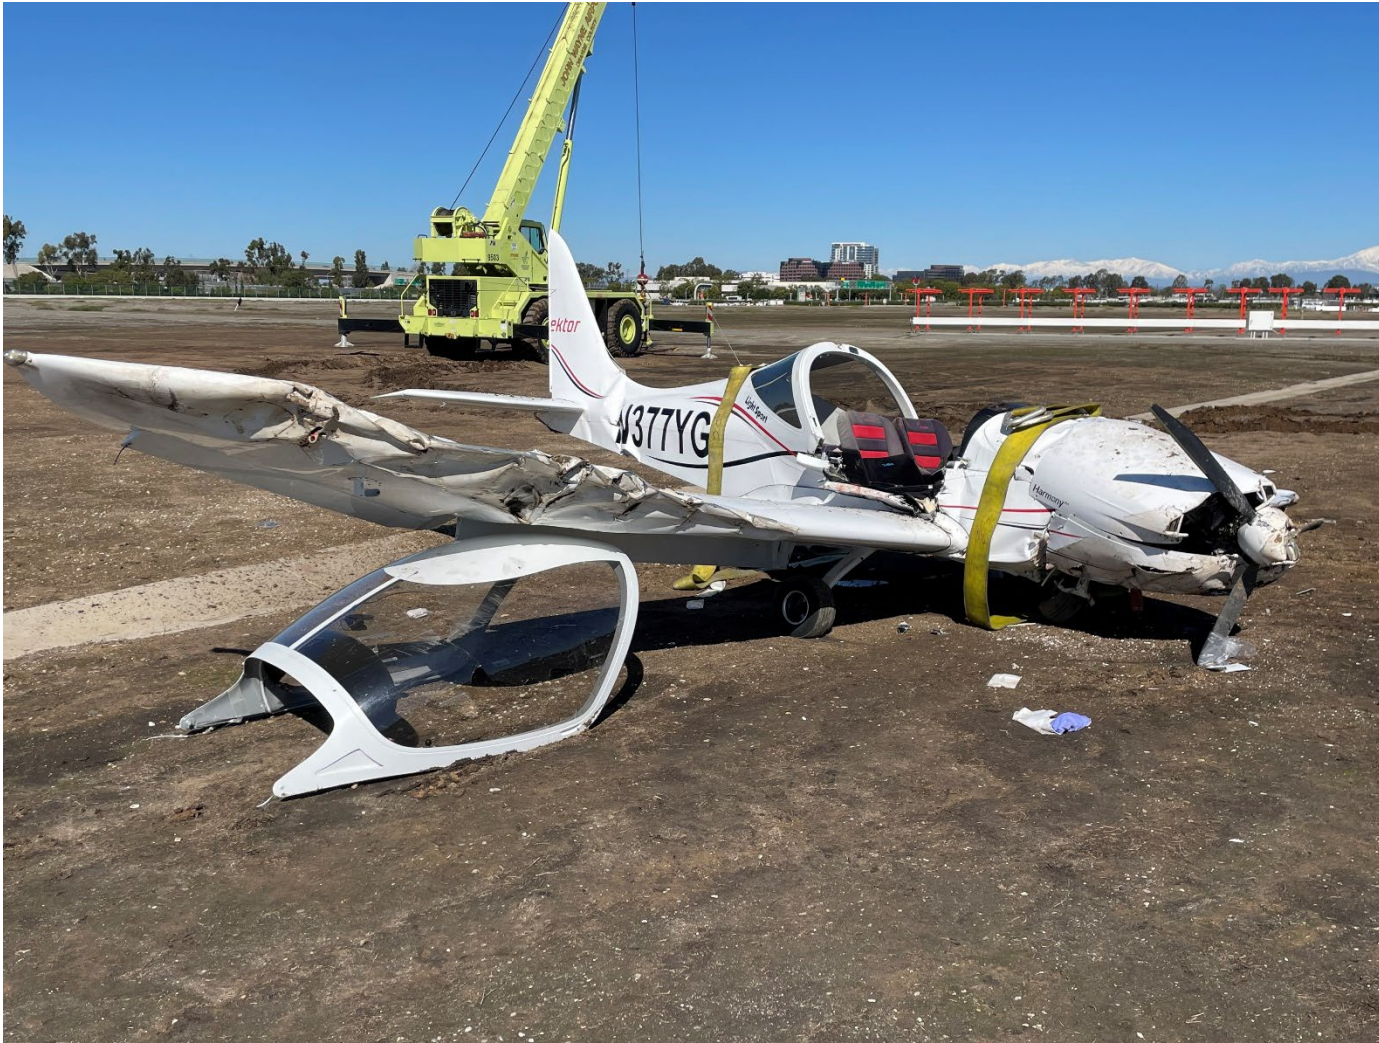
**Photograph 2 - View of substantial damage to the airplane's right wing and fuselage (Courtesy of Airport Operations)**

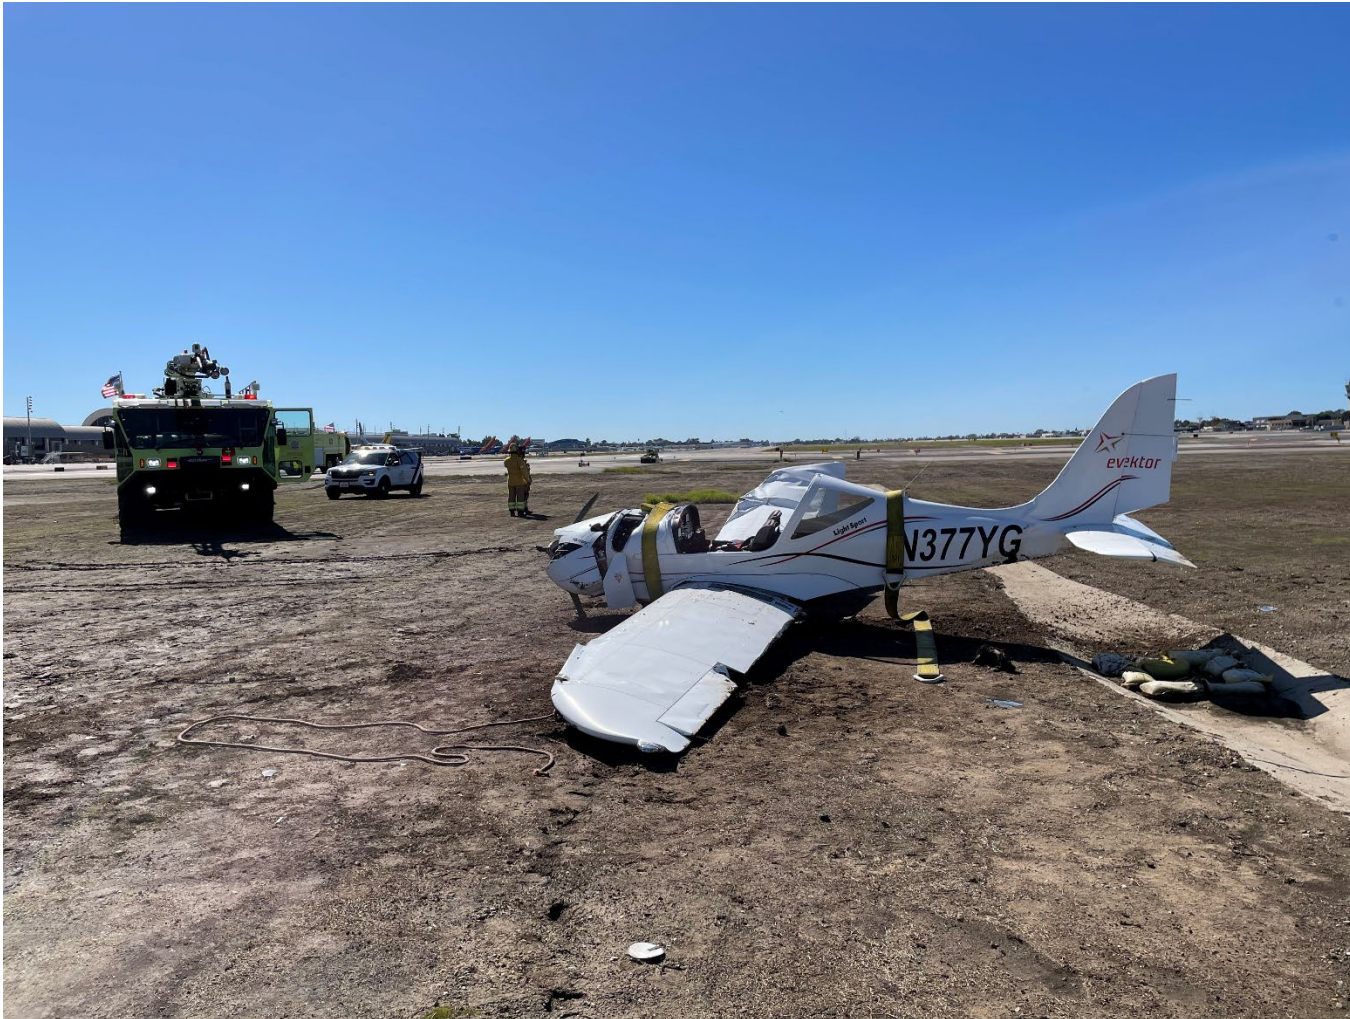
**Photograph 3 - View of the damage sustained to the left side of the airplane (Courtesy of Airport Operations)**

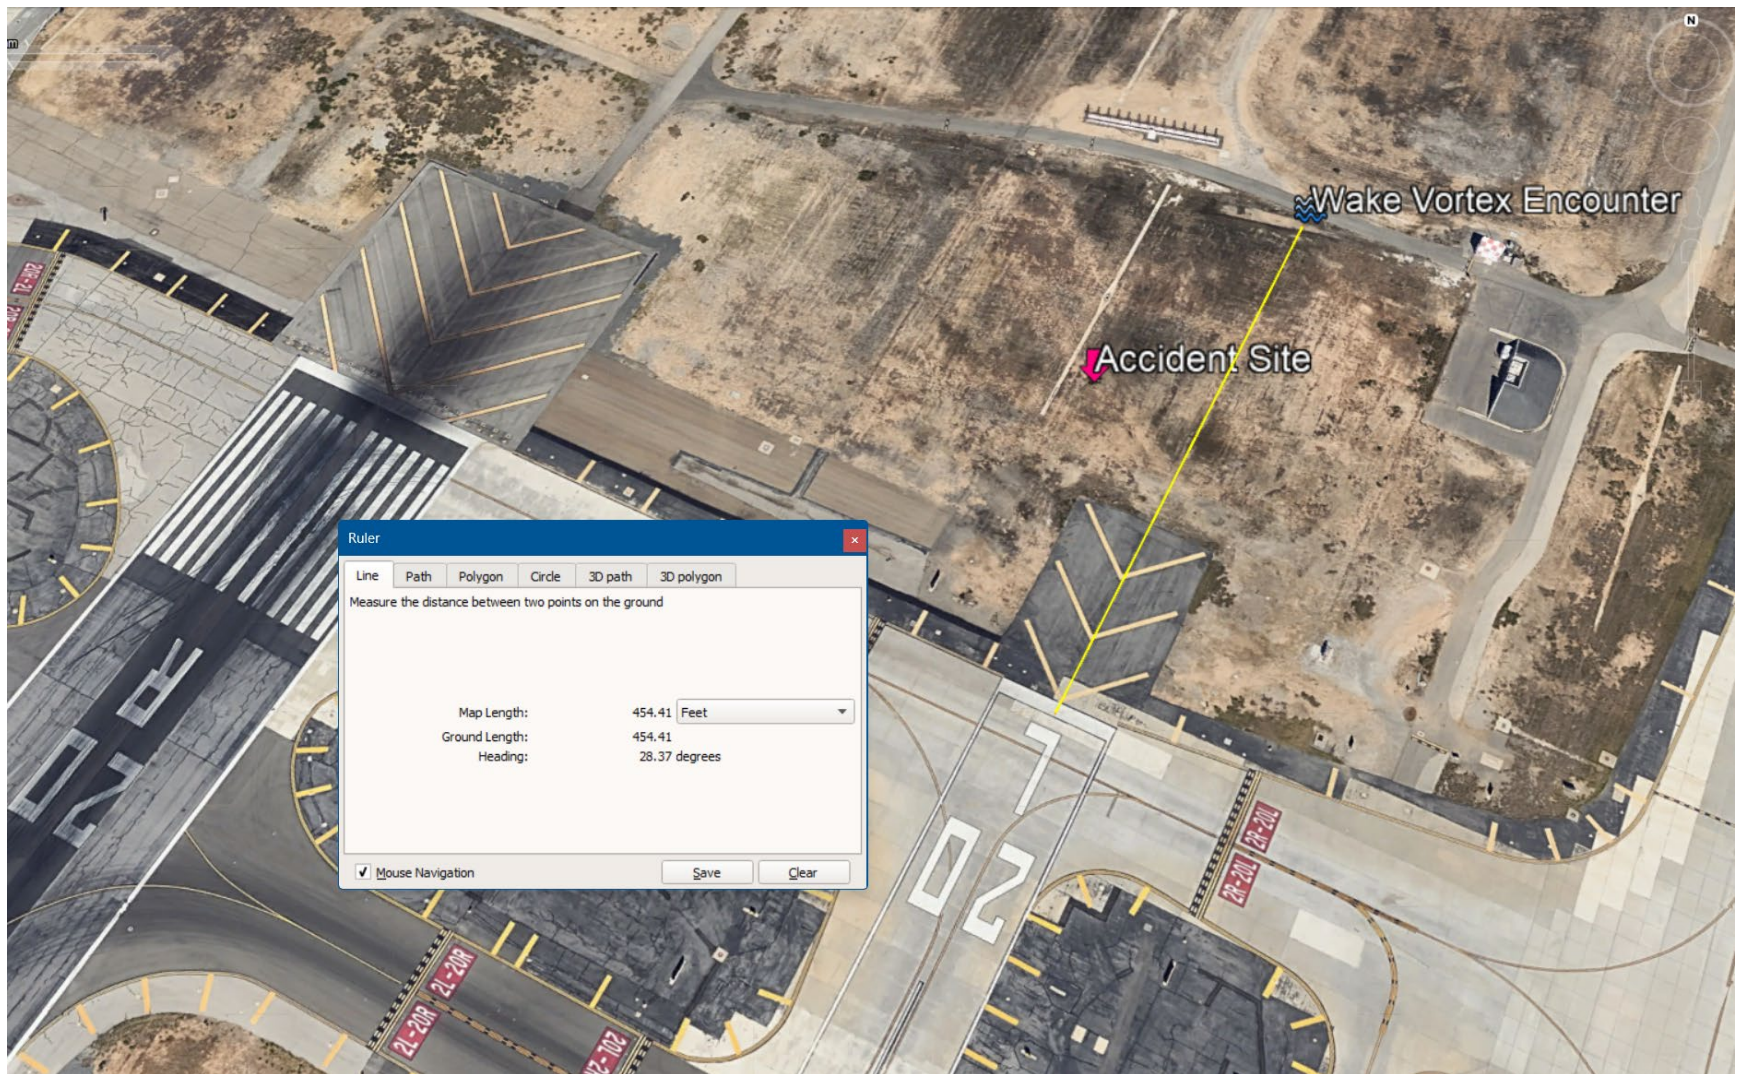
**Photo 5 -Distance between the airplane's wake vortex encounter and runway 20L ~450 ft**
