WPR24LA100

## INVESTIGATION PHOTOGRAPHS

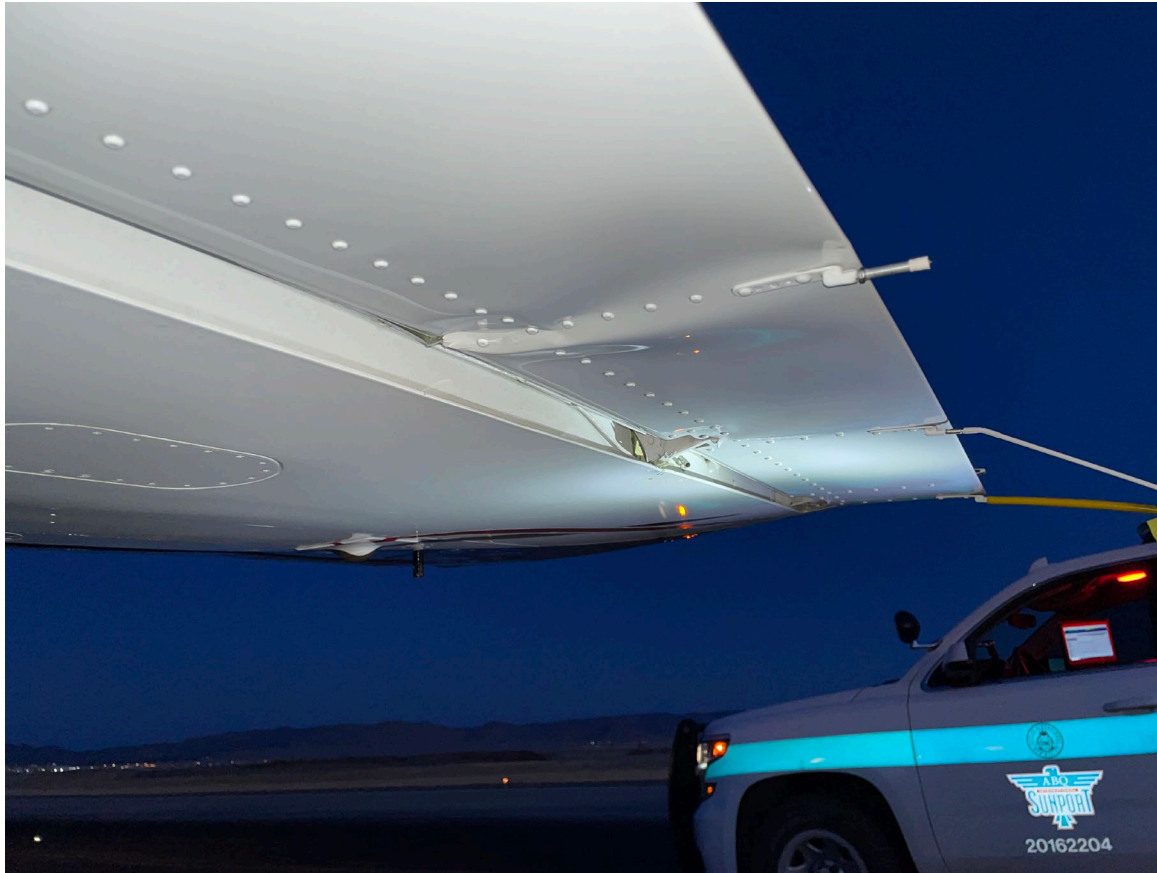
**Photograph 1 - Right Aileron Damage (Courtesy of FAA)**

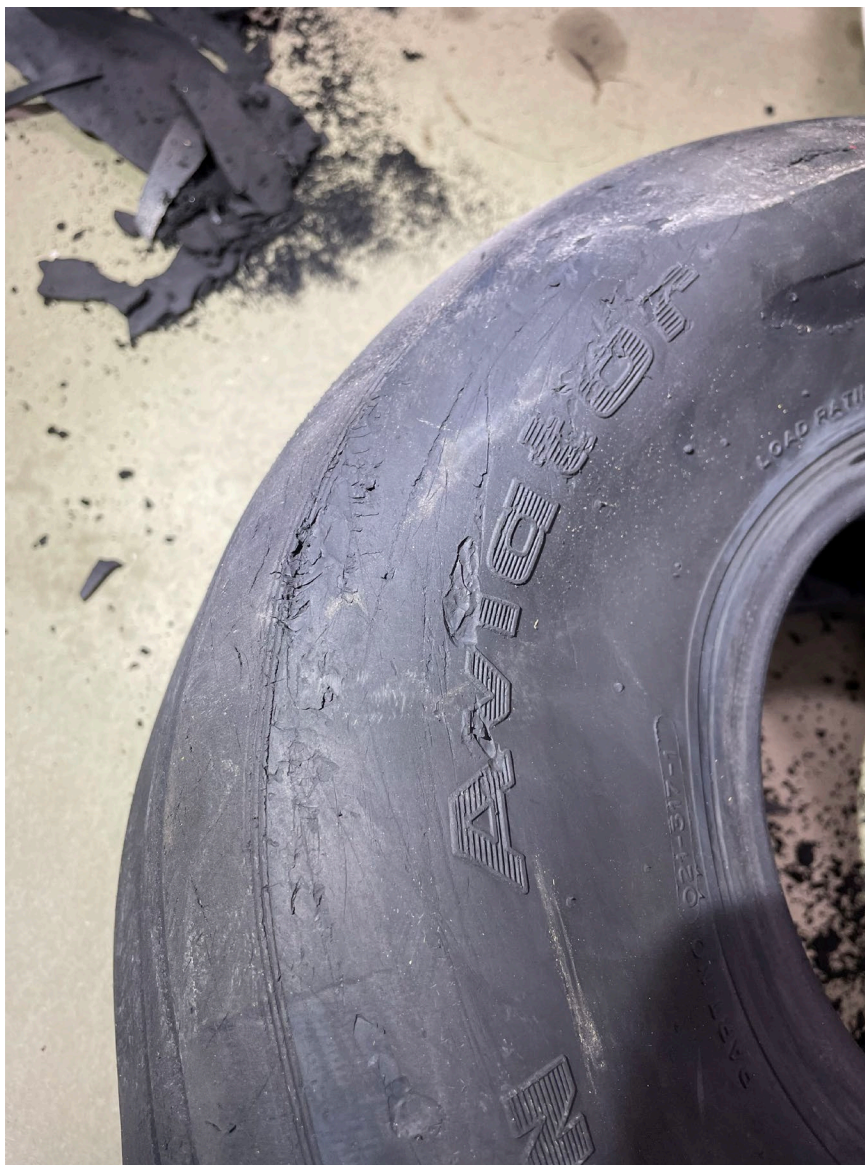
**Photograph 2 - Right Main Tire Sidewall (Courtesy of FAA)**

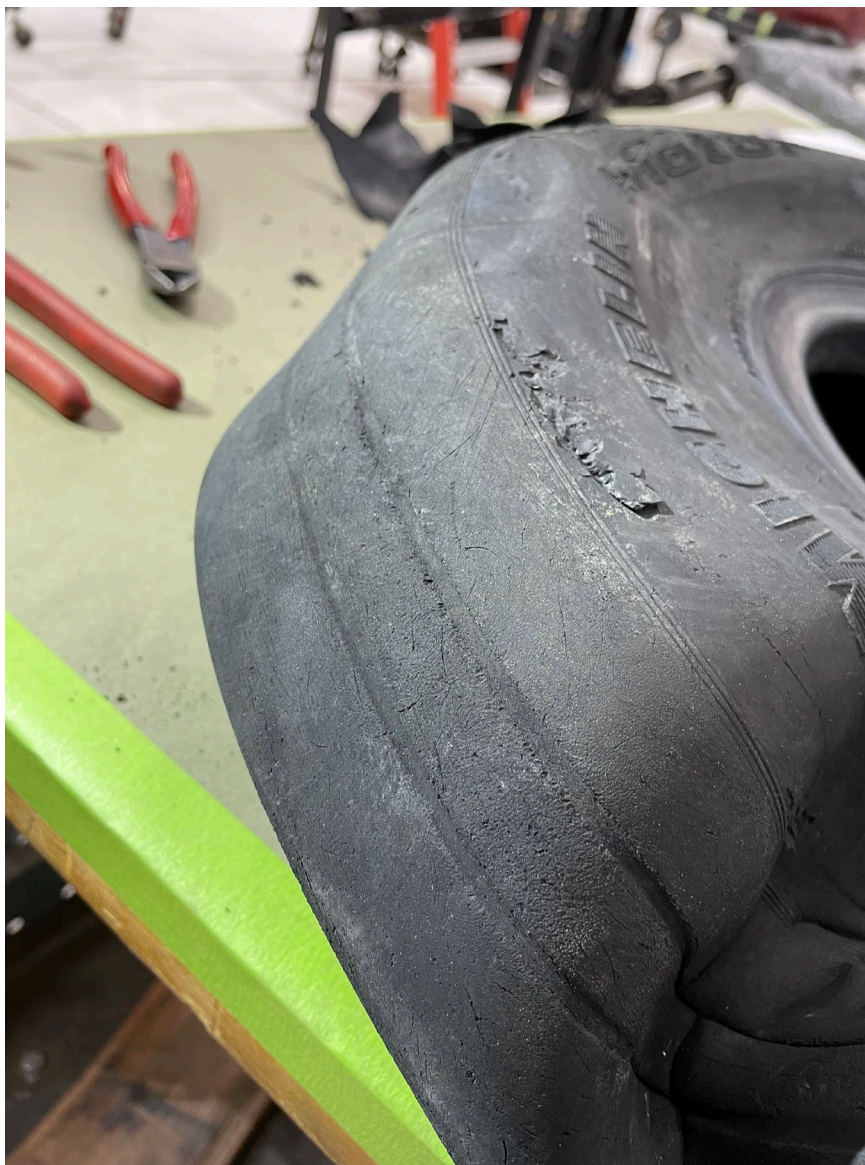
**Photograph 3 - Right Main Tire Tread (Courtesy of FAA)**
