Dan Baker  
Senior Air Safety Investigator  
AS-WPR

**Date:** March 27, 2024

**Subject:** WPR24LA100, Piper PA-46, N26DR Tire Examination Report

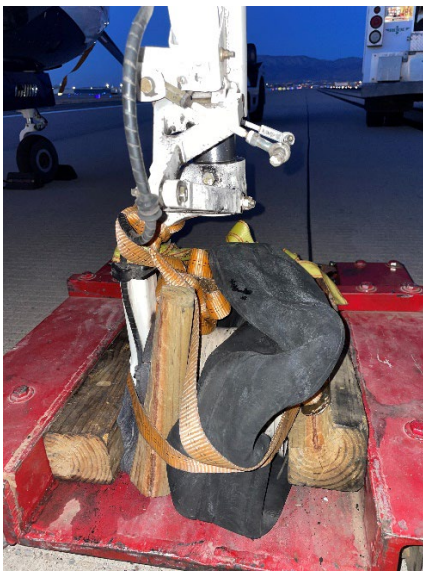
The right main tire of a Piper PA-46 airplane, N26DR, was found deflated following an accident that occurred during landing on February 28, 2024 (figure 1). A mechanic removed the tire from the airplane on March 27, 2024, under the supervision of Jose Figueroa, a FAA inspector from the ABQ FSDO.

Figure 1 - Right Main Tire (FAA Photo)

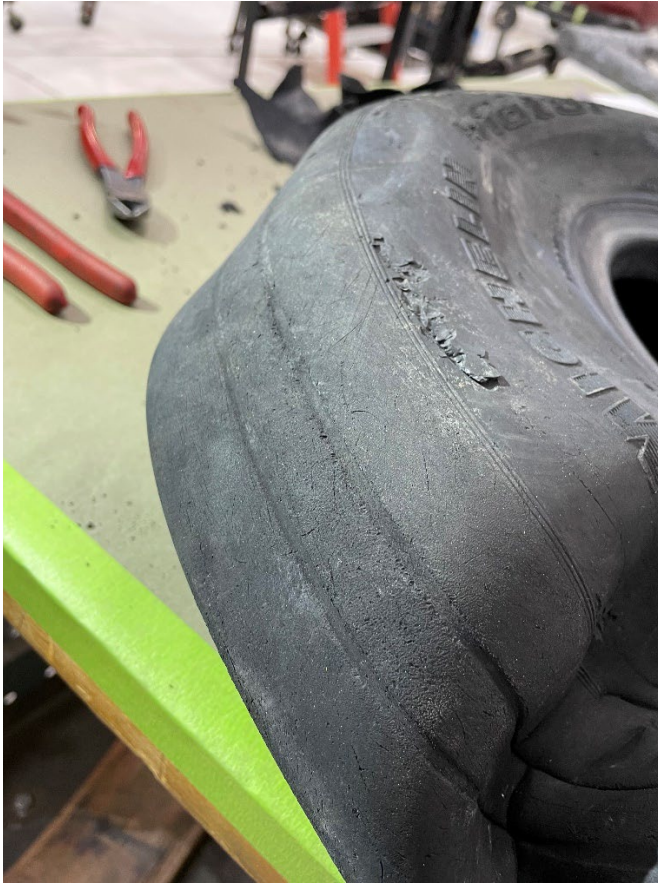
The tire was worn with little remaining tread and there were cuts and abrasion marks on the sidewalls (figures 2 and 3). The tire had an inner tube installed. The tube

Figure 2 - Right Main Tire Tread (FAA Photo)

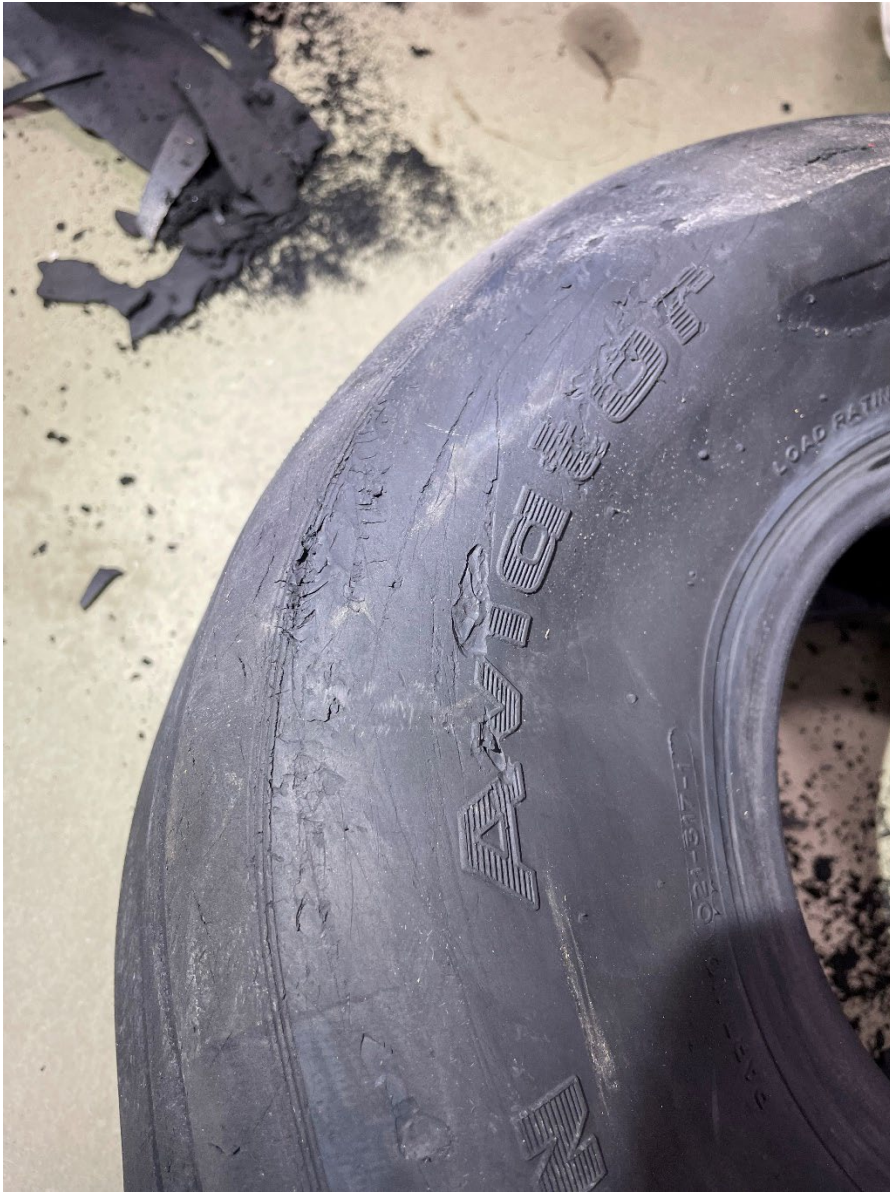
Figure 3 - Right Main Tire Sidewall (FAA Photo)

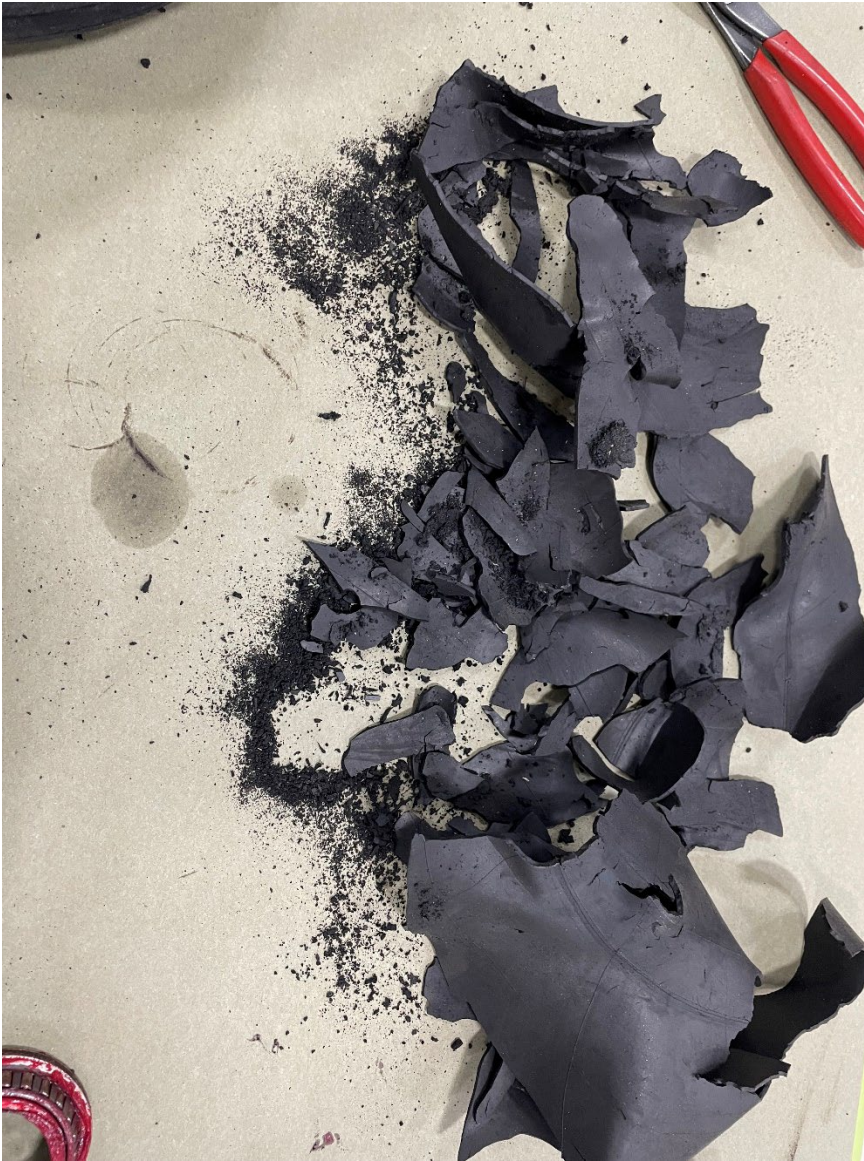
was fragmented (figure 4) and it was not possible to determine the reason for the tube's failure.

Figure 4 - Tire Inner Tube Remnants (FAA Photo)
